AVON WATERWAYS COMMITTEE

RIVER RECOVERY PLAN

Sections 7, 8 and 9 – Mile Pool to Spencers Brook

WATER AND RIVERS COMMISSION
RIVER RECOVERY PLAN
REPORT No RRP 9
NOVEMBER 2002

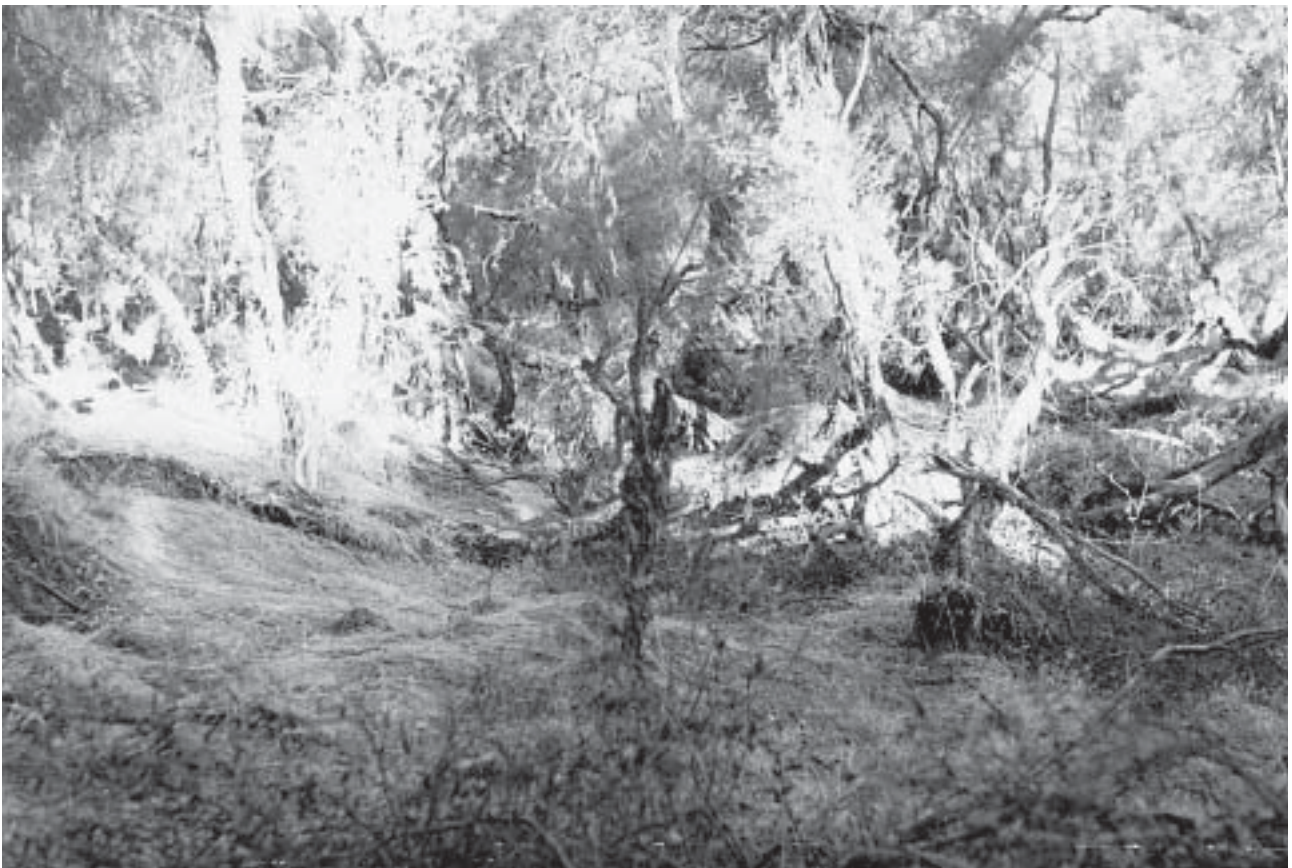
Photo 2: Characteristics of the pre-training braided river channel

Prior to the River Training Scheme (RTS), the river channel was braided (many intertwining channels). Training works during the 1960s converted this to a single channel approximately 60 m wide. Bulldozer action to clear the channel during the RTS has resulted in heaped spoil deposition parallel to streamflow. In places, this performs as a levee, restricting access of floodwaters to the adjacent floodplain. It also truncates some floodways and affects the discharge to the river of some tributaries.

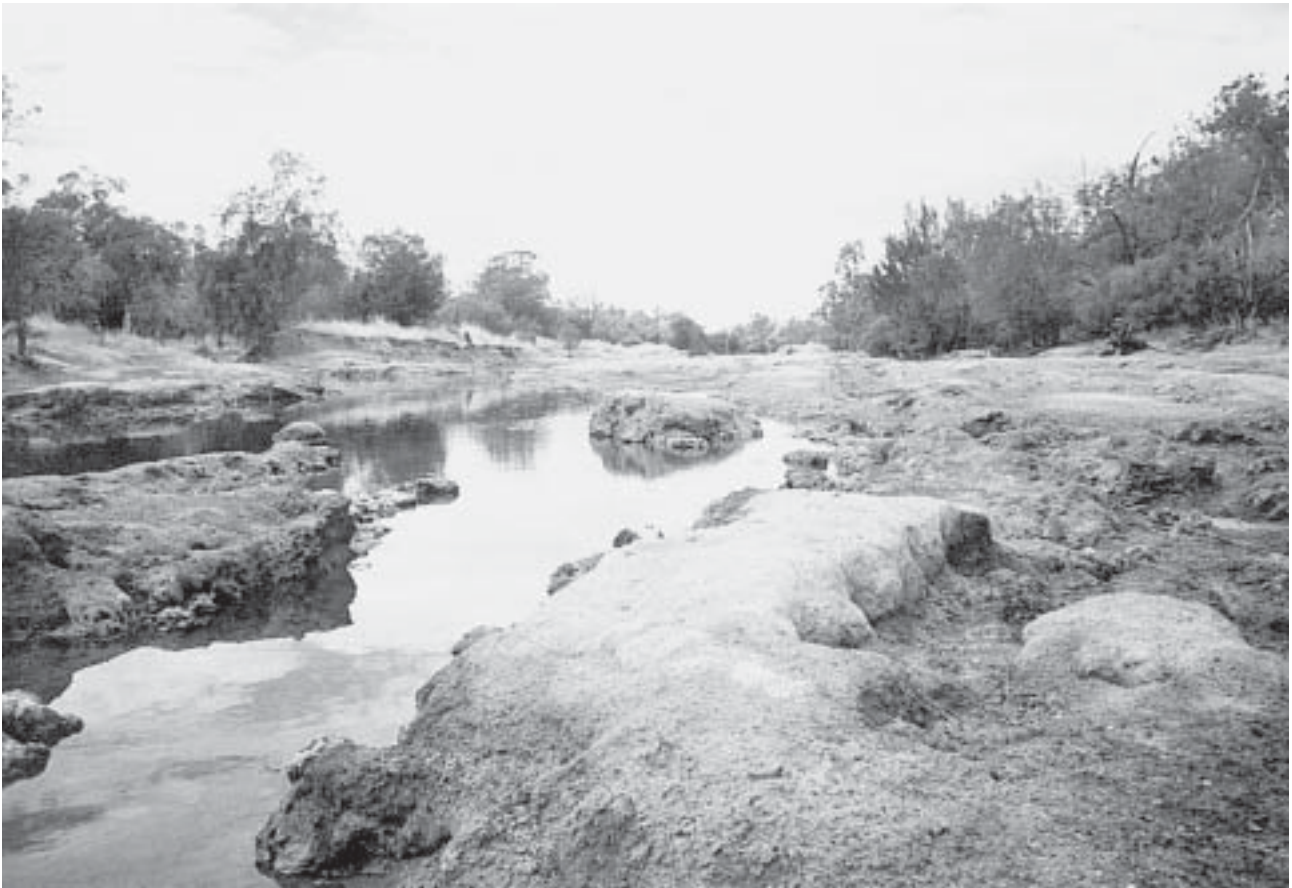
Photo 3: The scoured river channel after the training scheme

The River Training Scheme caused substantial scour of the riverbed and erosion of the spoil that was deposited in ‘windrows’ during the river bulldozing process. Stream-flow velocity is now higher than prior to river training and as a result, sediment transport is substantially greater. The combined effect of these processes is that there has been massive sediment mobilisation in the river and the pools have filled rapidly. Jangaling Pool and Little Pool have filled. Tipperary Pool and Church pools are substantially filled.

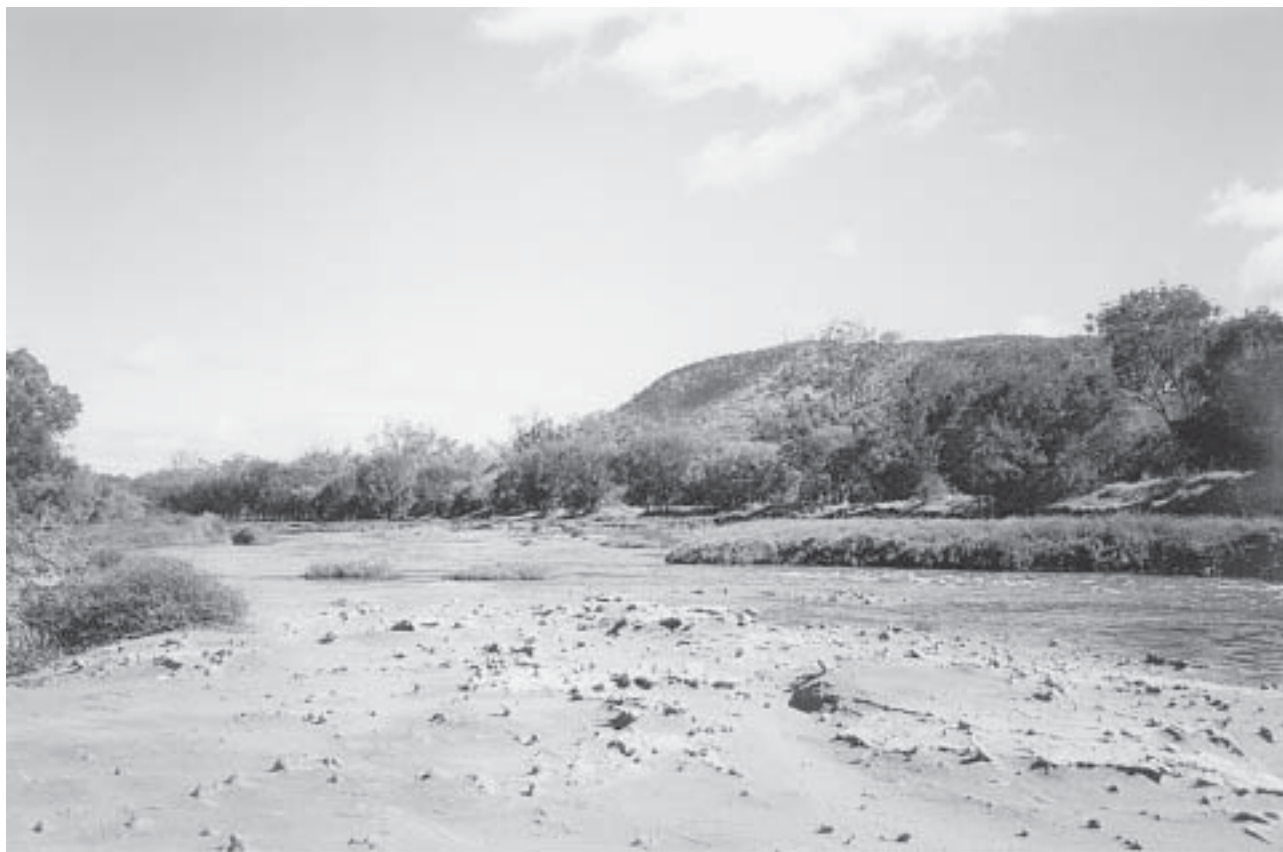
Photo 4: Stabilised island formed from sediments adjacent to recent scouring of the river bank

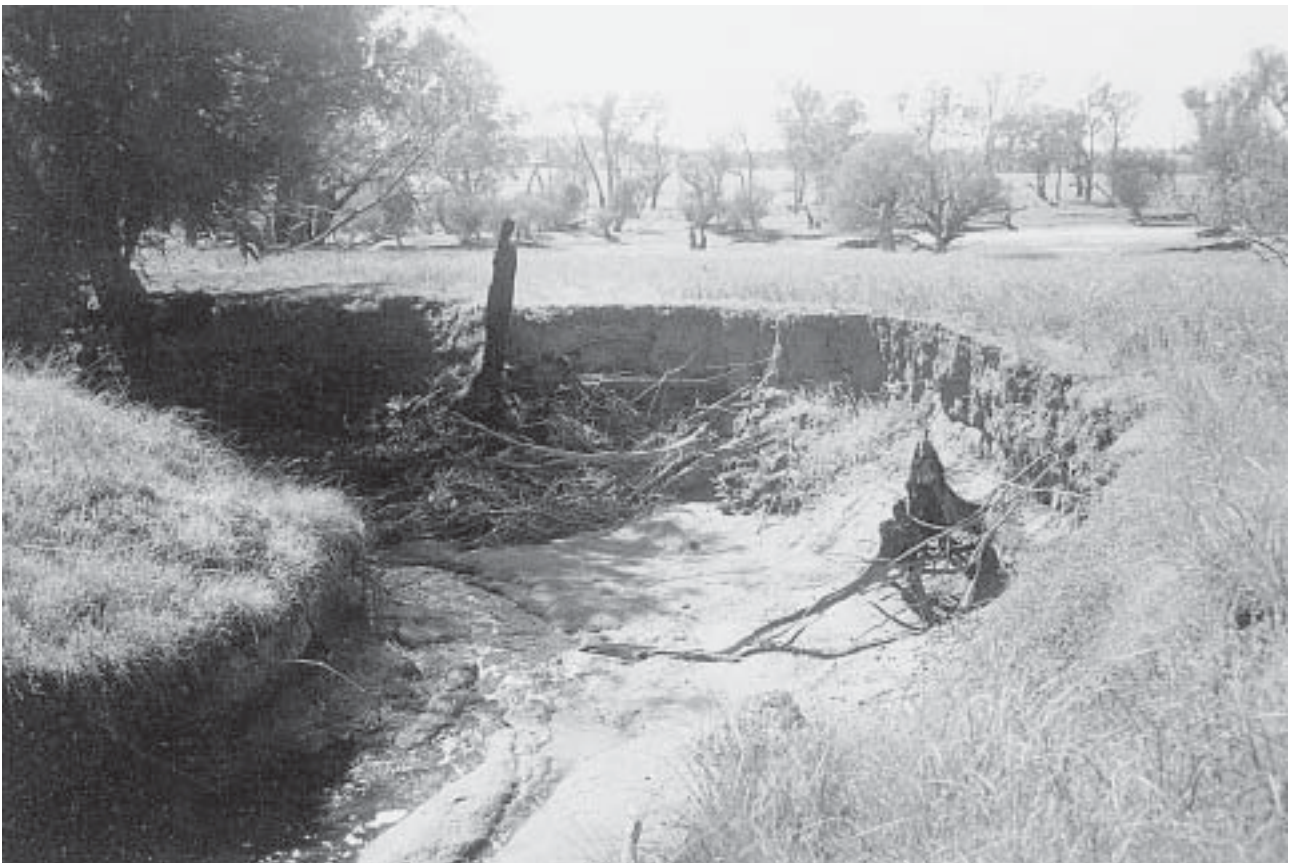
Photo 9: Active erosion of the Breckna Brook channel on the river floodplain

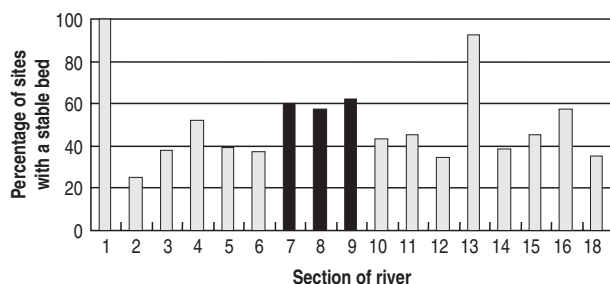
Figure 2: Bed stability along the Avon River
(from Black, 1997a)

The river survey shows that 96% of the banks of the channel in Section 9 are stable, 65% in Section 8, but only 47% in Section 7. Figure 1 shows how these compare with all river sections. All sections had similar bed stability and were generally more stable than other sections of the river (Figure 2).

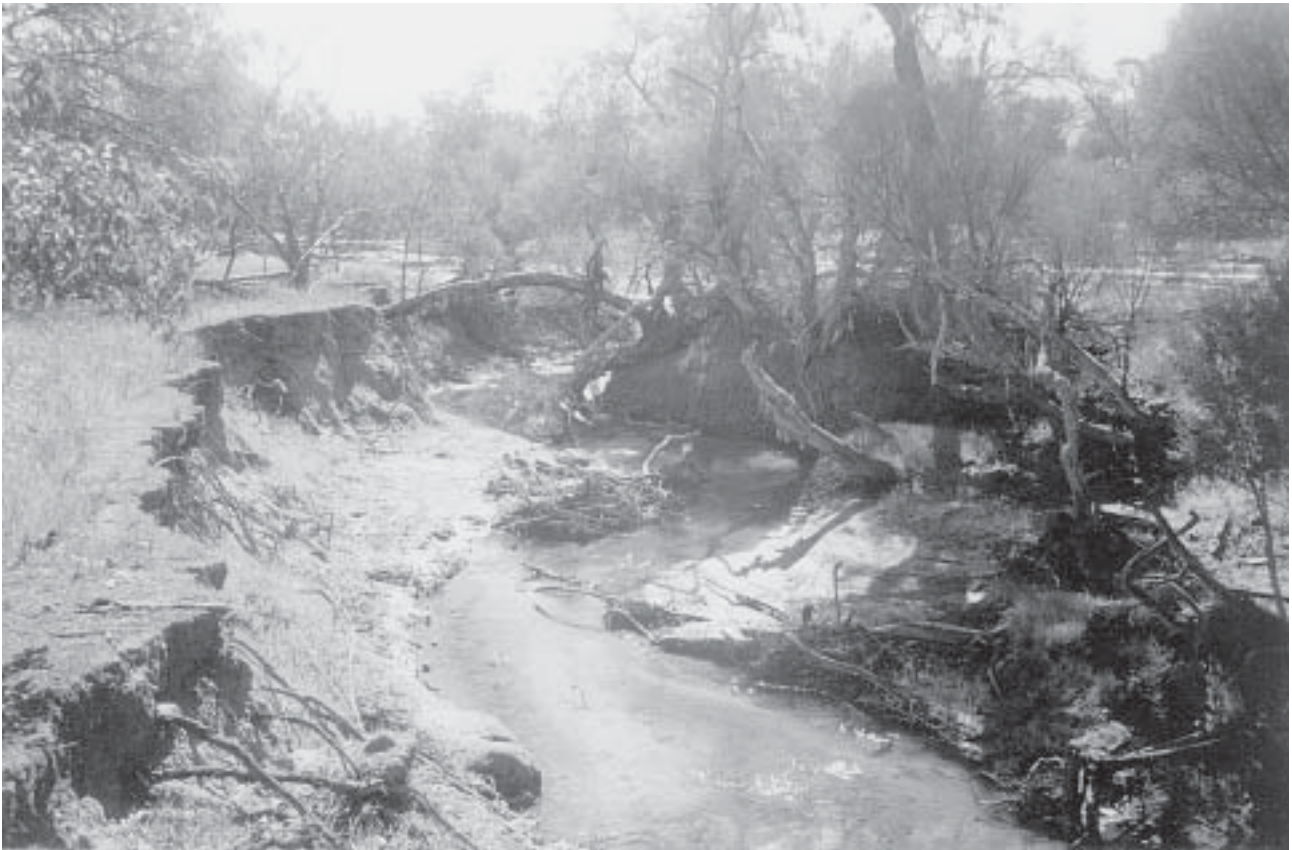
Photo 15: Active erosion of Breckna Brook at the confluence with the river

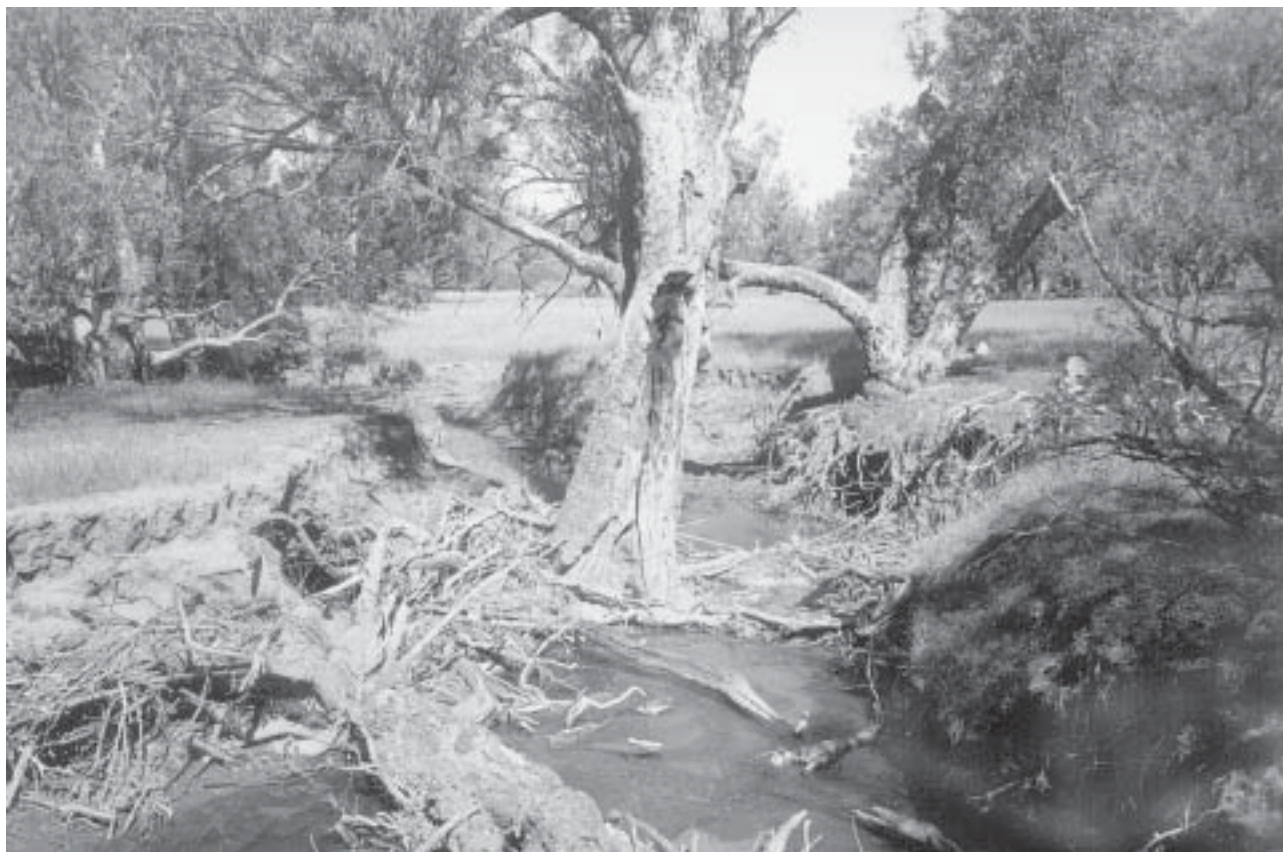
Photo 16: Channel erosion under-cutting fringing vegetation on Breckna Brook

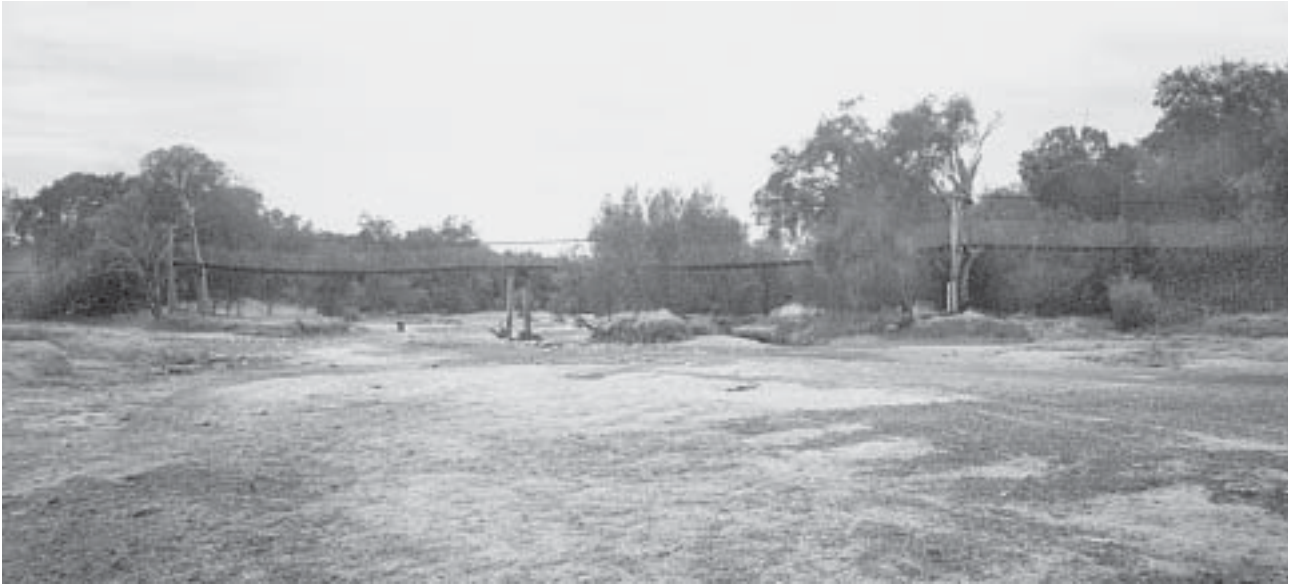
Photo 17: The Swinging Bridge at Muresk

The Swinging Bridge at Muresk, built in 1926 for student access to the college, is currently unsafe for use. An assessment of the feasibility to reconstruct the bridge to safe standards is proposed. Access across the bridge would provide a significant complement to river walks suggested for this area.

Action 7.3 Assess the feasibility of repairing Muresk's Swinging Bridge suitable for public use and developing a river walk trail.

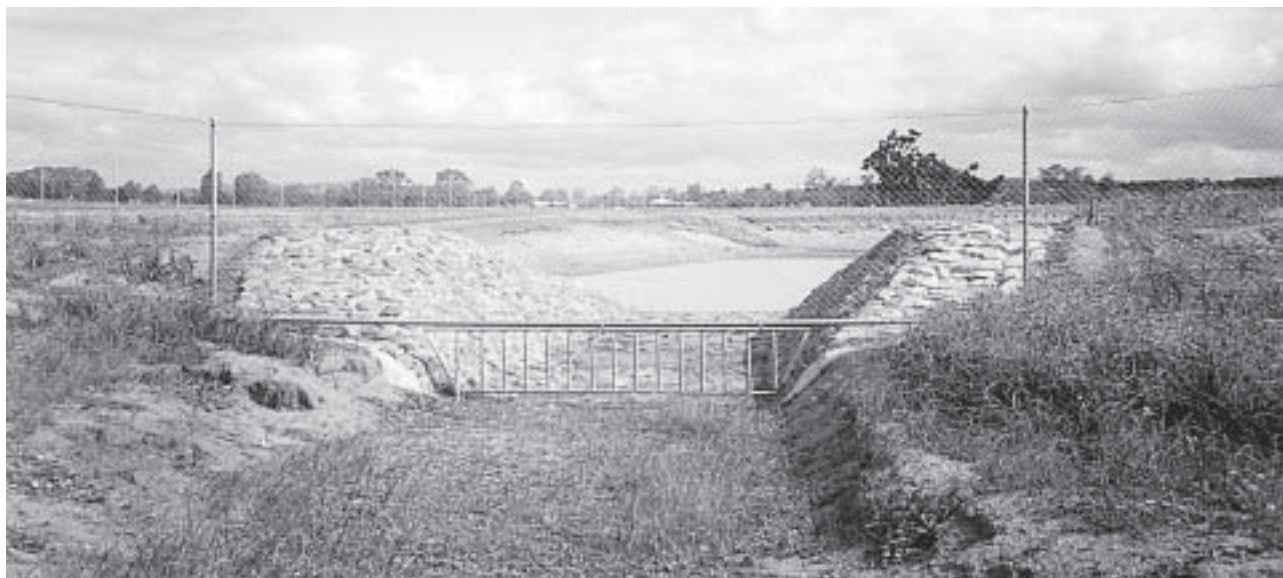
Photo 19: Detention pondage for rural-residential development near York
