Department of Parks and Wildlife
South Coast Region

**COMPLIANCE
ASSESSMENT REPORT
(Ministerial Statement 884)**

22 December 2012 to 21 December 2013

Fitzgerald River National Park Coastal
Walk Trails from Point Ann to Fitzgerald
Inlet and from Cave Point to Quoin
Head

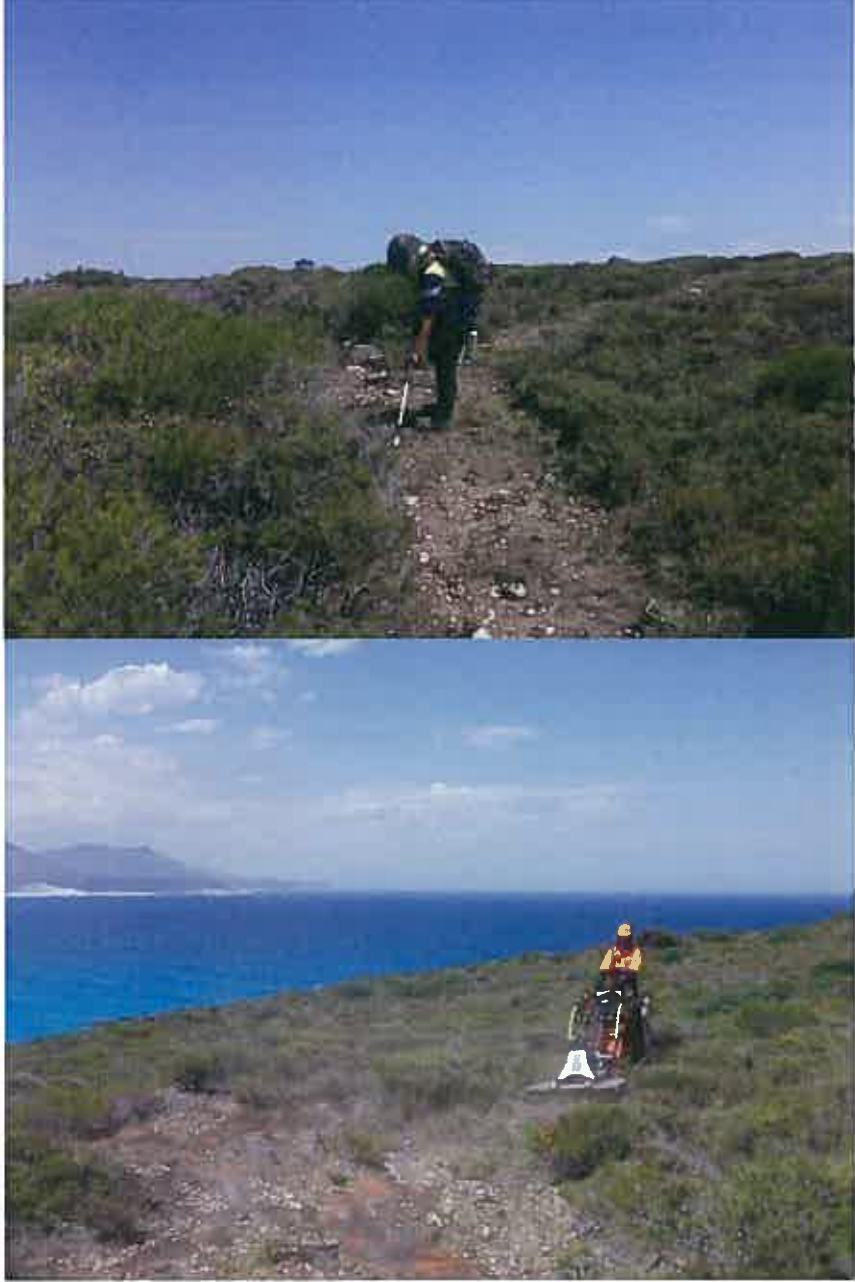
EMP Key Objectives	Status	Further Information
Vegetation Clearing Management	Compliant	<p data-bbox="584 232 1428 398">Clearing for the walk trail has been a maximum of 2m wide and completed either by hand or with a machine mounted slasher. The edges of the machine clearing have been kept very neat by pre-clearing by hand and cleaning up afterwards. This was done to reduce incidental deaths of damaged plants along edges of the trail.</p>

<p data-bbox="616 1686 1417 1711"><i>Trail construction Point Charles 2012 (The department Trails Officer and crew)</i></p>

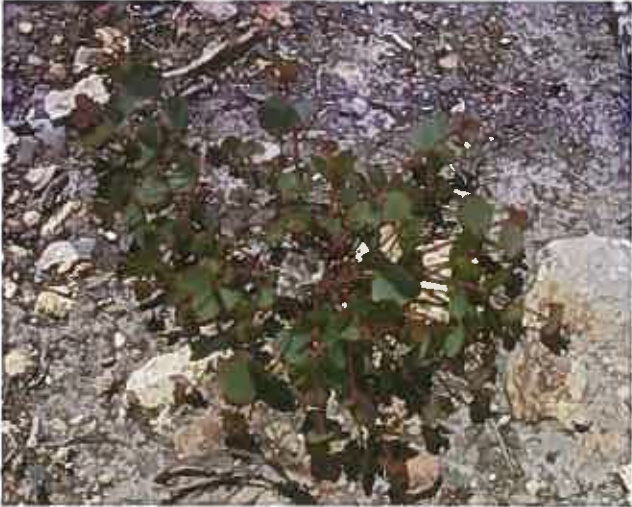
EMP Key Objectives	Status	Further Information
Rehabilitation Management	Compliant	<p>In most areas, mulched vegetation has been left on the trail to help stabilise the tread surface. Many of the plants within or on the edge of the slashed area are already re-sprouting.</p>

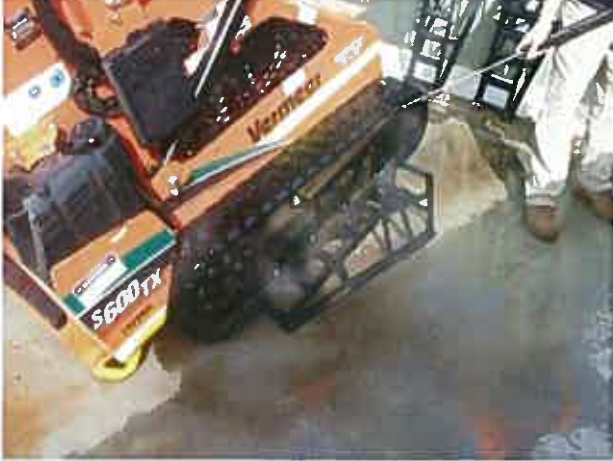
Dieback and other Plant Pathogens Hygiene Management	<p>Compliant within the control of the department</p> <p>Beyond the department control</p>	<p>All vehicles, machines and equipment taken on site have been cleaned and inspected by either the Walk Trail Project Officer, the Environmental Officer, Park Ranger staff or other project staff. Works have ceased following rainfall events to prevent potential spread of material along the trail alignment, and have not recommenced until soil conditions were suitable (soil no longer adhering to the tyres or undercarriages of vehicles, or being transported by machinery and footwear).</p>

<p><i>Pressure spray cleaning of equipment</i></p> <p>On two known occasions during 2013, vehicles driven by Aboriginal traditional owners entered the final 1.2 km of the Mamang Trail and Fitzgerald Inlet campground. Vehicles were inspected and found to be acceptably clean on entry at the park boundary, however there is no knowledge of the (otherwise formally closed) track conditions between there and the coast. On one occasion rainfall had occurred in the Jacup – Ravensthorpe area in the preceding week.</p>

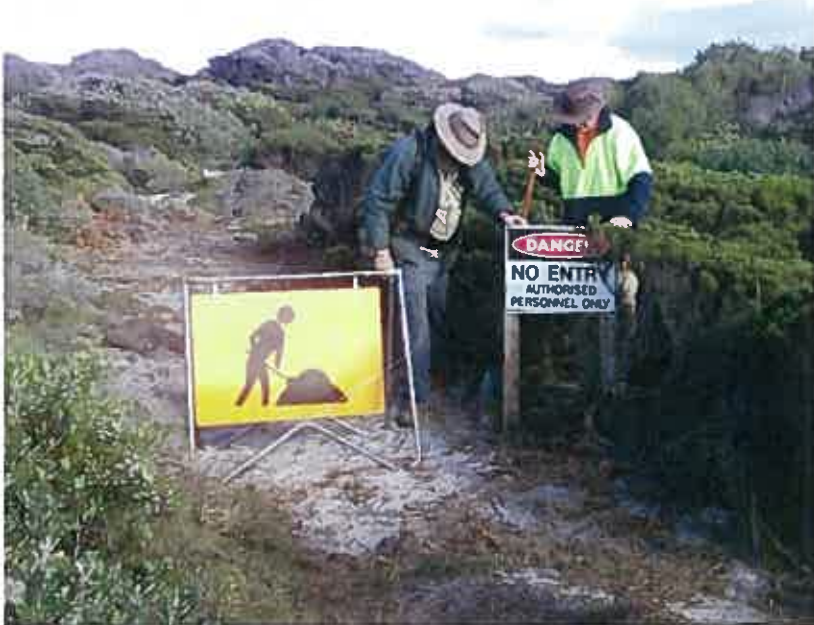
EMP Key Objectives	Status	Further Information
Access Management	Compliant	<p>The walk trail construction site has been closed to public access using signage and fencing. There were minor incidents of unauthorised trail bike and pedestrian access to both trails, following which further preventative action of improved management signage, several gates and more bollards were installed.</p>

<p><i>Mamang Trail (The Trails officer and crew member) 2012</i></p>

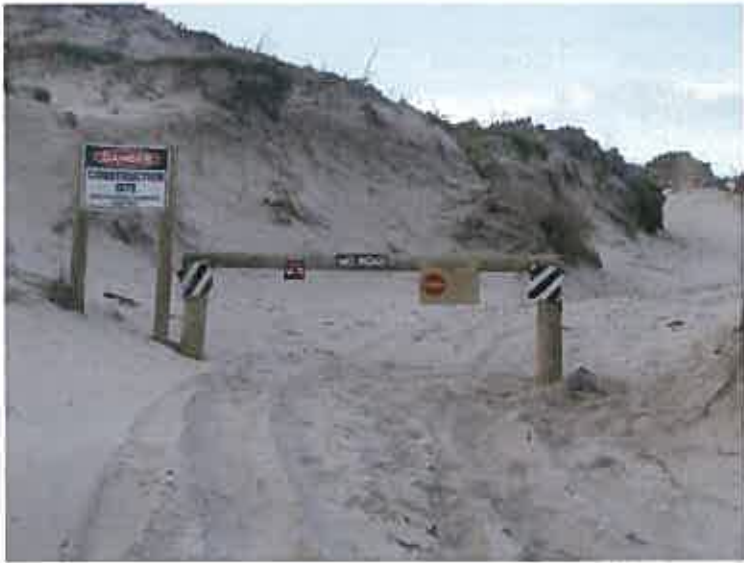
<p><i>Hakea Trail construction access to Whalebone area August 2013</i></p>

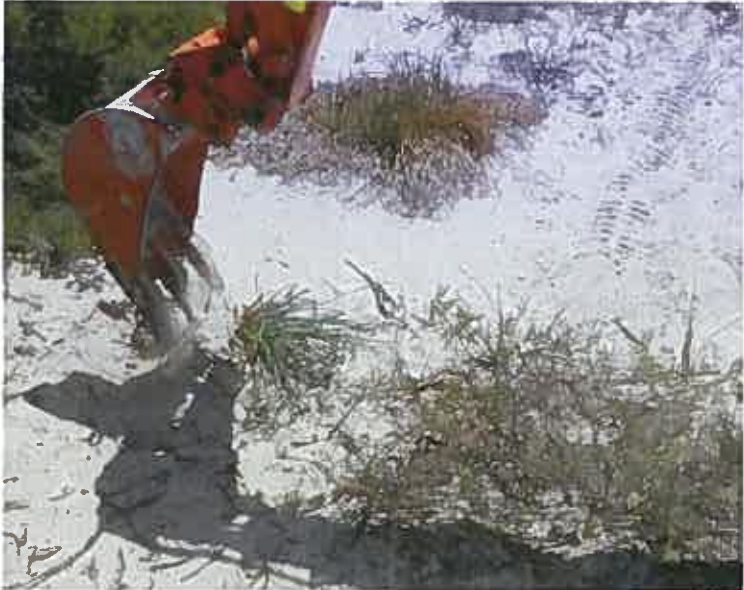
EMP Key Objectives	Status	Further Information
Weed Management	Compliant	<p>No new introduction of weeds has been noted. The small patch of Dune Onion Weed (<i>Trachyandra divaricata</i>) on the Point Charles fore-dune that was identified from the flora surveys was physically removed from site in the previous reporting period.</p>

<p>The area has been subsequently been observed on visits to the area about every 2-3 months. No noticeable spread has occurred. A vegetation monitoring point is established where the trail crosses the former weed site.</p>
Fauna management	Compliant	There have been no known deaths or injury of fauna on site.
Threatened and Significant Flora Species/ Communities Management	Compliant	Priority flora species have been marked on-site with flagging tape prior to clearing, and avoided where possible. Construction crews have been given priority flora identification booklets to enable them to identify the species to avoid on-site (Appendix 4).

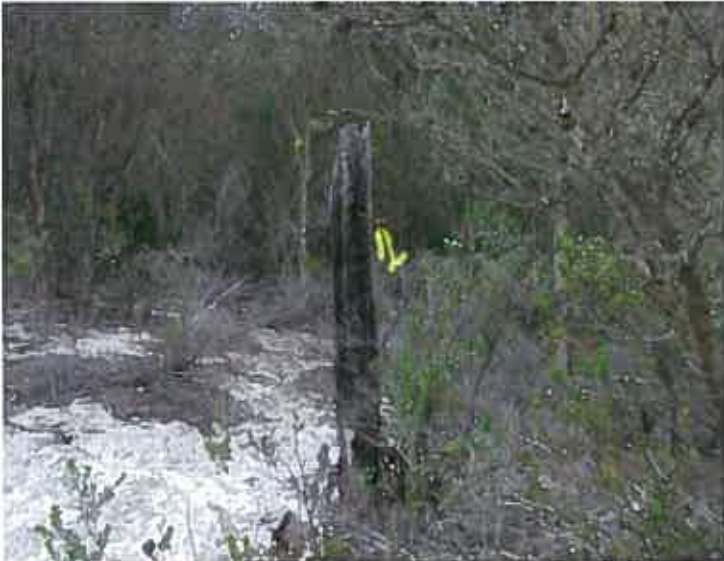
<p>19th century Intercolonial telegraph line post stump 2012</p>

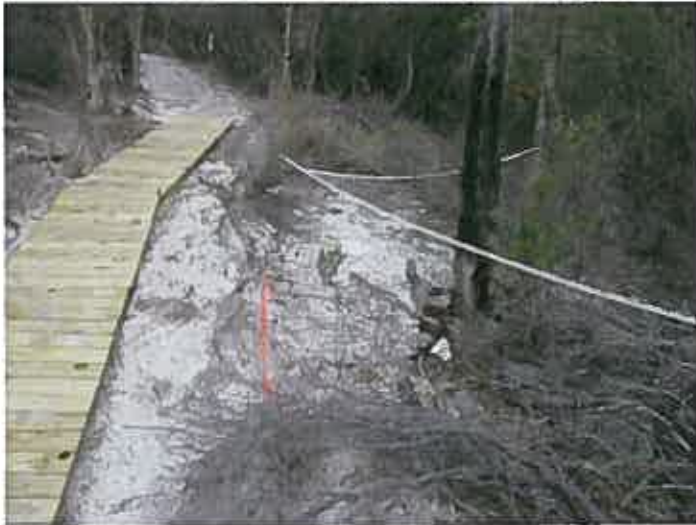
<p>Boardwalk around same heritage feature installed July 2013 (Green Skills). Old insulator (moveable heritage) will be taken for safe keeping and a low information panel will be installed as indicated by the red ribbon</p>

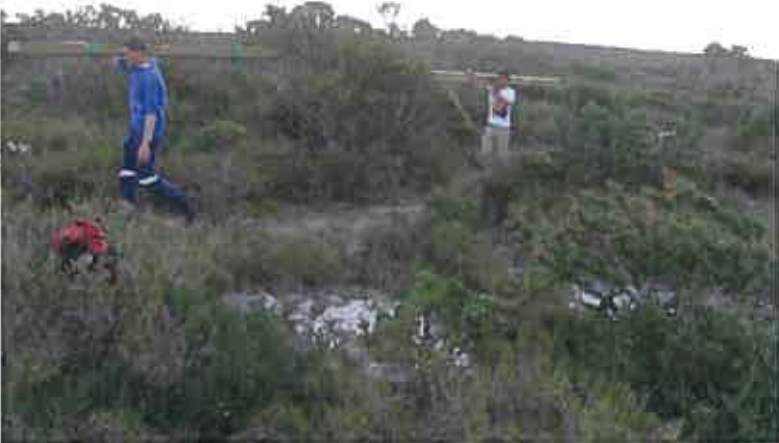
<p><i>All construction materials were carried in up to 3km by hand (Green Skills crew) to minimize vegetation impacts caused by machinery July 2013</i></p> <p>In order to provide resistance to termites and minimize risks of later structure failure, treated pine timber has been used in (e.g. platform support posts) or on the ground (primarily steps and drainage bars). Decking and seating materials have met required standards for human contact.</p>

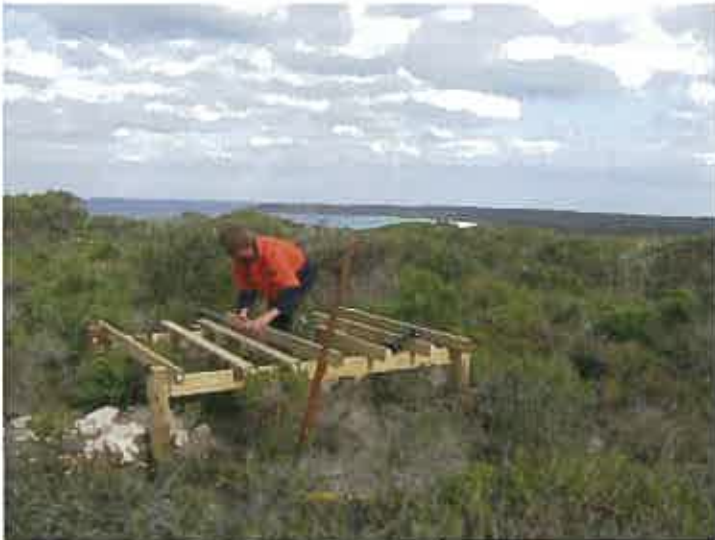
<p><i>Lookout platform construction (Green Skills supervisor) next to trail July 2013</i></p>

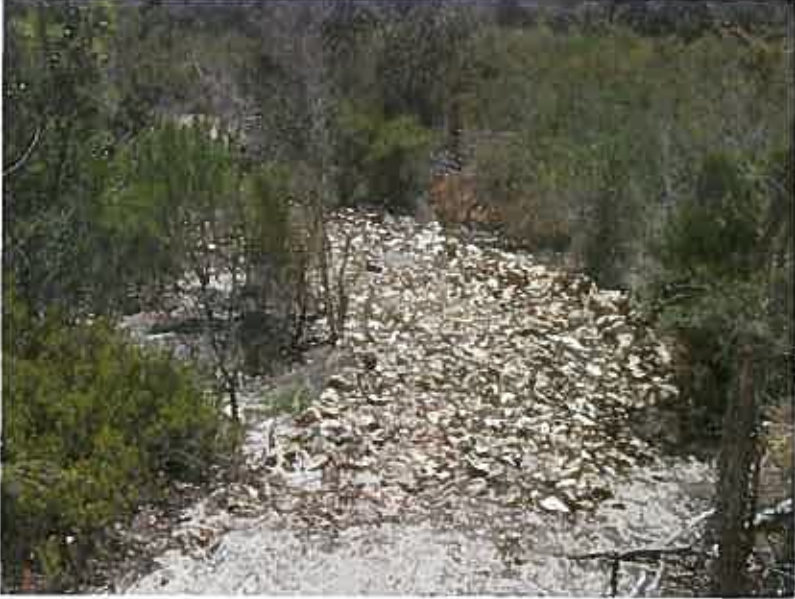
<p><i>Mamang Trail stone work (The Department crew) 2012</i></p>

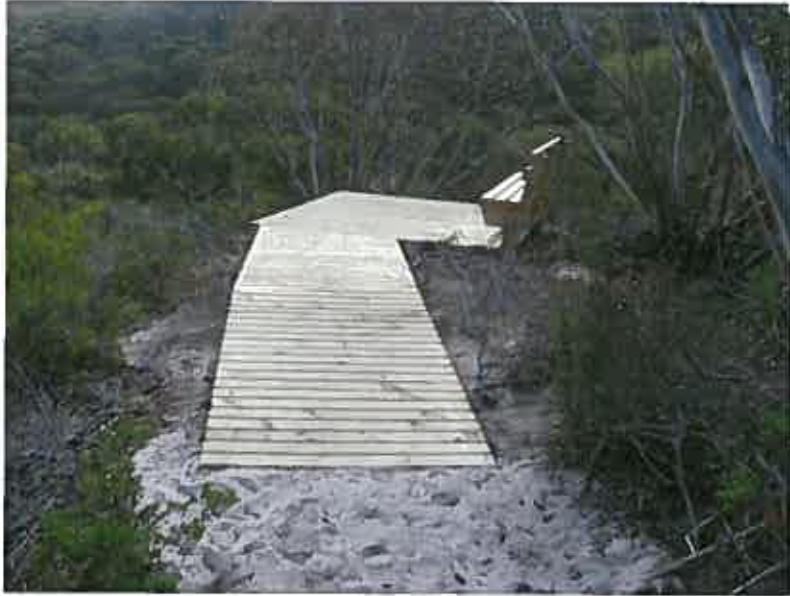
<p><i>Boardwalk and seating platform on sandy substrate (Green Skills), Lake Nameless, Mamang Trail July 2013</i></p>

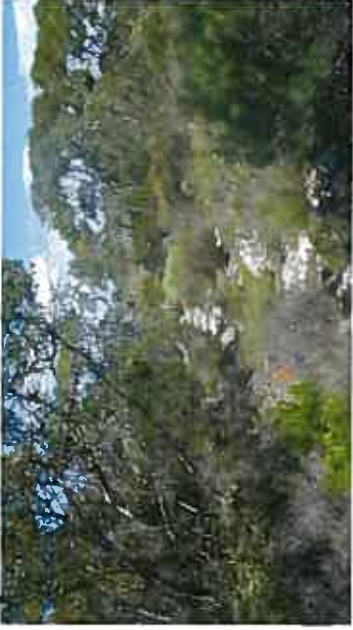
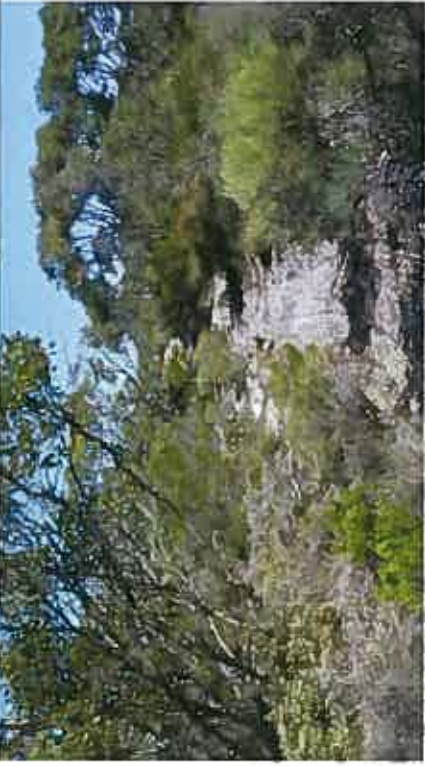
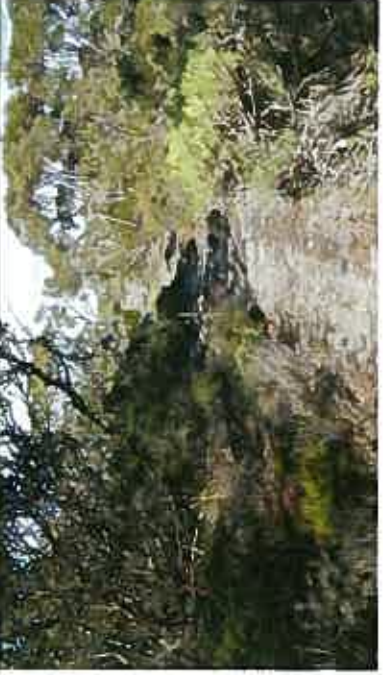
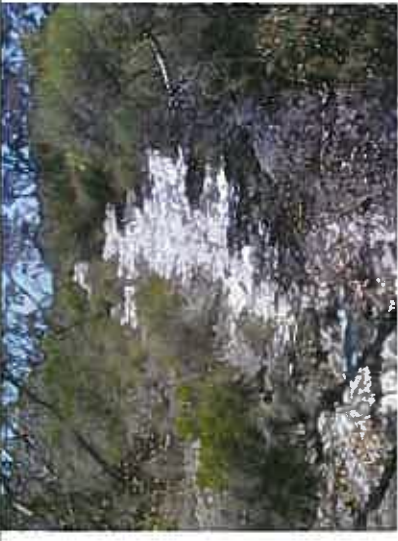
Monitoring Site M12

<p>Pre-construction – approaching machine slasher just visible in distance (5 October 2012)</p>

<p>Post vegetation clearing – temporary reference peg in place (6 October 2012)</p>

<p>~ 8 months after clearing (12 June 2013)</p>

<p>~ 16 months after clearing (17 February 2014 - in 2013/2014 reporting period with new permanent reference marker)</p>

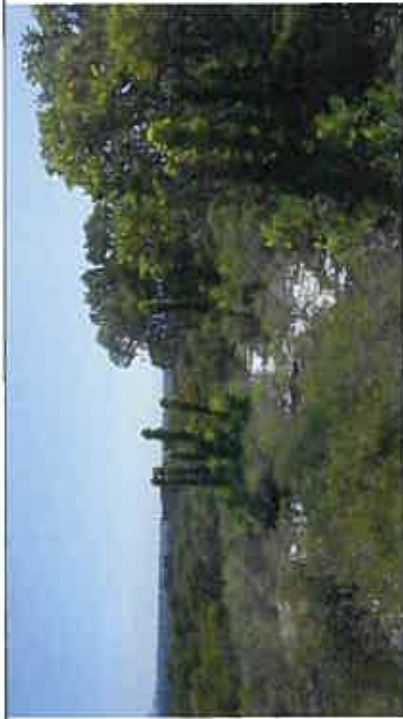
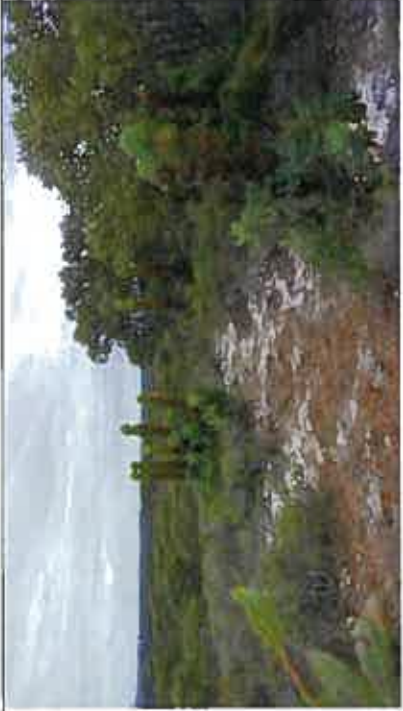
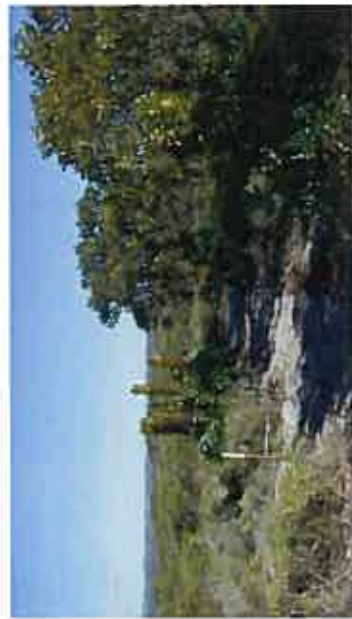
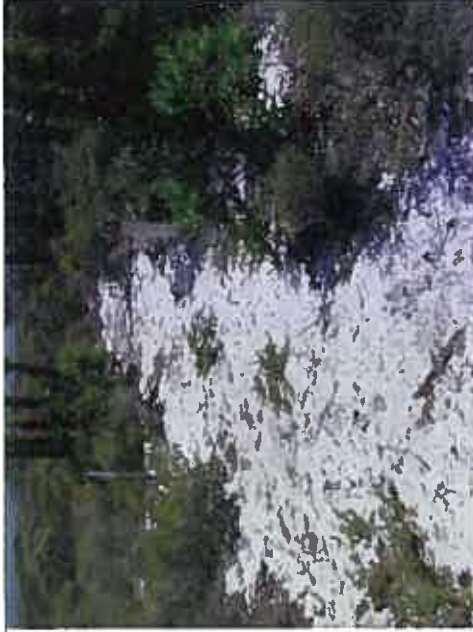
Monitoring Site M14

Pre-construction (22 November 2012)

Post vegetation clearing (28 November 2012)

~ 7 months after clearing with temporary reference peg (12 June 2013)

~15 months after clearing (21 February 2014 – in 2013/2014 reporting period with new reference marker on right – temporary peg removed after photograph taken)

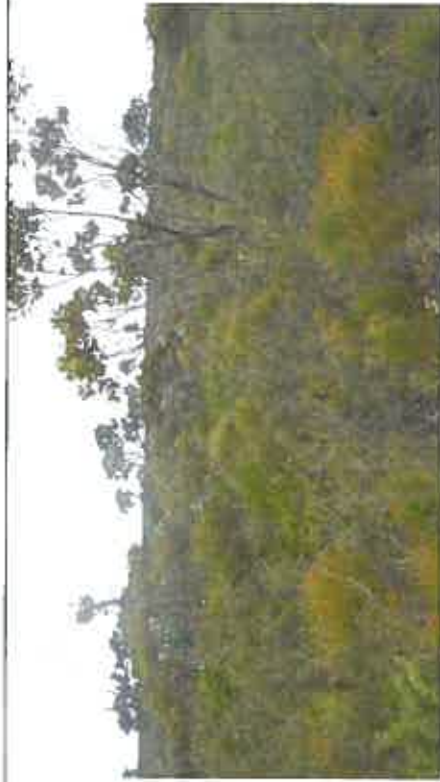
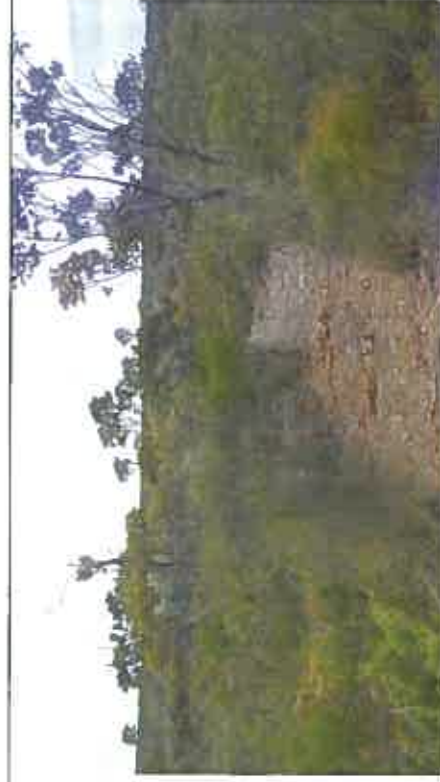
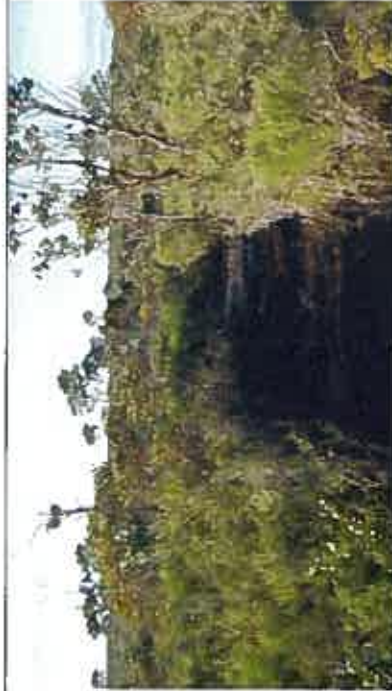
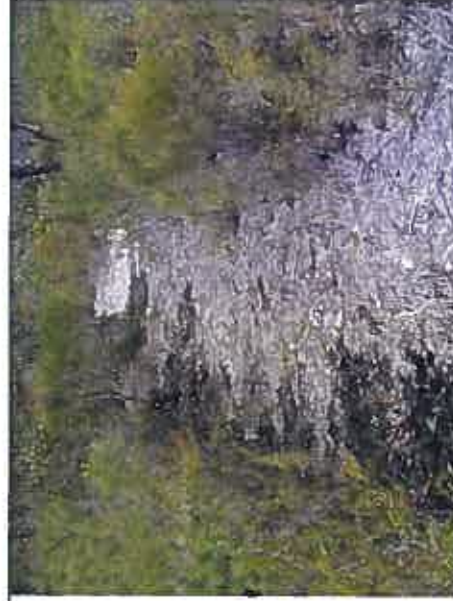
Monitoring Site M17

Pre-construction (22 November 2012)

Post vegetation clearing (28 November 2012)

~7 months after clearing (12 June 2013)

~ 15 months after clearing (21 February 2014 – in 2013/2014 reporting period with permanent reference marker installed)

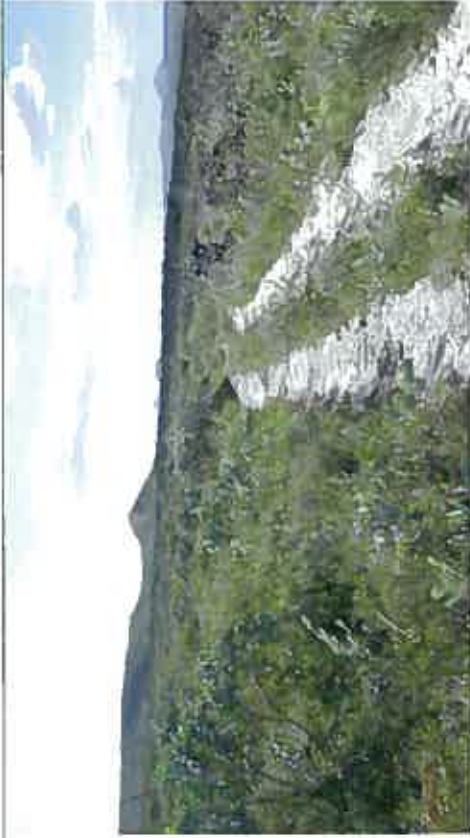
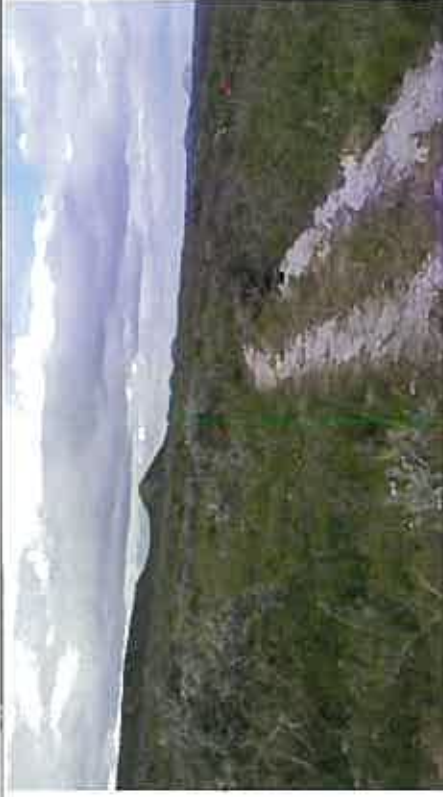
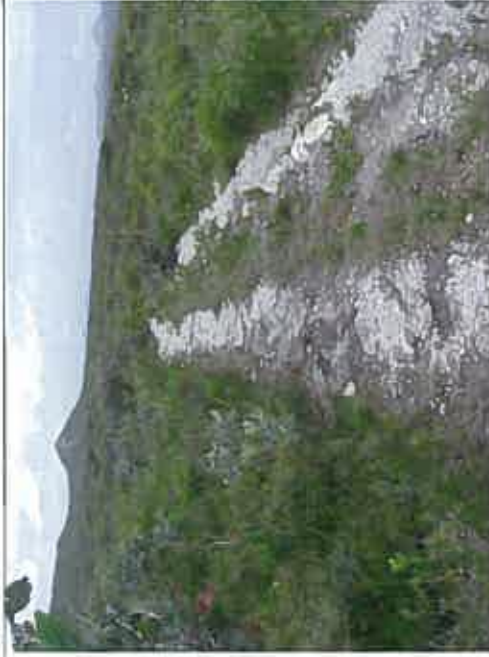
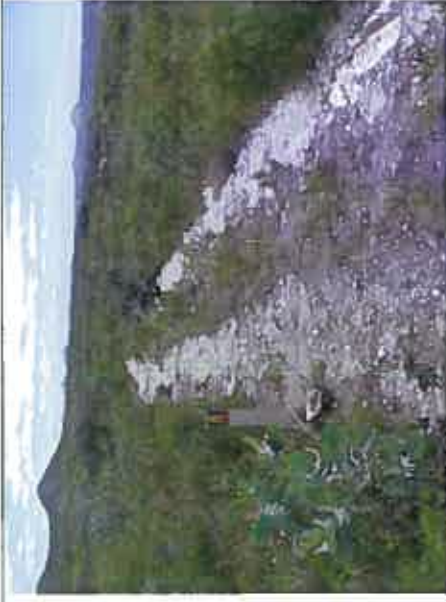
Monitoring Site H7 (Closed 4WD track on quartzite wave cut platform)

Pre-construction (9 May 2013)

One week after clearing - slasher has traversed left hand wheel track (17 May 2013)

Six months after clearing (6 November 2013)

~ 8 months after clearing (18 February 2014 - in 2013/2014 reporting period with new permanent reference marker)

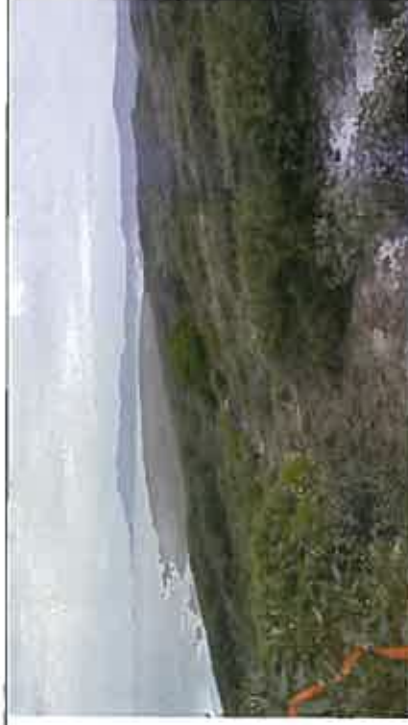
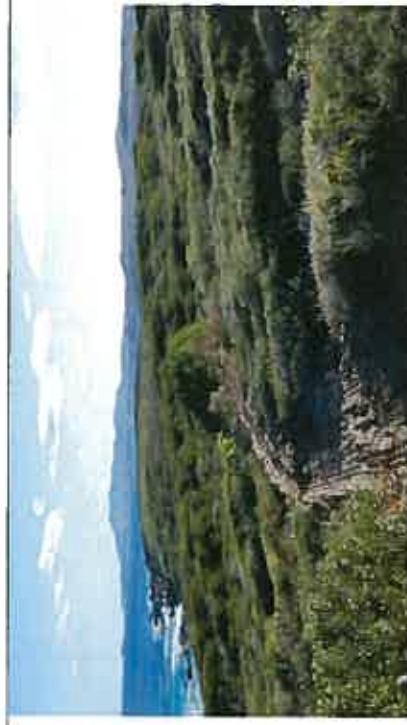
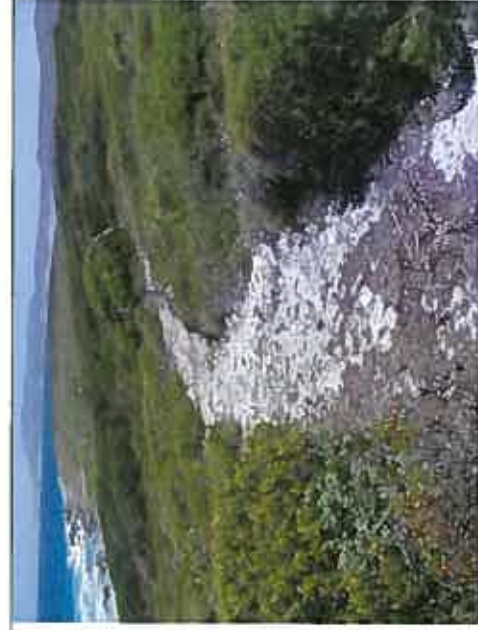
Monitoring Site H20 (shallow sand over Tamala limestone)

Pre-construction (1 May 2013)

Same day after clearing (1 May 2013)

~ 6 weeks after clearing and forming (13 June 2013)

~ 9 months post clearing (29 January 2014 - in 2013/2014 reporting period with new permanent reference marker)

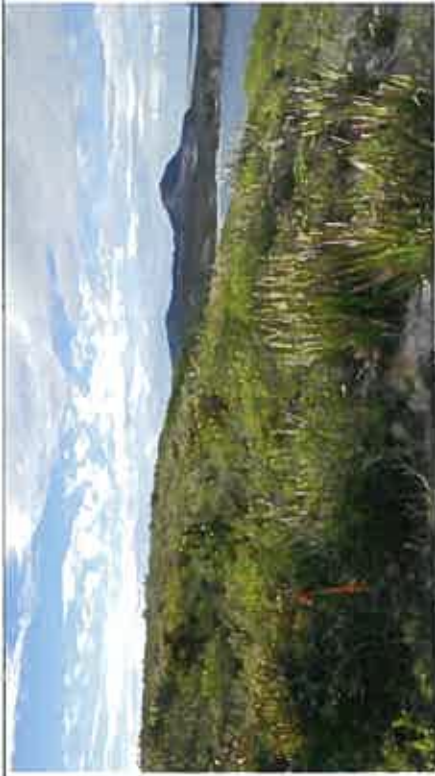
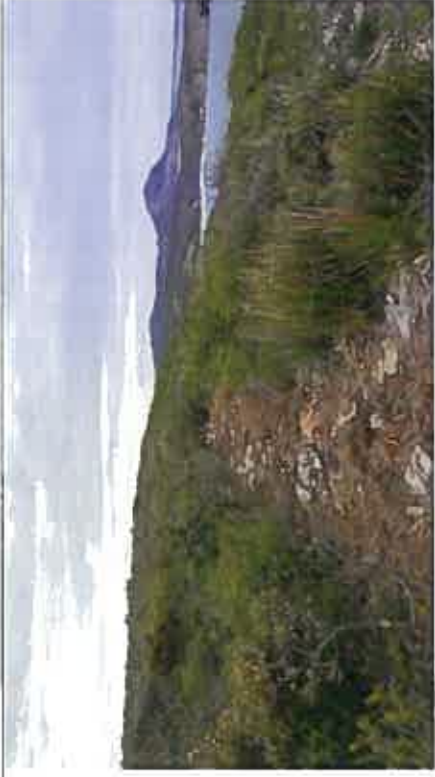
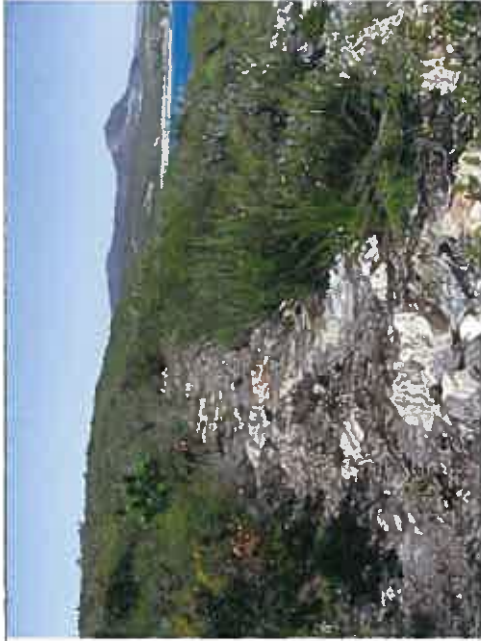
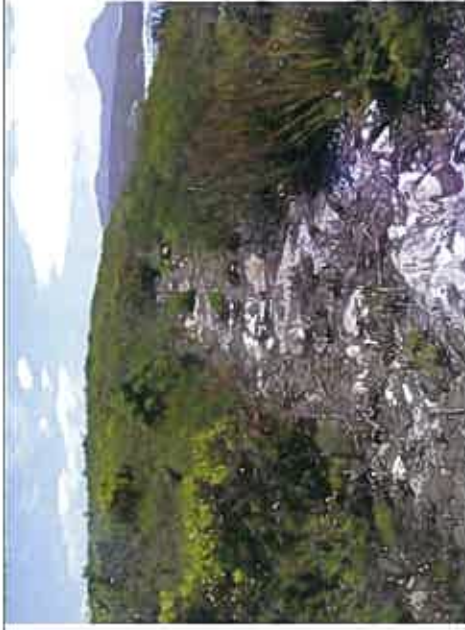
Monitoring Site H35 (quartzite wave cut platform West Beach Point)

Pre-construction (27 May 2013)

~ 3 months post clearing (7 September 2013)

~ 4 months post clearing (7 October 2013)

~ 7 months post clearing (20 February 2014 - in 2013/2014 reporting period with new permanent reference marker)
