**COMPLIANCE
ASSESSMENT REPORT
(Ministerial Statement 884)**

22 December 2013 to 21 December 2014

Coastal Walk Trails from Point Ann to
Fitzgerald Inlet and from Cave Point to
Quoin Head
– Fitzgerald River National Park

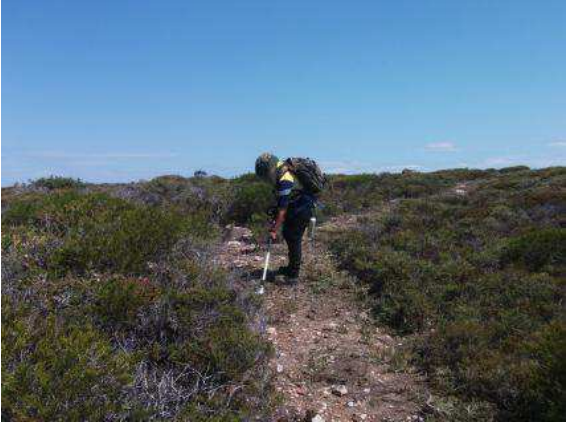
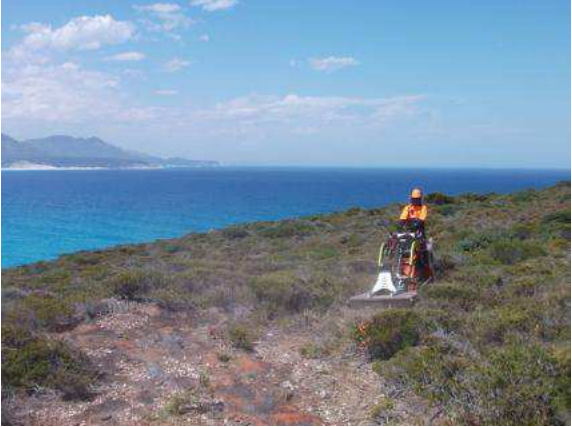
<p style="text-align: center;"><i>Trail construction Point Charles 2012</i></p>
Rehabilitation Management	Compliant	<p>In most areas, mulched vegetation has been left on the trail to help stabilise the tread surface. Many of the plants within or on the edge of the slashed area are already re-sprouting.</p>

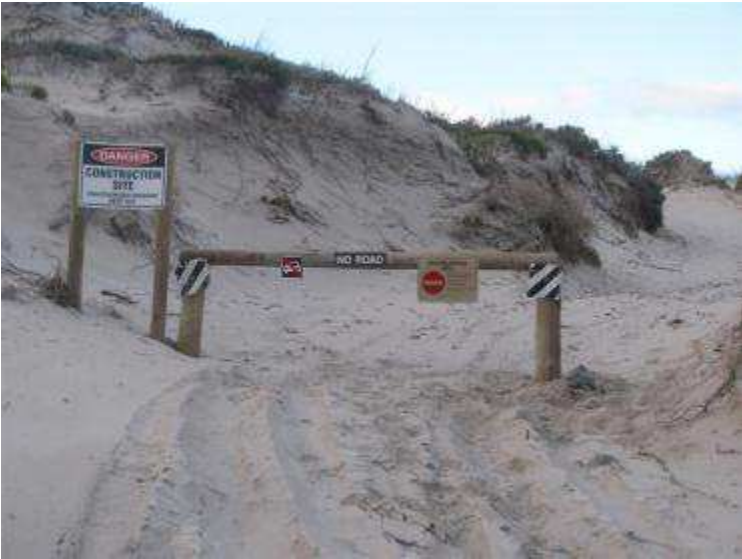
<p><i>Hakea Trail construction access to Whalebone area August 2013</i></p>
Weed Management	Compliant	<p>No new introduction of weeds has been detected by monitoring staff.</p> <p>The small patch of Dune Onion Weed (<i>Trachyandra divaricata</i>) on the Point Charles fore-dune that was identified from the flora surveys was subsequently removed from the site.</p> <p>The area is being monitored and while the onion weed is still present no noticeable spread has occurred. A vegetation monitoring point is established where the trail crosses the former weed site and control is being undertaken.</p>

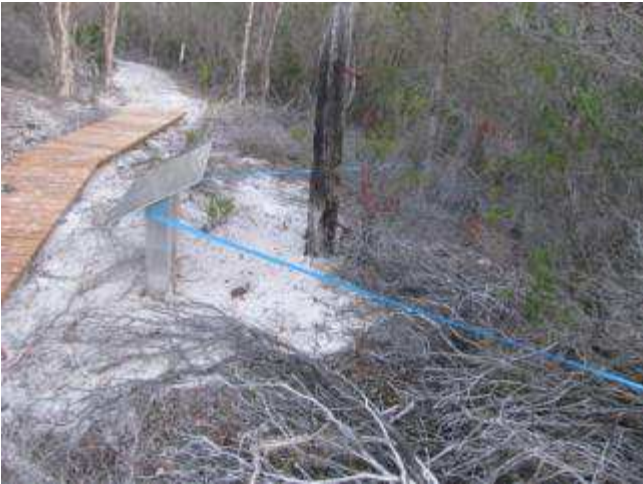
<p style="text-align: center;">Boardwalk around heritage feature installed July 2013. Old insulator (moveable heritage) will be taken for safe keeping and a low information panel has been installed with the interpretive panel still in production at the time of this photo.</p>

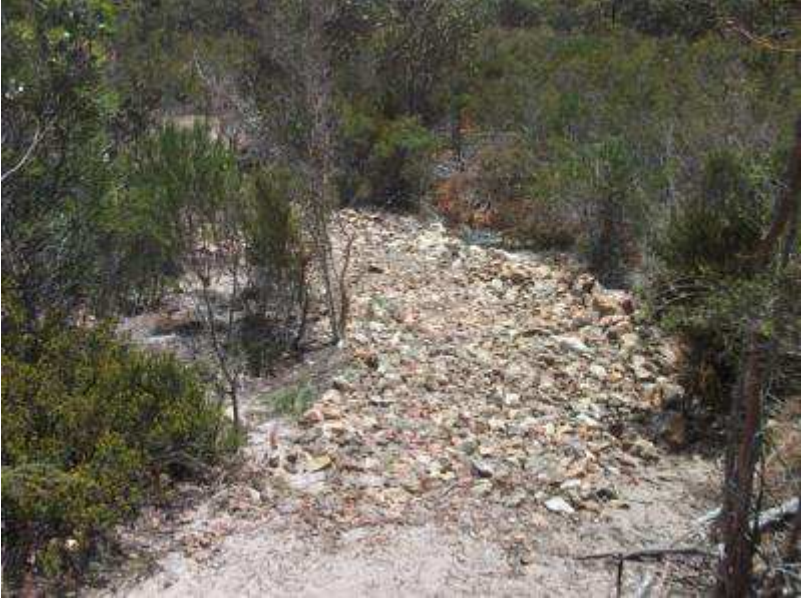
Drainage and Erosion Management	Compliant	<p>Water bars and other trail erosion management features have been constructed to minimise potential erosion of the trail.</p>

<p><i>Mamang Trail stone work 2012</i></p>

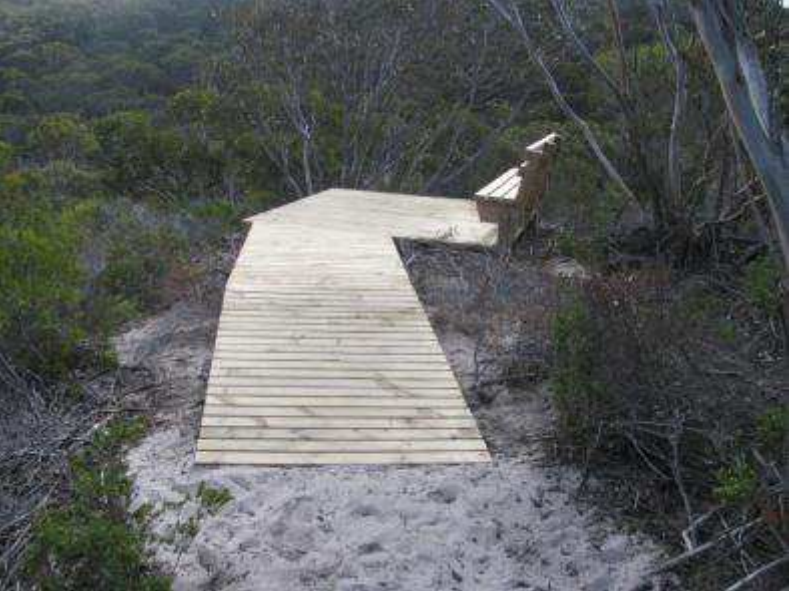
<p><i>Boardwalk and seating platform on sandy substrate Lake Nameless, Mamang Trail July 2013</i></p>
Fuel, Oil and other Hazardous Substances Management	Compliant	<p>There have been no oil or fuel spills or leaks. All fuel and oil have been managed according to the EMP procedures.</p> <p>Protective bituminised paint has been modestly applied to infrastructure posts in the ground to reduce the risk of deterioration. Wooden boardwalks and platforms <i>etc</i> have been double coated with a protecting water based stain. Only fine localized droplet spillage has occurred.</p>
Fire Control and Response Management	Compliant	<p>Construction activities have been following strict safety protocols including fire extinguishers on all machines and work has ceased during Extreme or Catastrophic fire weather conditions – or the announcement of harvesting or vehicle movement bans.</p>

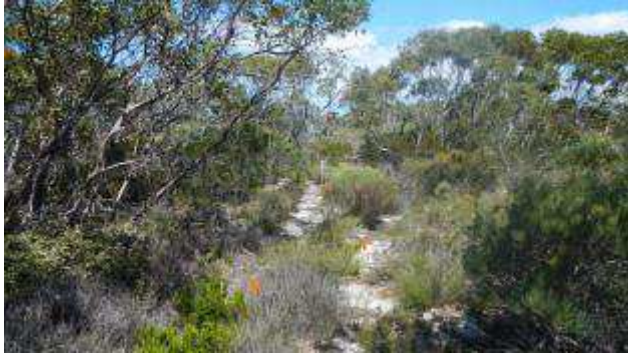
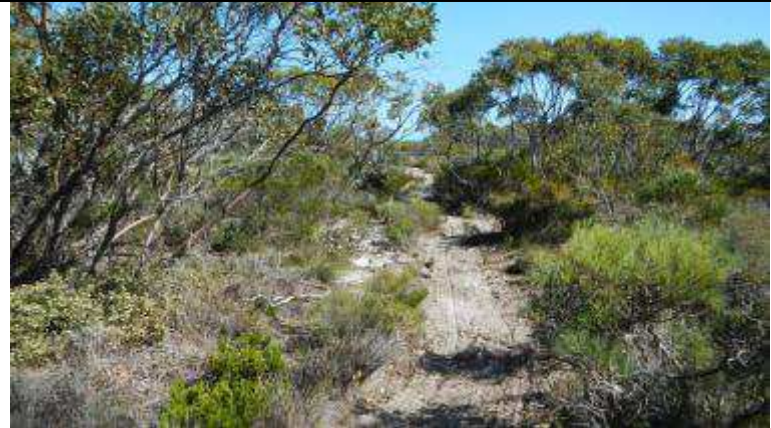
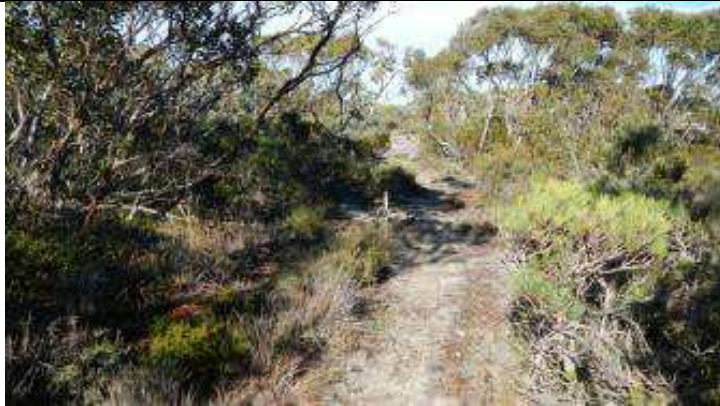
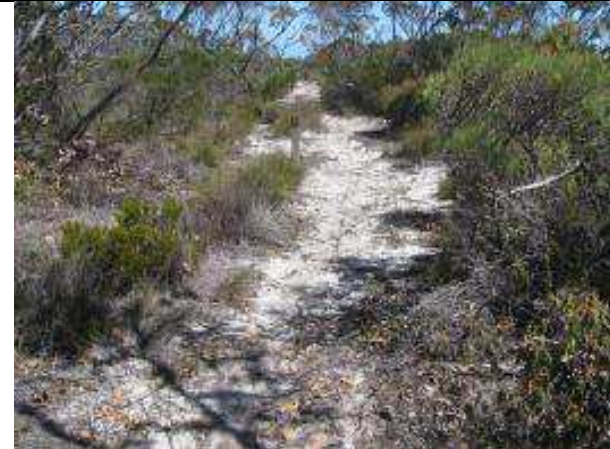
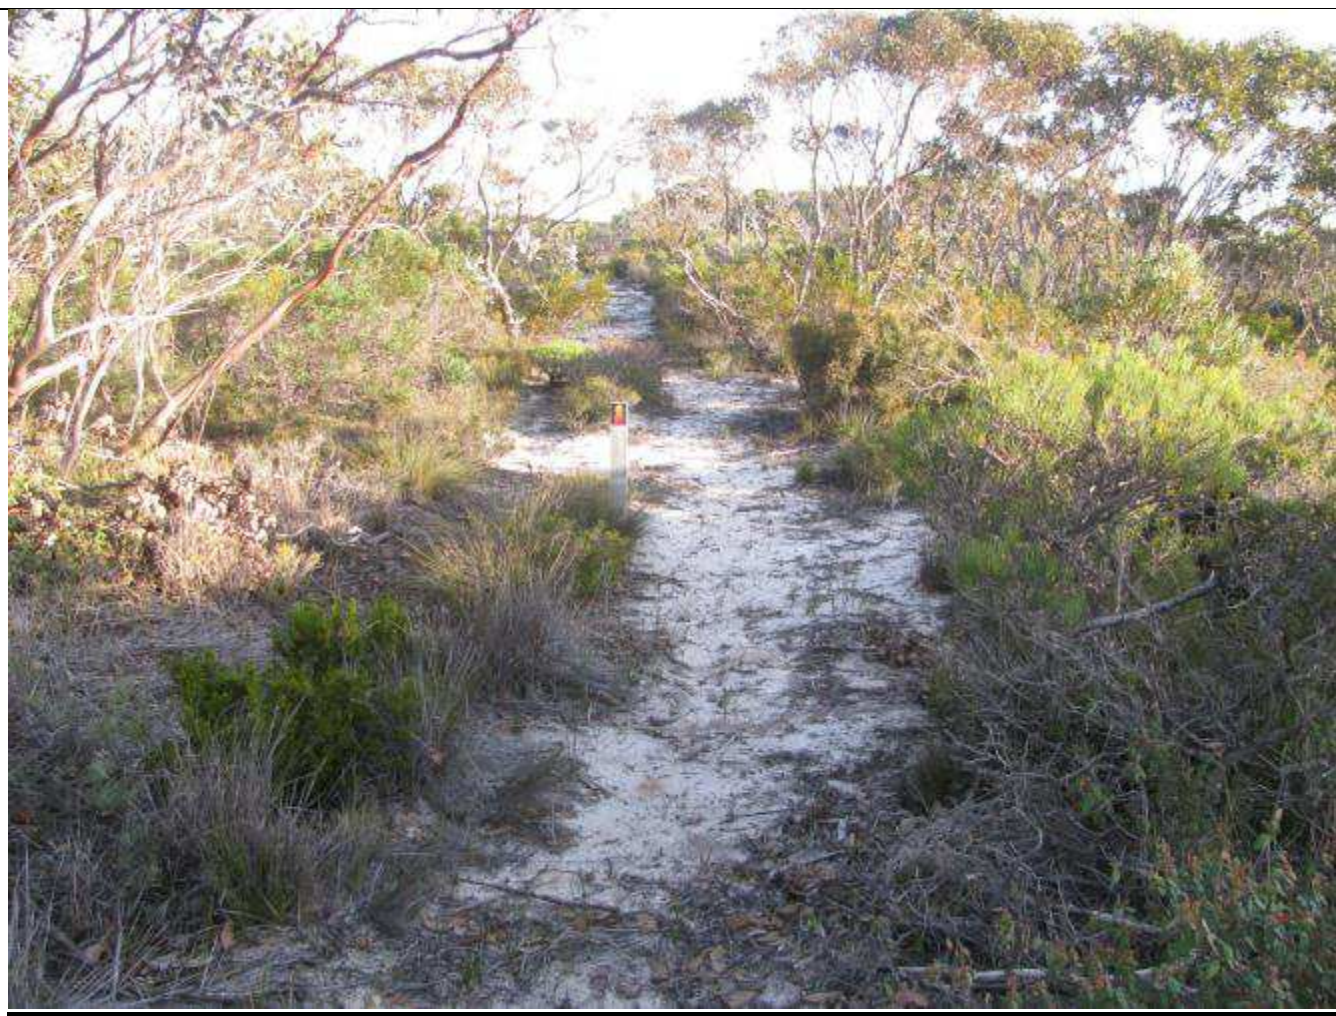
Monitoring Site M12

Pre-construction – approaching machine slasher just visible in distance (5 October 2012)

Post vegetation clearing – temporary reference peg in place (6 October 2012)

~ 8 months after clearing (12 June 2013)

~ 16 months after clearing (17 February 2014 - in 2013/2014 reporting period with new permanent reference marker)

~19 months after clearing 6 June 2014 – in 2014/2015 reporting period

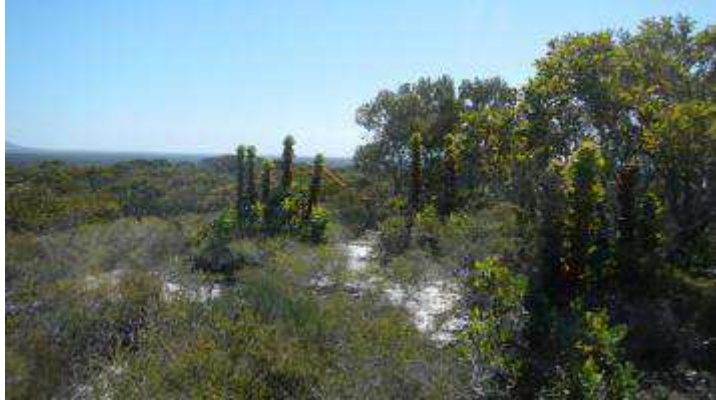
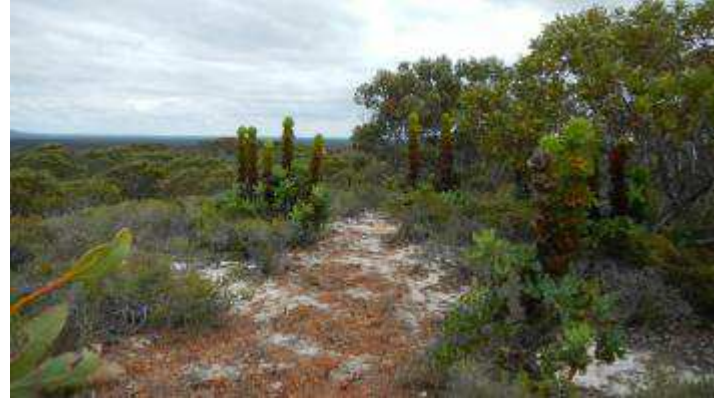
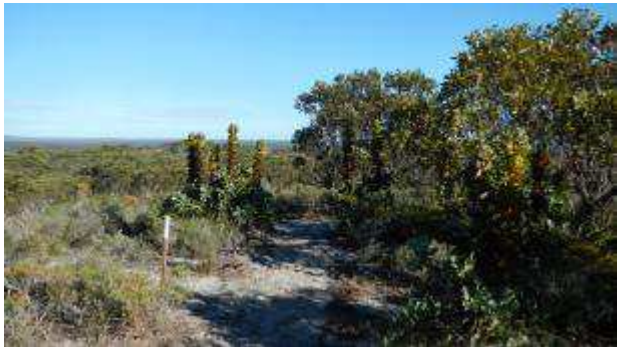
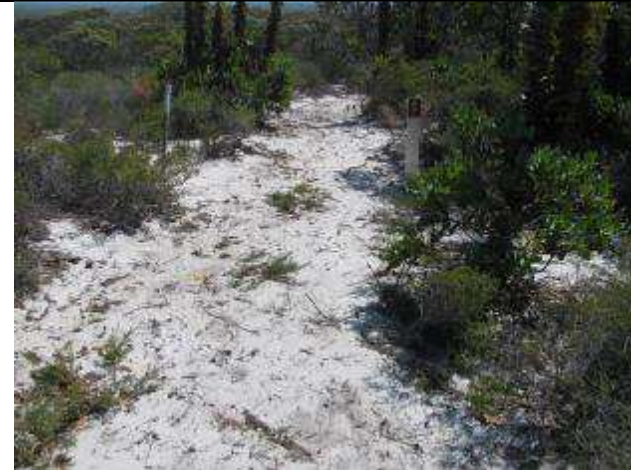
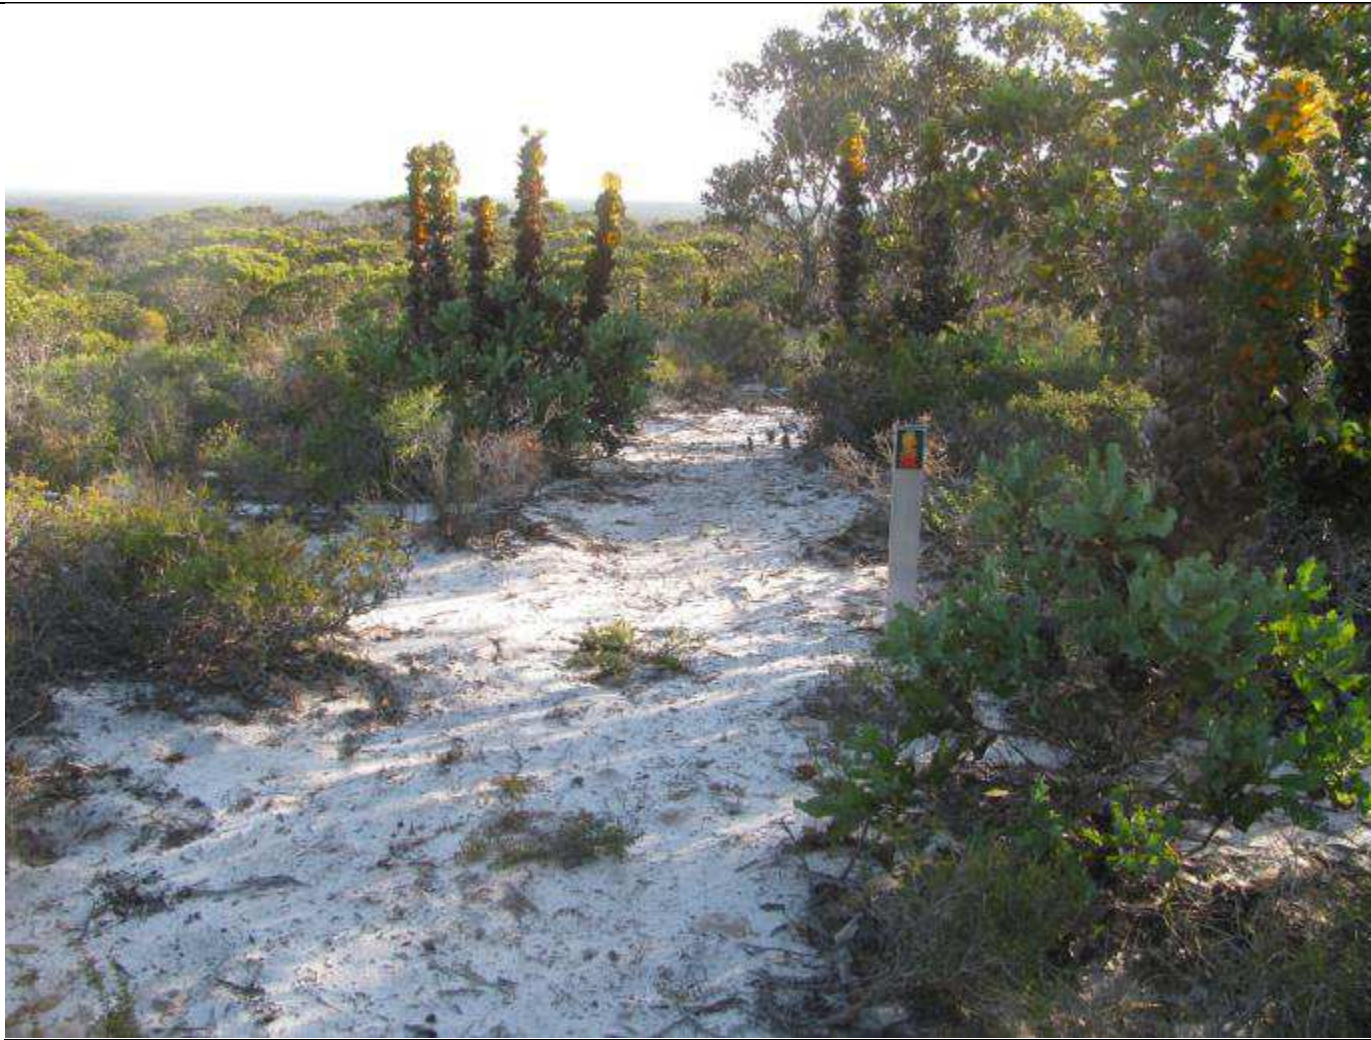
Monitoring Site M14

Pre-construction (22 November 2012)

Post vegetation clearing (28 November 2012)

~ 7 months after clearing with temporary reference peg (12 June 2013)

~15 months after clearing (21 February 2014 – in 2013/2014 reporting period with new reference marker on right – temporary peg removed after photograph taken)

~19 months after clearing 6 June 2014 – in 2014/2015 reporting period (regrowth can be seen occurring on the trail path)

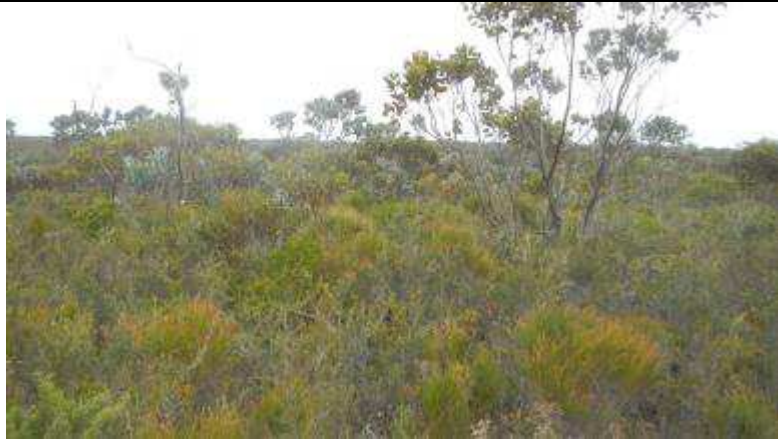
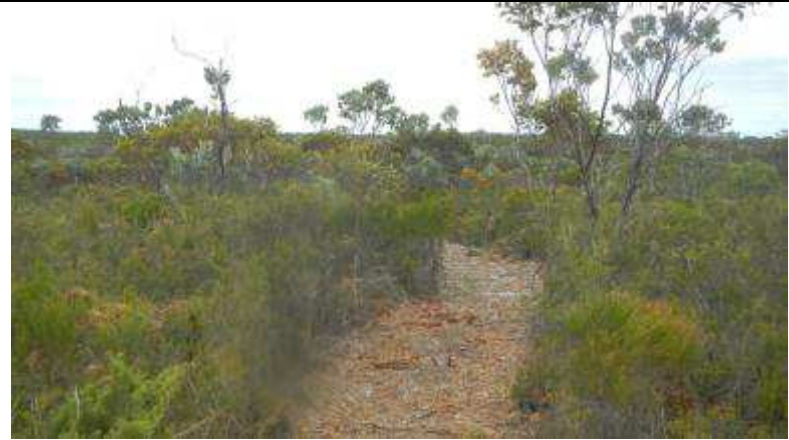
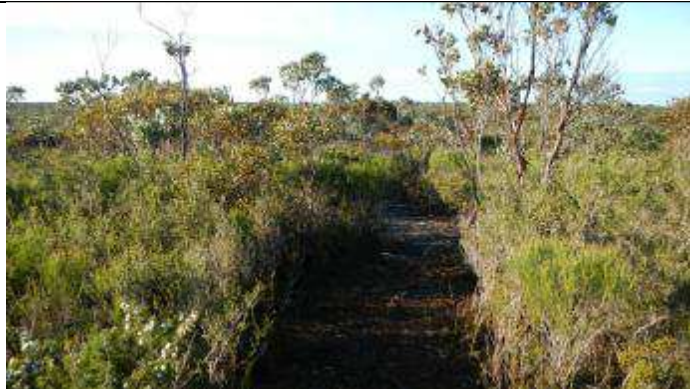
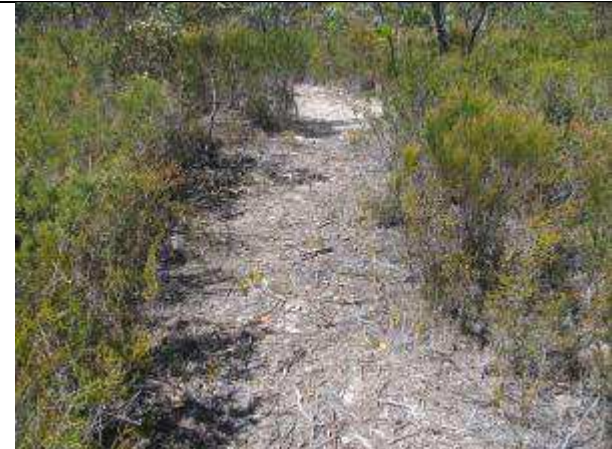
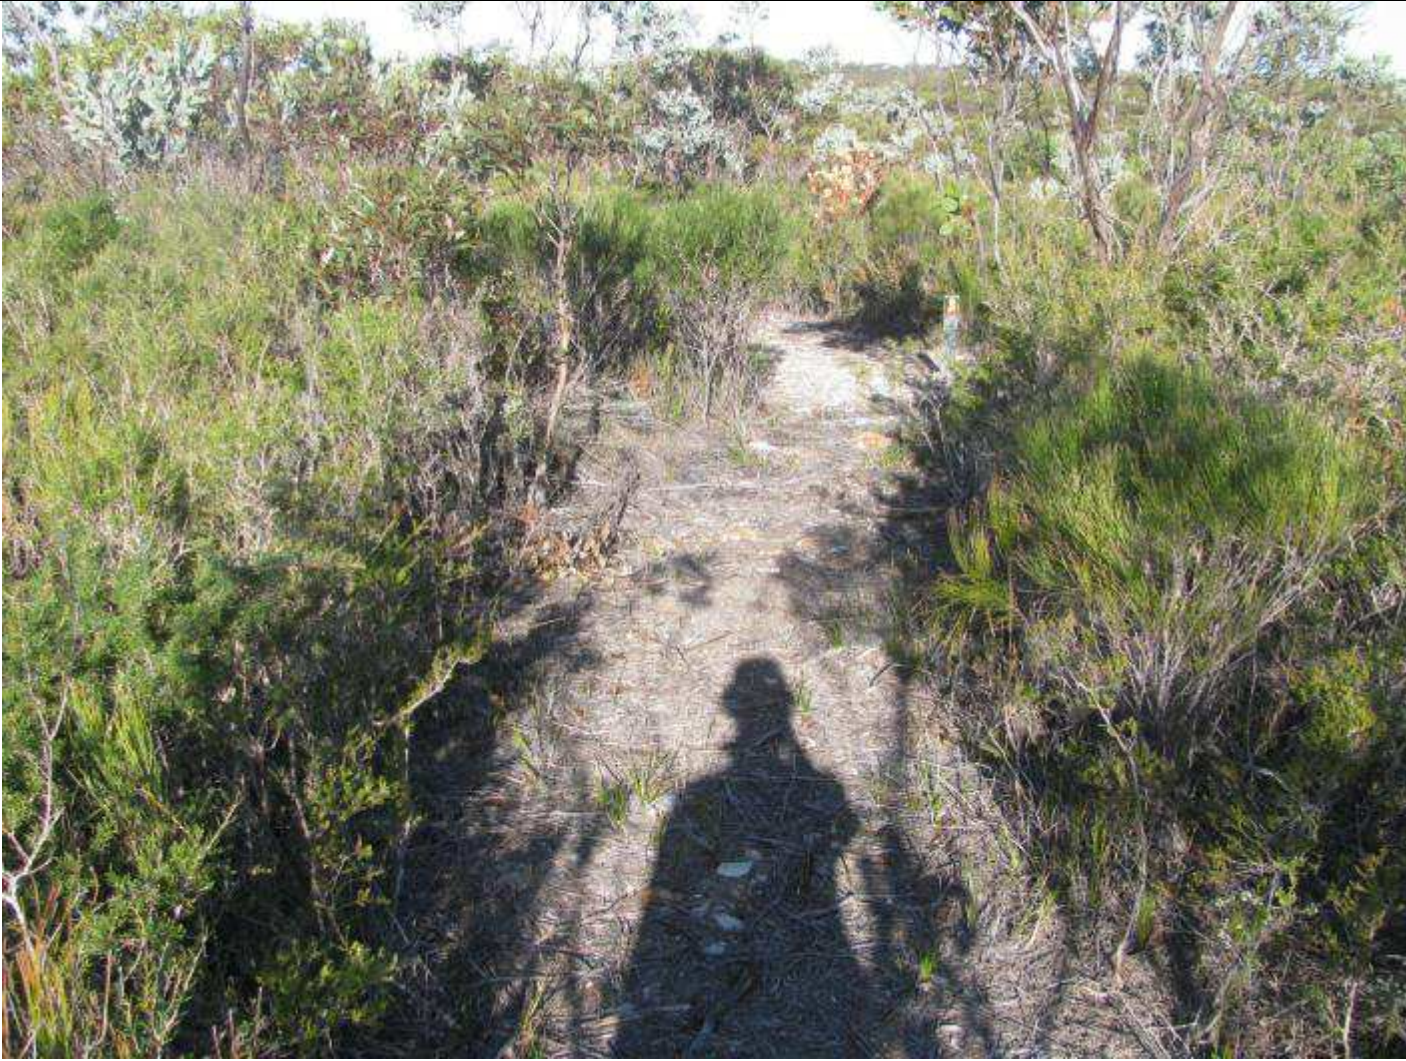
Monitoring Site M17

Pre-construction (22 November 2012)

Post vegetation clearing (28 November 2012)

~7 months after clearing (12 June 2013)

~ 15 months after clearing (21 February 2014 – in 2013/2014 reporting period with permanent reference marker installed)

~19 months after clearing 4 June 2014 – in 2014/2015 reporting period

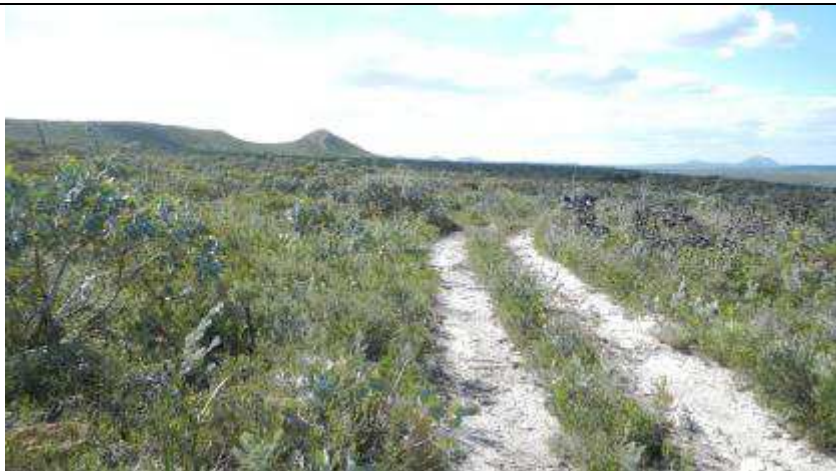
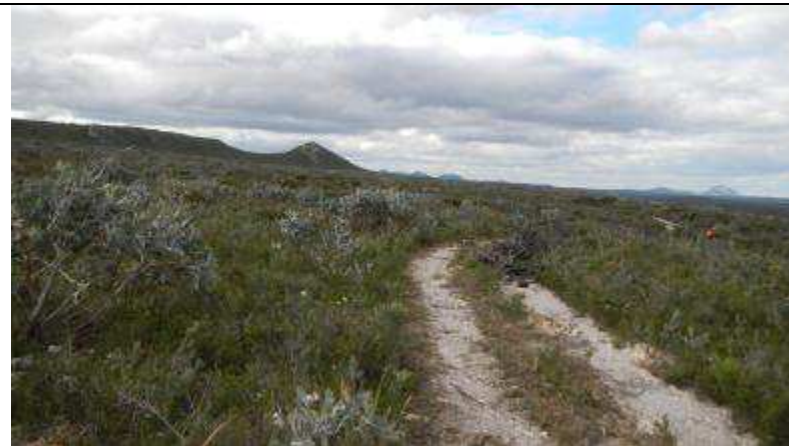
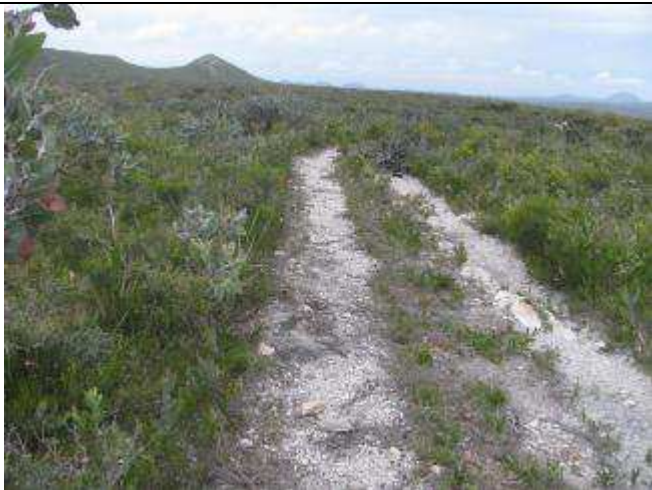
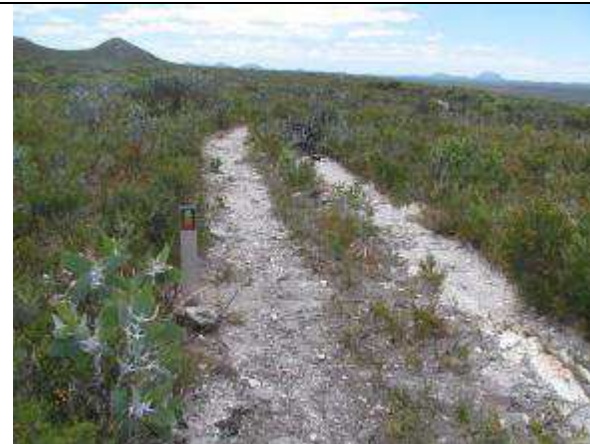
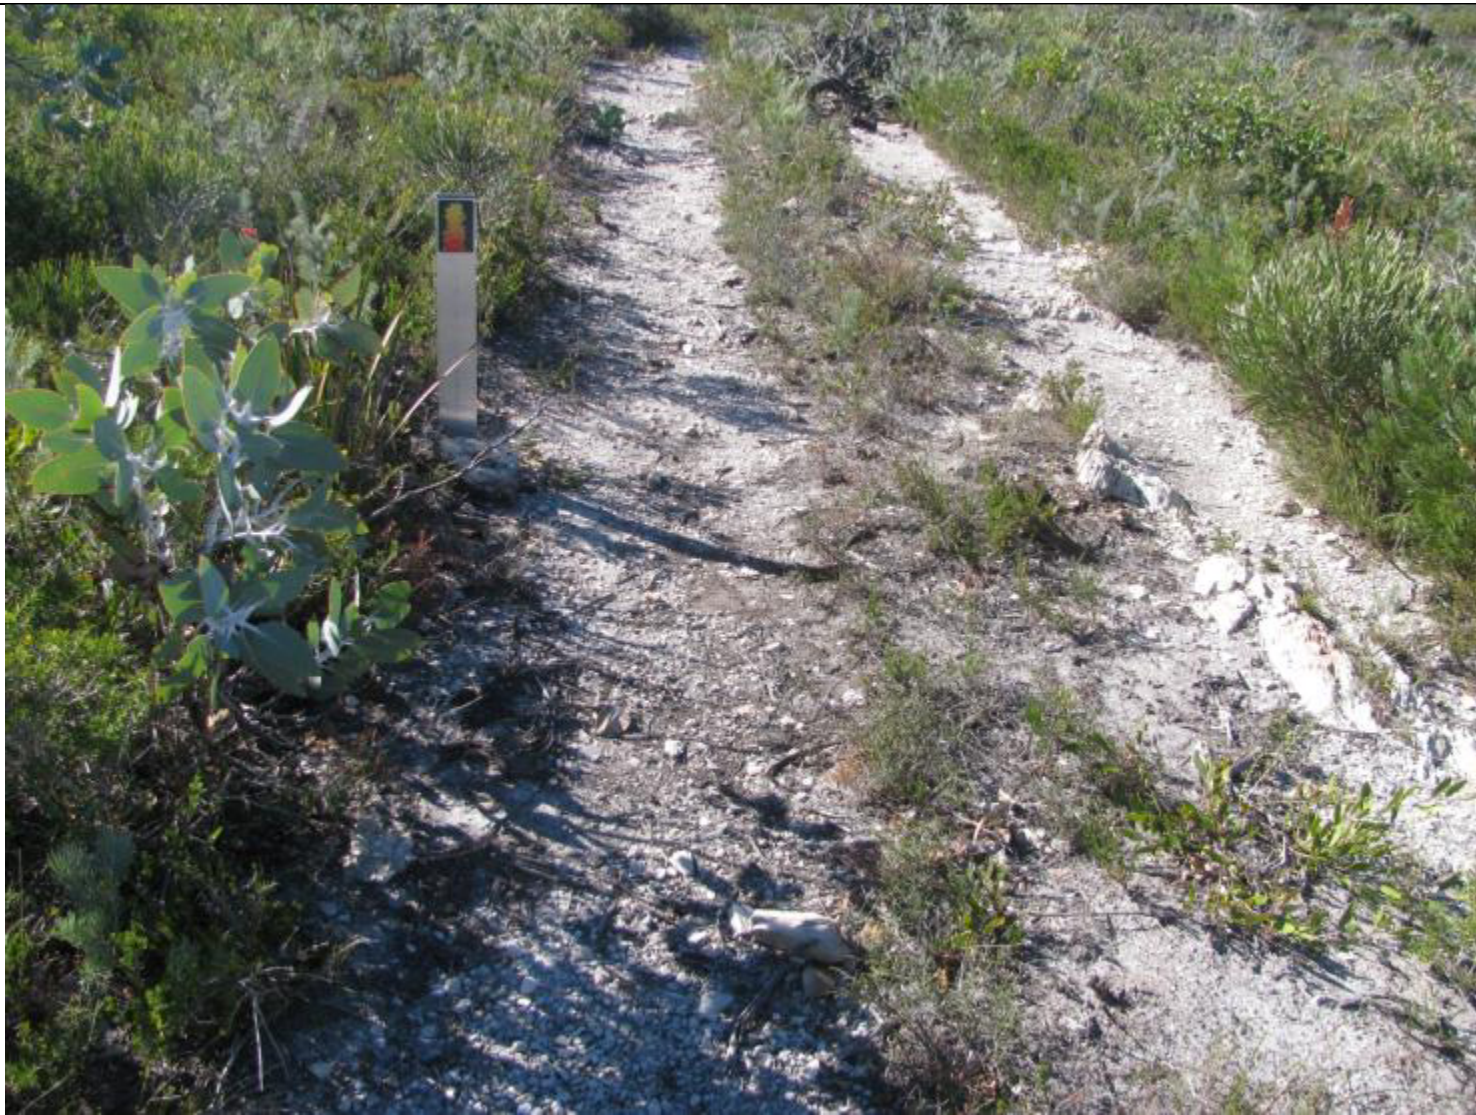
Monitoring Site H7 (Closed 4WD track on quartzite wave cut platform)

Pre-construction (9 May 2013)

One week after clearing - slasher has traversed left hand wheel track (17 May 2013)

Six months after clearing (6 November 2013)

~ 8 months after clearing (18 February 2014 - in 2013/2014 reporting period with new permanent reference marker)

~19 months after clearing 6 June 2014 – in 2014/2015 reporting period

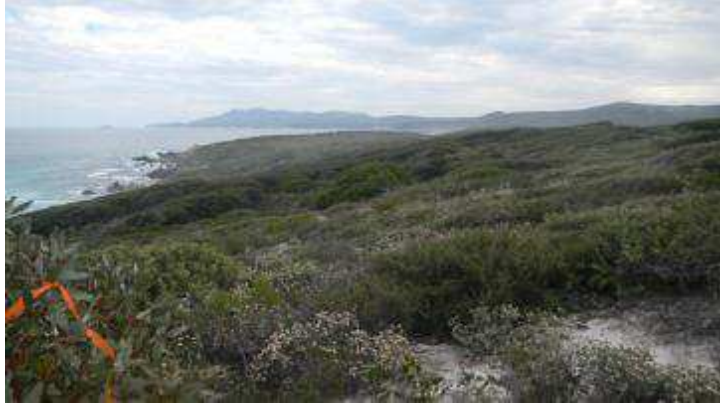
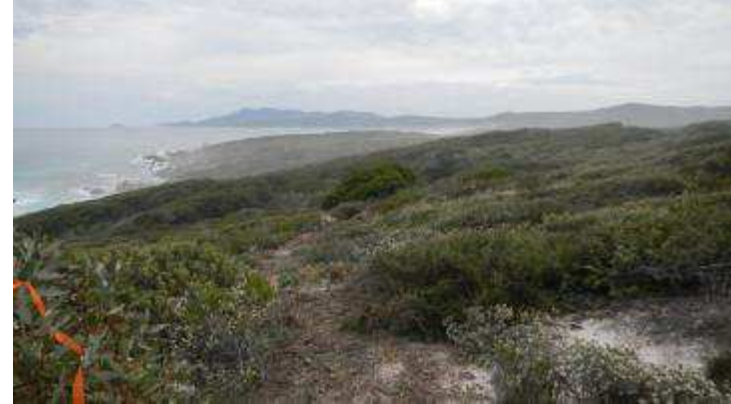
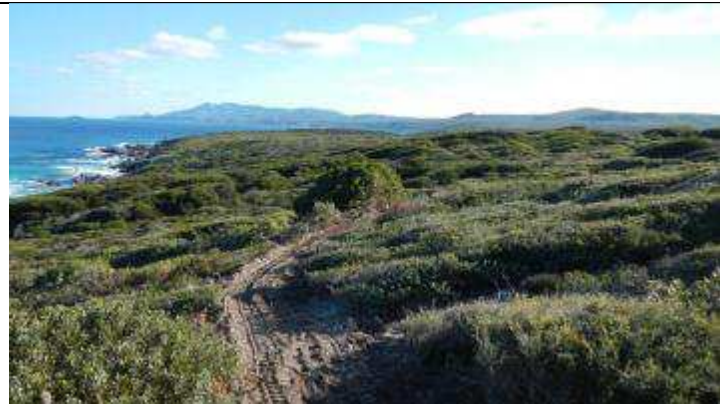
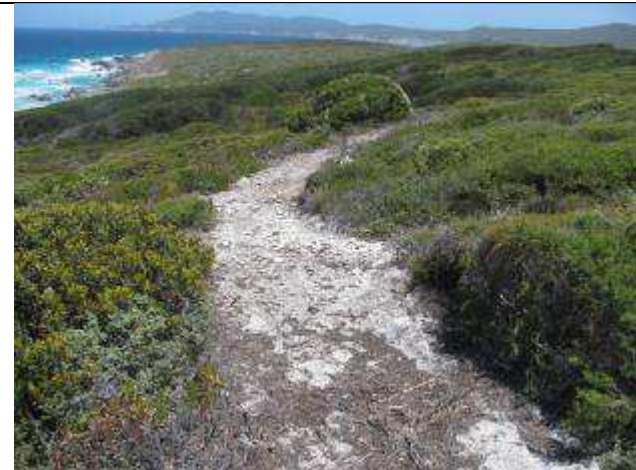
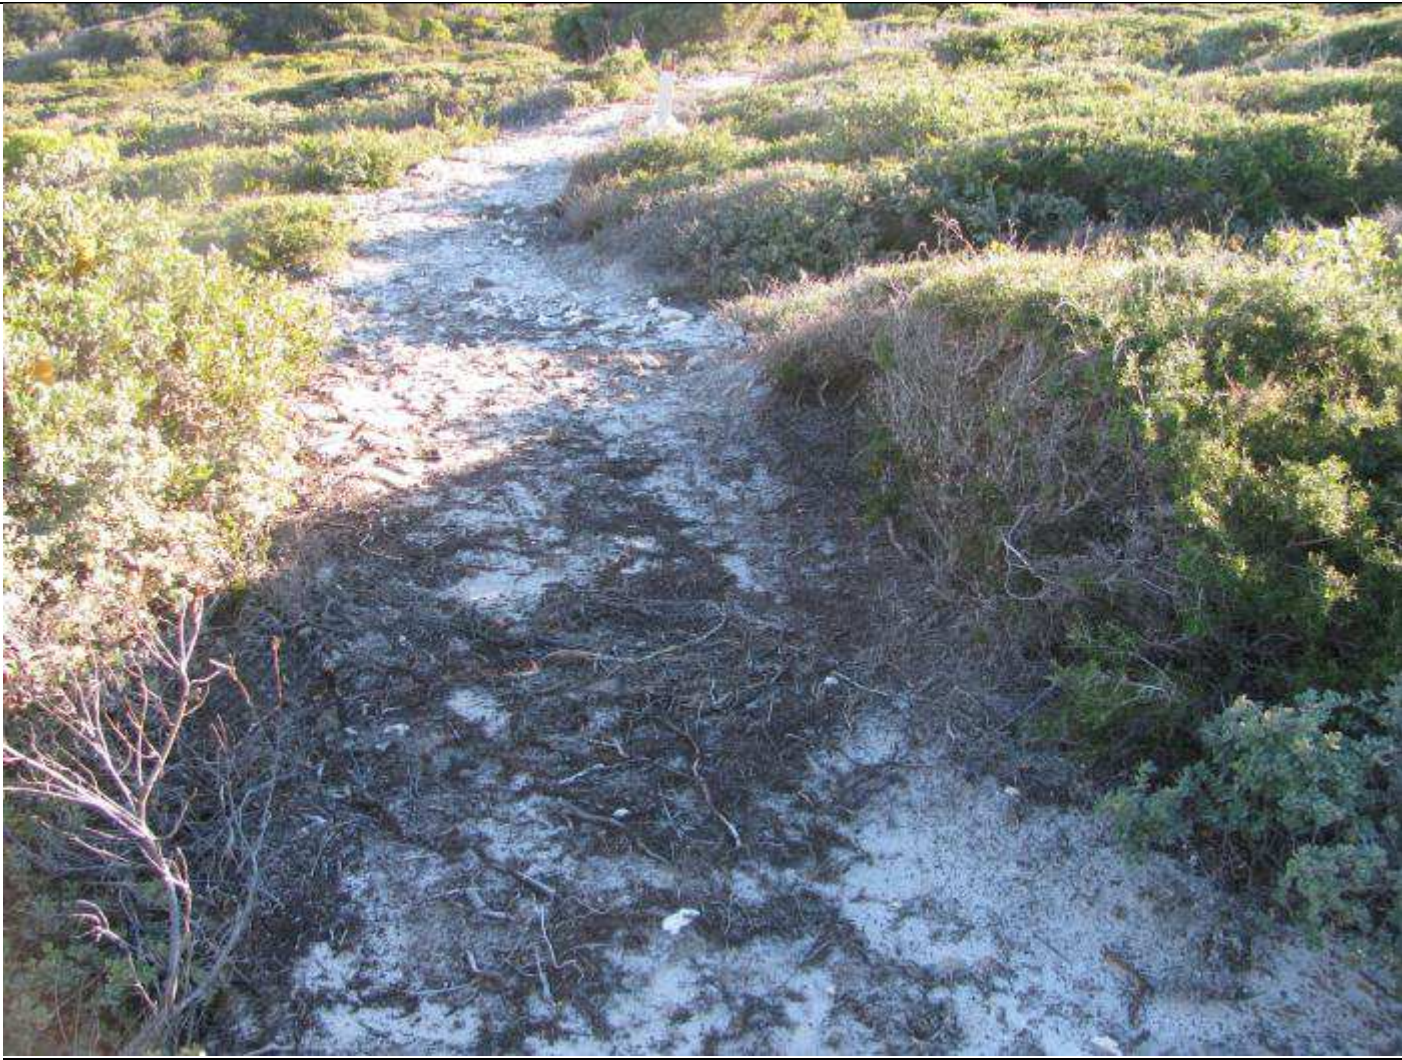
Monitoring Site H20 (shallow sand over Tamala limestone)

Pre-construction (1 May 2013)

Same day after clearing (1 May 2013)

~ 6 weeks after clearing and forming (13 June 2013)

~ 9 months post clearing (29 January 2014 - in 2013/2014 reporting period with new permanent reference marker)

~19 months after clearing 6 June 2014 – in 2014/2015 reporting period

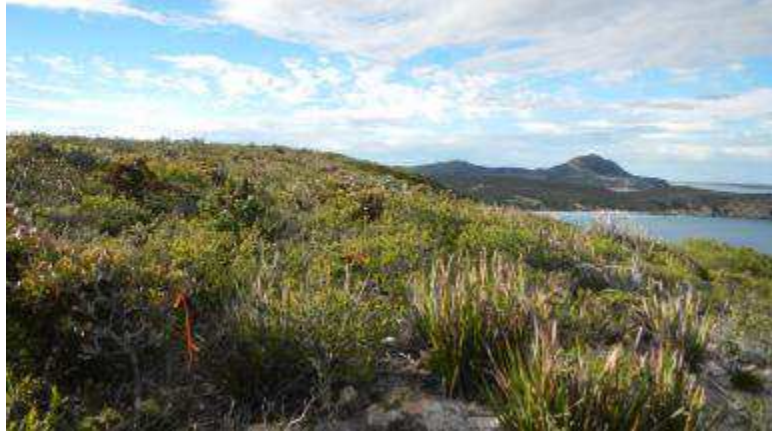
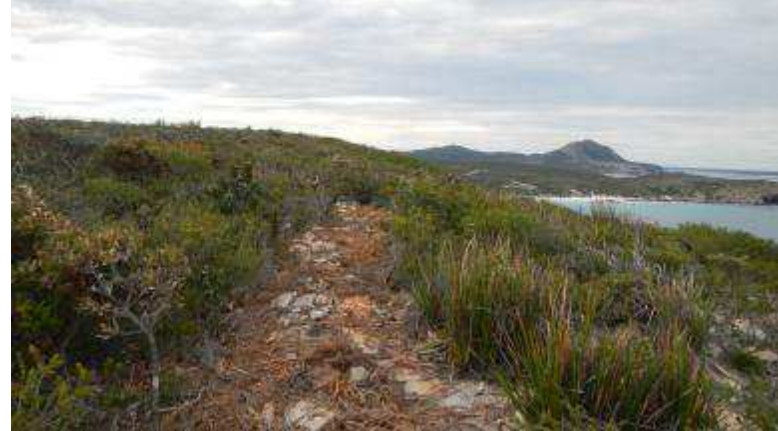
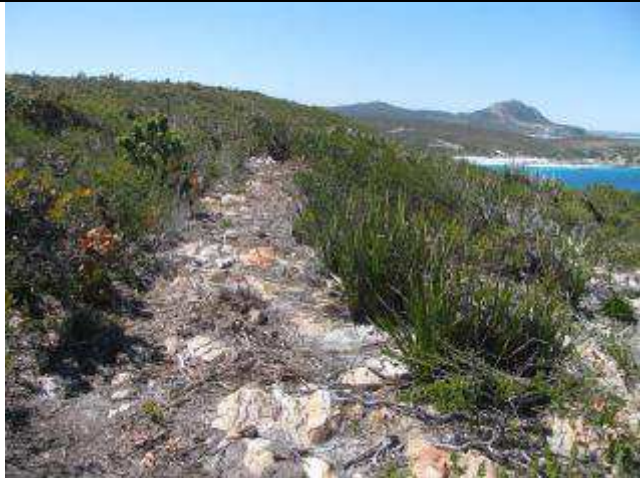
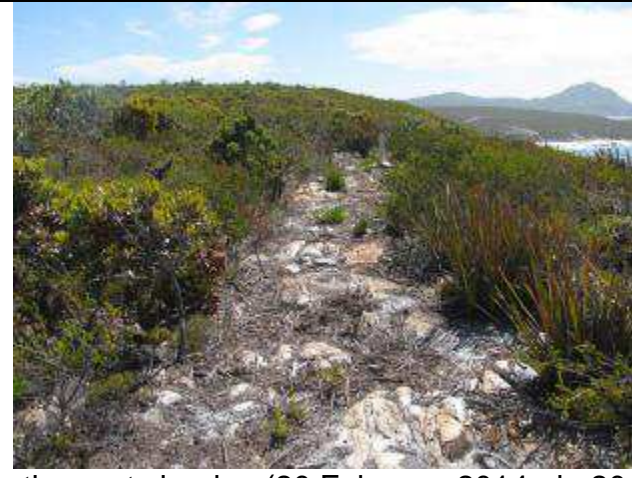
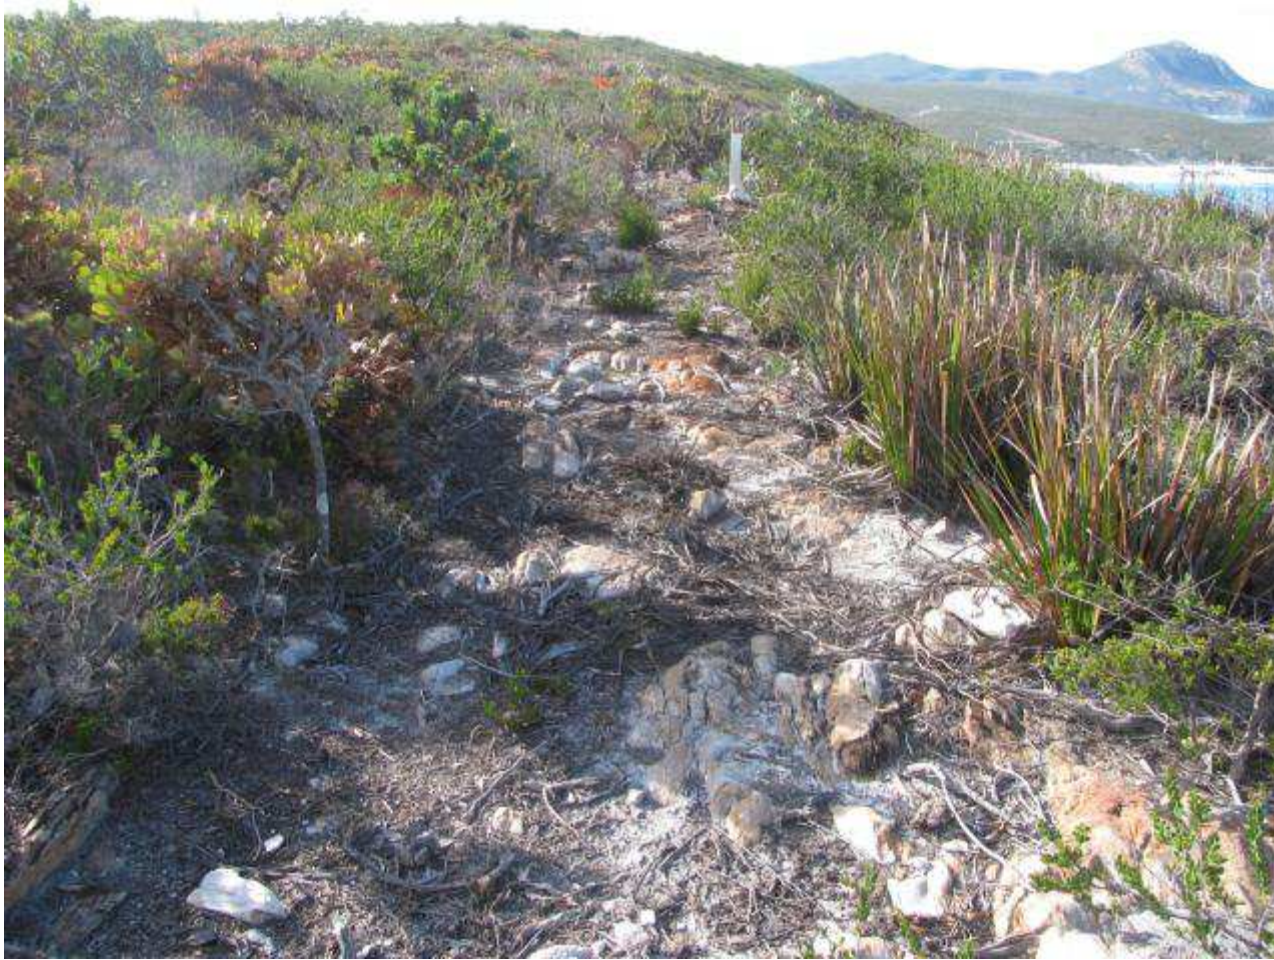
Monitoring Site H35 (quartzite wave cut platform West Beach Point)

Pre-construction (27 May 2013)

~ 3 months post clearing (7 September 2013)

~ 4 months post clearing (7 October 2013)

~ 7 months post clearing (20 February 2014 - in 2013/2014 reporting period with new permanent reference marker)

~19 months after clearing 5 June 2014 – in 2014/2015 reporting period
