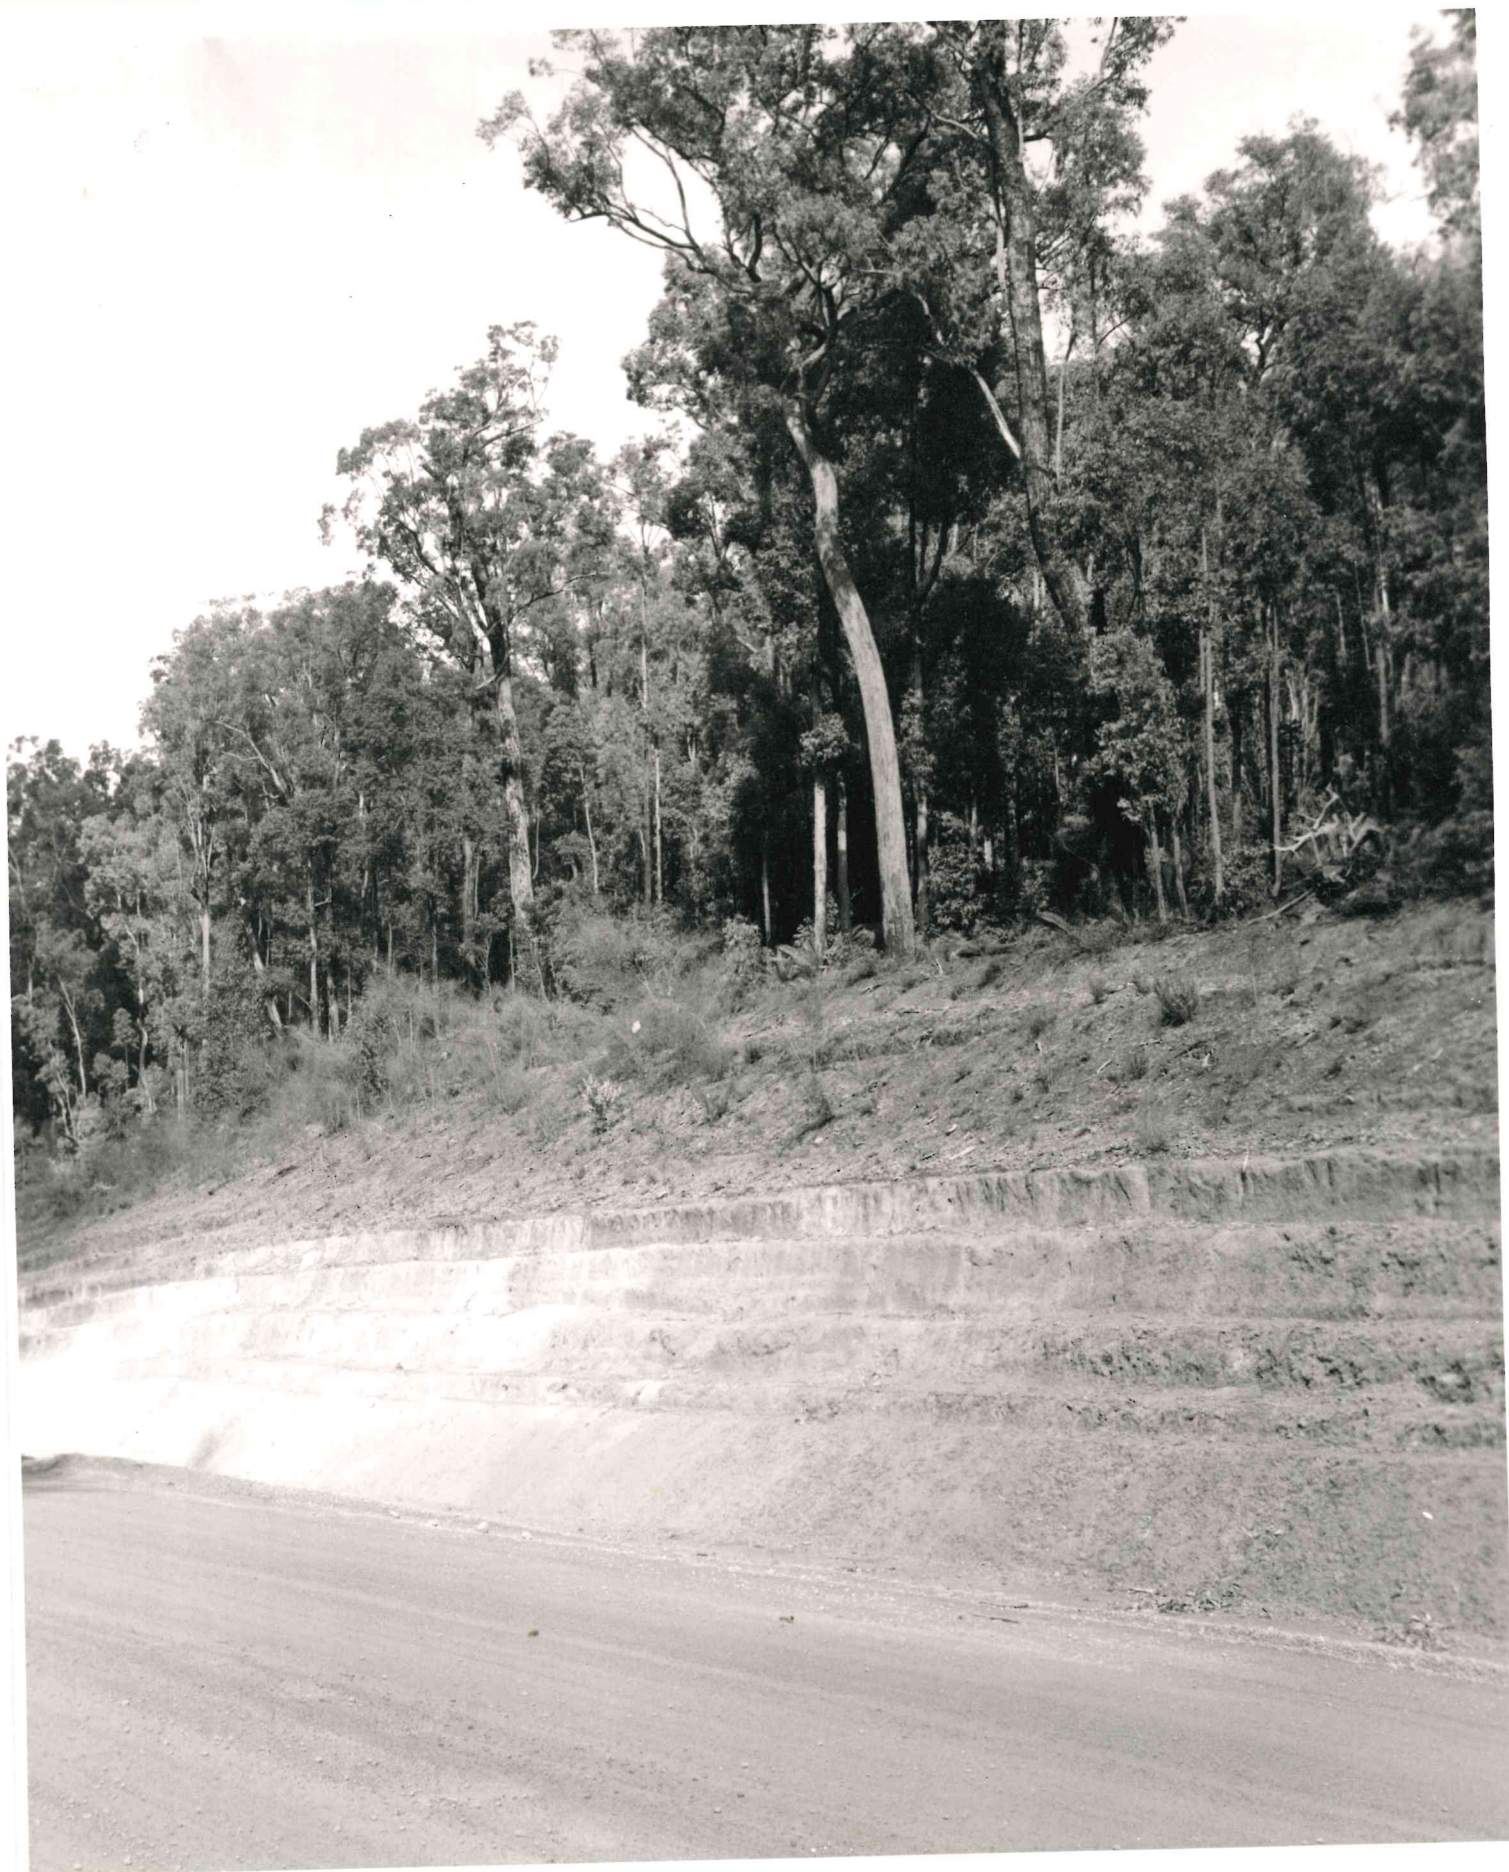
6/7/73. Del Park Rd. Shows terracing on road banks. Top of terracing earthfilled and shows vegetation established after 18 months. Lower terracing is unchanged after this period.
