# Capel River Action Plan

1999

Prepared for Geographe Catchment Council - GeoCatch  
and the Capel Land Conservation District Committee

by  
Kirrily White and Sarah Comer  
in association with  
Evangelisti & Associates

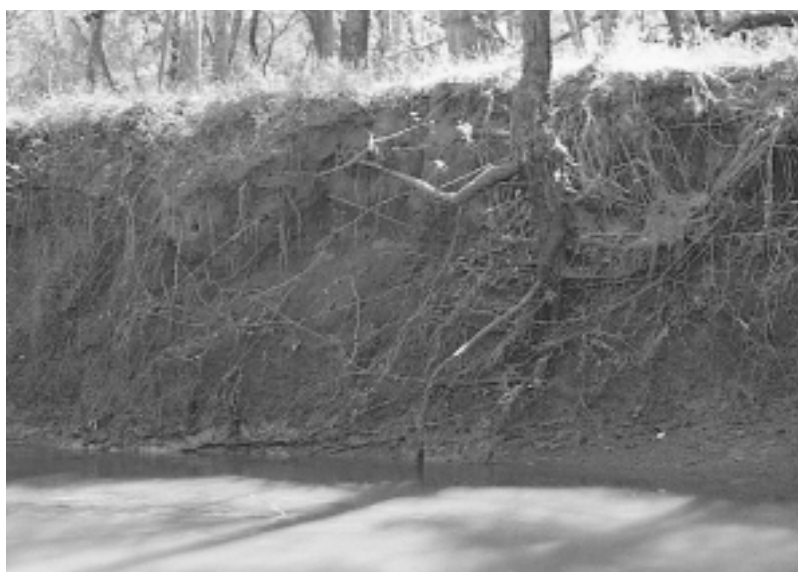
Plate 2: Roots of vegetation provide some anchorage even when scoured.

Large roots of trees and shrubs anchor the river embankments in place (Plate 2, page 11). The finer roots of shrubs, sedges and rushes effectively stabilise the riverbanks by reinforcing the river embankments. Well vegetated stream banks are less likely to suffer from undercutting and slumping.

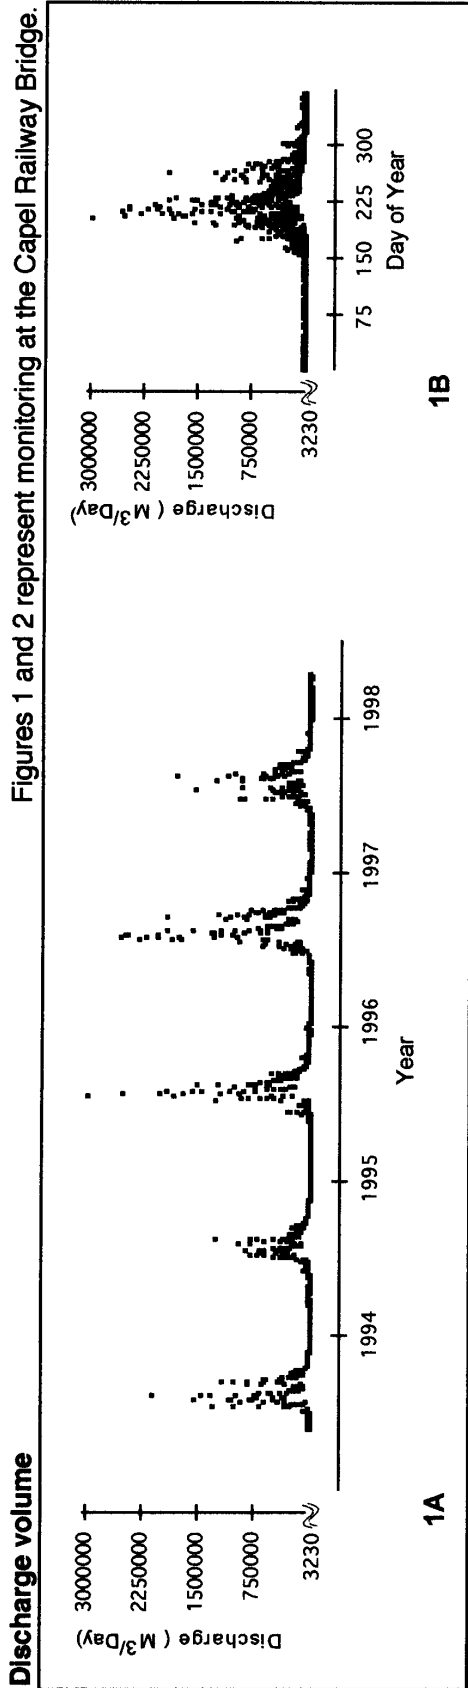
There are no established criteria for nitrogen levels in southwest waterways since natural levels are often highly varied. The levels of total nitrogen measured in the Capel River during the sampling period appear to be strongly related to the flow (discharge) pattern (Appendix B, Figures 1A and 1B). As for conductivity, there is a strong seasonality in the data, with nitrogen levels increasing rapidly during the early winter rainfall period ('first flush'), then decreasing as winter flow continues to dilute the concentration.

Figure 1A: Capel River discharge (m<sup>3</sup>) at the railway bridge between 1994 and 1998.

Figure 1B: Capel River seasonal discharge (m<sup>3</sup>).

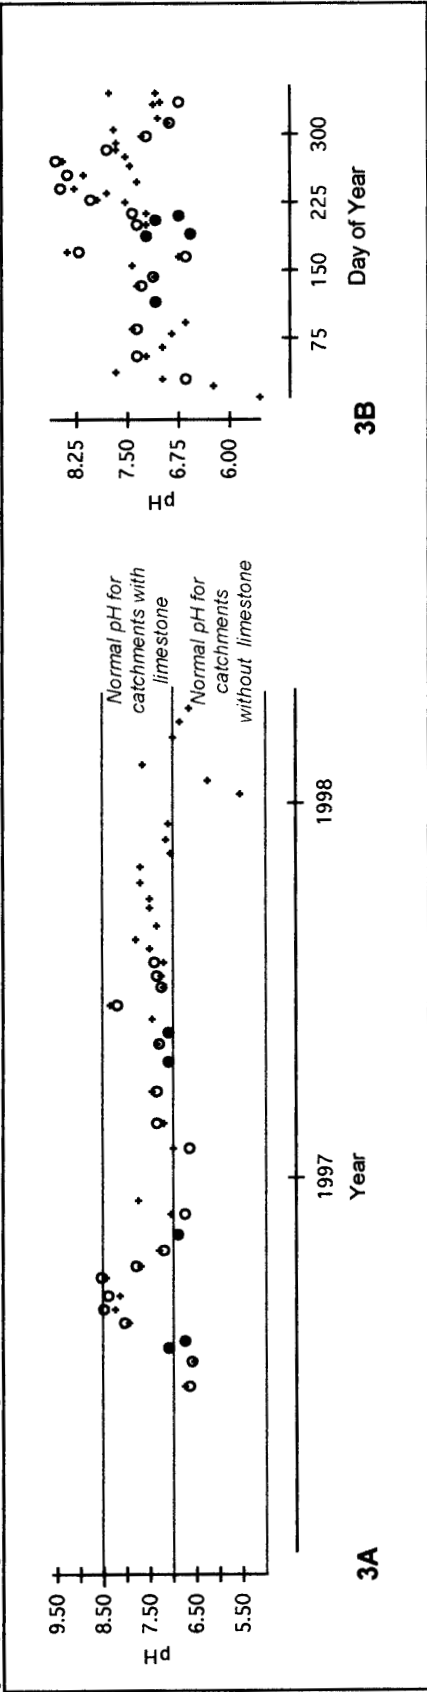
The pH measurements recorded for the Capel River at Yate's farm and the railway bridge between 1996 and 1998 are presented in Figures 3A and 3B of Appendix B respectively. Results for both sites are within acceptable criteria, although Yate's farm recorded slightly lower pH in early 1998. The levels recorded were not low enough to be of concern, and may be related to differences in soil type present in the upper Capel River catchment.

**Figure 3A:** Capel River pH between 1997 and 1998.

**Figure 3B:** Capel River seasonal pH.

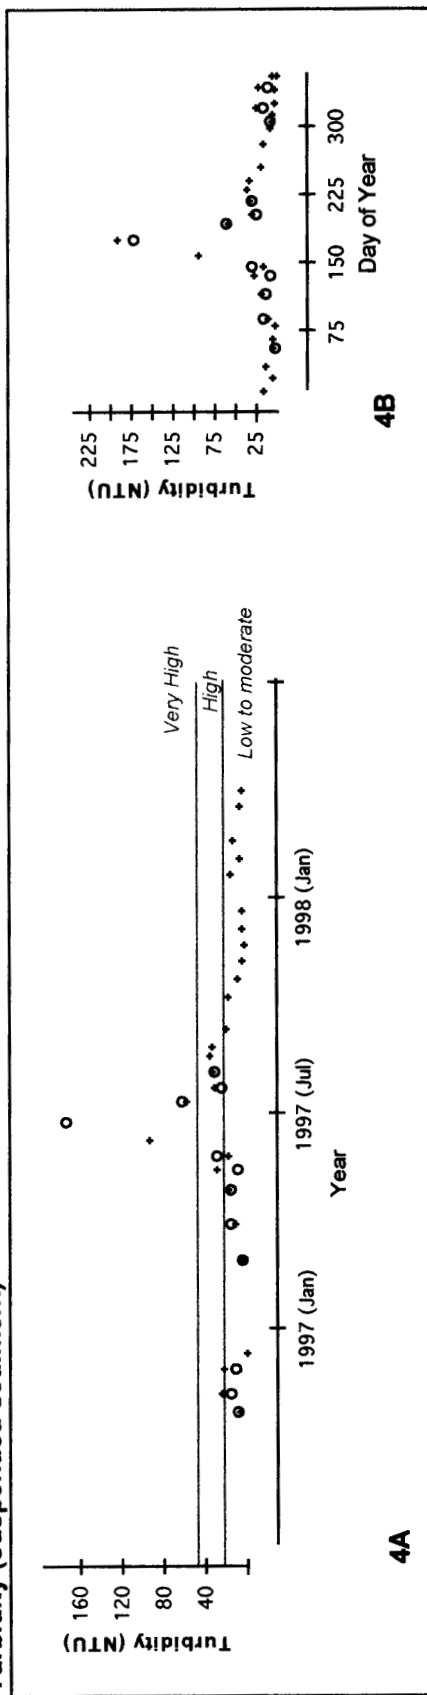
Turbidity measurements recorded for the Capel River between 1997 and 1998 are presented in Figures 4A and 4B of Appendix B. For much of period sampled, the turbidity was low to moderate, reflecting relatively stable conditions in the water. The only winter period monitored was in 1997. The peak in the graphs at July 1997 clearly shows the extreme turbidity measurements recorded at that time (values of over 160 NTU were recorded in the Capel River at both monitoring stations, indicating a serious erosion problem). The Swan River Trust recommends that for waterways with turbidity measurements exceeding 45 NTU, urgent action should be taken to reduce erosion.

**Figure 4A:** Capel River turbidity (NTU) between 1997 and 1998.

**Figure 4B:** Capel River seasonal turbidity (NTU).
