CONSERVATION MANAGEMENT STRATEGY

GOLDEN VALLEY TREE PARK HOMESTEAD

PREPARED FOR: DEPARTMENT OF
BIODIVERSITY, CONSERVATION AND
ATTRACTIONS

DATE: FEBRUARY 2023

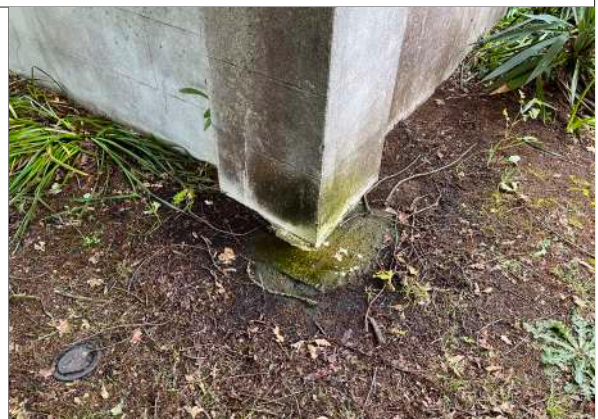
North-west corner pier foundation

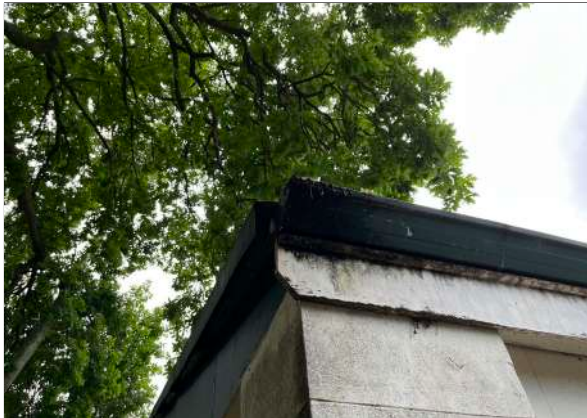
North -west organ room corner gutter

- 3 Install a temporary gutter and downpipe to the north west corner of the organ room. Ensure water is directed away from the building.
- 4 Repair windows in the organ room. Repair to all non-operable doors including outdoor WC. Refit existing doors and replace hardware to windows (where faulty) using appropriate hardware styles.

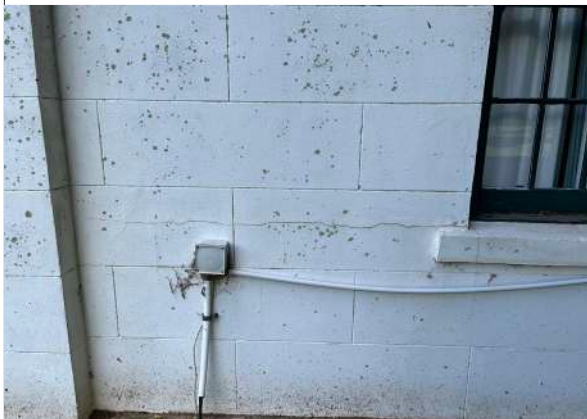
Conduit to northern organ room wall

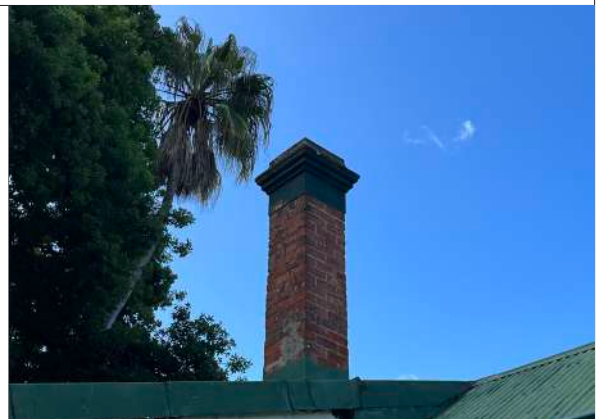
Chimney to organ room

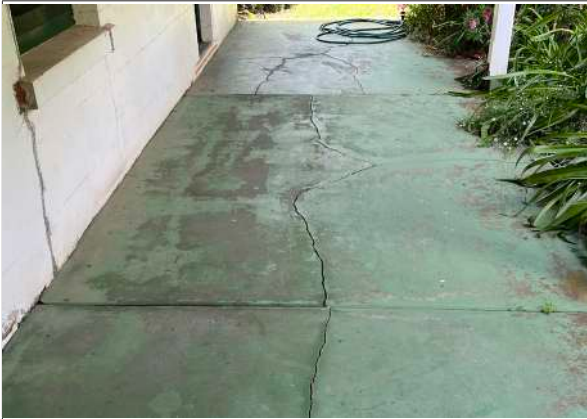
Front verandah slab

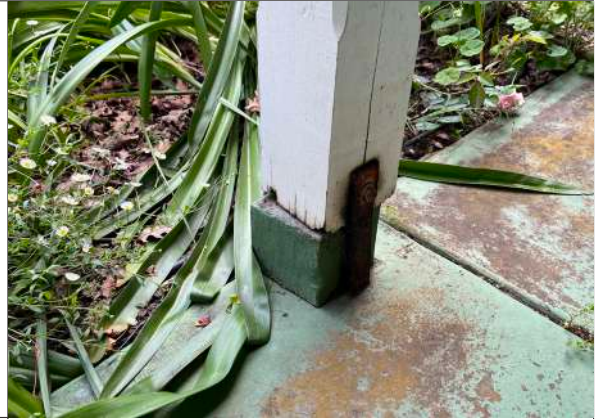
Front verandah post connection

Repair timber posts to the front verandah and use a steel stirrup detail to the base of the columns.

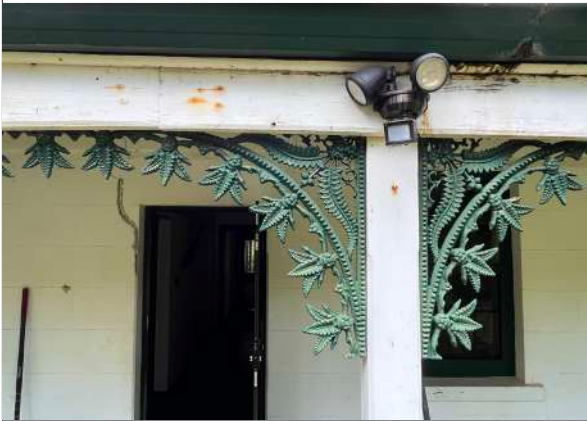
Front verandah post and frieze brackets

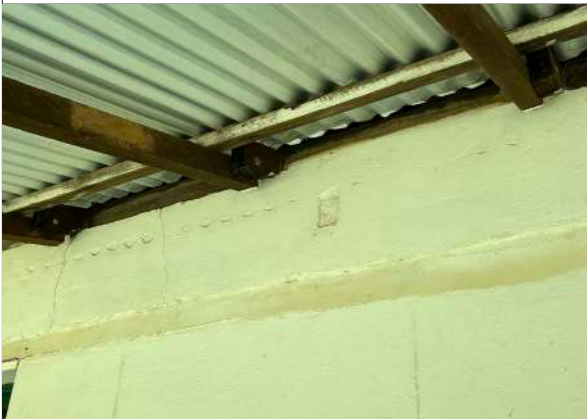
Wall connection showing previous location

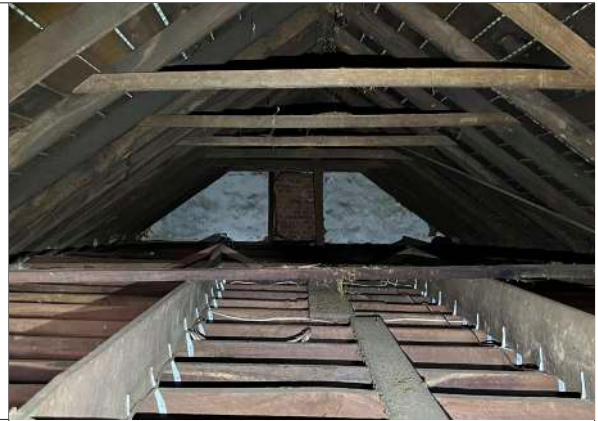
Bricked in window to northern gable

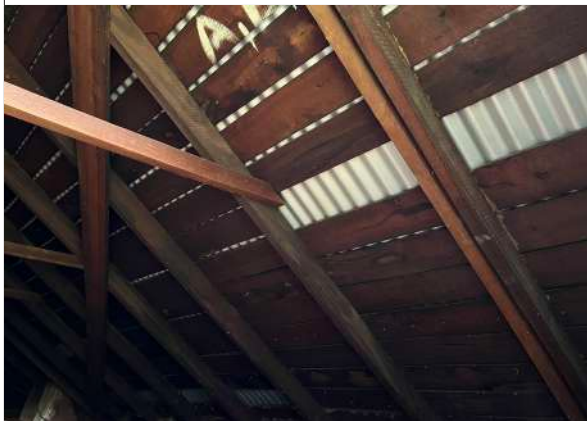
Timber roof slats

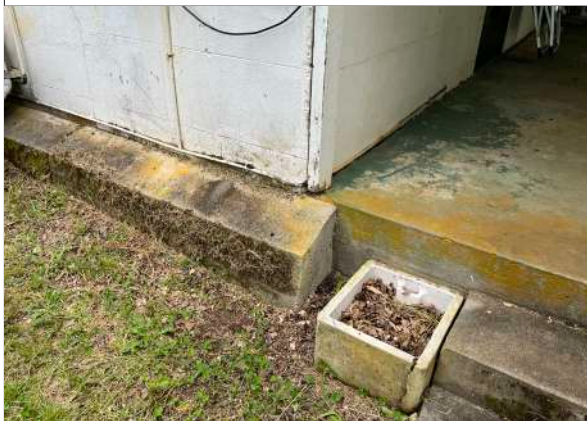
South elevation foundation

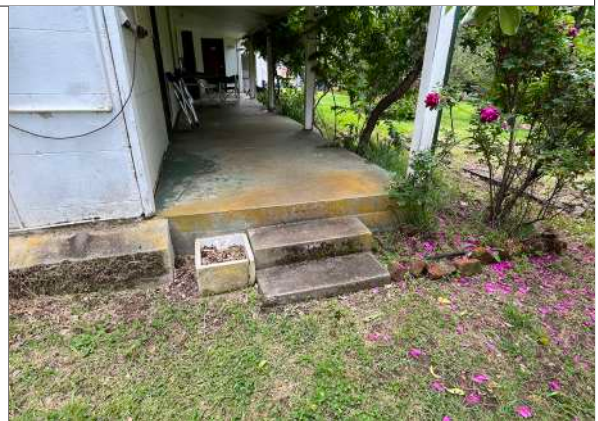
Southern steps to rear verandah

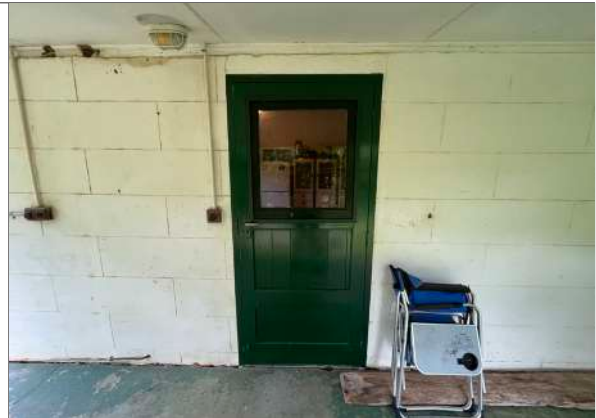
Door to Kitchen

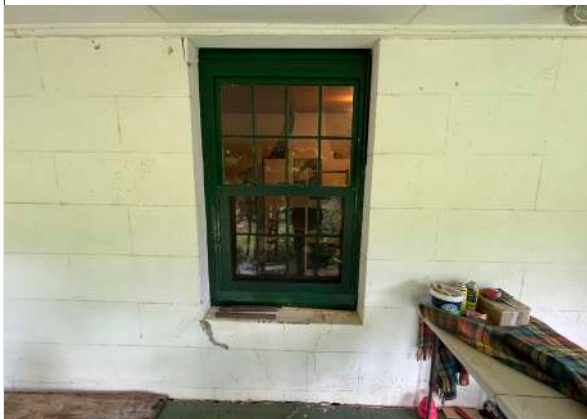
Window to dining room (W6)

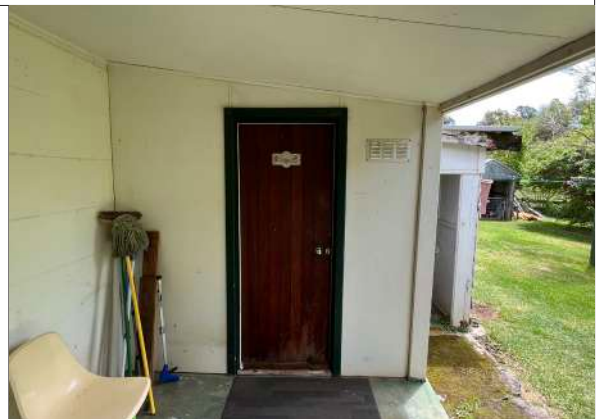
Bathroom built into verandah

- 11 Repair of external weatherboard to outdoor WC. Repair areas of damaged fibre cement sheets to bathroom addition.

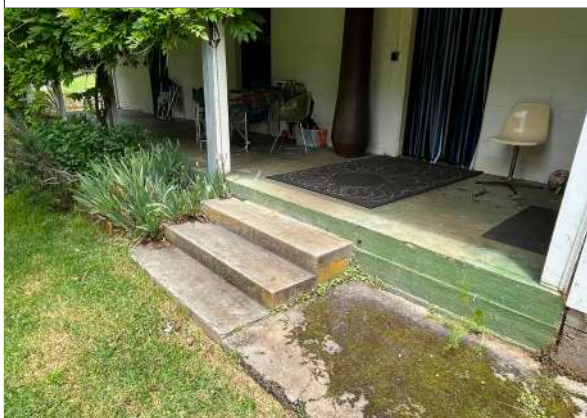
Northern concrete stairs to rear verandah

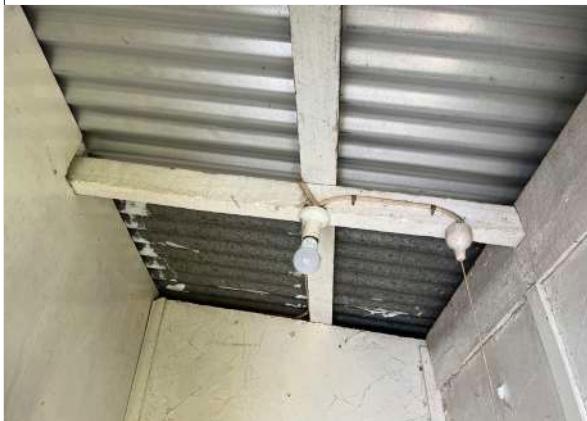
Toilet roof structure

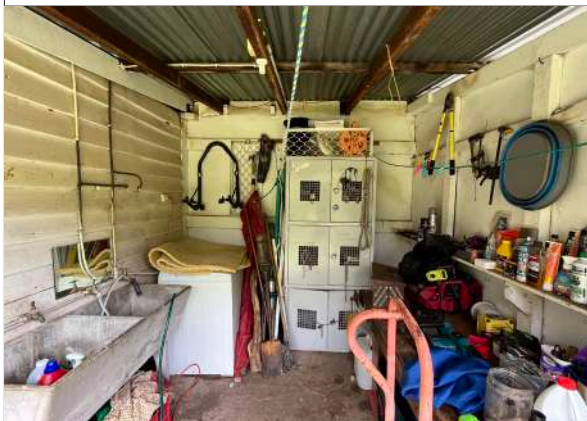
Shed/ Laundry space

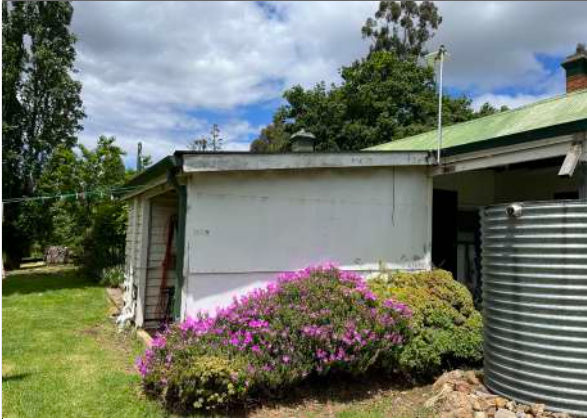
Shed/ Laundry to north corner

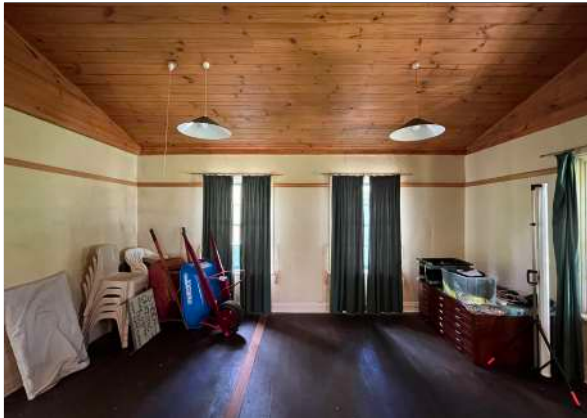
Organ Room western windows

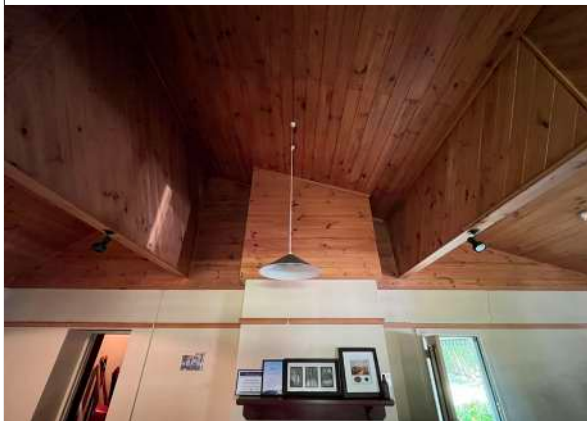
Organ Room roof structure

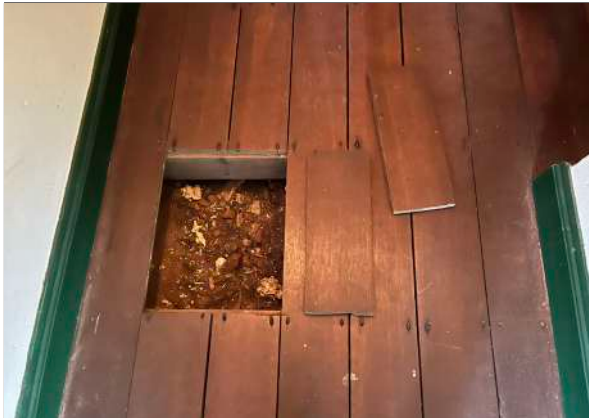
Original timber floor to hallway

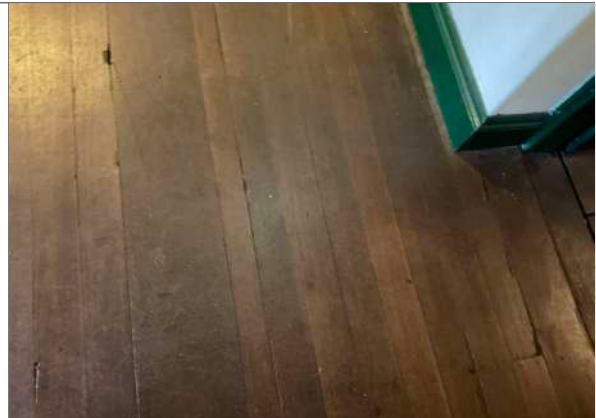
Replaced floorboards to Dining Room

- 10 Local repairs to floorboards where required.
