Golden Valley Homestead, Golden Valley Tree Park,
164 Old Padbury Road, Balingup WA
Structural Engineering Services Assessment

Department of Biodiversity, Conservation and Attractions

Date: March 2023

Our Ref: 2234B

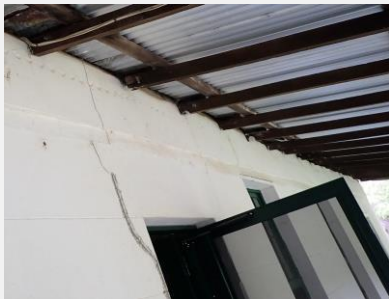
<ul style="list-style-type: none"> Undertake re-protection work to stirrup steel and replace bolts to prolong life of post bases. Replace stirrups where corrosion is advanced. 	M
Bedroom 2, Hall, Living and Bedroom 1 external wall	C	<ul style="list-style-type: none"> Render cracking over all openings to varying degrees, most strongly over the Hall door (4mm wide). Lighter cracks occur below Bedroom 1 window (hairline) and the southern window of the Living room. Many areas have seen previous patching and re-opening. Damage is symptomatic of behaviour on reactive soil. The render is hard compared to the mid brick substrate but is not delaminating in any quantity. The presentation of wall movement in such render may be heightened. The balance in materials is uneasy but render is allowing some breathability to the substrate. 	<ul style="list-style-type: none"> Implementing the actions on drainage and vegetation, included removal of the garden bed on this side of the house, recommended in 3.3 and 3.4 will aid these movements. It is advisable to provide some mechanical stitching across these cracks at the time of next decoration to resist re-opening and safeguard the new finishes being applied.
