**Biodiversity and
Conservation Science**

Preliminary assessment of plastic infrastructure in the Swan Canning Riverpark

Katrina Bornt, Joshua Rule and Peter Novak

June 2024

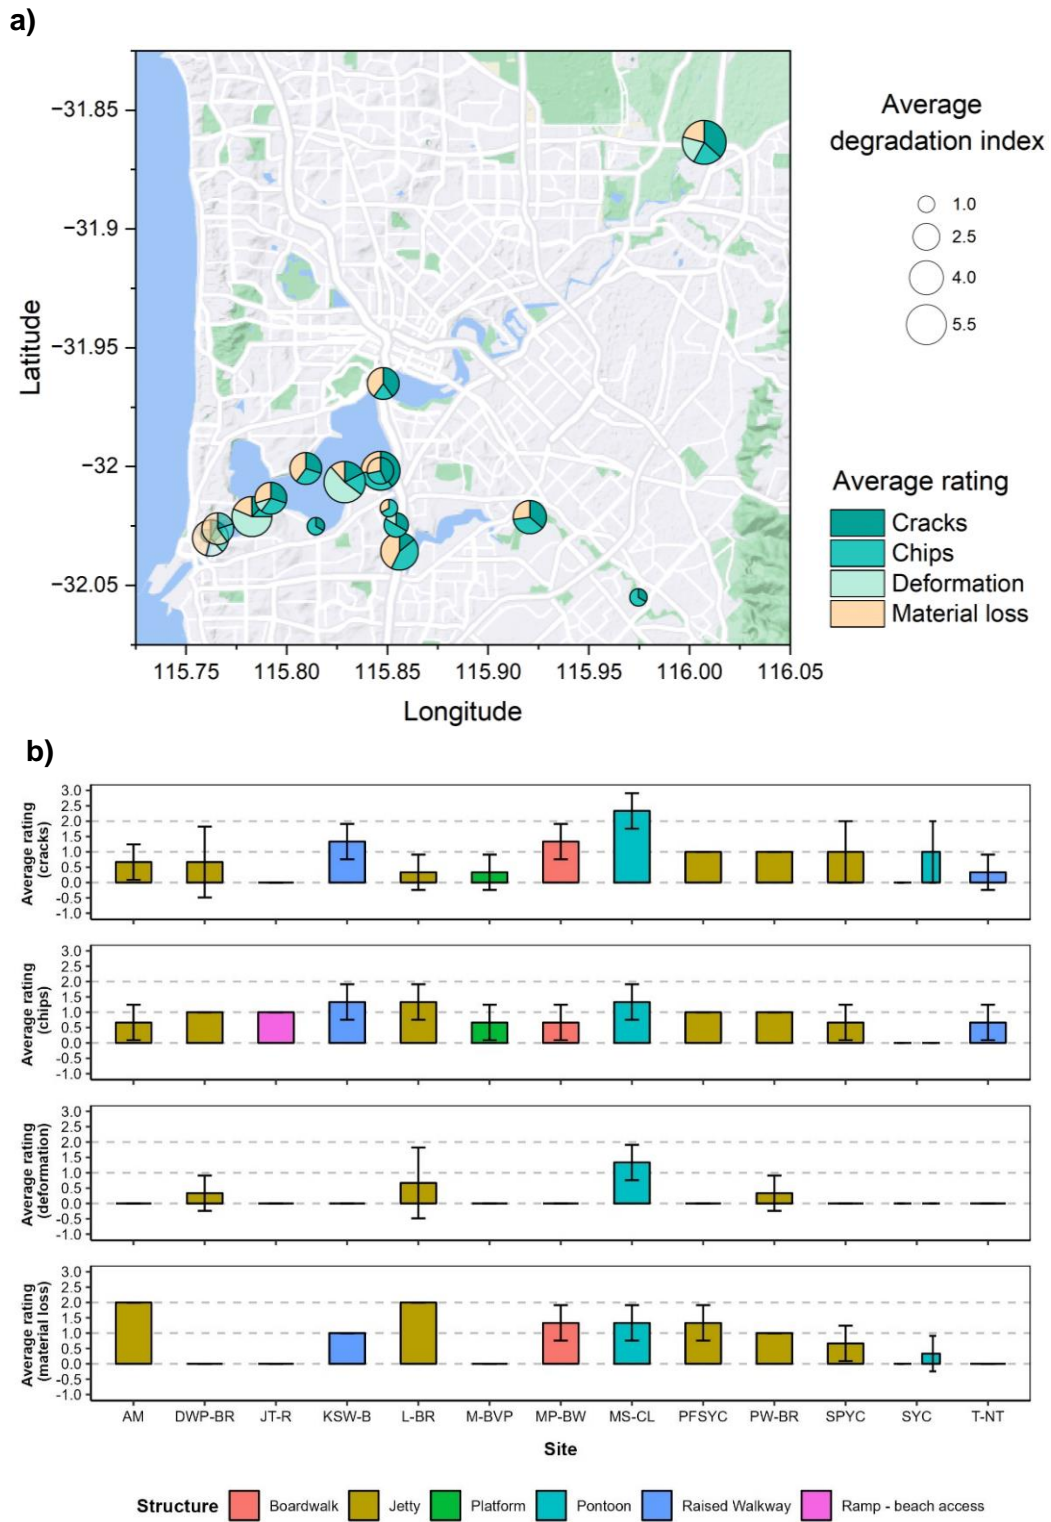
The severity of cracks worsened towards the edges of the structures, particularly if it was not protected with a kick rail or another form of edging or exposed to other wear in addition to abrasion from foot traffic (e.g. boat strikes).

The only FRP decking where cracking was negligible was the decking with standard grating and a solid top (see Appendix 5 Figure 37) at the Swan Yacht Club (Jetty 2) installed in 2014 and the small beach access ramp with mini mesh grating at John Tonkin Reserve installed in 2015. The FRP decking on Jetty 2 at the Swan Yacht Club was only trafficked by boat users with swipe card access and closed to the public. Furthermore, the ramp at John Tonkin Reserve was shaded and relatively small (~17 m²) and didn't appear to be used frequently.

Figure 10. Average degradation rating with standard error from each assessment criteria (cracks, chips, deformation, material loss) across the three quadrats for structures where fibre reinforced plastic decking was used at different sites. Refer to Table 2 for site name abbreviations.

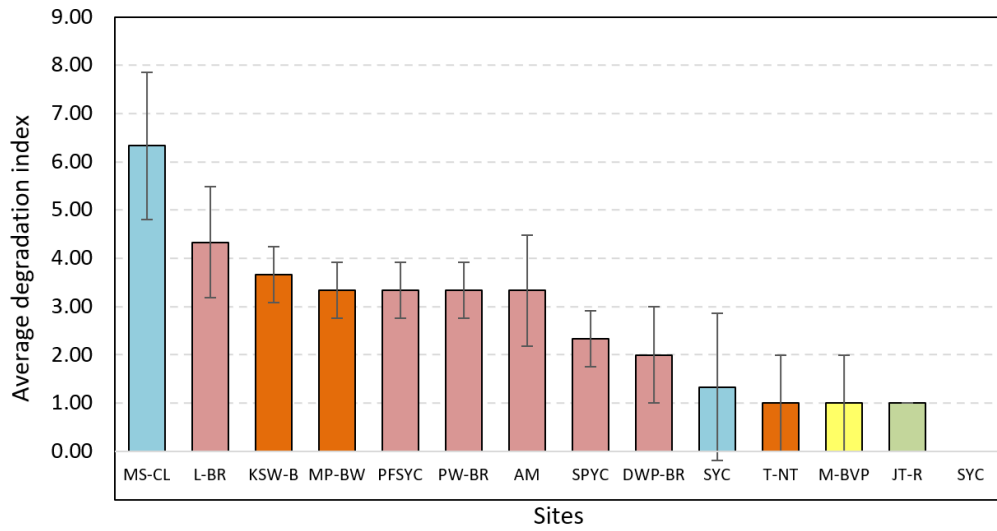
Figure 15. Average degradation index with standard error for structures with fibre reinforced plastic decking across sites. See Table 1 for site names. Pontoons (blue), jetties (pink), boardwalks (orange), platforms (yellow), ramps (green).

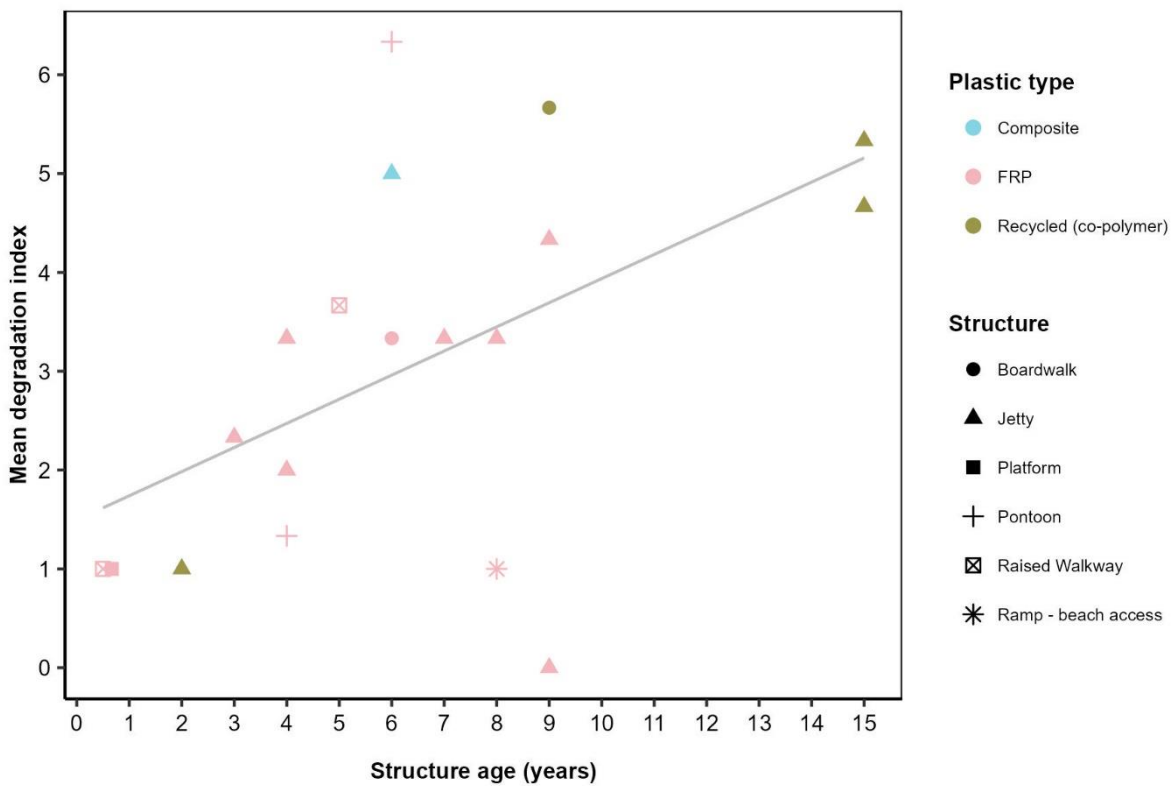
Age: The severity of degradation significantly increased with the age of the structure across all types of plastic decking (Figure 16). Material loss and deformation became more common when structures exceeded five years of age.

Figure 16. The relationship between the age of a structure (years) and the mean degradation index (FRP – fibre reinforced plastic) for plastic decking on different structure types with a linear trendline (grey).

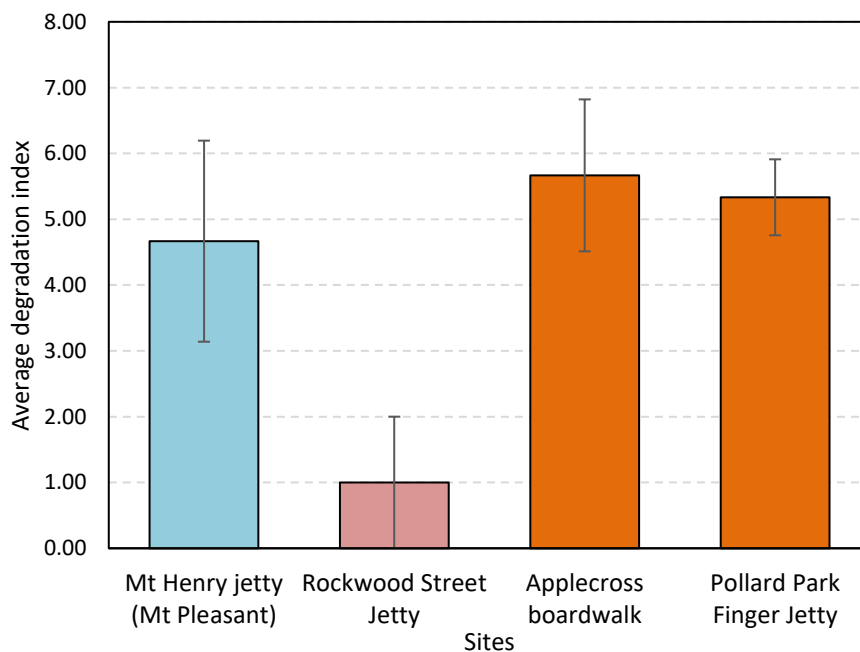
Overall, the degradation observed at Mt Henry Jetty, Applecross boardwalk and Pollard Park finger jetty were similar (Figure 23). The lowest degradation index was observed at Rockwood Street Jetty, which was the most recently installed asset, in 2021.

Figure 23. Average degradation index and standard error for structures with recycled decking. Colours indicate structure type; pontoons (blue), jetties (pink), boardwalks (orange).

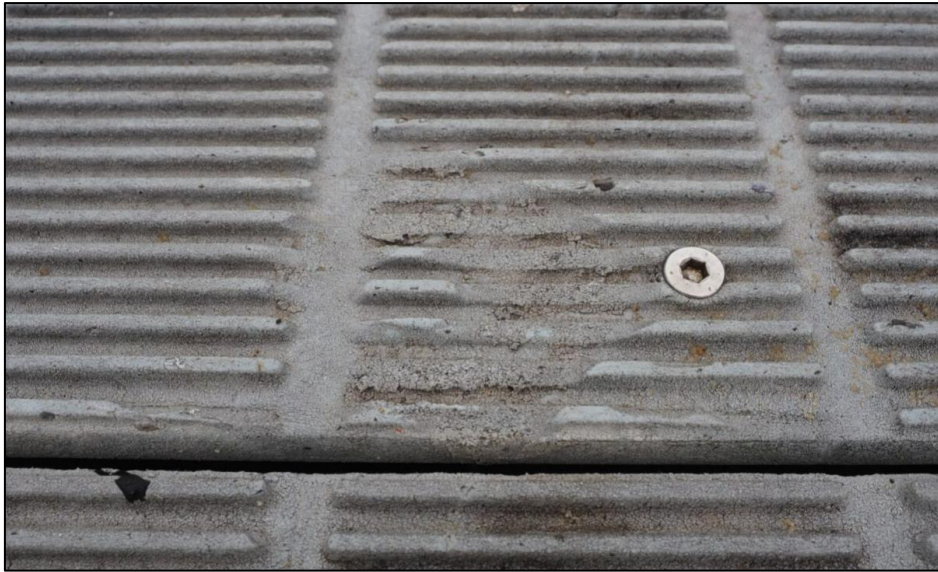
Figure 25. Correct installation of screws to install recycled plastic decking at Mt Henry Jetty.

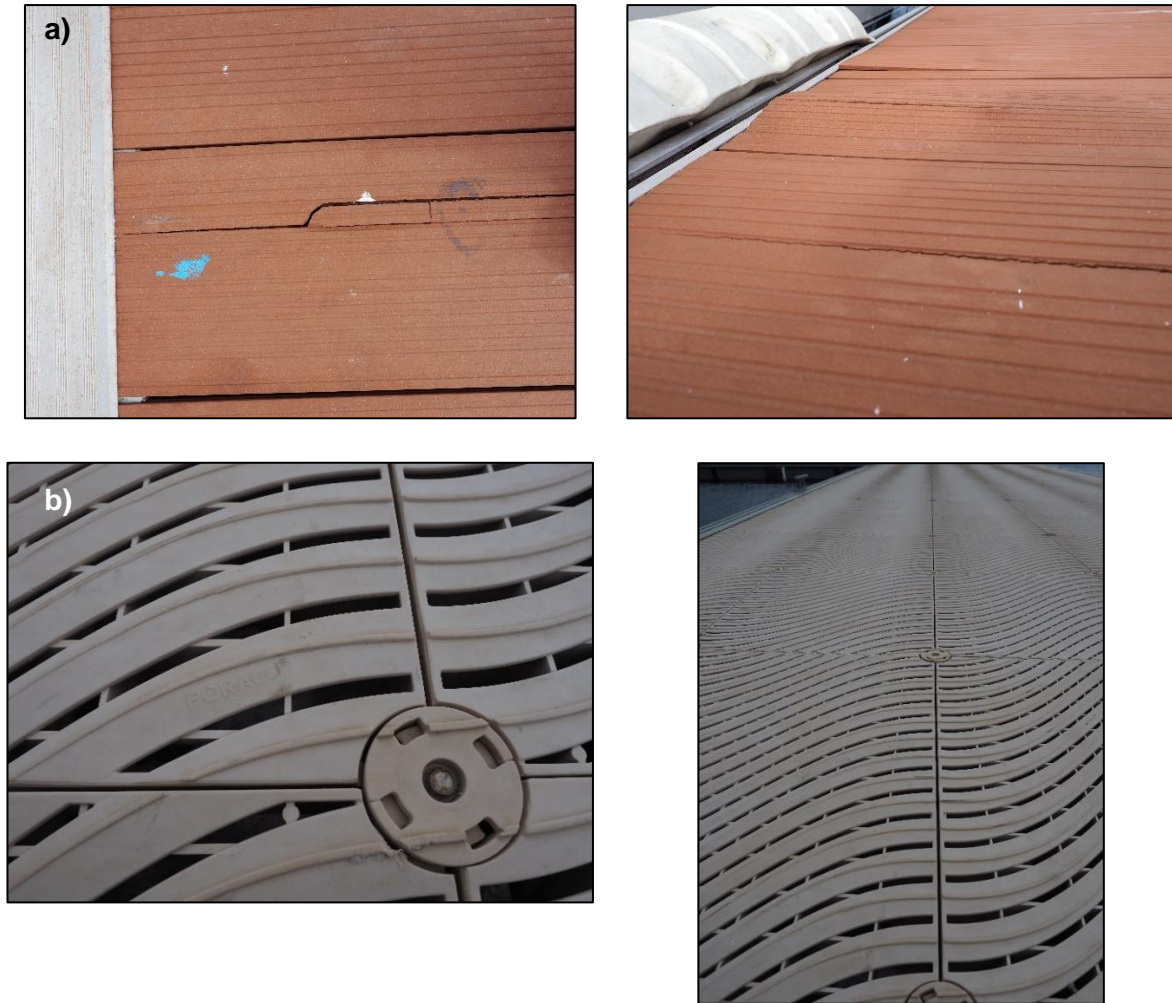
Decking 'tiles' most likely made from PP, were installed on one jetty at the Perth Flying Squadron Yacht Club (Figure 26b). Fading was noticed across the structure and peeling of plastic where panels were joined with a circular disc was also evident (Figure 26b). PP is usually a more rigid type of plastic and may perform differently when exposed to degradation factors that are impacting structures at other sites. More investigation of this material is required before reliable recommendations can be made.

Figure 26. Other types of plastic decking observed including composite plastic at the South of Perth Yacht Club (a) and hard plastic decking (most likely polypropylene) at the Perth Flying Squadron Yacht Club (b).

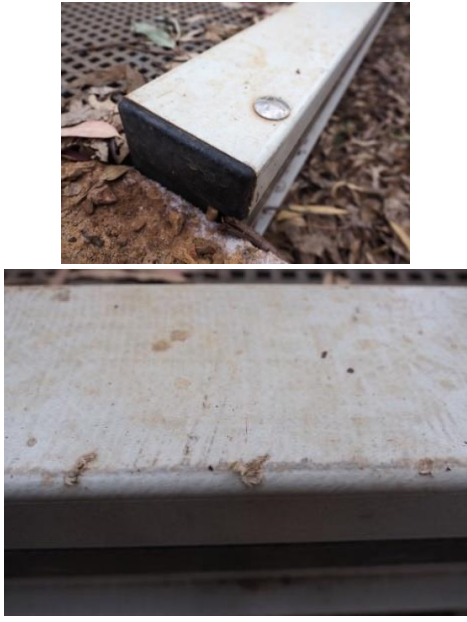
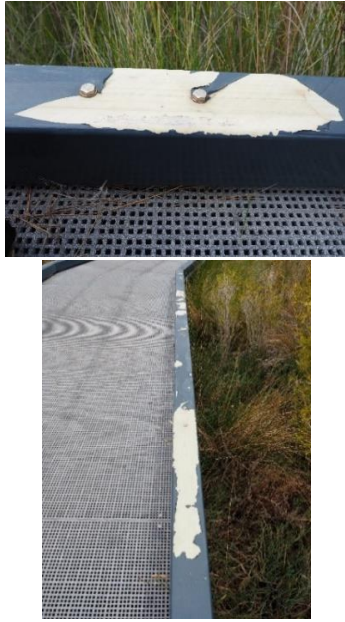
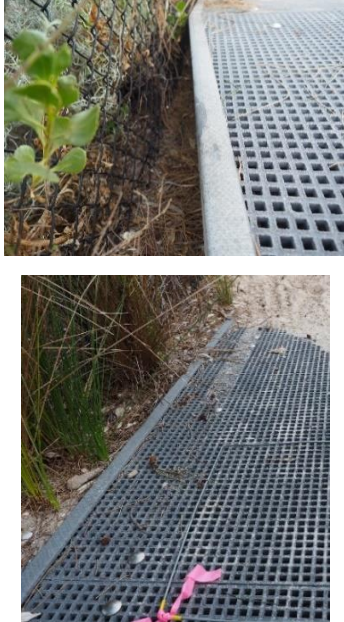
Table 3. Qualitative visual assessments of fibre reinforced plastic (FRP) kick rails used on different structures in the Swan Canning Riverpark from May 2023.

Material	Fibre reinforced plastic		
Structure type	<i>Boardwalk</i>		<i>Ramp (beach access)</i>
Site name	Thornlie Nature Reserve	Miller's Pool boardwalk	John Tonkin Reserve
Structure age (years)	< 1	6	8
Observations	Scuffing evident from installation or transport.	Peeling of dark blue paint along structure exposed FRP material.	Good condition. Very narrow FRP kick rail but seemed to protect decking well.
Degradation index from observations	1 (minor)	1 (minor)	0 (negligible)
Images from May 2023

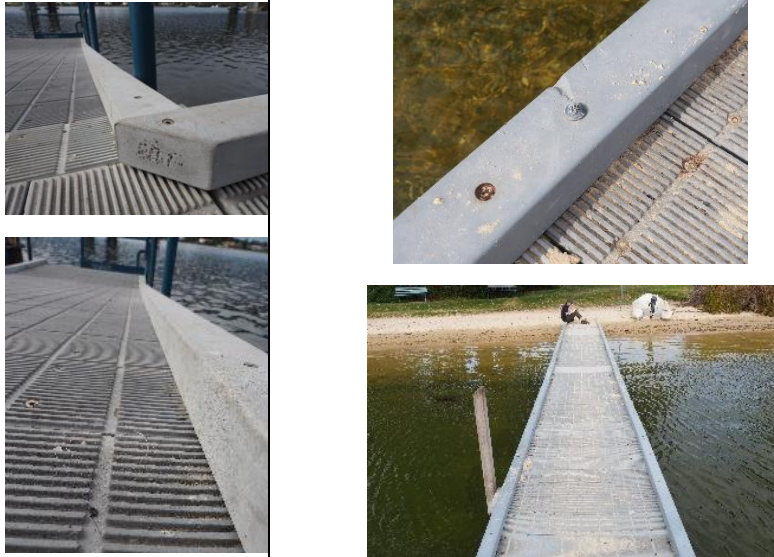
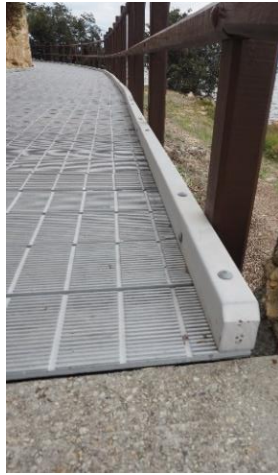
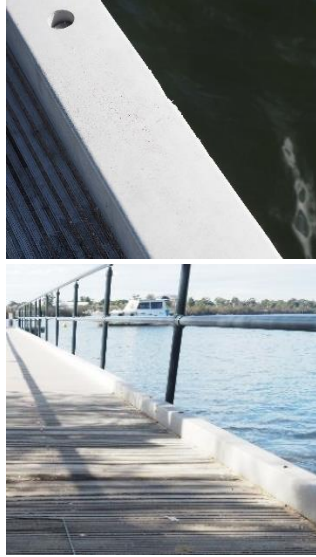
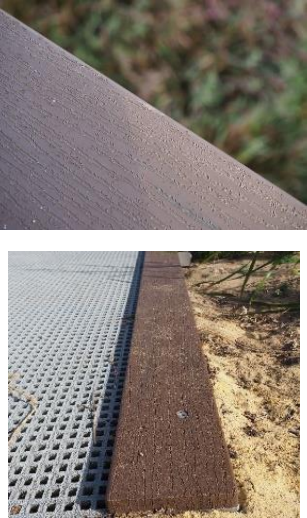
Table 4. Qualitative visual assessments of recycled and other plastic kick rails used on different structures in the Swan Canning Riverpark from May 2023.

Material	Recycled plastic		Other		
Structure type	Jetty		Boardwalk	Jetty	Platform
Site name	Mount Henry jetty	Pollard Park jetty	Applecross boardwalk	Rockwood Street jetty	Melville Bird view platform
Structure age (years)	15	15	9	2	< 1
Observations	Chalky / powdery texture. Solid integrity of structure for age.	Chipping and scuffing evident along edges. Powdery texture. 5mm deformation evident.	Relatively good condition with some chalky texture evident on surface.	Likely composite plastic with some minor wear (scuffing) otherwise in good condition.	Thick plank of hard brown plastic (most likely PE / PP), timber look finish which made it look etched and rough. Good condition and looked like it was installed properly.
Degradation index from observations	1 (minor)	2 – 3 (moderate – severe)	1 (minor)	1 (minor)	0 (negligible)
Images from May 2023

Plastic kick rails: Potential causes of degradation

Boat strike: A greater number of cracks and chips were noticeable on the outer edges of kick rails used on jetties that were exposed to boat strike. Plastic kick rails installed on structures mostly trafficked by pedestrians (i.e. boardwalks) showed less signs of degradation from chips and cracks.

Installation: There was moderate to severe deformation and warping of the recycled plastic kick rails at the Pollard Park finger jetty, which was most likely caused by incorrect installation particularly evident from the deformation in the rest of the jetty (i.e. recycled plastic decking). The FRP kick rail along the boardwalk on the Thornlie Nature Trail was in good condition except for some ‘scuffing’ along the sides of the structure (Table 3). Given it was less than one year in age at the time of the RVCA and didn’t look like it could be exposed to this kind of wear in its present location, it was most likely caused during installation or transport.

High temperatures / UV degradation: The ‘chalky’ or ‘powdery’ surfaces of recycled plastic kick rails likely resulted in material loss from high temperatures and UV degradation. In all cases where this chalky texture was evident, the surface material could easily be rubbed off by hand with minimal pressure. The degraded MP particles from the chalky surface of the kick rails are likely to shed from these structures and enter the surrounding environment. The dark paint on the FRP kick rail at Miller’s Pool was severely peeling in multiple places. Paint is often prone to UV degradation from sun exposure and given this site was fully exposed, it could be causing the paint to peel (Table 3). Toxic chemical components in paint could also be contaminating the local environment from painted structures. Further FRP would be more exposed to other types of degradation once the paint peels from these structures.

Manufacturing: Porosity was noticed in some kick rails, particularly recycled plastic, which is likely due to imperfections during manufacturing. This porosity may lead to an increase in degradation due to the ingress of water if plastic is submerged.

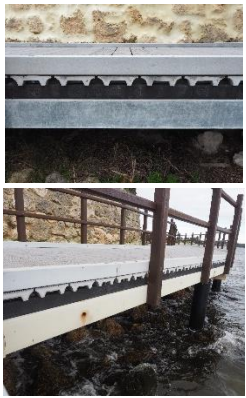
Table 5. Qualitative assessments of fibre reinforced plastic (FRP) sub-structure and polyethylene (PE) float bricks used on different structures in the Swan Canning Riverpark (May 2023). PE float bricks were also present at the Perth Flying Squadron Yacht Club and the Aquarama Marina but were not assessed.

Material	FRP sub-structure			PE float bricks		
Structure type	Jetty	Boardwalk		Platform	Pontoon	
Site name	Rockwood Street jetty	Thornlie nature trail	Applecross boardwalk	Melville bird view platform	Swan Yacht Club	Middle Swan canoe pontoon
Structure age (years)	2	1	> 9	< 1	4	6
Observations	Good condition as evident from shoreline.	Some light wear (e.g. scratches) possibly from installation.	Fading in colour and wear on surface that was most exposed.	Good condition from side view of structure.	Good condition according to asset owner. Algae present on all bricks.	Bricks used for access ramp in good condition as evident from shoreline.
Degradation index from observations	<i>Not assessed (limited accessibility)</i>					
Images from May 2023

Plastic sub-structure and float bricks: Potential causes of degradation

Wet and dry cycling: Most sub-structure and float bricks were constantly exposed to water that may influence the integrity of the structure over time given the likely impacts associated with exposure to wet and dry cycling, particularly for FRP.

Installation: Damage likely occurred during transport and installation, particularly when care was not taken to properly install the structure according to design specifics.

Maintenance: Pressure washing to remove algal growth could degrade plastic over time and shed MPs into the surrounding environment.

UV radiation: The edges of the structure could be more prone to degradation from UV radiation (particularly black float bricks) than surfaces underneath the structure, but they would likely be less impacted than other more exposed plastic structures (e.g. decking).

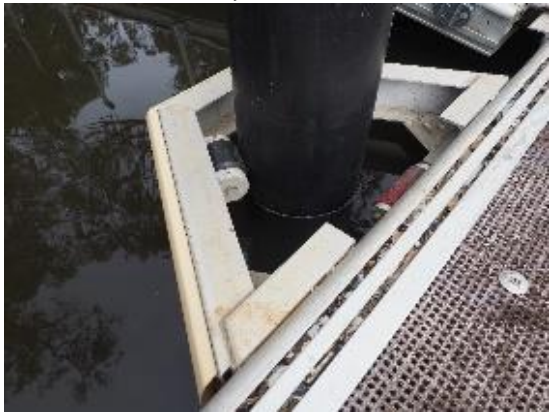
<p style="text-align: center;">Middle Swan canoe pontoon Nylon rollers</p>

Pile capping was in relatively good condition; however, it was difficult to assess most caps properly given the height of some piles. Caps did not appear to get as damaged from boat strike as the sleeves themselves. The white colour used for all capping could help reduce UV degradation. Rollers and edging used to allow movement of floating structures around piles resulted in material loss from chaffing (Table 6). Rollers and edging were installed in various ways (Table 6) and were necessary for preventing wear to other plastic structures, such as decking.

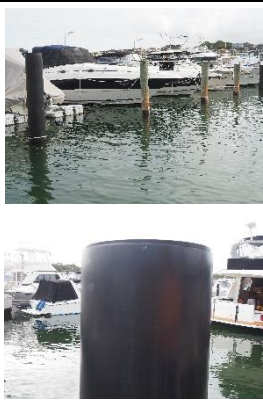
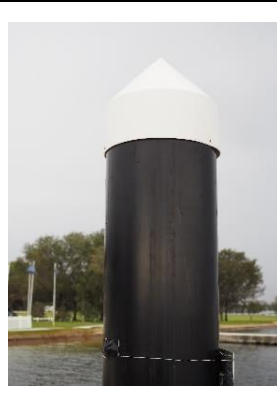
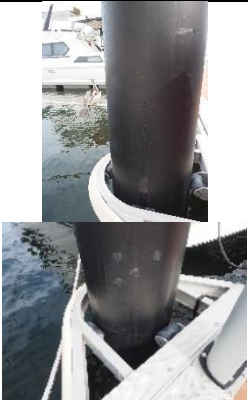
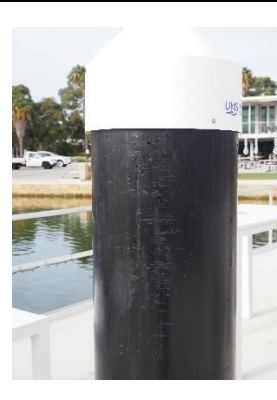
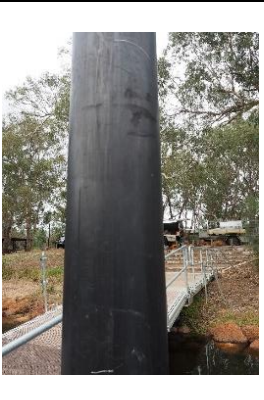
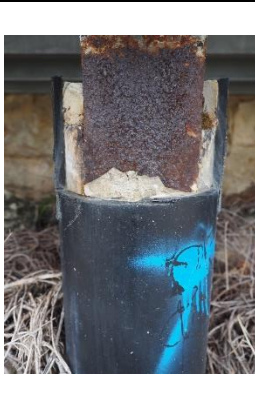
Table 7. Qualitative visual assessments of polyethylene pile sleeves and caps used on different structures in the Swan Canning Riverpark (May 2023). Degradation index applies to sleeves only since capping was often out of reach and could not be reliably assessed.

Material	PE (Pile sleeves + caps)					
Structure type	Jetty			Pontoon		Boardwalk substructure
Site name	Aquarama Marina	Perth Flying Squadron Yacht Club	South of Perth Yacht Club	Swan Yacht Club	Middle Swan Canoe launch	Applecross boardwalk (no cap)
Structure age (years)	< 8	8	0 - 23	4	6	9
Observations	Slowly replacing wooden piles from 1985. Used in boat pens (not assessed) and loading jetty. Some did not have white PE caps. Scratches from boat strikes evident. Drill tailings evident from capping installation.	Only observed on central floating jetty and were in good condition with minimal scuffing and scratches evident.	Wear evident from boat strike and repairs in some places. Some wear from rollers at base of piles.	Scratches evident on pontoon piles, particularly near table settings and where boats dock. Otherwise in good condition. Could not assess piles used for boat pens.	Very damaged at the top of the piles (far out of reach) possibly from installation. Large chunks of plastic missing along the pile, particularly >2m on piles.	Roughly cut piles with metal and fibre reinforced plastic substructure. Vandalism and damage evident but difficult to assess whole structure as it was mostly inaccessible.

Degradation index from observations	1 (minor)	1 (minor)	1 – 2 (minor to moderate)	1 (minor)	2 (moderate)	1 – 2 (minor to moderate)
Images from May 2023

Boat strike: Given the usual purpose of piles, chafer posts and fenders are to minimise impact from boats on jetties and pontoons, most physical damage (e.g. scuffing, scratches, scrapes) was likely caused from boat strike. Fenders were the most impacted plastic structure of all assessed given they are often the first point of contact with boats and a much softer material than the high-density PE and recycled plastic used for piles and chafer posts, respectively.

Wet and dry cycling: Piles and chafer posts were often partially submerged in water and may be more prone to degradation from interacting with estuarine water. Rubber and foam fenders would also be constantly wet from being close to the water. Degraded piles, chafer posts and fenders (i.e. damaged from boat strikes) could be more susceptible to degradation from wet and drying cycling.

Installation: Large scuff marks evident high on the piles at the Middle Swan canoe pontoon suggest damage was possibly caused when they were lowered for installation. Further drill tailings were present where screws were used to install pile caps (Table 10). Peeling PE was observed where edging was cut into shape around the bases of piles. Rigid edging installed around the base of piles could be causing more wear on piles than rollers (Table 6).

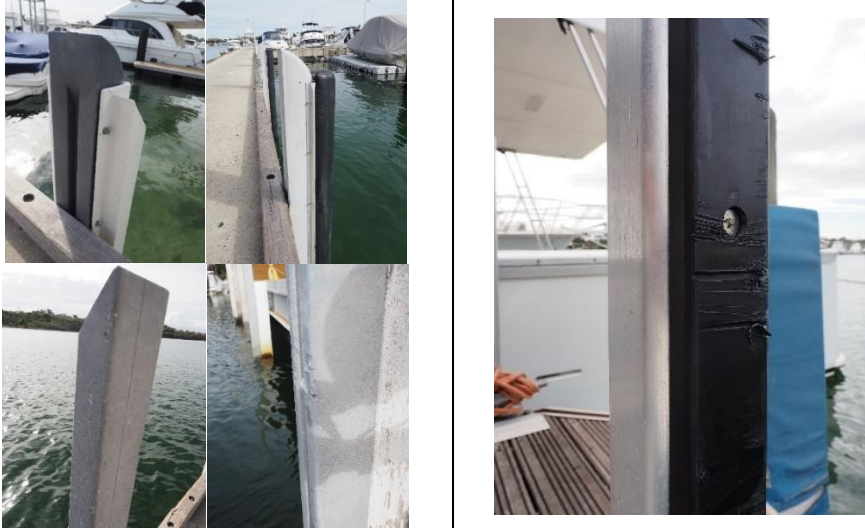
Table 8. Qualitative visual assessments of plastic (recycled plastic and polyethylene; PE) chafer posts used on jetties in the Swan Canning Riverpark (May 2023).

Structure type	<i>Jetty (chafer posts)</i>	
Material	Recycled plastic	PE
Site name	Aquarama Marina	Swan Yacht Club
Structure age (years)	2 – 10	> 4
Observations	Newer grey REPLAS posts (~ 2 years) showed minimal wear. Most degradation (chipping, scratches) were evident on large chafer posts used in the most exposed location at the fuelling station. Most posts had additional plastic padding on outer sides.	Black plastic attached to aluminium posts were used along smaller access jetties for boats. They were scuffed in places with plastic sloughing off.
Degradation index from observations	1 – 2 (minor – moderate)	1 – 2 (minor – moderate)
Images from May 2023

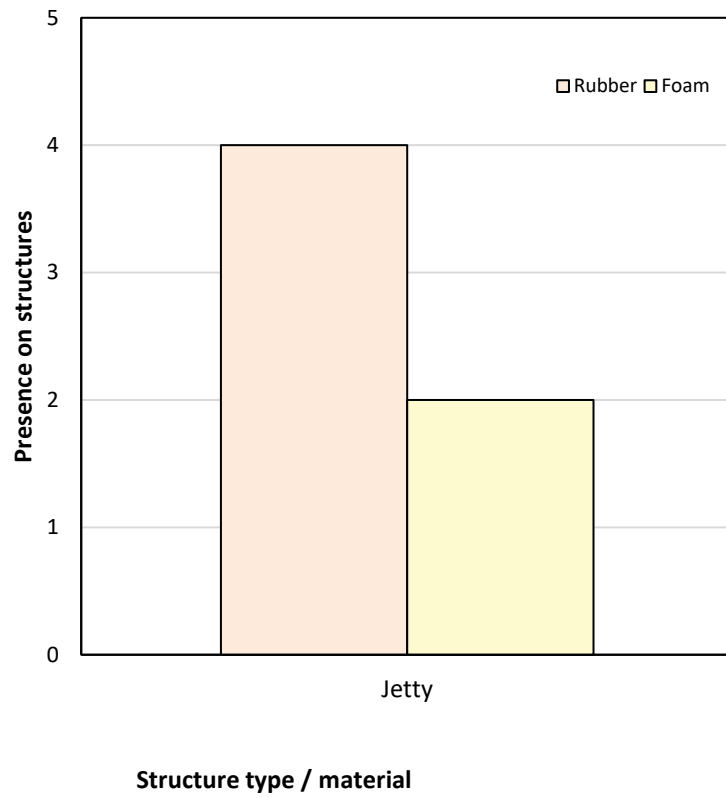
Figure 30. The different kinds of materials used as wharf fenders on jetty structures.

Fenders provided additional cushioning on chafer posts along jetties prone to boat strike and, therefore, were generally more degraded (Table 9). The softer fenders made from rubber and foam (Figure 30) also meant they were very prone to sloughing of plastic into the water under jetties. A harder unknown type of plastic was used for protecting the corners of the canoe pontoon at Middle Swan. This plastic was faded and severely damaged with larger pieces missing along the edge of the water (Figure 31).

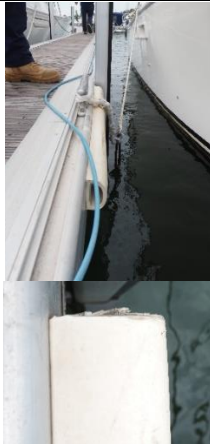
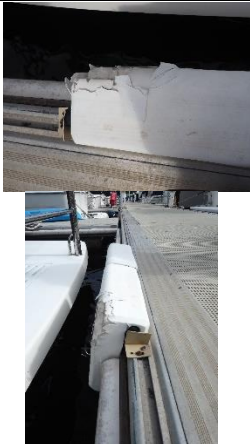
Table 9. Qualitative visual assessments of plastic fenders used on jetties in the Swan Canning Riverpark (May 2023). The specific type of rubber and foam are unknown.

Structure type	<i>Jetty</i>					
Material	Rubber (polymer unknown)			Foam (polymer unknown)		
Site name	South of Perth Yacht Club	Perth Flying Squadron Yacht Club	Swan Yacht Club	Point Walter	South of Perth Yacht Club	Aquarama Marina
Structure age (years)	<i>Uncertain</i>					
Observations	Faded and shedding noticed at the ends cut roughly during installation.	Faded with mild wear.	General scuffing and wear evident.	Faded with black scuff marks and chunks missing. Powdery texture.	Example in image of foam fender severely damaged with chunks of foam falling off into the river.	Faded and plastic peeling and shedding into river. Huge pieces of plastic found loose on structure.
Degradation index from observations	2 (moderate)	1 (minor)	1 (minor)	2 (moderate)	3 (severe)	3 (severe)
Images from May 2023

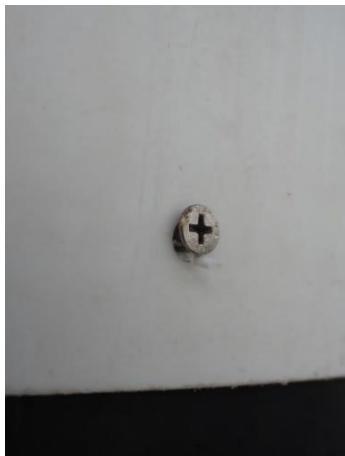
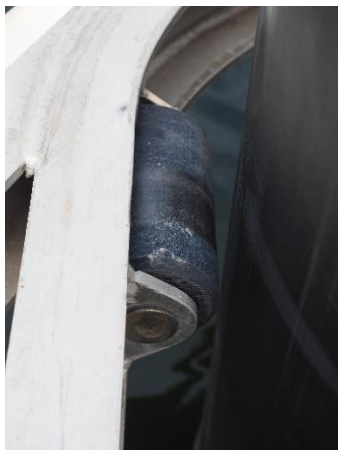
Table 10. Other signs of degradation evident on piles in the Swan Canning Riverpark (May 2023).

Site name	Aquarama Marina	South of Perth Yacht Club
Observations	Drill tailings falling out under screws.	Wear noticed on nylon rollers from friction with polyethylene pile sleeve.
Images (May 2023)

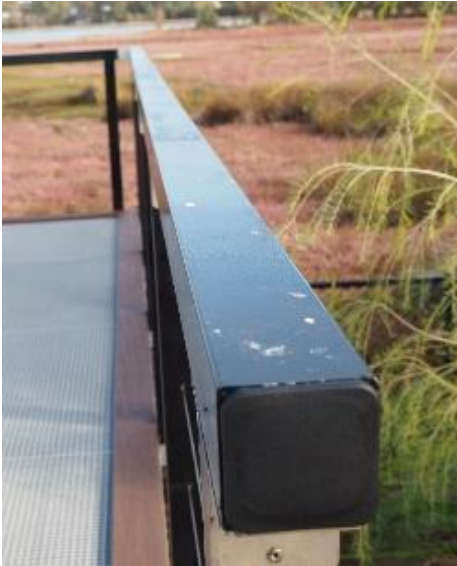
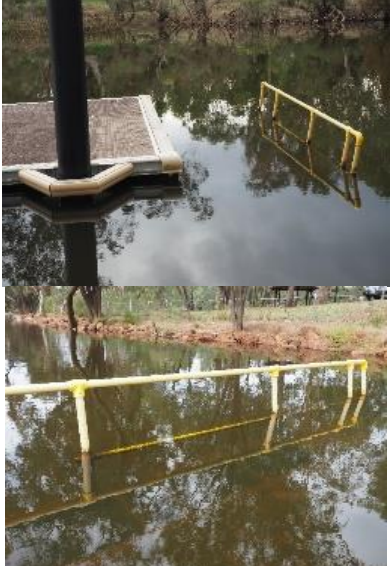
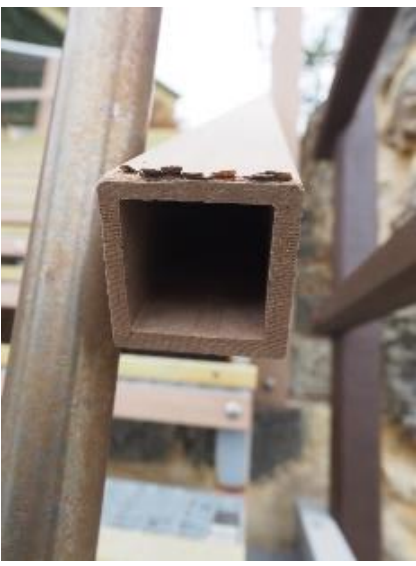
Plastic handrails, seats and posts: Potential causes of degradation

High temperatures / UV degradation: Fades plastic over time and creates weaknesses in structures, particularly handrails. Not as evident in seats and posts.

Age: Older handrails showed more signs of degradation (e.g. material loss at ends) but this would also depend on the frequency of their use.

Table 11. Qualitative visual assessments of handrails made from fibre reinforced plastic (FRP) on different structures in the Swan Canning Riverpark (May 2023).

Material	<i>Unknown</i>	FRP	
Structure type	<i>Handrails</i>		
Site name	Melville bird view platform	Middle Swan canoe pontoon	Applecross boardwalk access staircase
Structure age (years)	< 1	6	>9
Observations	Plastic type needs confirming. Black handrail with no damage present. Plastic capping on ends.	Severely degraded handrail submerged in water and attached to algae covered FRP decking. Partially metal.	Surface layer peeling on end of rail (no capping). Faded brown colour.
Degradation index from observations	0 (negligible)	3 (severe)	2 (moderate)
Images from May 2023

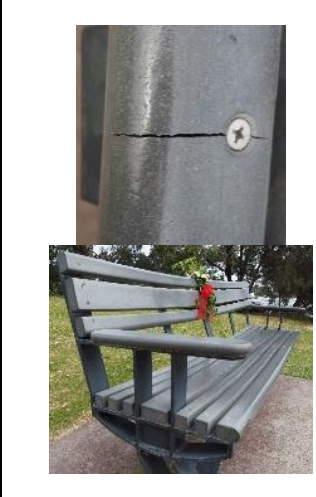
Vandalism: Obvious etchings present on structures causing additional degradation, particularly on seats.

Table 12. Qualitative visual assessments of seats and posts on different structures in the Swan Canning Riverpark (May 2023).

Material	Recycled plastic			
Structure type	<i>Jetty seats</i>		<i>Boardwalk seats</i>	<i>Beach access ramp posts</i>
Site name	Rockwood street jetty	Pollard Park Street Jetty	Miller's Pool boardwalk	John Tonkin Reserve
Structure age (years)	2	Unknown	Unknown	Unknown
Observations	Some chipping and scraping evident likely from vandalism.	Metal frame with plastic seat and backing. Cracking evident from screws. Some scratches present.	Black plastic seat in good condition but not thoroughly assessed.	Plastic posts observed in shaded position along the access ramp and shore front. Good condition.
Degradation index from observations	1 (minor)	1 - 2 (minor - moderate)	0 (negligible)	0 (negligible)
Images from May 2023

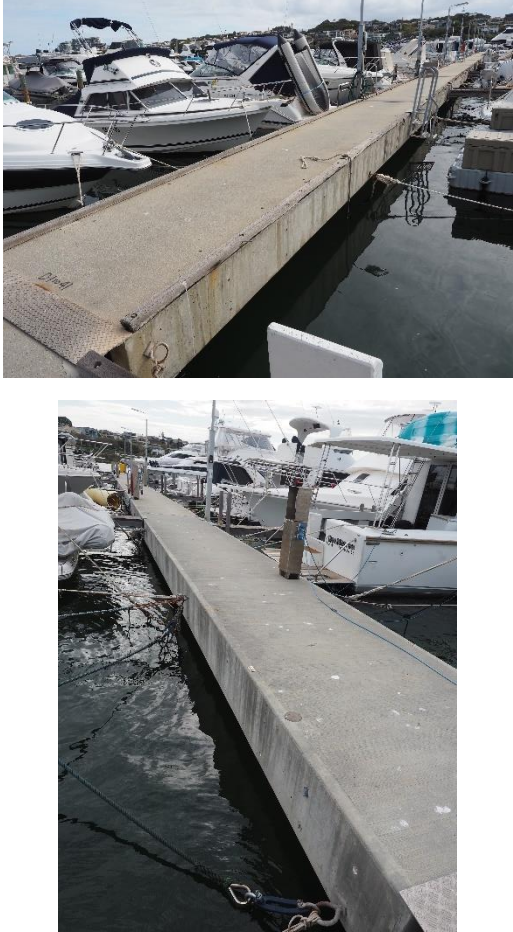
<p>Concrete jetty at Aquarama Marina (top) and Swan Yacht Club (bottom)</p>	<ul style="list-style-type: none"> • Concrete is the recommended material from multiple yacht club managers. • Negligible signs of degradation after a 25+ year service life. Low maintenance. • High embodied carbon but this may be offset by an increased service life, reduced maintenance cost and eliminating the possibility of plastic fragments ending up in the Swan and Canning rivers. • Concrete float example (https://www.poralu.com/en/products/). The construction of a concrete dock float meets concrete standards IN 206-1. They are encapsulated and reinforced by a layer of galvanized steel, ensuring optimal protection and resistance regardless of site conditions. They are filled with high-density expanded polystyrene foam which ensures their unsinkability.
<p>Concrete</p>	<ul style="list-style-type: none"> • Example https://www.permacomposites.com/concrete-decking/
