Tributary Foreshore Assessment: Bennett Brook

Conservation and Ecosystem Management Division

March 2019

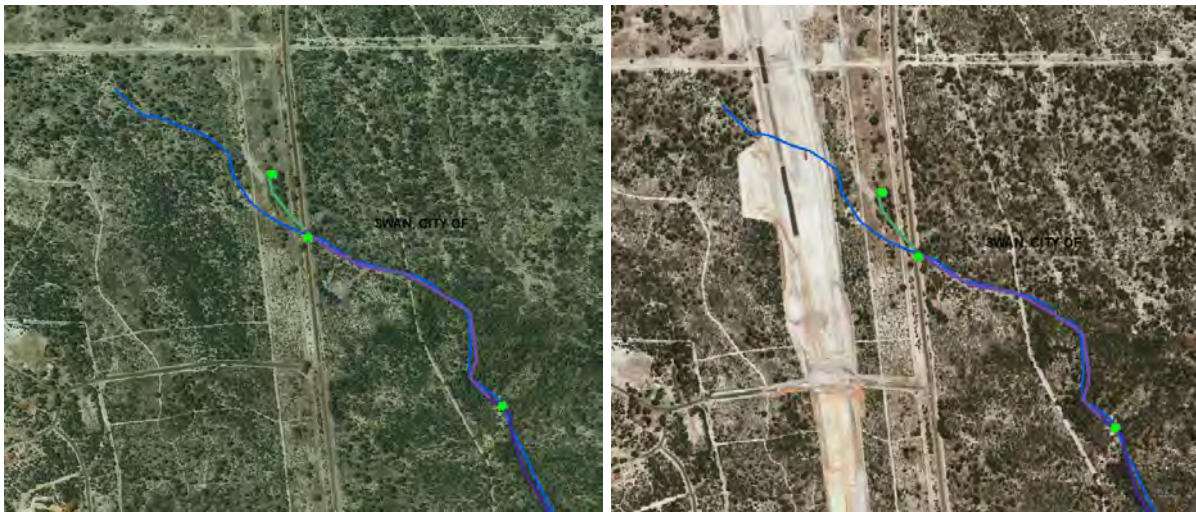
NorthLink WA is a 37km highway currently under construction between Reid Highway and Muchea to reduce pressure on Great Northern Highway. Clearing of the alignment is evident on the 2017 satellite image (*Figure 10, Figure 11*).

Figure 10 (left): 2006 satellite image of the headwaters of Bennett Brook prior to construction of NorthLinkWA.

Figure 11 (right): 2017 satellite image showing the cleared alignment of NorthLinkWA.

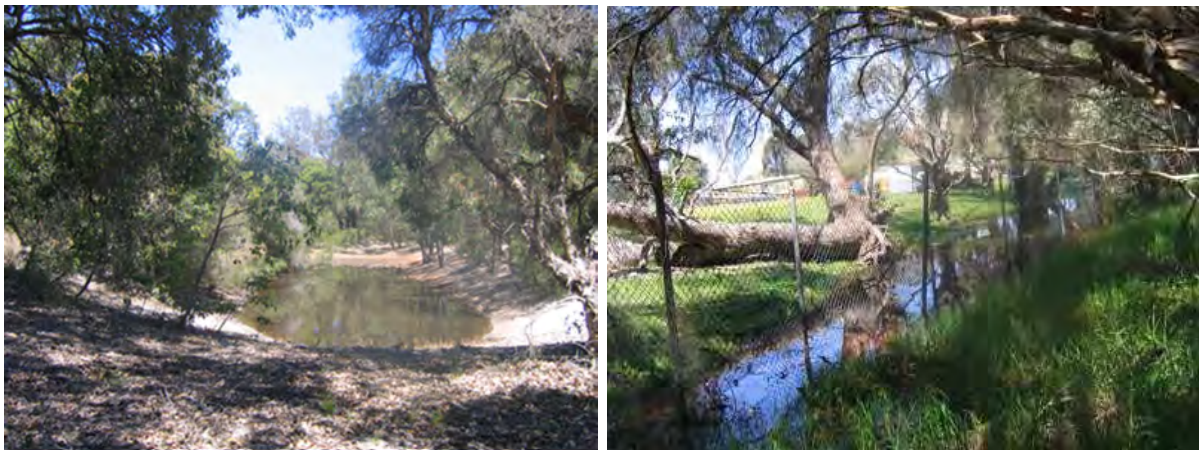
Figure 22 (left): Small dam on Bennett Brook in 2007 (was dry in 2017).

Figure 23 (right): The private property fenceline in 2007.

Towards Marshall Road and adjacent to private property bank stability was average where domestic sheep and pigs had access to the brook (Figure 21, Figure 23). This area was in a similar condition when assessed by DBCA in 2007.

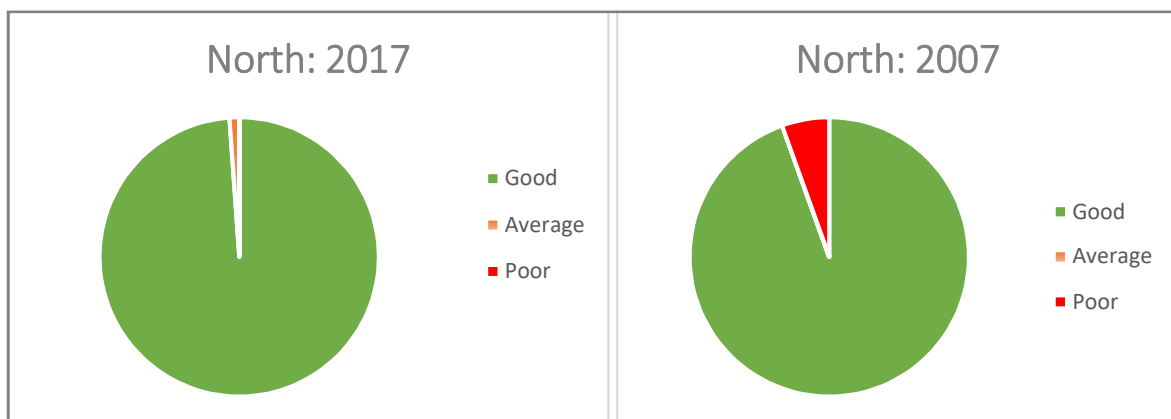
Figure 24: Bank stability ratings for the North section in 2017 (left) and 2007 (right).

Bank stability is good for most of the North section (*Figure 24*). In only three segments erosion or sedimentation were noted. At the headwaters localised sedimentation was associated with a culvert on the Beechboro Road North crossing. A sand-based dam is located in the brook near the northern-most rail crossing (*Figure 22*). Near another rail crossing about 700m north of Mussel Pool, the rail embankment appears to have impeded water flow and the surface water was stagnant (*Figure 20*).

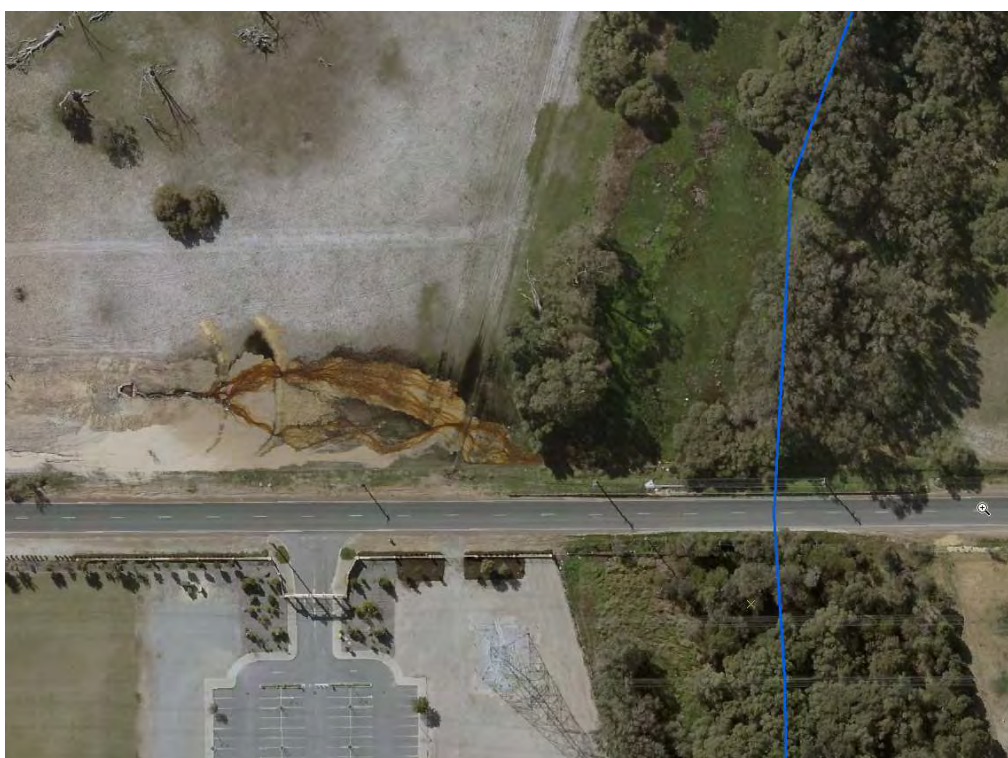
In winter 2018 the City of Swan redirected a drainpipe outlet to relieve flooding near houses on Marshall Road. However, the pipe was placed high on a slope, and the drop below the drainpipe onto sandy substrate together with the volume and speed of flowing water has resulted in severe gully erosion and sheeting of sand towards Bennett Brook. Some of the sand has been trapped by vegetation but a significant plume was visible at the Marshall Road crossing in September 2018 (*Figure 25*).

Figure 25: Sediment plume evident on the north side of the Marshall Road crossing.

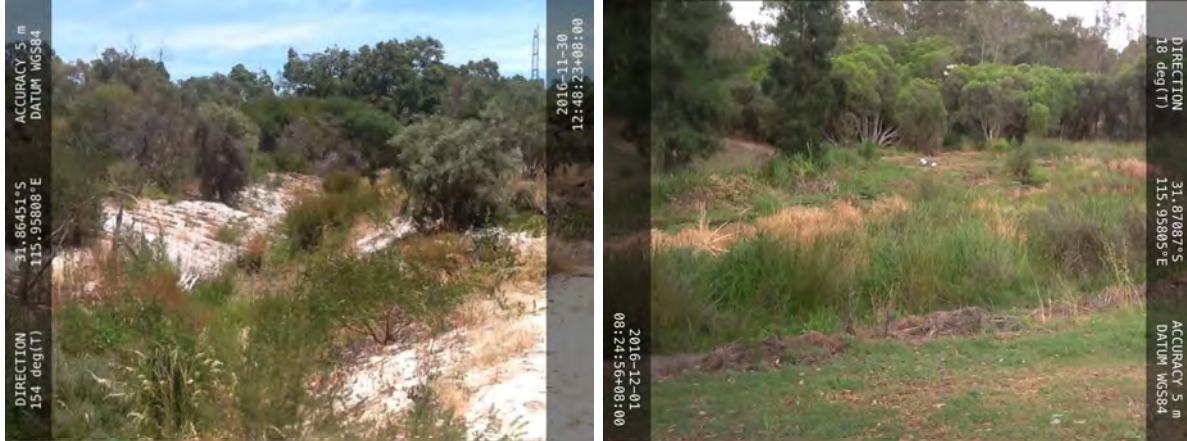
Several drainage channels enter the brook in this section. Bandicoot Creek flows in immediately south of Reid Highway and is being rehabilitated with DBCA support. Coonawarra Drain is steep-sided and narrow and has been revegetated by the Friends of Bennett Brook (*Figure 26*). In 1998 this drain was noted as causing localised erosion.

At Simla Park a series of compensation basins flow into the brook from the adjacent housing estate (*Figure 27*). Erosion was evident where these basins flowed into the brook in 1998, but this was no longer noted as an issue. Lanius Drain flows into the brook north of the Buddhist temple on Benara Road. Part of this drain has also been restored by the Friends group.

Figure 26 (left): Coonawarra Drain.

Figure 27 (right): Last of a series of three compensation basins that flow into Bennett Brook.

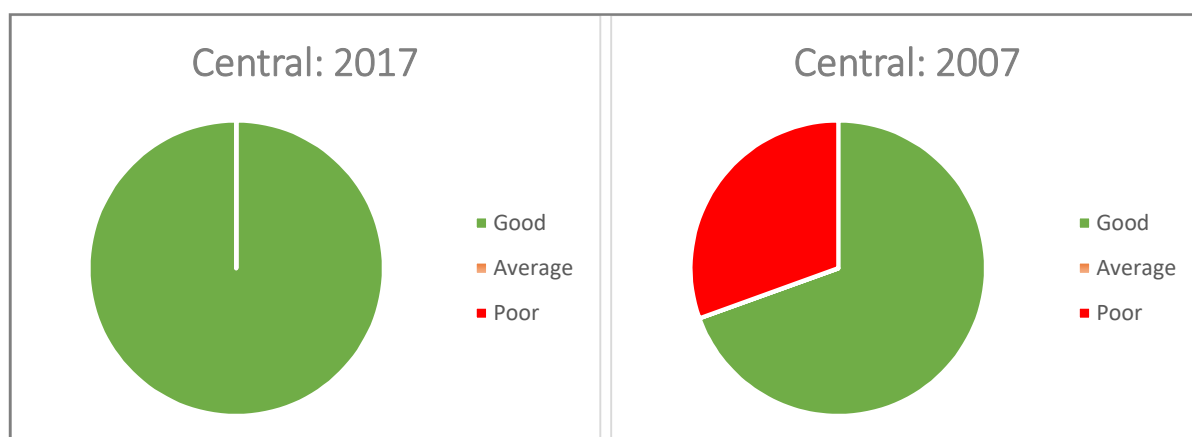
Figure 28: Bank stability ratings for the Central section in 2017 (left) and 2007 (right).

Throughout the Central section erosion is not apparent and bank stability is good (*Figure 28*). Most of the section has been revegetated and has good coverage of sedges, understorey plants and tree roots (*Figure 29*). In the short reaches that have not yet been revegetated a dense kikuyu layer helps to provide bank stability. In 2007 bank stability was average or poor in nine of the 21 segments that had been assessed, indicating a substantial improvement in bank condition since then.

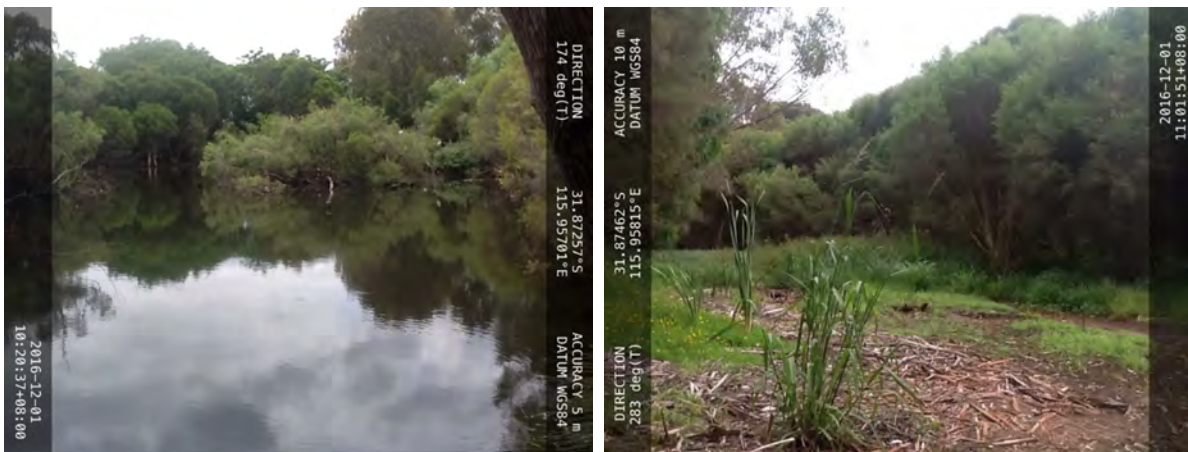
There are several braided channels and an open waterbody in the lower reaches of the Central section (Figure 31-Figure 34). In 1998 the high level of weed invasion in the channels had resulted in slow stream flow and extensive retention of sediment from upstream erosion (WRC 1999). Where private property is adjacent to the left bank of the brook weed invasion is still high but where it is possible to see the bank, stability is good, and erosion and siltation issues are not evident.

Figure 31 (left): Open waterbody on Bennett Brook 350m north of Benara Road.
 Figure 32 (right): Open shallow channel near Benara Road.

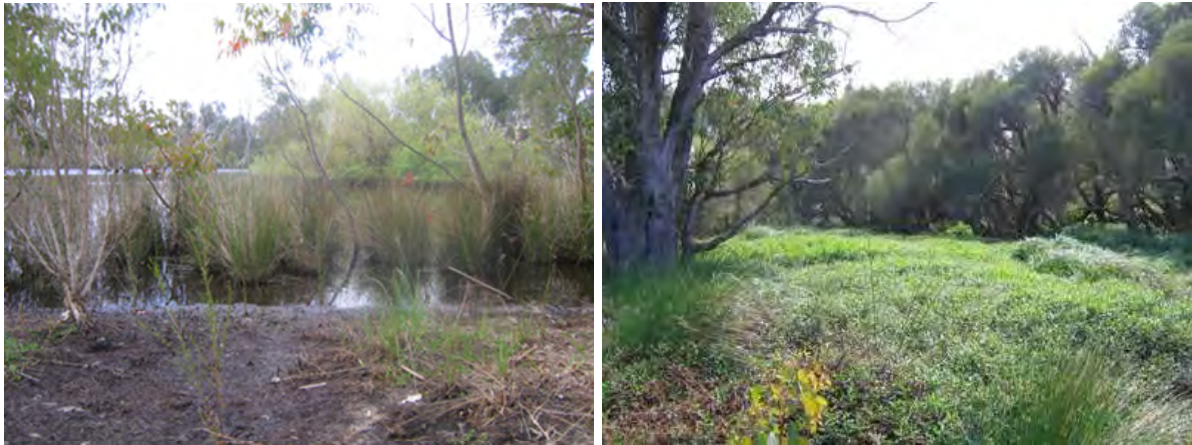
Figure 33 (left): Waterbody in 2007.
 Figure 34 (right): Shallow channel in 2007.

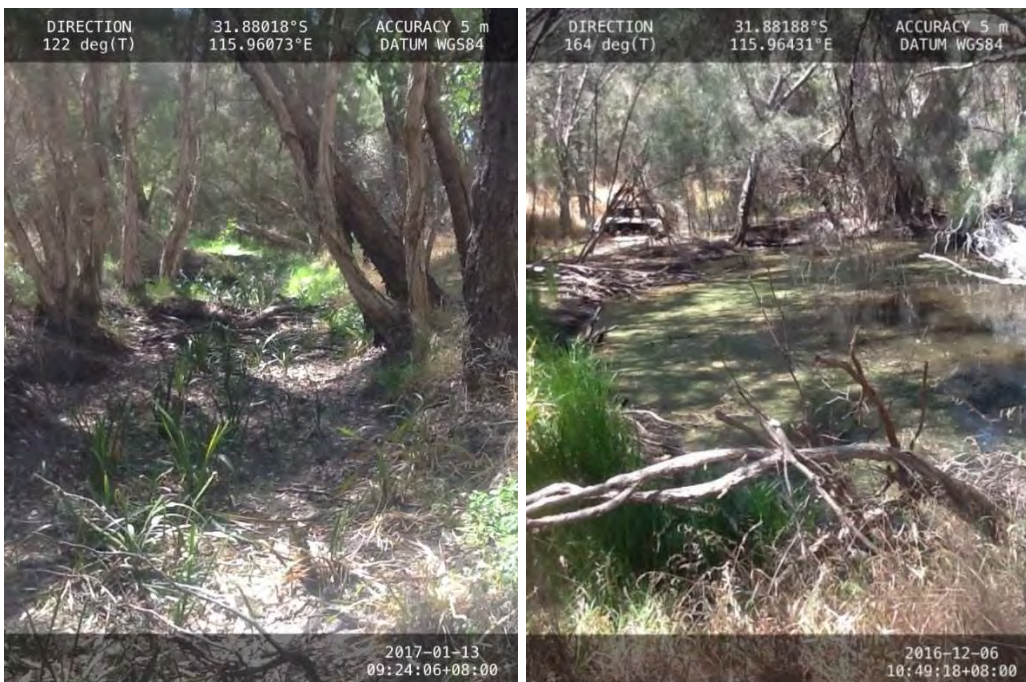
Close to Grogan Swamp there are multiple channels and high embankments where the drainage appears to have been modified (Figure 35, Figure 37). In 2007 some erosion and siltation was observed, but this was not visible in 2017 due to the dense vegetation and inaccessible banks.

Figure 35 (left): Multiple channels upstream of Grogan Swamp.
 Figure 36 (right): Open water and swamp paperbark woodland in Grogan Swamp.

The floodplain opens out around Grogan Swamp and there are several open areas of surface water within the swamp system (Figure 36). The banks are shallow and low. On the eastern side of the swamp several claypans and low-lying cracking clays flood during high rainfall events (Figure 39).

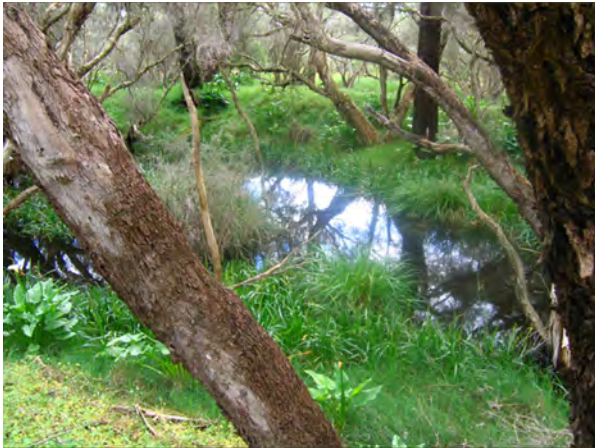
Figure 37: Channels north of Grogan Swamp in 2007.

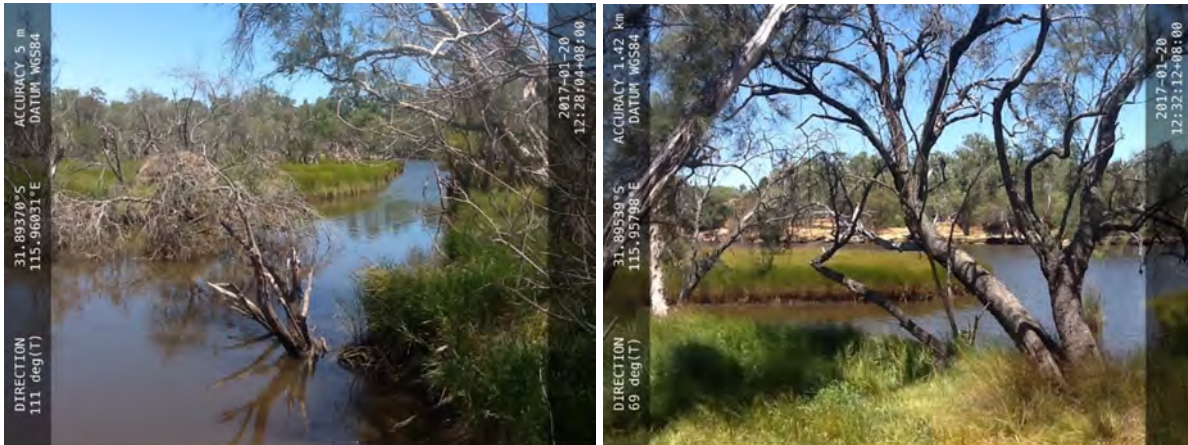
Downstream of Grogan Swamp the brook becomes a single channel that flows into the Swan River (Figure 40-Figure 43). The banks range from 1-2m to >2m high but are gently sloped. Some erosion was noted in this area where the banks are undermining. Bank stability is average. Erosion was also recorded in 2007, where the bank was exposed and several *Casuarina obesa* (swamp sheoak) trees had fallen over. The WRC assessment did not include this section of Bennett Brook.

Figure 40 (left) and Figure 41 (right): Confluence of Bennett Brook and the Swan River.

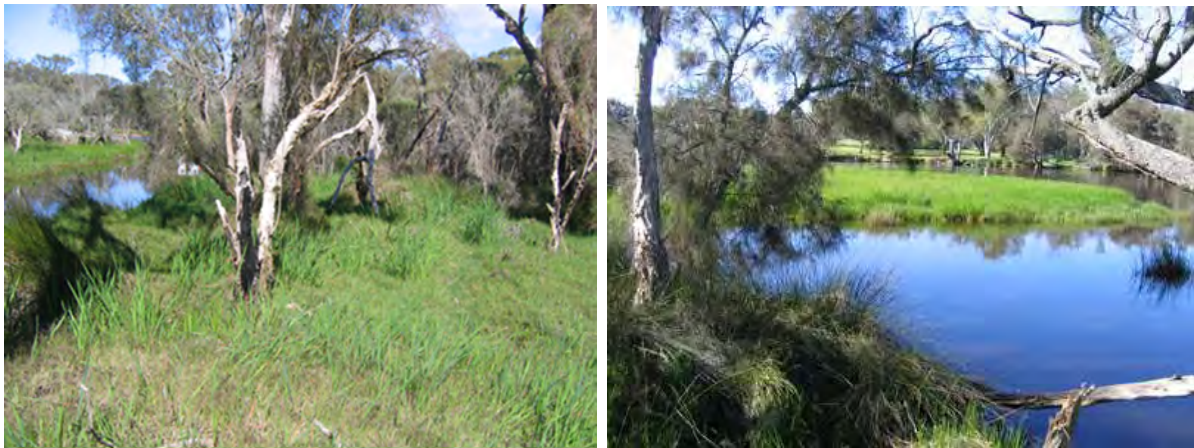
Figure 42 (left) and Figure 43 (right): Confluence in 2007.

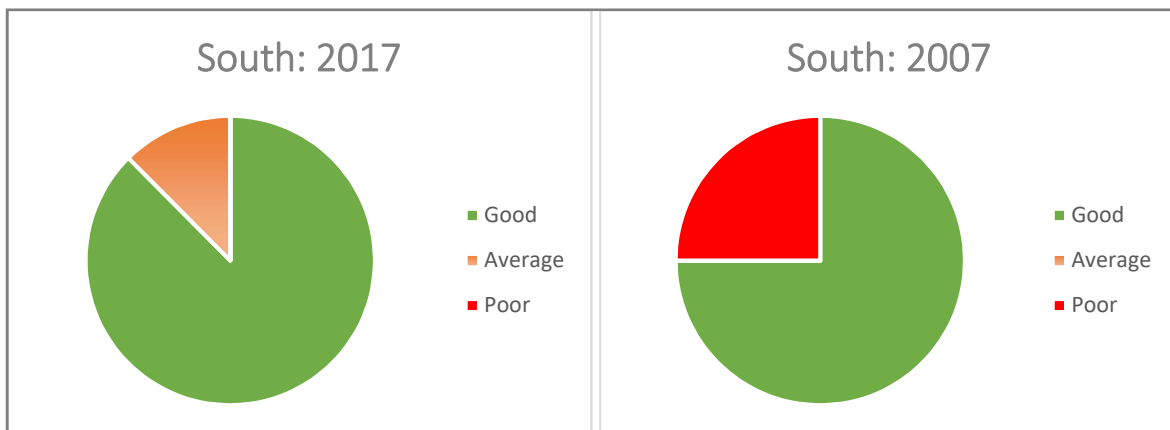
South of Benara Road the brook splits into several channels. In Clarry Small Park the banks are >2m high and the slope is medium to steep. There is a cleared paddock at the south of Clarry Small Park where old farming infrastructure is present and the channel opens out, possibly modified drainage for the farm. Bank stability is average due to the exposed bank (Figure 44).

Figure 44: Bank stability ratings for the South section in 2017 (left) and 2007 (right).

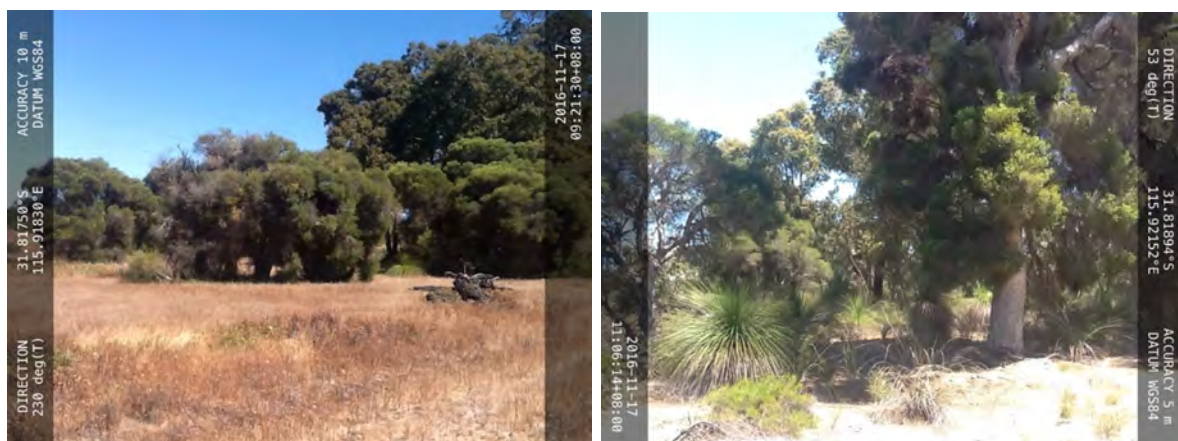
The vegetation in the headwaters of Bennett Brook (west of Beechboro Road North) has been impacted by grazing and historic clearing, and the understorey is comprised of mixed weedy grasses and virtually no native species (*Figure 51*). Vegetation condition is poor in this segment.

Figure 51 (left): Headwaters of Bennett Brook west of Beechboro Road North.
Figure 52 (right): Undefined channel east of Beechboro Road North.

East of Beechboro Road North where the brook enters Whiteman Park the vegetation is more representative of its remnant form prior to European settlement (Figure 52, Figure 54). Species are diverse and dominant genera include *Banksia*, *Xanthorrhoea*, *Melaleuca* and *Corymbia*. Vegetation condition is good.

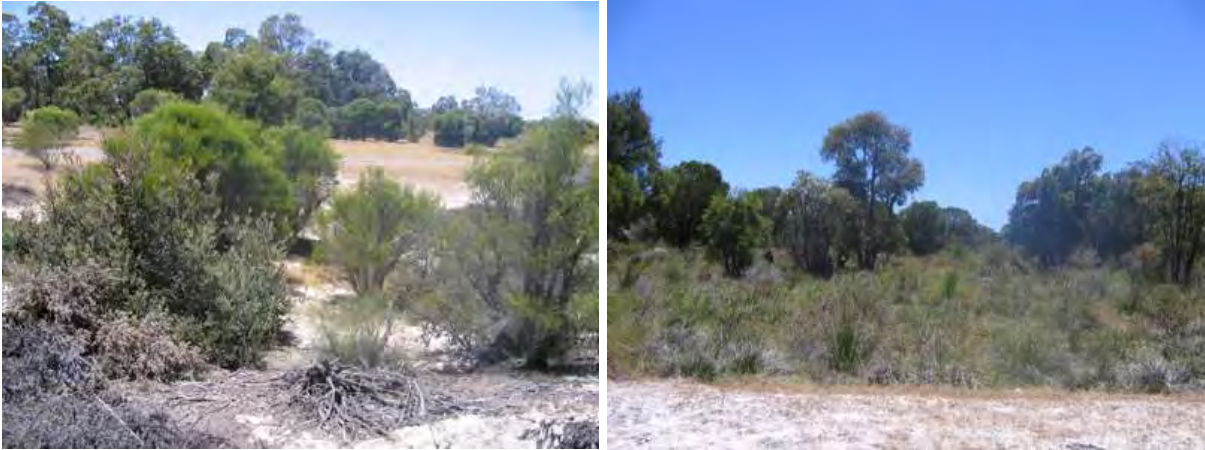
Figure 53 (left): Headwaters west of Beechboro Road North in 2007.

Figure 54 (right): Headwaters east of Beechboro Road North in 2007.

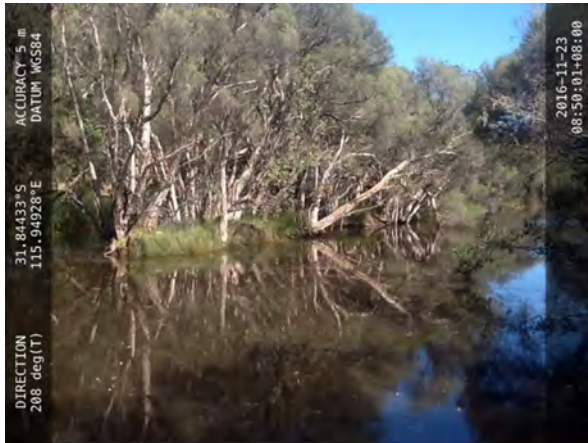
Figure 57 (left): Riparian vegetation around Mussel Pool.

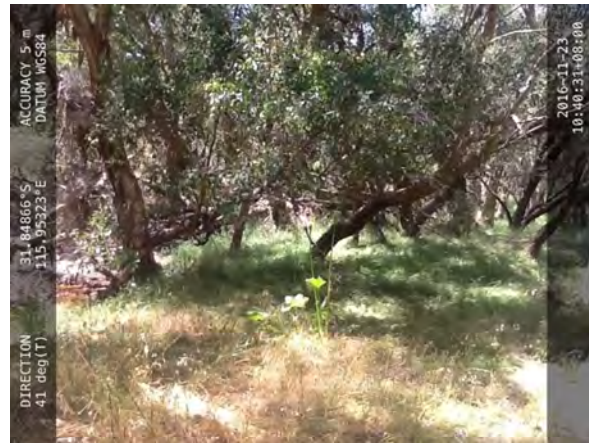
Figure 58 (right): Weed dominated vegetation south of Mussel Pool.

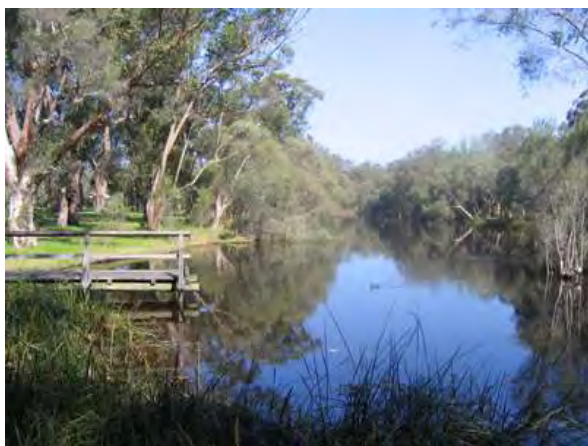
Figure 59 (left): Mussel Pool in 2007.

In 2007 vegetation condition for the entire section had been rated good (Figure 61), although weeds were prevalent from Mussel Pool downstream (Figure 59, Figure 60). The field assessors in 2007 may have placed greater emphasis on the apparent health of the remaining native vegetation (e.g. live canopy, no evidence of insect attack) rather than the resemblance of the overall vegetation composition to a pre-European-settlement state.

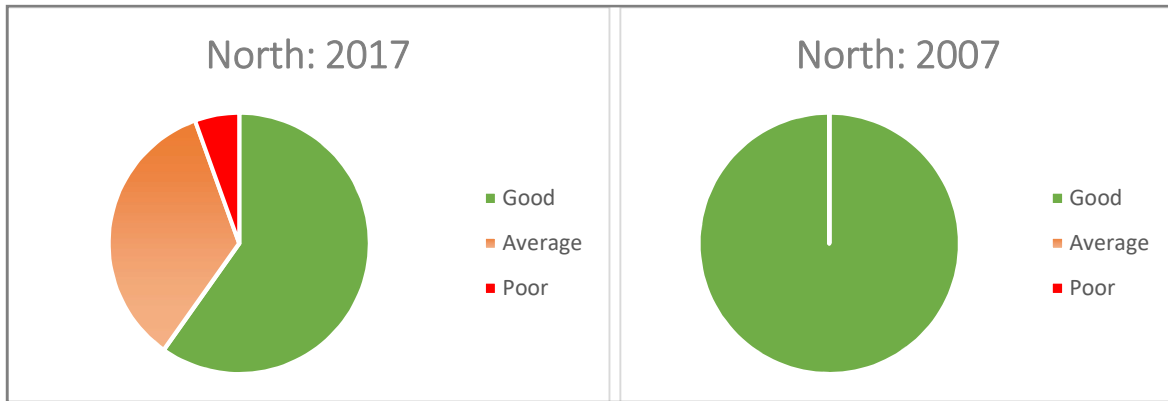
In 1998 vegetation condition was rated poor to very poor from Mussel Pool to Marshall Road as the understorey was dominated by weeds. The area where private property abuts the brook vegetation condition was considered very poor, the same area that is rated poor (the lowest category) in our assessment.

Figure 61: Vegetation ratings for the North section in 2017 (left) and 2007 (right).

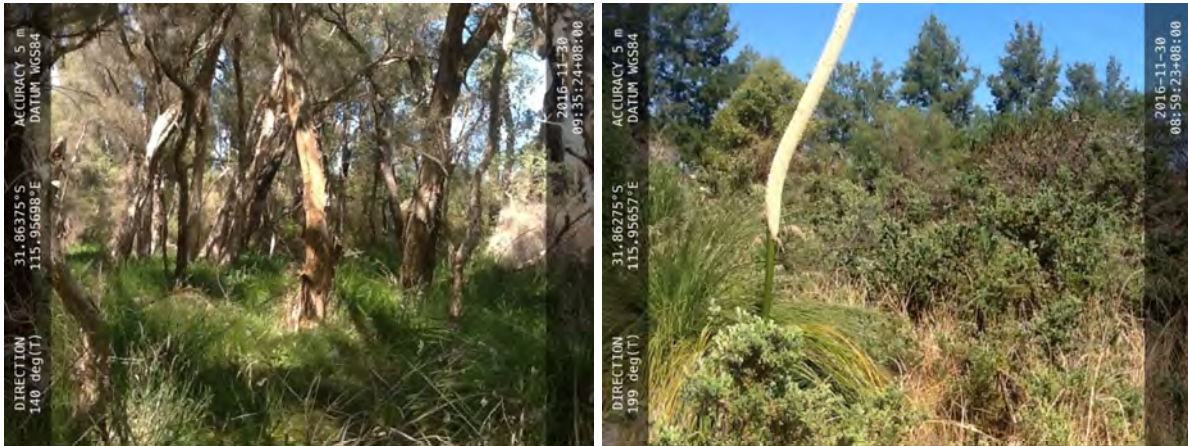
From Reid Highway to Simla Park, weed control and revegetation by the Friends of Bennett Brook is very evident. A remnant overstorey of flooded gum and swamp paperbark overhangs the channel. *Centella asiatica* and *Carex fascicularis* are extensive in the understorey (Figure 66). On the upper banks *Hakea*, *Corymbia* and *Jacksonia* species are dominant, with some grassy weeds amongst the understorey (Figure 67). Native species regeneration is evident from Reid Highway to Simla Park, where it is likely that the revegetation is amassing a seed bank and seedlings are not competing with weeds. Vegetation condition is average, due to the decreased coverage of weeds in the understorey.

Figure 66 (left): Extensive understorey of *Carex fascicularis*.

Figure 67 (right): A densely revegetated upperbank of dryland species.

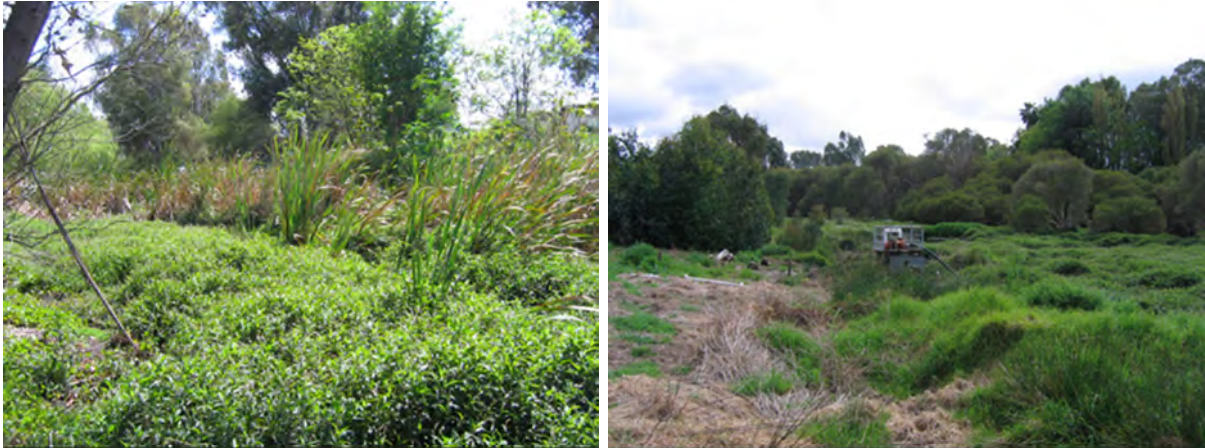
Immediately north of Benara Road the Friends of Bennett Brook have removed most of a dense infestation of *Typha* because of its impact of slowing water flow and sedimentation (Figure 68-Figure 71). There is also currently a large infestation of *Ipomoea cairica* (morning glory). In 1998 *Typha* was dominant in this area and *Watsonia* sp. was present. Vegetation condition was rated very poor.

Figure 70 (left): *Typha* population north of Benara Road in 2007.

Figure 71 (right): Dense kikuyu infestation north of Benara Road in 2007.

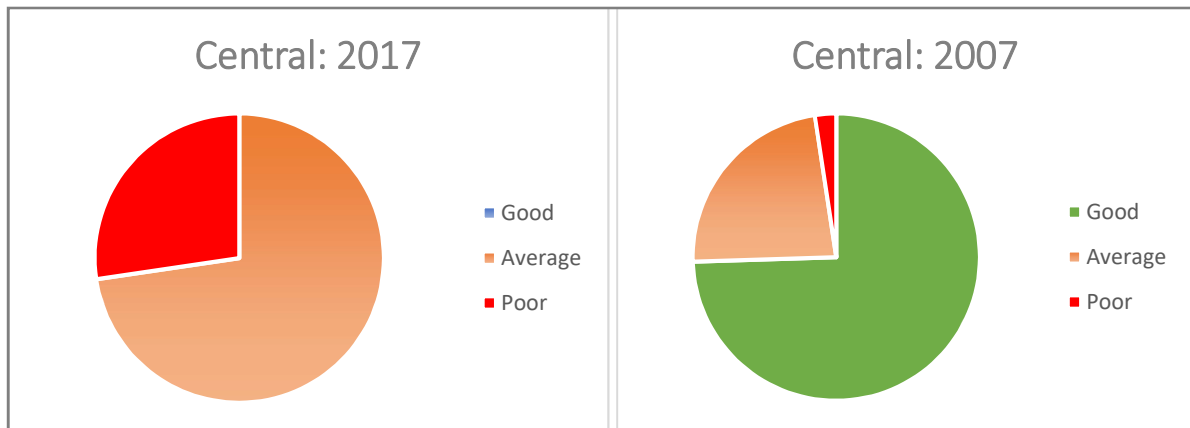
In 2007, vegetation condition was considered good from Marshall Road to St Elias Park (500m upstream of Simla Park), presumably due to the intact overstorey as weed coverage ranged up to extensive. It was rated average for most of the rest of the section to Benara Road (Figure 72). Weed control was evident in 2007.

Figure 72: Vegetation ratings for the Central section in 2017 (left) and 2007 (right)*.

*Note comments made above in the discrepancy of ratings between 2007 and 2017. It is unlikely that vegetation condition has declined. Photos taken during the 2007 assessment indicate that vegetation condition if evaluated by 2017 field assessors would have been rated as poor for most of this section.

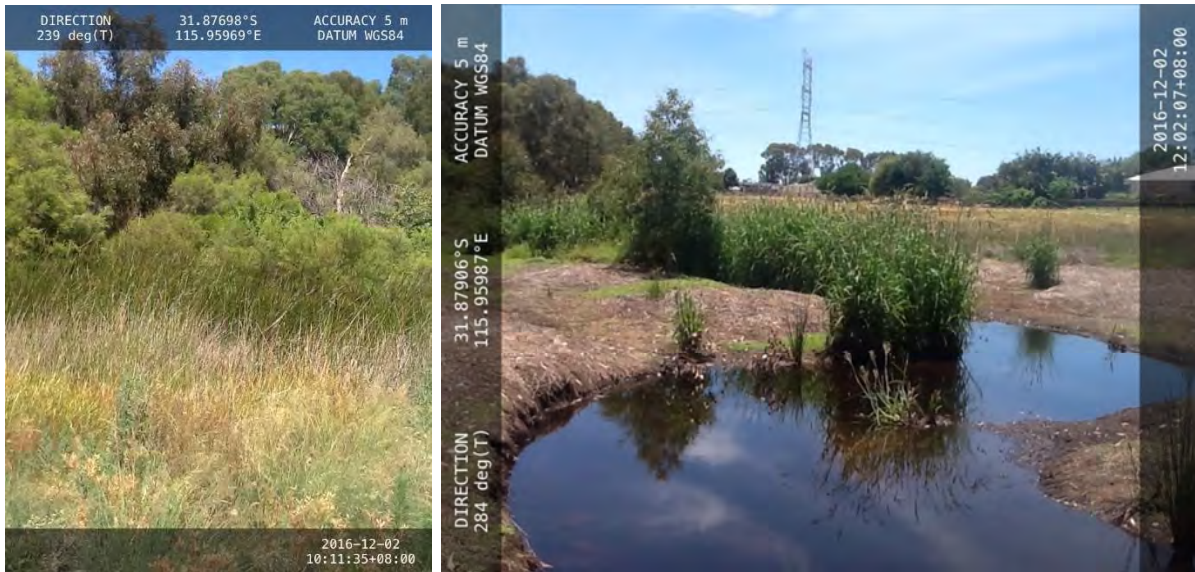
At the northern end of Clarry Small Park there is a dense overstorey of flooded gum and swamp paperbark, with *Typha* common in the midstorey following on from the dense upstream infestation. Native species have been planted on the upper banks, including *Banksia*, *Astartea* and *Hakea* species (Figure 73, Figure 75). Vegetation condition is average.

At the southern end of Clarry Small Park the cleared channel has no remaining native over or midstorey. The understorey is dominated by weeds, although control of arum lily is evident. Vegetation condition is poor (Figure 74, Figure 76).

*Figure 73 (left): Dense instream vegetation at the north of Clarry Small Park.
Figure 74 (right): Cleared channel at the south of Clarry Small Park.*

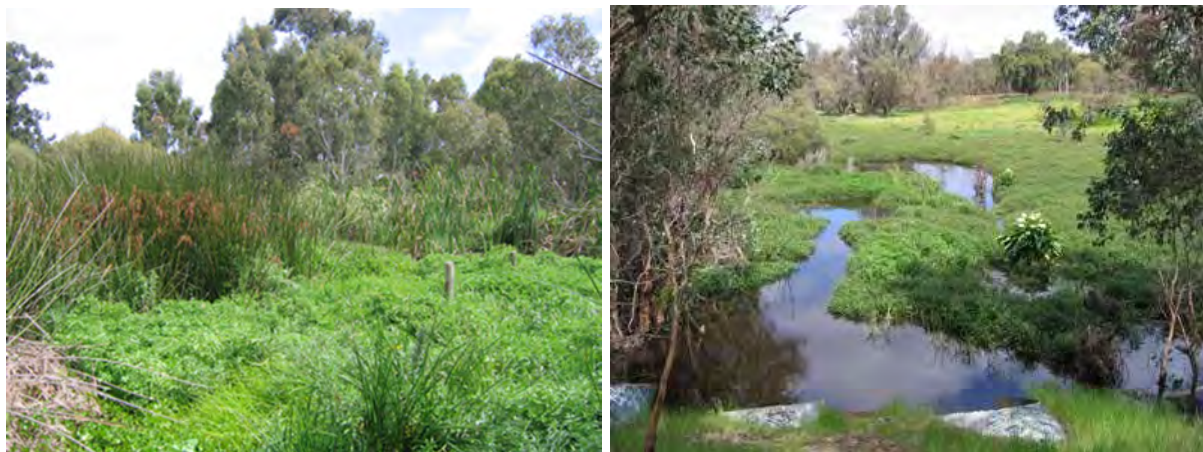
*Figure 75 (left): Instream vegetation at the north of Clarry Small Park in 2007.
Figure 76 (right): Cleared channel in Clarry Small Park in 2007.*

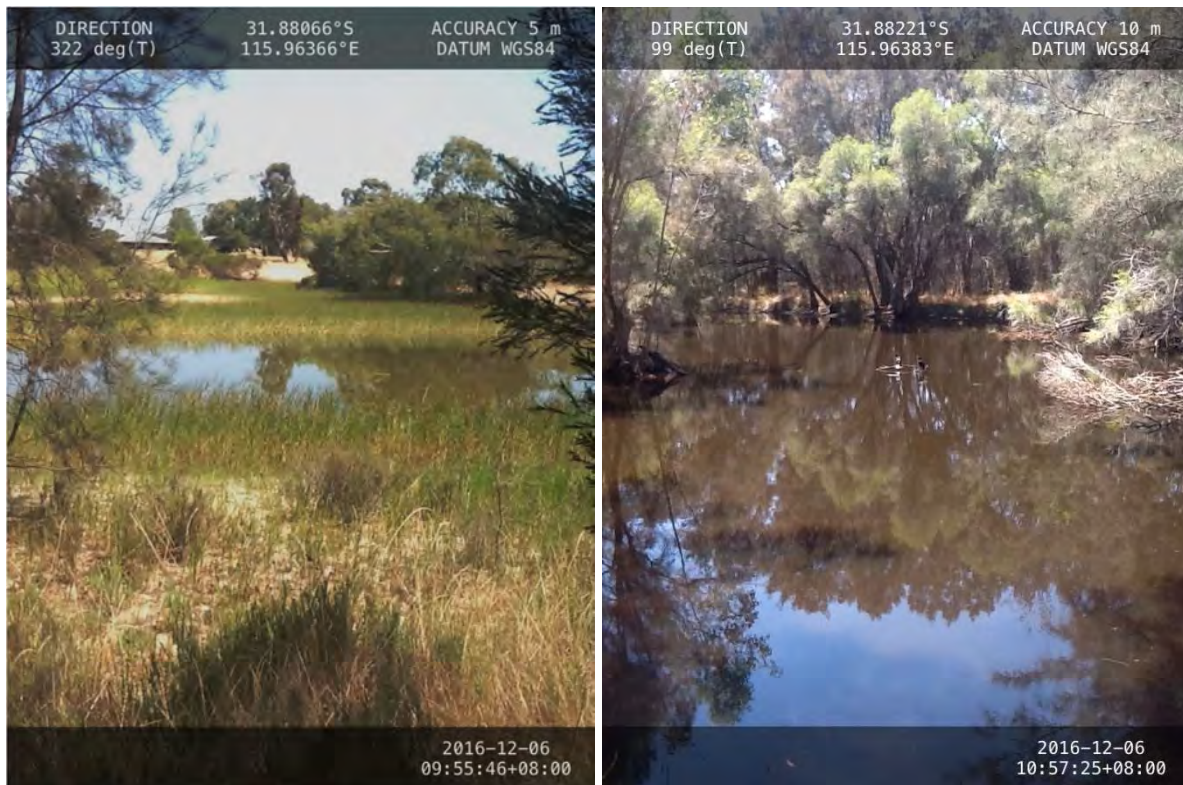
The claypans on the eastern floodplain are surrounded by sedges but behind this are infested with *Lolium* sp. (ryegrass) and *Avena barbata* (bearded oats) (*Figure 77*). The claypans are connected to the swamp via a vegetated floodplain and function as

an associated wetland, providing varied habitat from the wooded swamp. However, vegetation condition is poor due to the extensive coverage of weedy grasses.

Figure 77 (left): Claypan on the eastern side of Grogan Swamp.

Figure 78 (right): An open water section of Grogan Swamp.

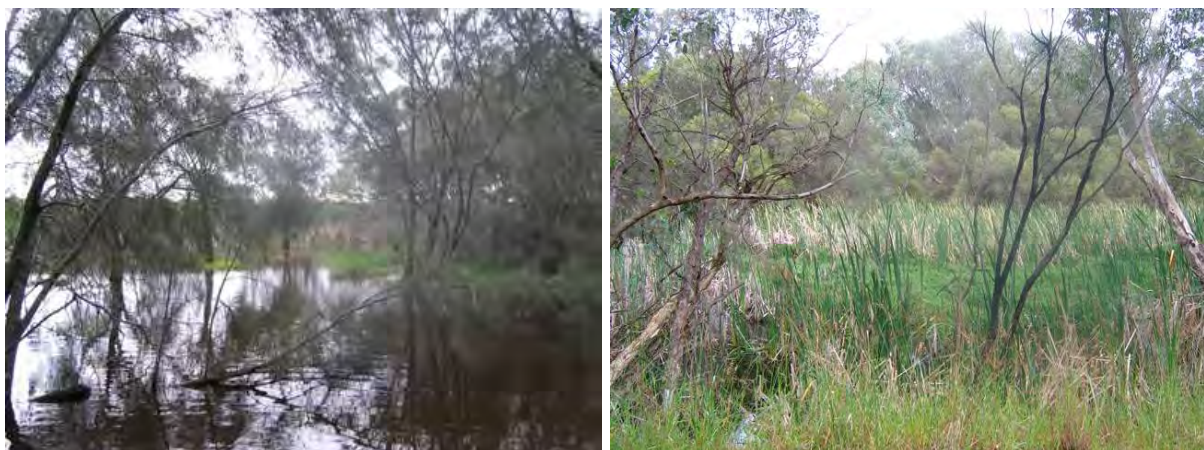
Grogan Swamp has significant stands of dense, mostly native vegetation comprising diverse ecosystems, including braided channels, claypans, open waterbodies, samphire flats and sedgeland. Much of the area is inaccessible by foot due to the density of vegetation and low-lying wet flats (*Figure 78-Figure 80*). A series of drains is also present on the western side that contain a native overstorey but many weed species.

Figure 79 (left): Open water body on the eastern side of Grogan Swamp, 2007.

Figure 80 (right): Typha population on the north east of Grogan Swamp, 2007.

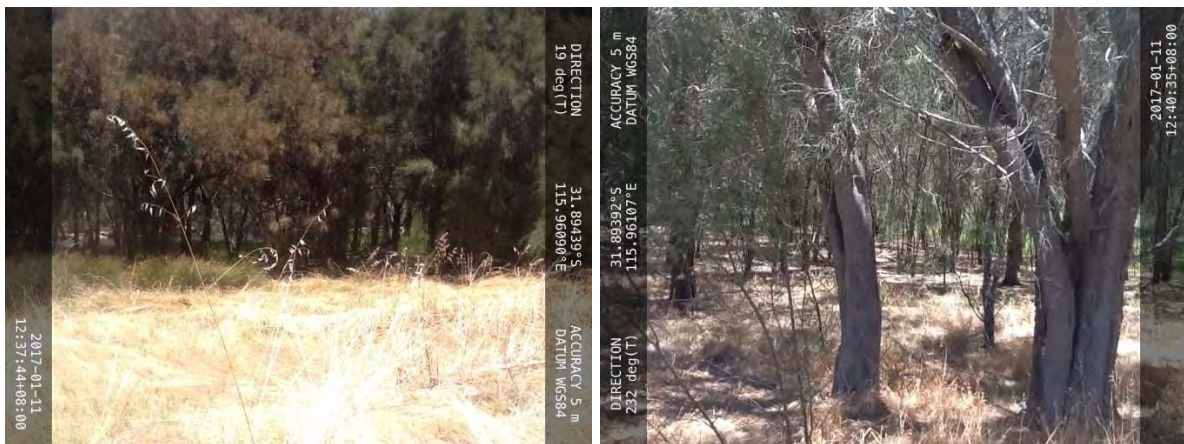
Swamp sheoak is dominant at the southern end of the swamp (Figure 83, Figure 85). Vegetation condition is poor where tree roots have been exposed on the undermining bank, and due to historic grazing on the eastern side of the brook.

Downstream of Grogan Swamp the riparian vegetation is limited to a narrow strip as the surrounding floodplain was historically cleared. Vegetation is dominated by flooded gum, swamp sheoak, *Bolboschoenus caldwellii* and *Juncus kraussii*. Close to the confluence swamp sheoak is dense and a native understorey is almost absent. Vegetation condition is average.

Figure 83 (left) and Figure 84 (right): Dense swamp sheoak woodland on the lower reaches of Bennett Brook.

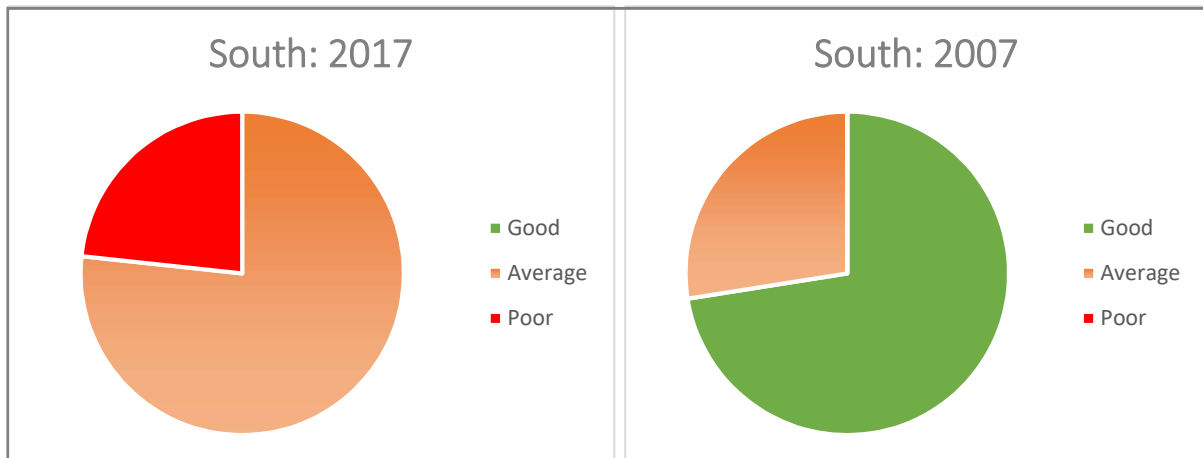
Figure 85: Vegetation ratings for the South section in 2017 (left) and 2007 (right).*

**The apparent decline in vegetation condition from 2007 to 2017 may be because the field assessors in 2007 placed greater emphasis on the apparent health of the remaining native vegetation rather than the resemblance of the overall vegetation composition to a pre-European-settlement state.*

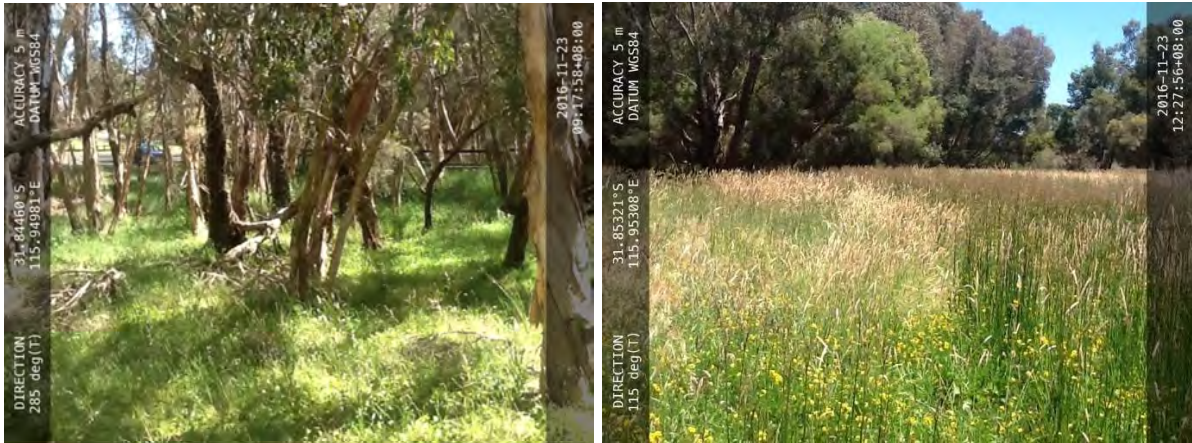
Immediately downstream of Mussel Pool weed cover is extensive (Figure 91-Figure 94). Common weed species include *Ficus carica* (fig), *Juncus microcephalus*, arum lily and annual grasses. Invasive species that first appear in this area are blackberry and Japanese pepper.

Figure 91 (left): Weeds are dominant in the understory downstream of Mussel Pool.
 Figure 92 (right): From Cranleigh St to Marshall Road trefoil, *Juncus microcephalus* and *paspalum* are common.

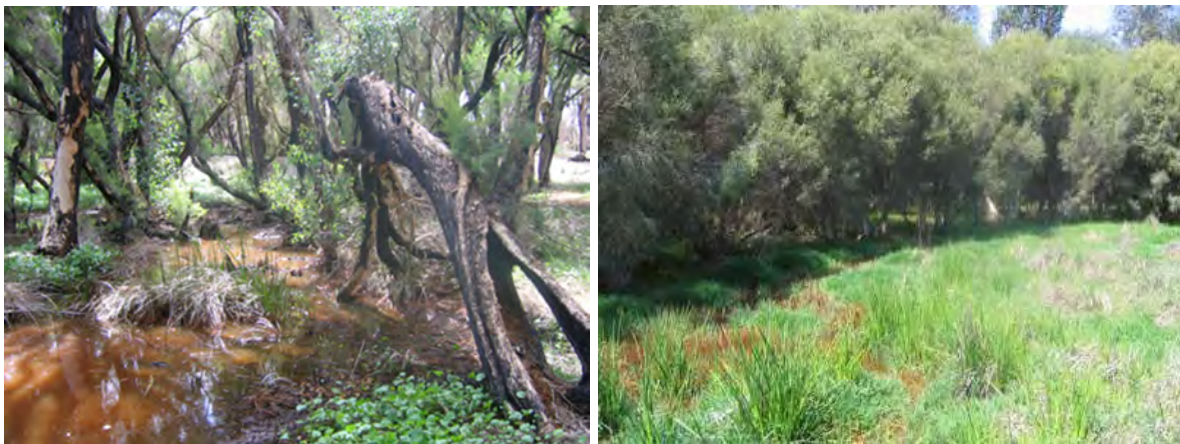
Figure 93 (left): Sedge and *Centella* understory north of Mussel Pool, 2007.
 Figure 94 (right): Similar area to Figure 80 above, in 2007.

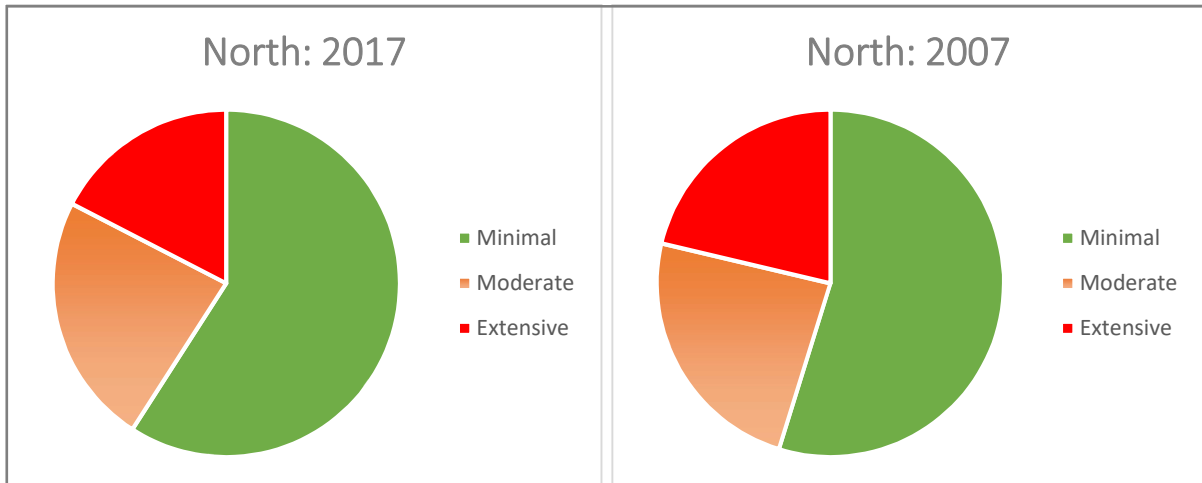
Figure 95: Weed cover ratings for the North section in 2017 (left) and 2007 (right).

In 2007, weed cover ranged from minimal to moderate from the headwaters to Mussel Pool and then was mostly rated extensive (Figure 95). This indicates some improvement in weed cover to 2017. Weed control was not noted in 2007.

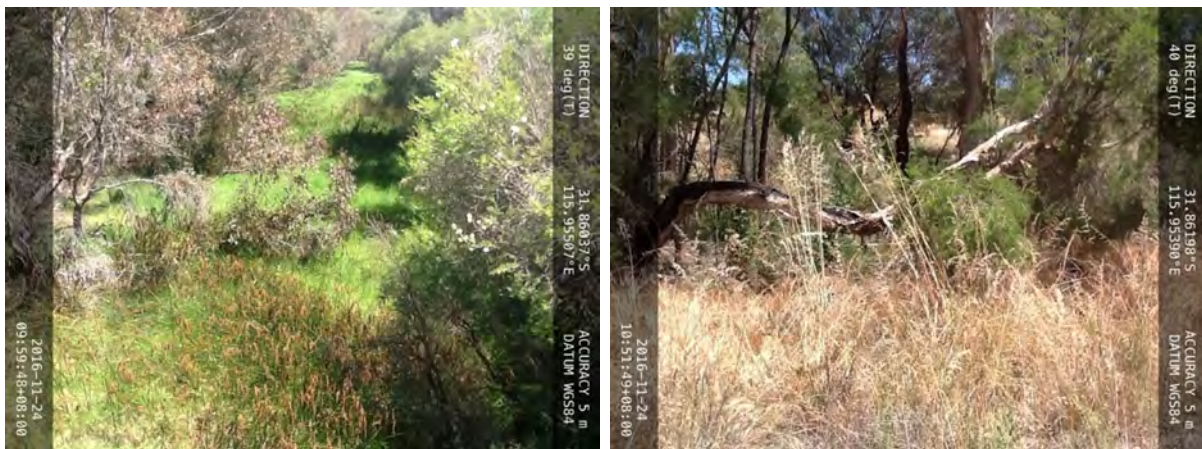
Weed cover is extensive from Marshall Road to Reid Highway, with kikuyu making up the bulk of the understorey (Figure 96, Figure 98, Figure 99). A major weed contributor is a drainage channel from Oriole Park. Invasive species that first appear in the brook at this point include watercress and lantana.

Bandicoot Creek has extensive weed cover due to the prevalence of weedy grasses on the upper banks (Figure 97). These grasses have been sprayed and watercress has been manually removed from the watercourse since the assessment.

Figure 96 (left): Kikuyu is abundant in the understorey north of Reid Highway.

Figure 97 (right): Annual grasses are common on the upper banks adjacent to Bandicoot Creek.

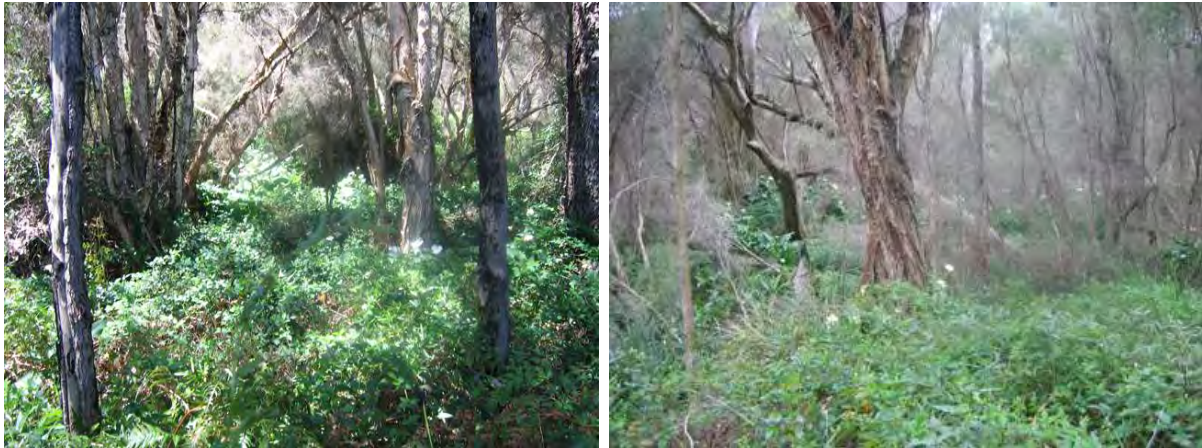
Weed cover is mostly moderate from the junction of Bandicoot Creek with Bennett Brook downstream to Simla Park. The weed control efforts of the Friends of Bennett Brook are significant and effective as large areas of kikuyu have been controlled and replanted with native sedges and rushes (Figure 100-Figure 103). On the upper banks annual grasses have been replaced with native dryland species. The most commonly found weeds are bearded oats and *Ehrharta* sp (veldt grass).

Figure 102 (left): Blackberry infestation near Coonawarra Drain in 2007 which is no longer present.

Figure 103 (right): Arum lily and blackberry infestations near Simla Park in 2007, no longer present.

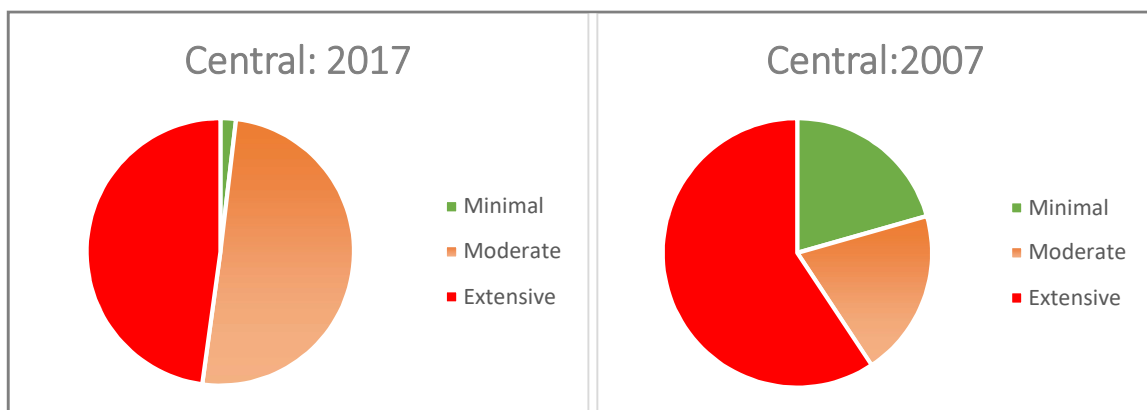
Figure 104: Weed cover ratings for the Central section in 2017 (left) and 2007 (right).

While more of the vegetation had minimal weed cover in 2007 than in 2017, the area of vegetation with extensive weed cover is less in 2017 (Figure 104). It is difficult to make accurate comparisons in the two assessments as it appears that the vegetation condition and weed cover was rated differently to what the 2017 field assessors would have rated it.
