Tributary Foreshore Assessment: Bennett Brook

Conservation and Ecosystem Management Division

March 2019

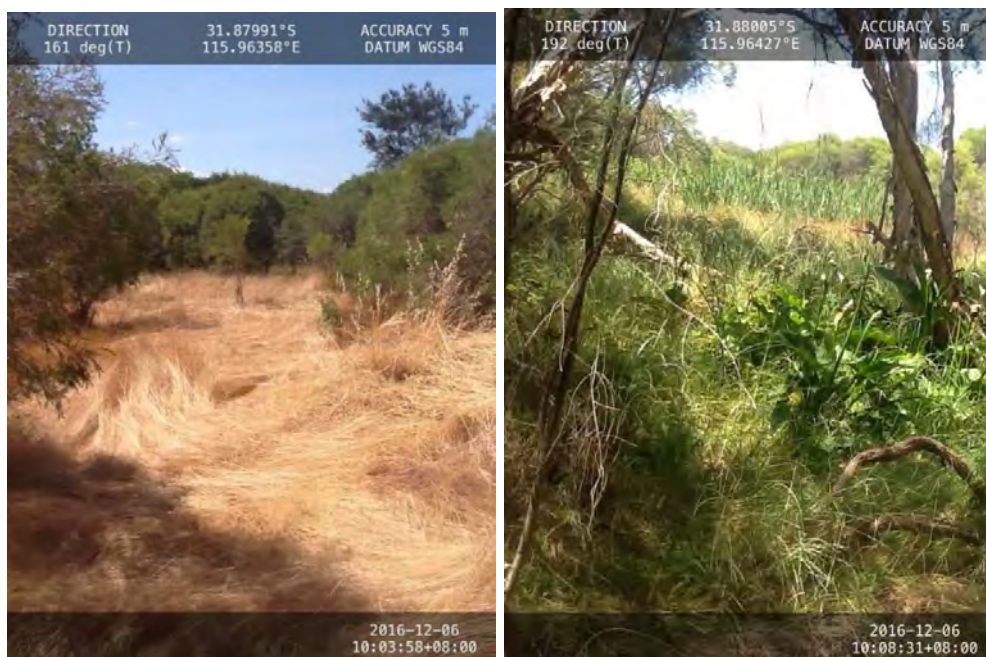
On the eastern side of Grogan Swamp Japanese pepper and arum lily are common. Weedy grasses, particularly *Lolium* sp. and bearded oats, are dominant away from the dense canopy of the main watercourse (Figure 105-Figure 108).

Figure 105 (left): Weedy grasses are common on the eastern side of Grogan Swamp.

Figure 106 (right): Scattered populations of arum lily are common in Grogan Swamp.

- Protect the natural diversity of Grogan Swamp by undertaking activities to prevent further degradation, including weed control. Engage with the Noongar community and relevant stakeholders to stage weed removal and revegetation with a diverse mix of native species;

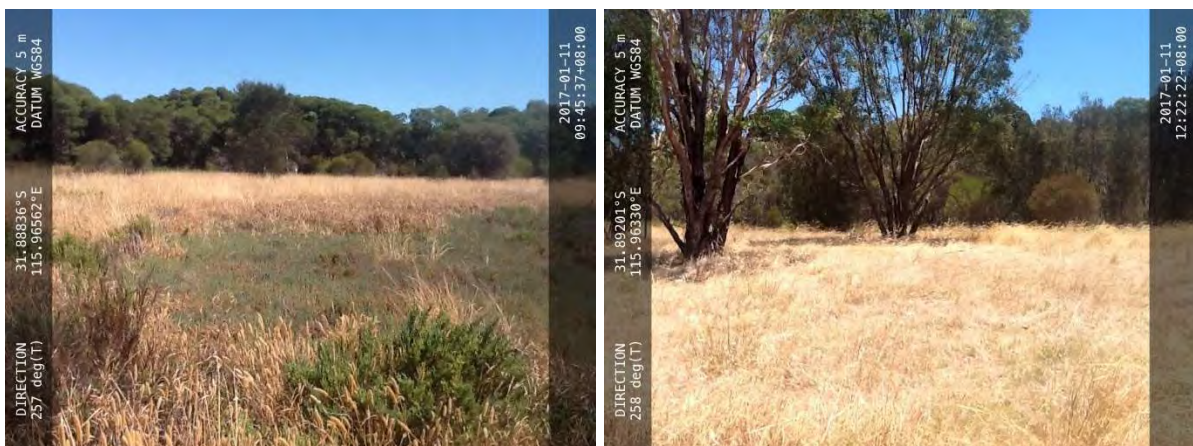
Where samphires are dominant, weeds appear to be limited by salinity and species richness is low. The main weeds are coastal barbgrass (*Polypogon maritimus*) and *Cotula* sp. (Figure 109).

Where the brook reforms as a single channel south of Grogan Swamp, veldt grass, bearded oats and *Lolium* sp. are common on the floodplain (Figure 110). Weeds are partially excluded from the lower banks by dense populations of native *Bolboschoenus caldwellii*.

Figure 109 (left): Coastal barbgrass is common in samphire flats of Grogan Swamp.

Figure 110 (right): Bearded oats and other grassy weeds dominate the upper banks near the confluence with the Swan River.

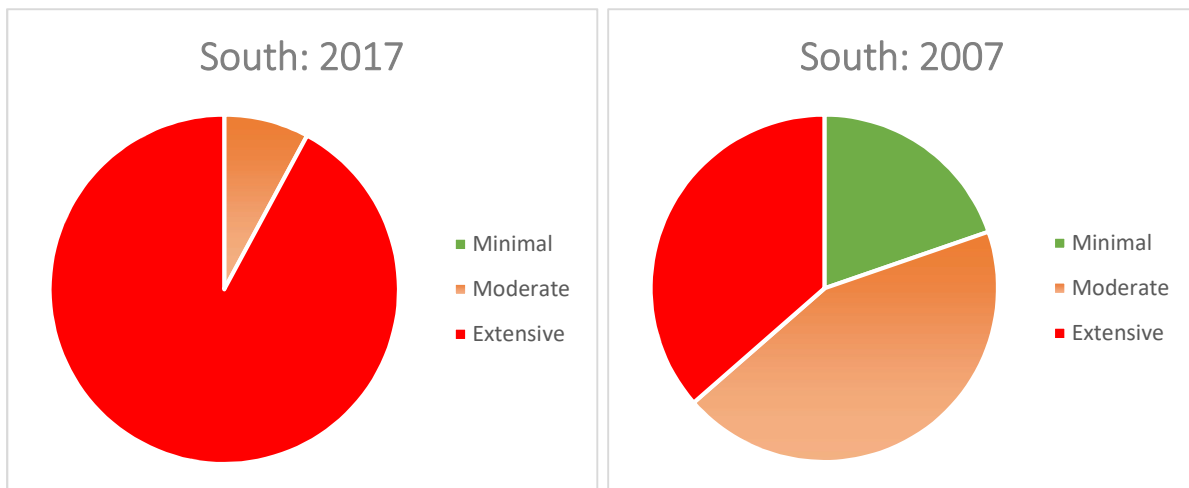
Figure 111: Weed cover ratings for the South section in 2017 (left) and 2007 (right).

There appears to be little improvement in overall weed coverage of the South section from 2007 to 2017 although populations of arum lily have been controlled (*Figure 111*). There has been a reduction in weed coverage in Clarry Small Park on the right bank from extensive to moderate. Segments on the single channel below Grogan Swamp had minimal weed cover in 2007 but the assessment may have concentrated on the lower banks where weed coverage was also found to be less in 2017, rather than including the upper banks as we did in 2017. It is difficult to make accurate comparisons between weed cover from 2007 to 2017 as it appears that the field assessors gave different ratings to what we would have.

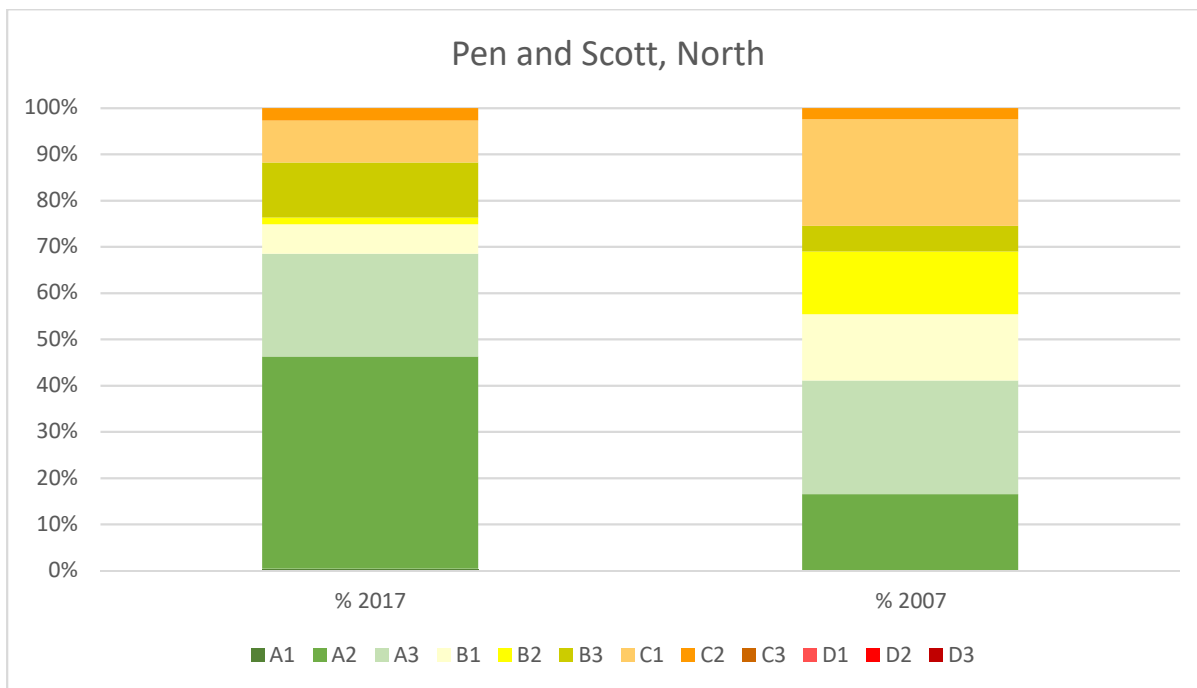
Figure 115: Comparison between Pen and Scott grades for 2017 and 2007 assessments, as a proportion of length of stream bank in the North section.

In 2007 the highest and lowest grades across the section were similar and no segments were in the D grades (Figure 115). Less stream bank was assigned an A grade in 2007. While this may indicate a slight improvement in condition, the subjectivity inherent in the grading system could also account for this.

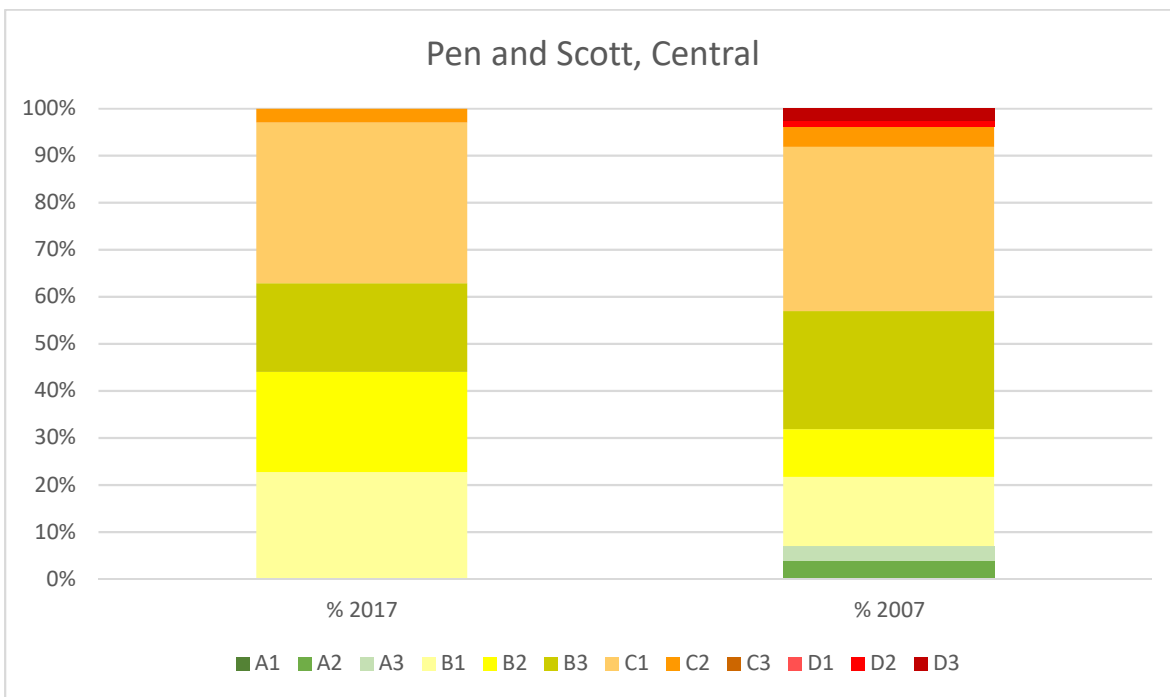
Figure 116: Comparison between Pen and Scott grades for 2017 and 2007 assessments, as a proportion of length of stream bank in the Central section.

No segments are graded in the A grades (*Figure 116*). The highest grade is B1 and the lowest is C2. Segments are evenly spread across B and C grades.

In 2007 a small amount of stream bank had been assigned A however none was in 2017, as all segments had some level of weed incursion. More stream bank was assigned a B grade in 2017 than in 2007, and a similar amount of stream bank was assigned in a C grade. In 2007 a small amount of stream bank was graded D2 and D3; no segments were assigned D in 2017 (*Figure 116*).

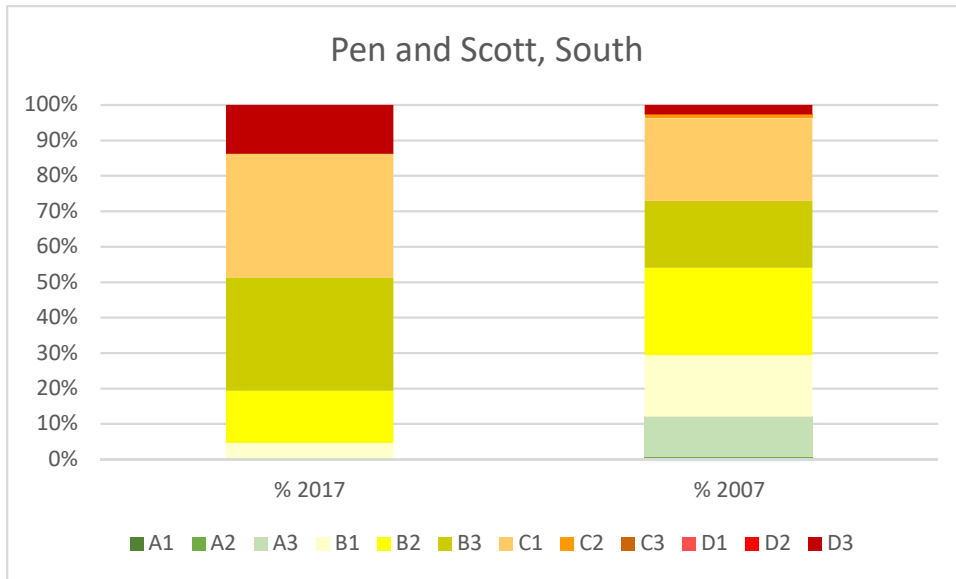
Figure 117: Comparison between Pen and Scott grades for 2017 and 2007 assessments, as a proportion of length of stream bank in the South section.

In 2007 most segments were rated in the B grades, with a small amount of stream bank in the A grades (Figure 117). None of the A grade segments in 2007 were rated A grade in 2017 due to the level of weed coverage. Nearly 50% of stream bank was graded C or D in 2017 while less than 30% was rated C or D in 2007. This indicates a decline in condition though should be considered in the context of subjectivity within the grading system.

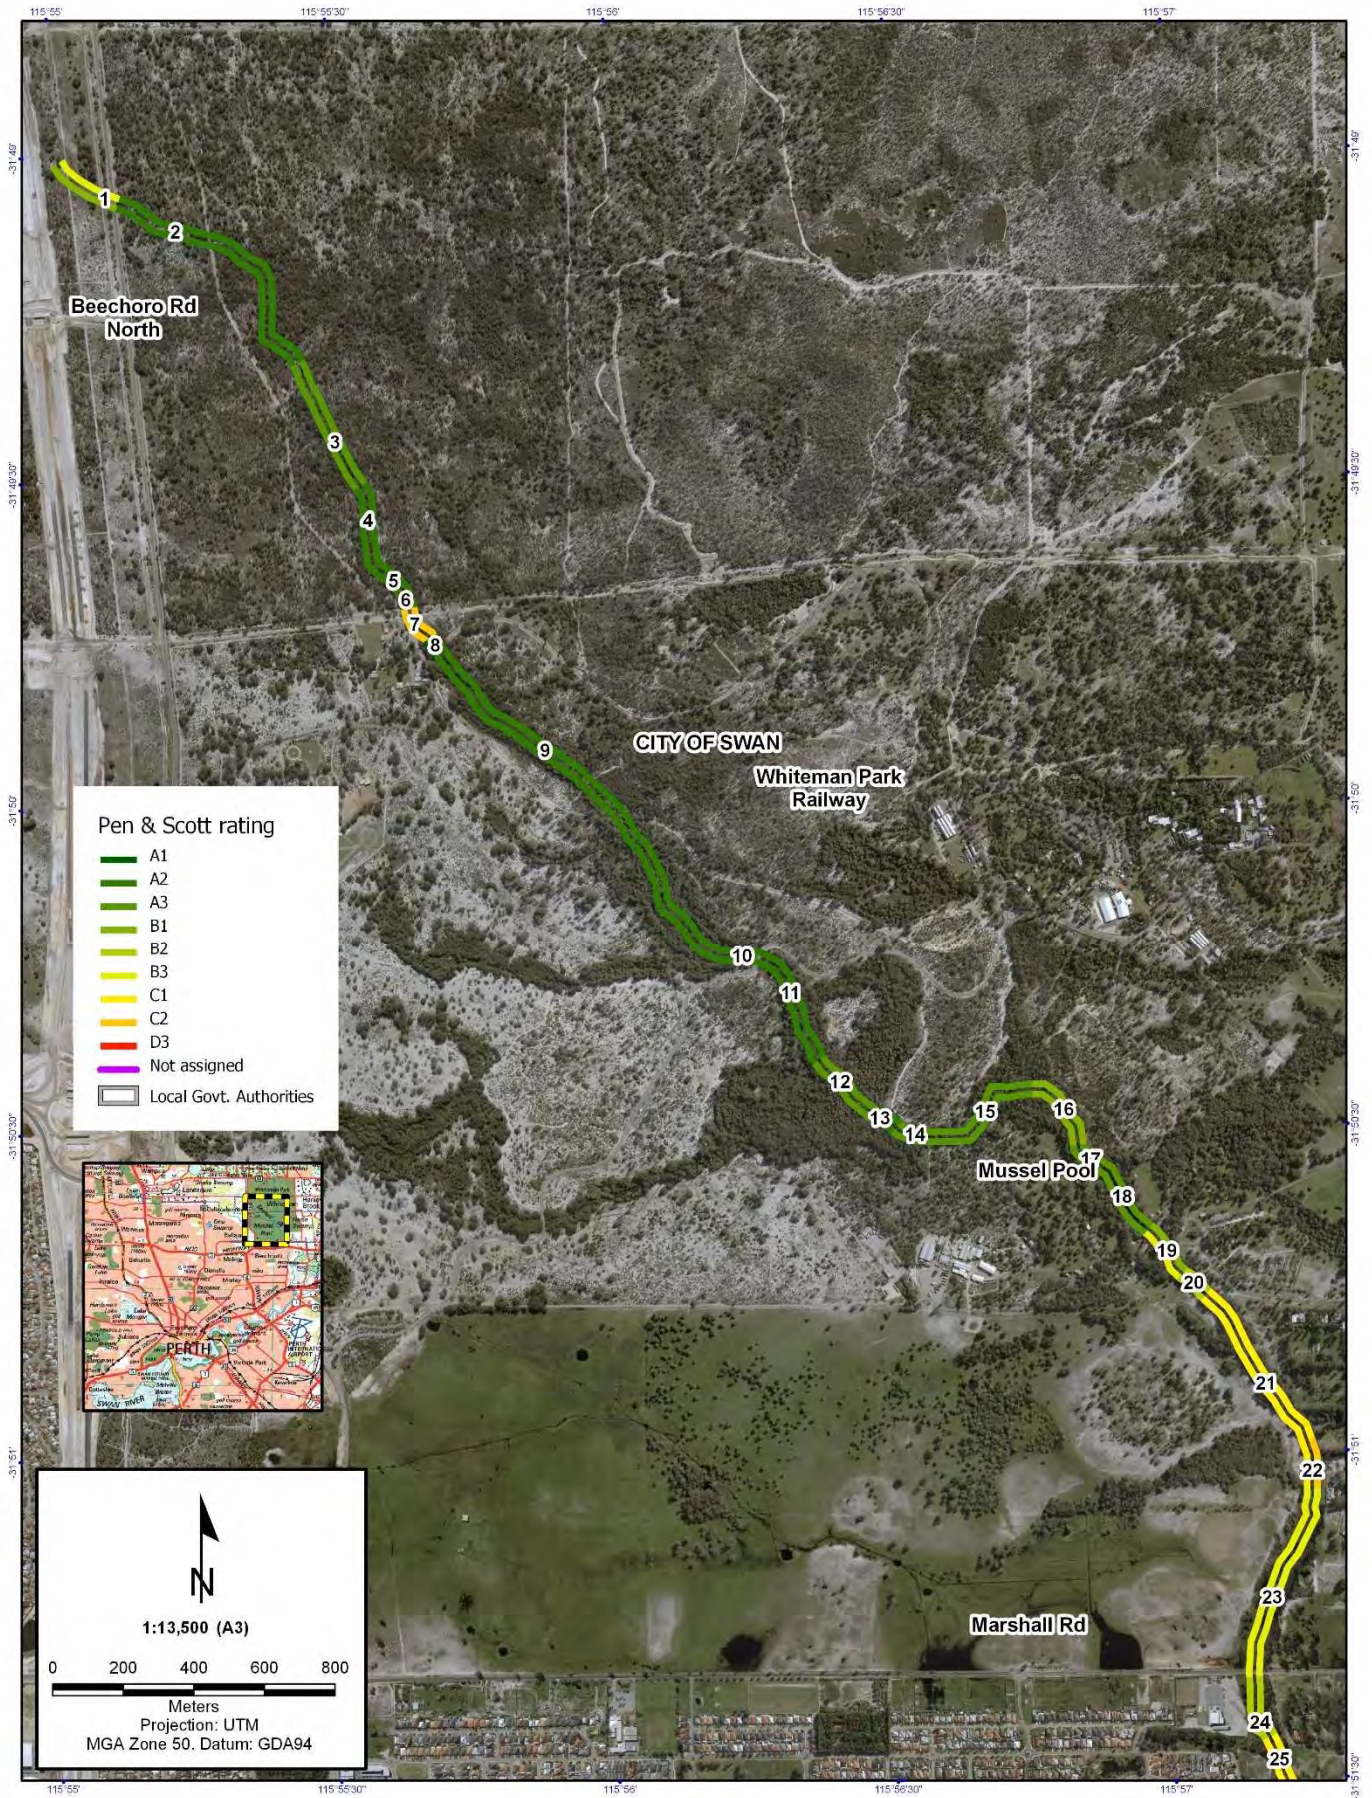
Figure 118: Pen and Scott grading, North section.

The highest Pen and Scott grade is A1 and the lowest is C2 (**Error! Reference source not found.**, Figure 118). Only one short segment scored a grading of A1. This segment is located north of the first Whiteman Park railway crossing.

Five segments are rated in the B (weed infested to weed dominated) grades – these are scattered throughout the section, with one segment at the headwaters, three near Mussel Pool and the other immediately north of Marshall Road.

There are three segments in the C (erosion prone) grade – one contains a sand-based dam in Whiteman Park and is rated C2, and the other two are near private property in Bennett Springs. One is rated C1 where there is extensive weed cover in the understorey. The other segment is rated C2 where stock access the brook and are destabilising the banks, vegetation condition is poor and weed cover is extensive.

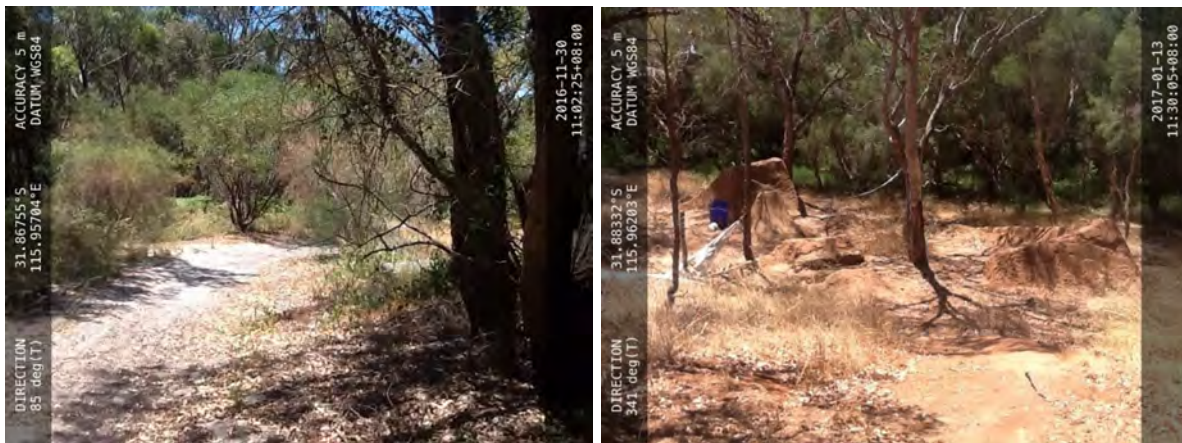
Footpaths along the upper banks and footbridges provide structured walkways in the Central section (*Figure 121*), although off-road driving is evident near Bandicoot Creek and Reid Highway which limits the potential for native plant regeneration.

Most of the South section is fenced and closed to the public on Lord Street and Meadow Street. However, some trail bikes were accessing the floodplain near the Swan Valley Nyungah Community site during the assessment. A jump track has been constructed and there are several make-shift camps nearby (*Figure 122*).

Figure 121 (left): Informal pathways in the Central section.

Figure 122 (right): Bike jump track on the western side of Grogan Swamp.

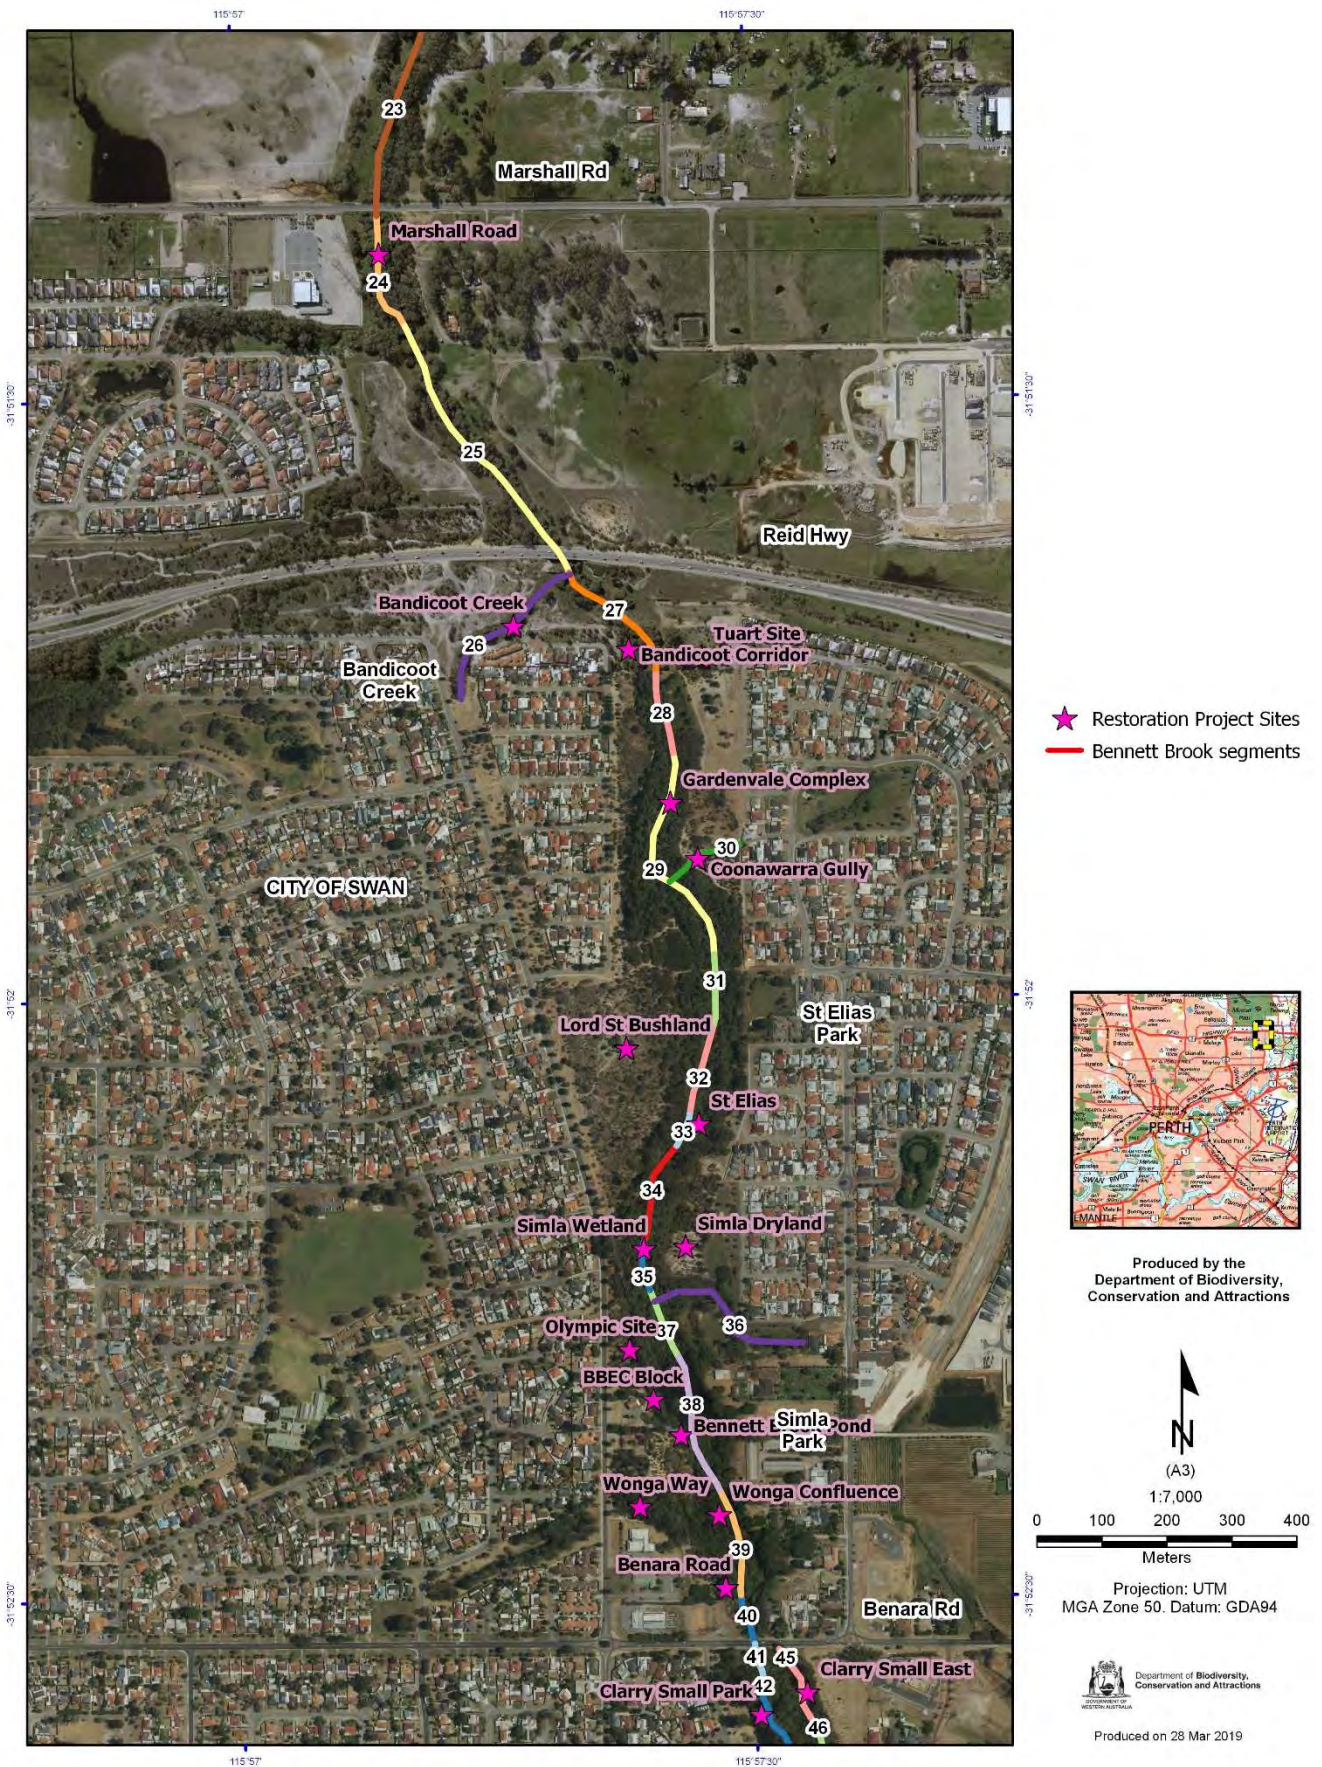
Figure 124: Known restoration project sites over current categories, Central section. (Site names referenced in Appendix 11).

Sites have included both dryland and wetland areas and drainage channels including Bandicoot Creek, Coonawarra Gully, Wonga Way (*Figure 124, Appendix 11*). Whiteman Park, DBCA and Water Corporation have contributed funds for restoration, and the group has successfully secured support from State and Federal government funding programs.

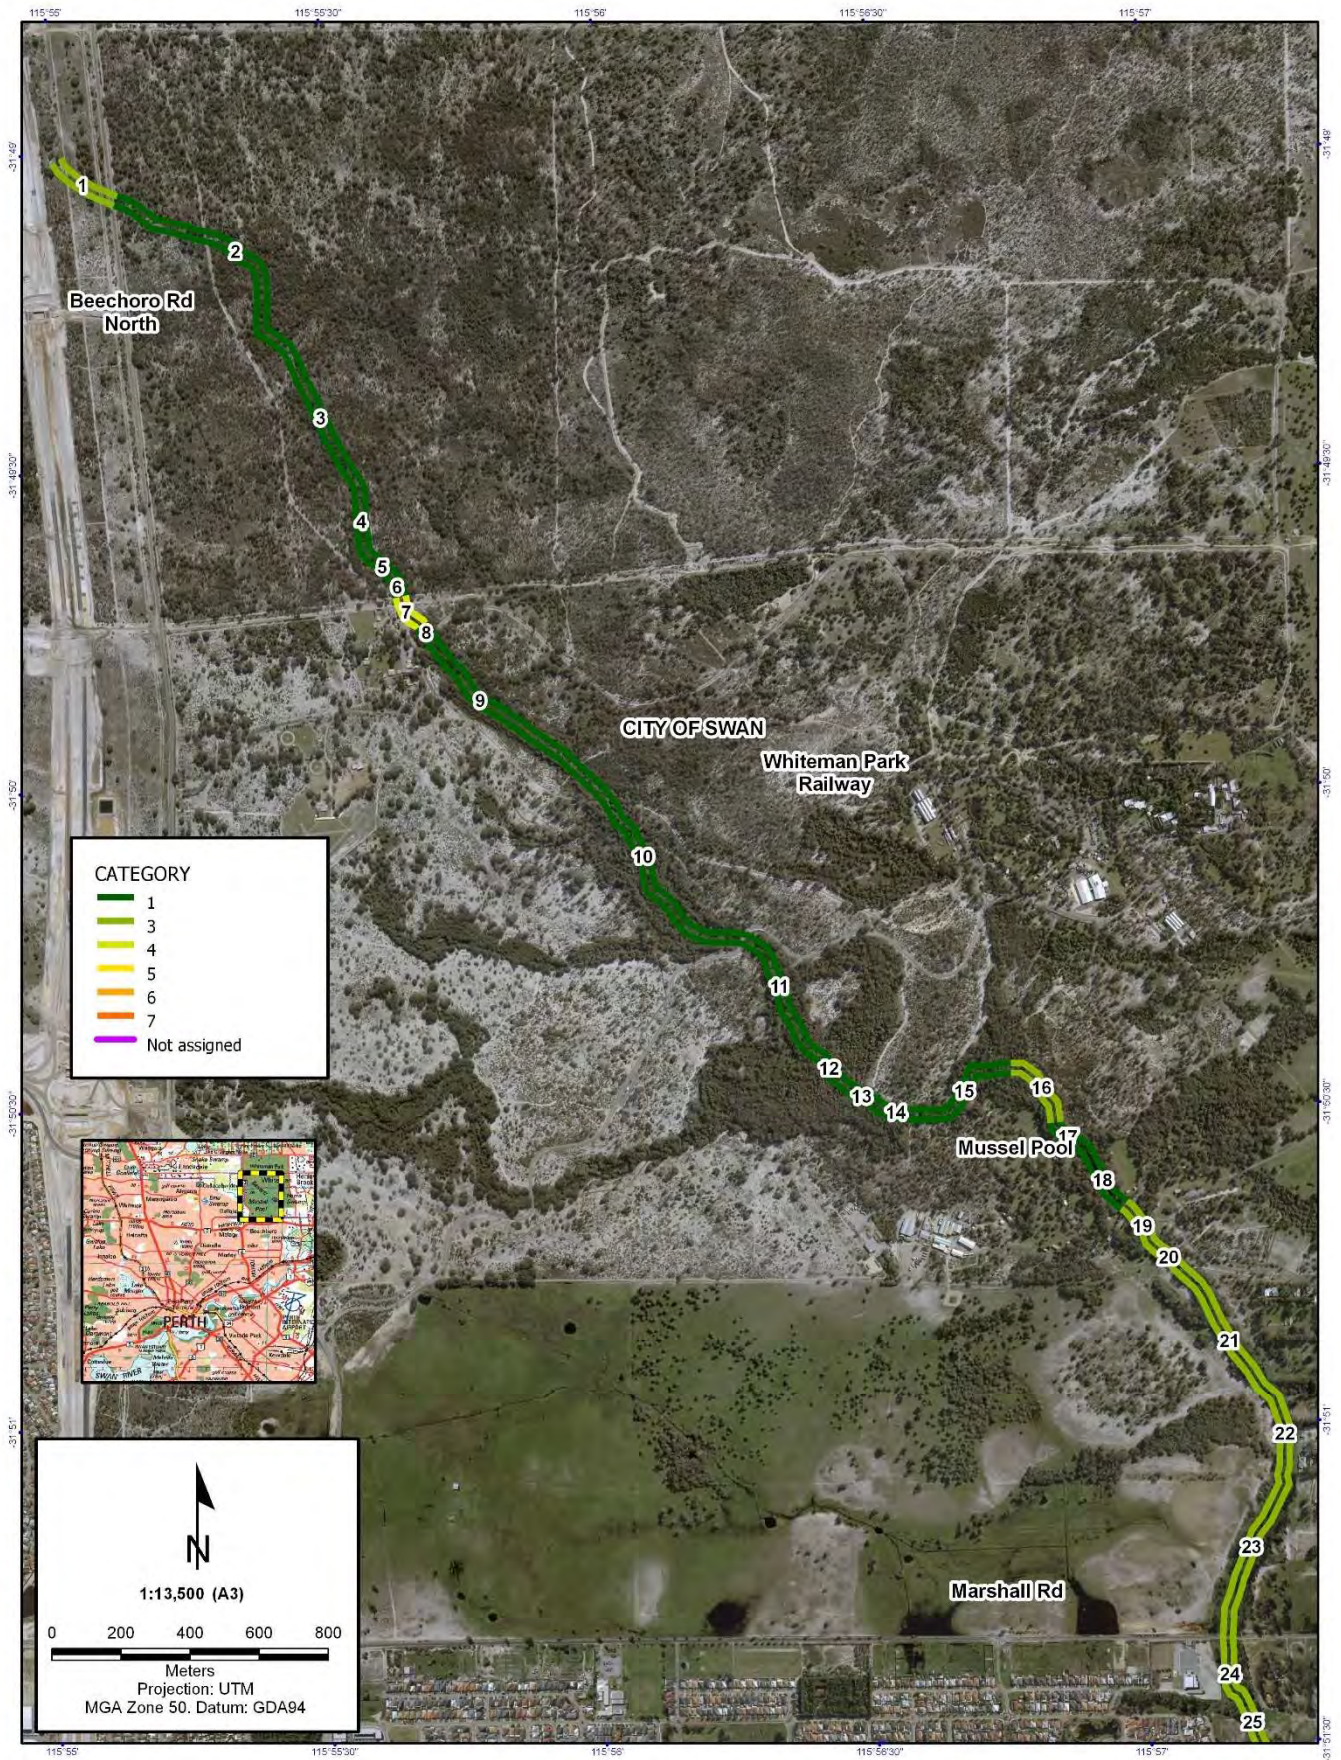
Figure 126: Management categories assigned to Bennett Brook, North section (refer to Table 1 for criteria used).

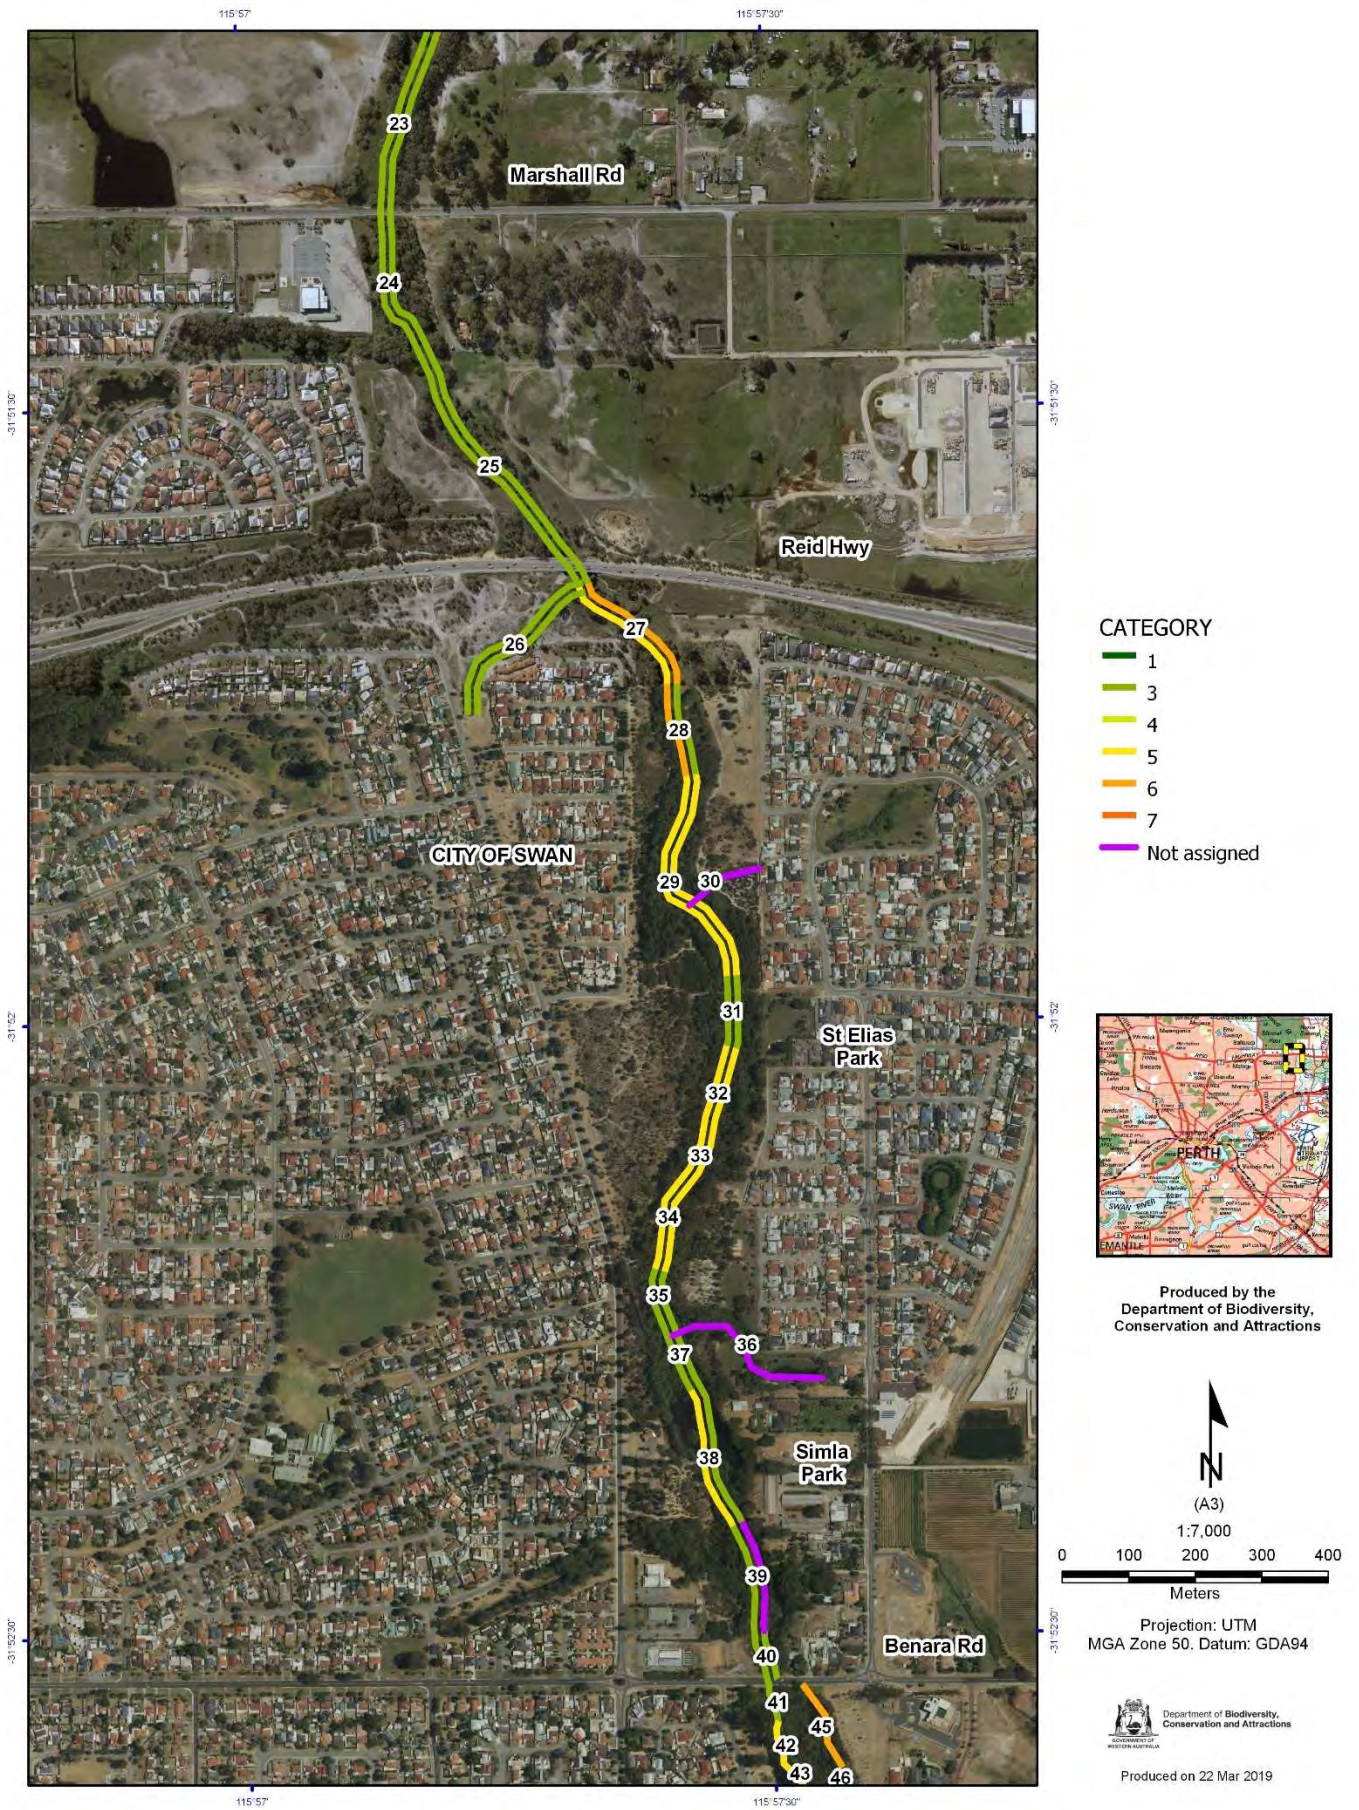
Figure 127: Management categories assigned to Bennett Brook, Central section.
