Final report on erosion mitigation projects at Deep Reach Pool (Nhanggangunha), October 2014 – July 2015 and future recommendations

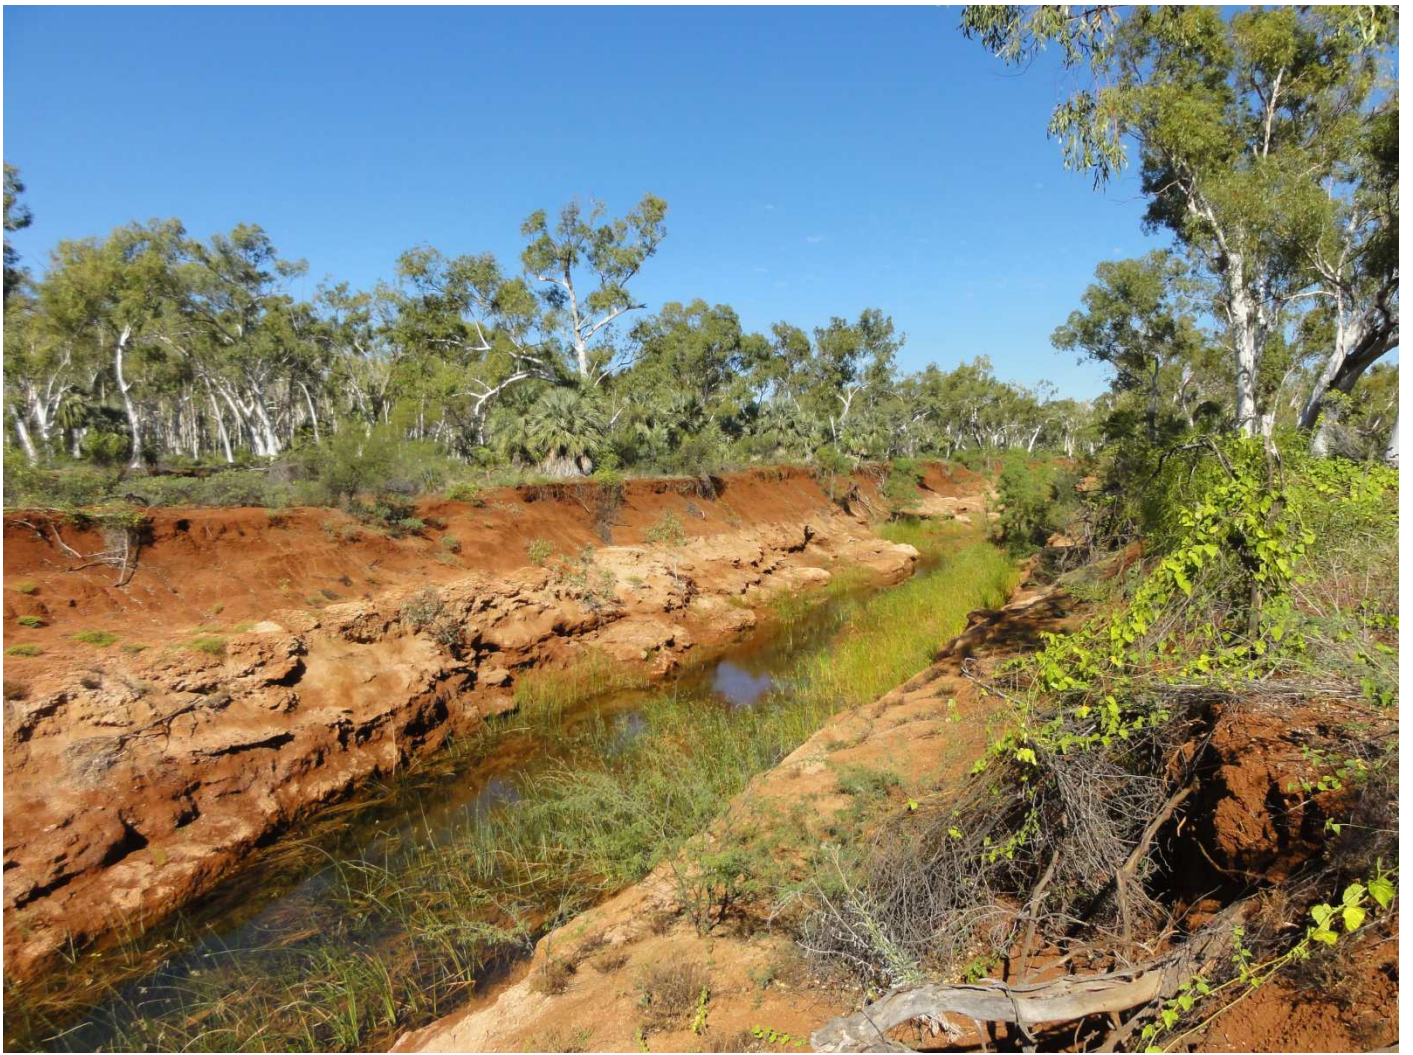
^^ Main erosion gully 60m from headcut, July 15. Trees have been felled (Oct 14) and log dams constructed. Note rehabilitation of incised channel

The gully rehabilitation should be done annually in conjunction with structure maintenance. If a summer period passes without a discharge event or without damage to the structures, gully rehabilitation should be planned and implemented regardless – the further downstream gully rehabilitation progresses the more moderate the eventual effects of gully breakthrough into Deep Reach. However gully rehabilitation should not be undertaken so quickly that quality is reduced – significant amount of work needs to be made over a short area (i.e. 100m) to have the desired effect. This may include the coppicing of living trees if this is the material available.
