SURVEY OF STREAM FORESHORES IN THE  
SCOTSDALE BROOK CATCHMENT  
DENMARK, W A

WATER RESOURCE MANAGEMENT SERIES

WATER AND RIVERS COMMISSION REPORT WRT 19  
1998

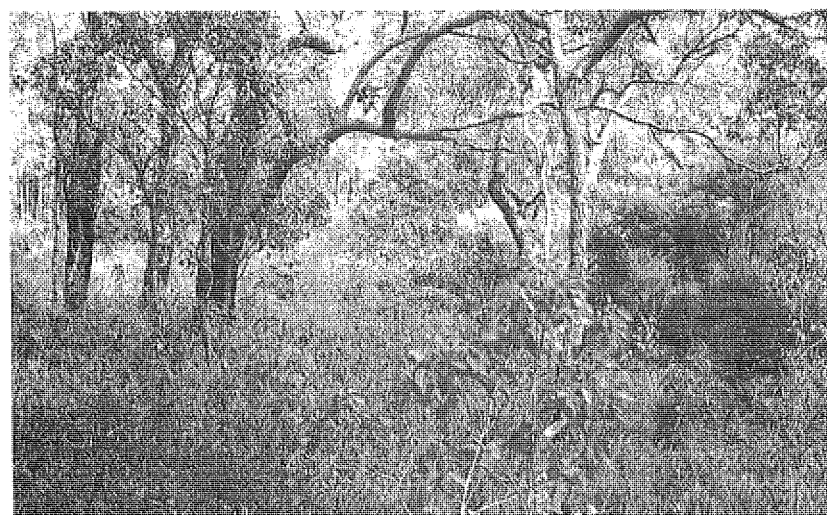
*High quality vegetation growing over a tributary of the Scotsdale Brook. At Grade. In their original state many of the watercourses are completely covered by native vegetation.*

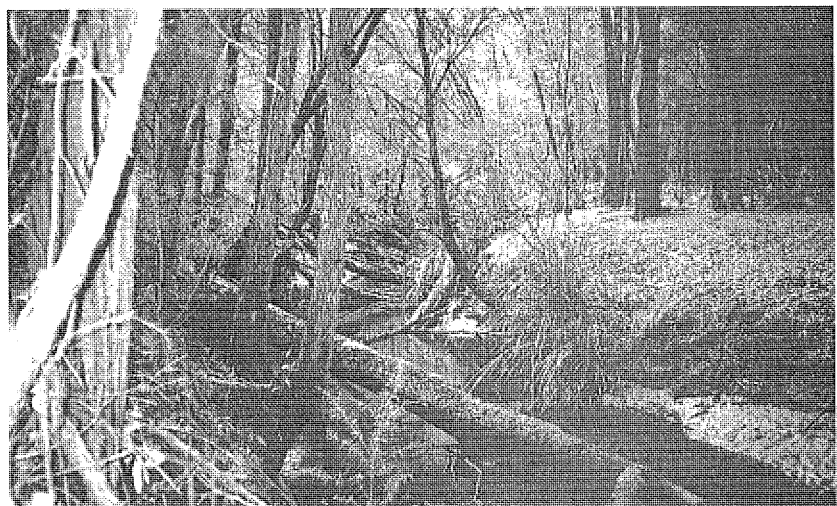
*Erosion and woody  
snags along the  
Scotsdale Brook. It is  
recommended that such  
logs not be removed, as  
they provide aquatic  
habitat.*

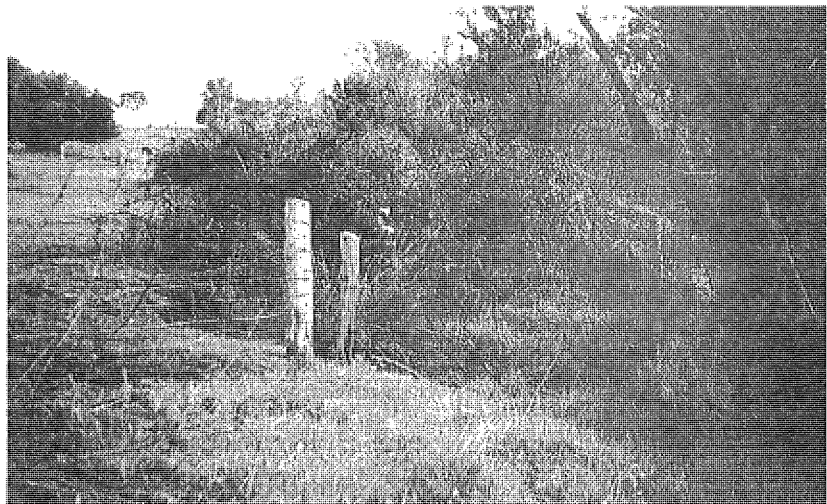
*Blackberry growing beside a waterway in the catchment. This is a major weed species and requires a carefully planned catchment approach for its control.*

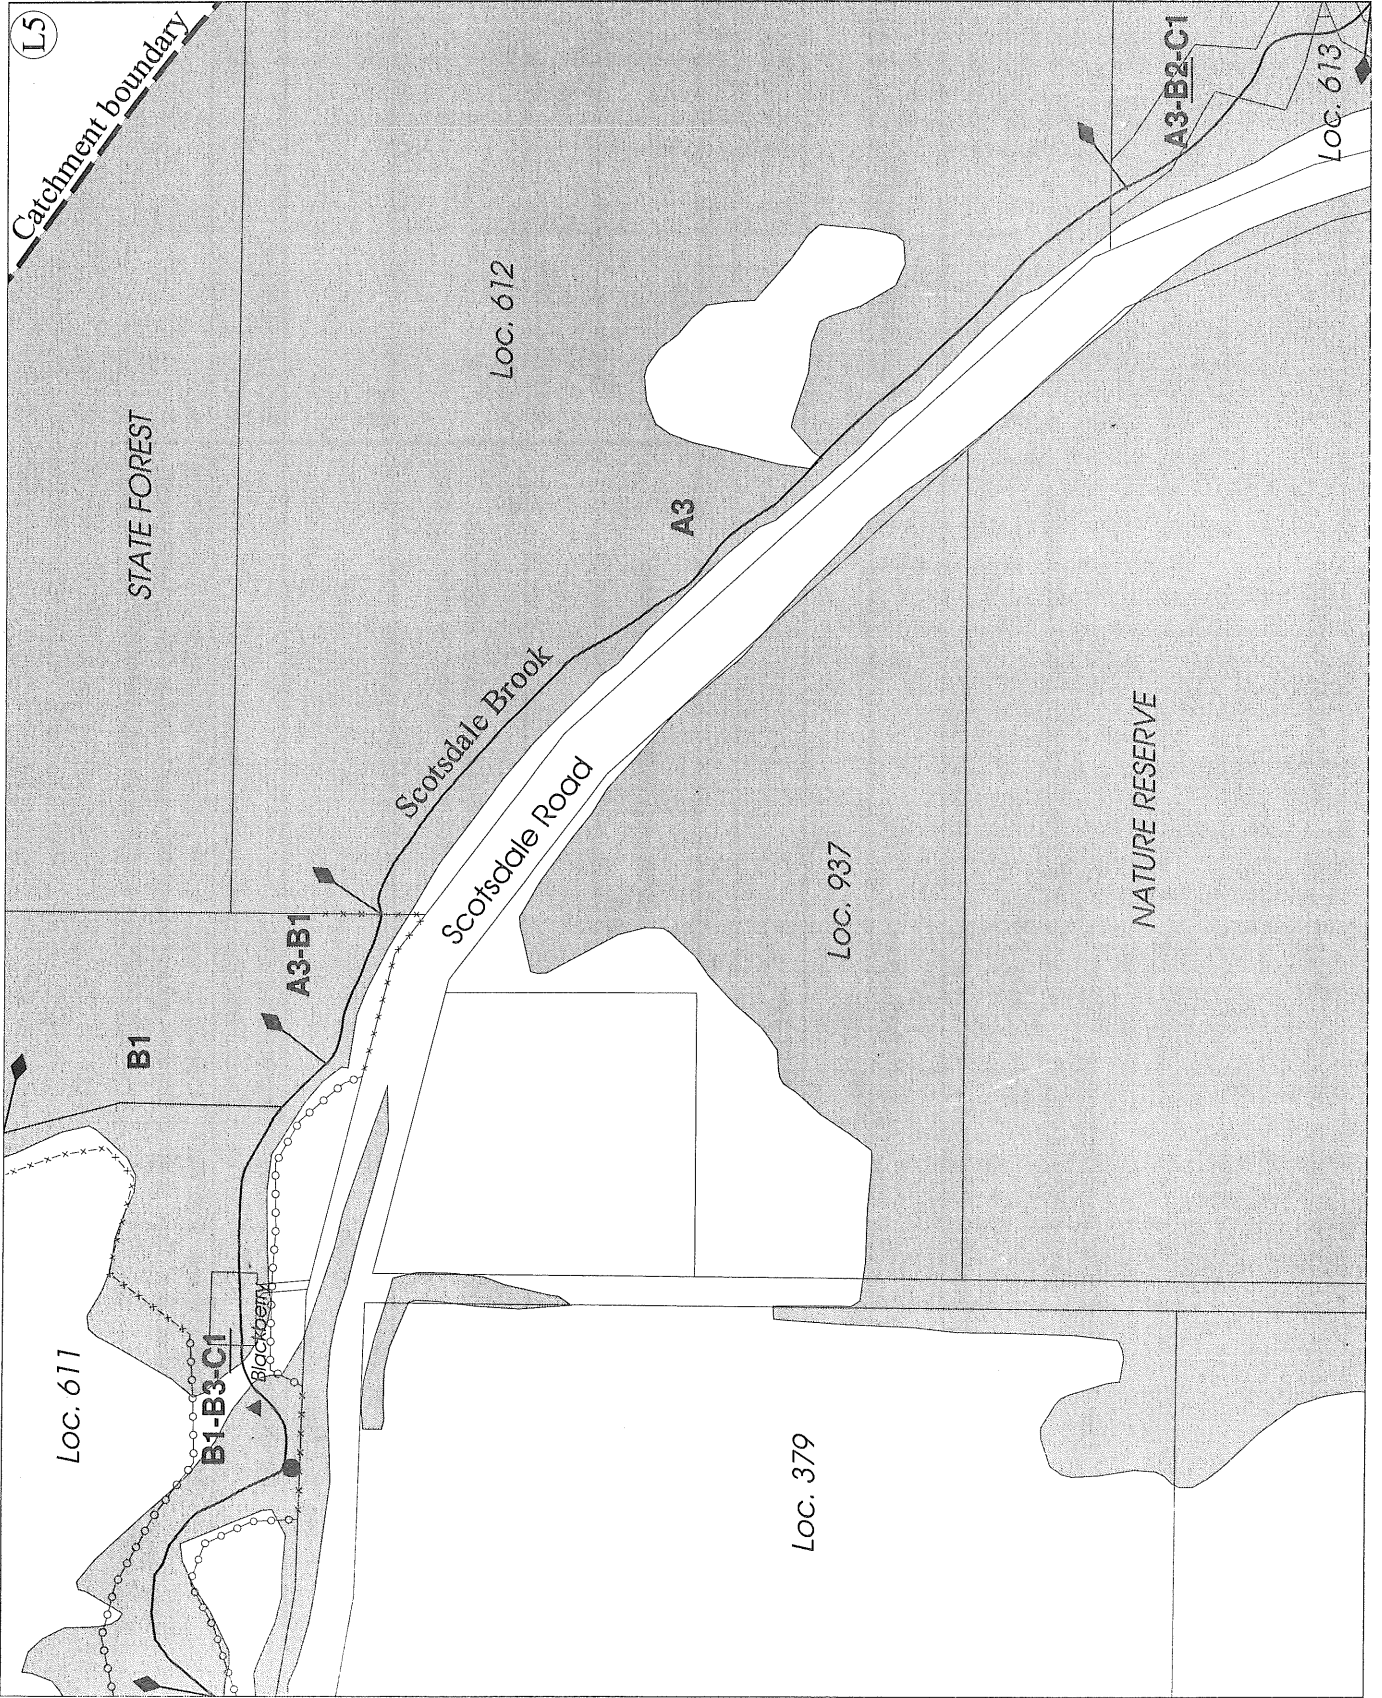
L5

| | Scotsdale Brook | Tributaries/Tributary |
|---|---|---|
| Other Management Related Information for this map | Occasional severe undercutting with slumping. The problem lies with greatly increased water volumes during flood events caused by vegetation removal in the catchment. | N/A |

| | Scotsdale Brook | Tributaries/Tributary |
|---|---|---|
| Advice on Rehabilitation of these sites | Recommendation:<br>Control Blackberry and garden escapes | Recommendation:<br>N/A |

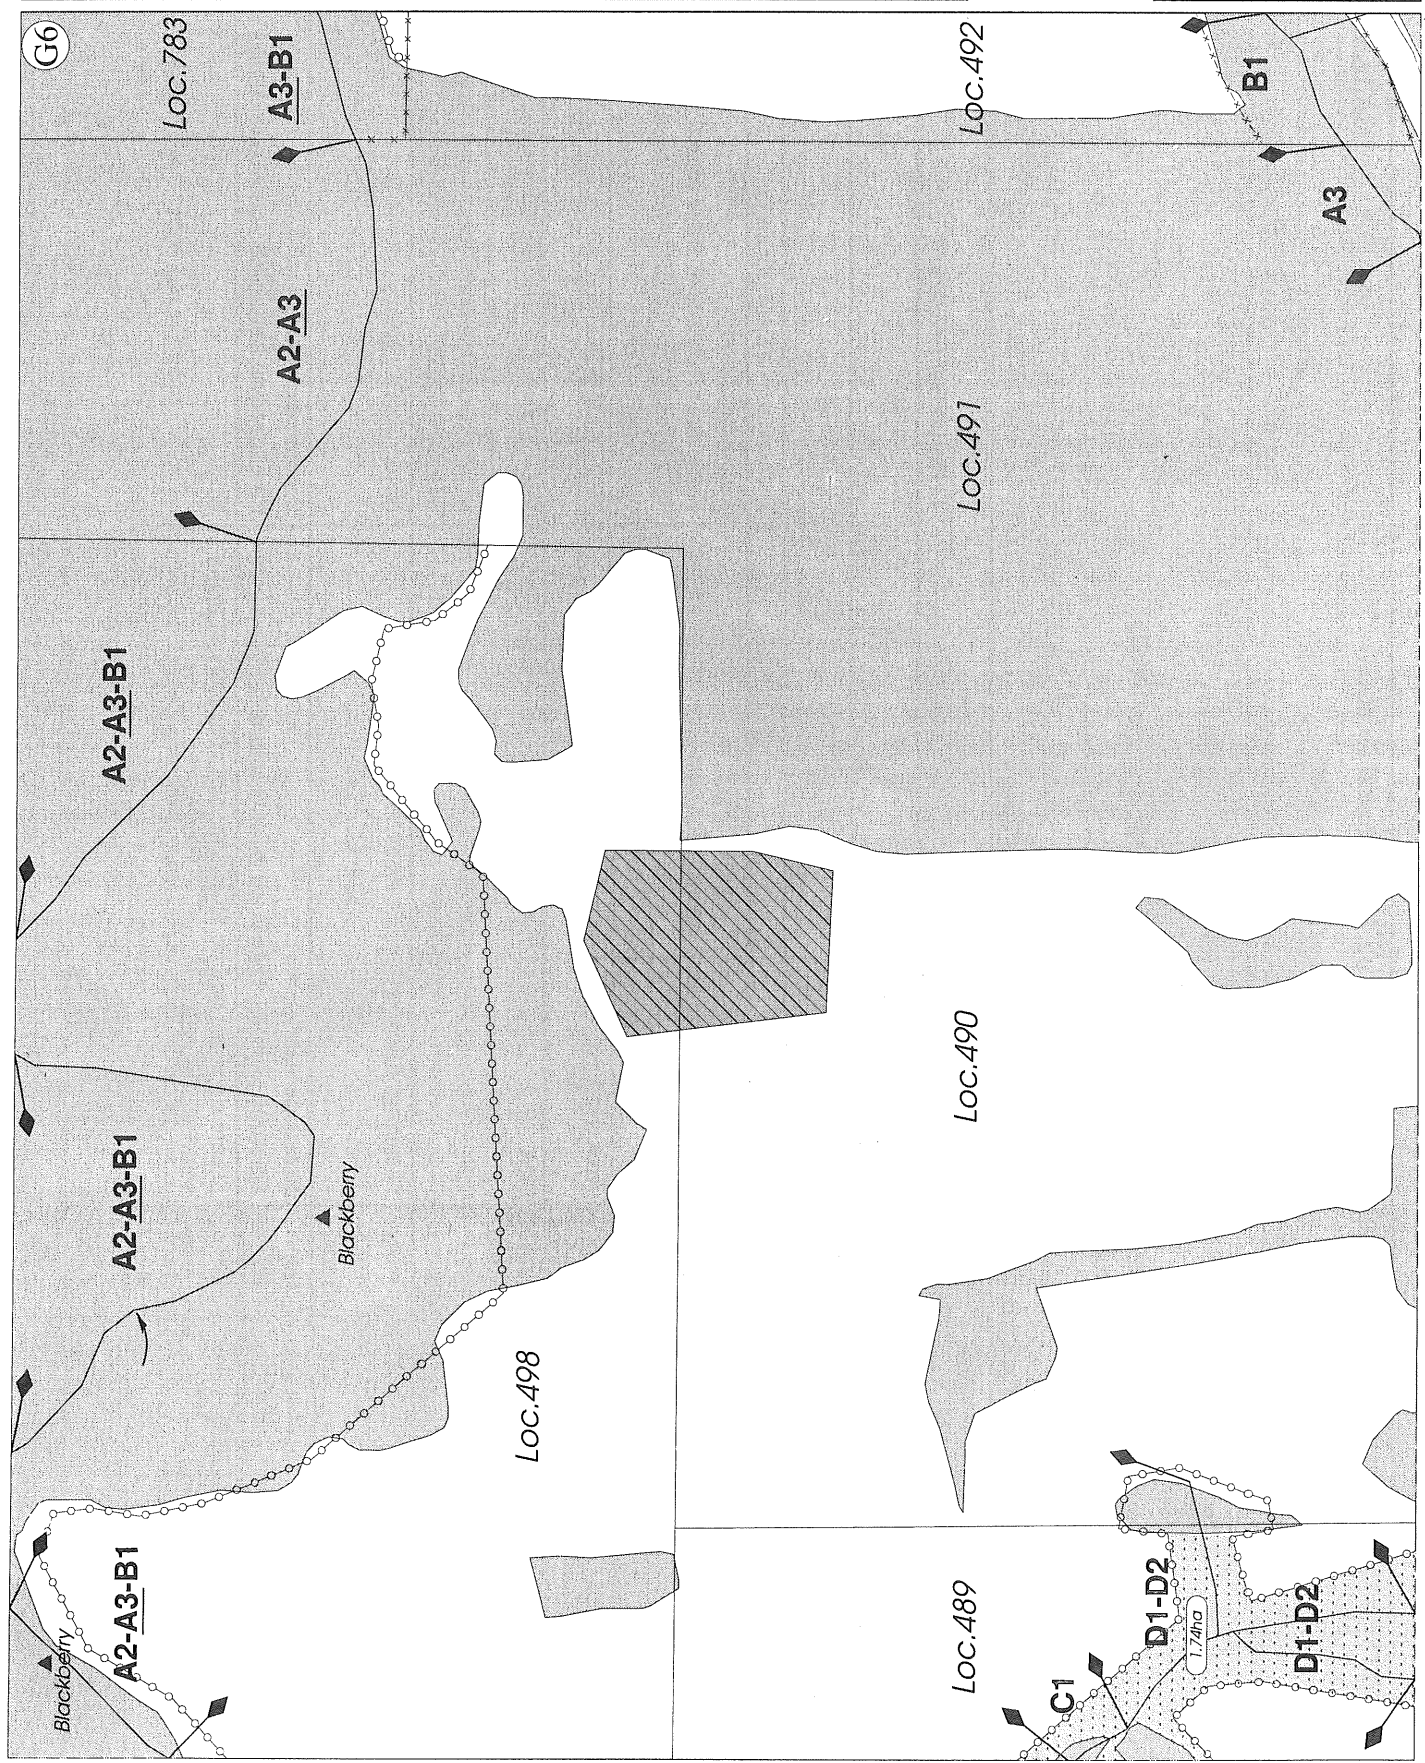
| | Scotsdale Brook | Tributaries/Tributary |
|---|---|---|
| Other Management Related Information for this map | N/A | The stream in need of revegetation has been severely degraded by the high volumes of run off coming from the now disused gravel pits to the south of Glenrowan Road. Successful rehabilitation of these pits is urgently required. |

| | Scotsdale Brook | Tributaries/Tributary |
|---|---|---|
| Advice on Rehabilitation of these sites | Recommendation:<br>N/A | Recommendation:<br>N/A |

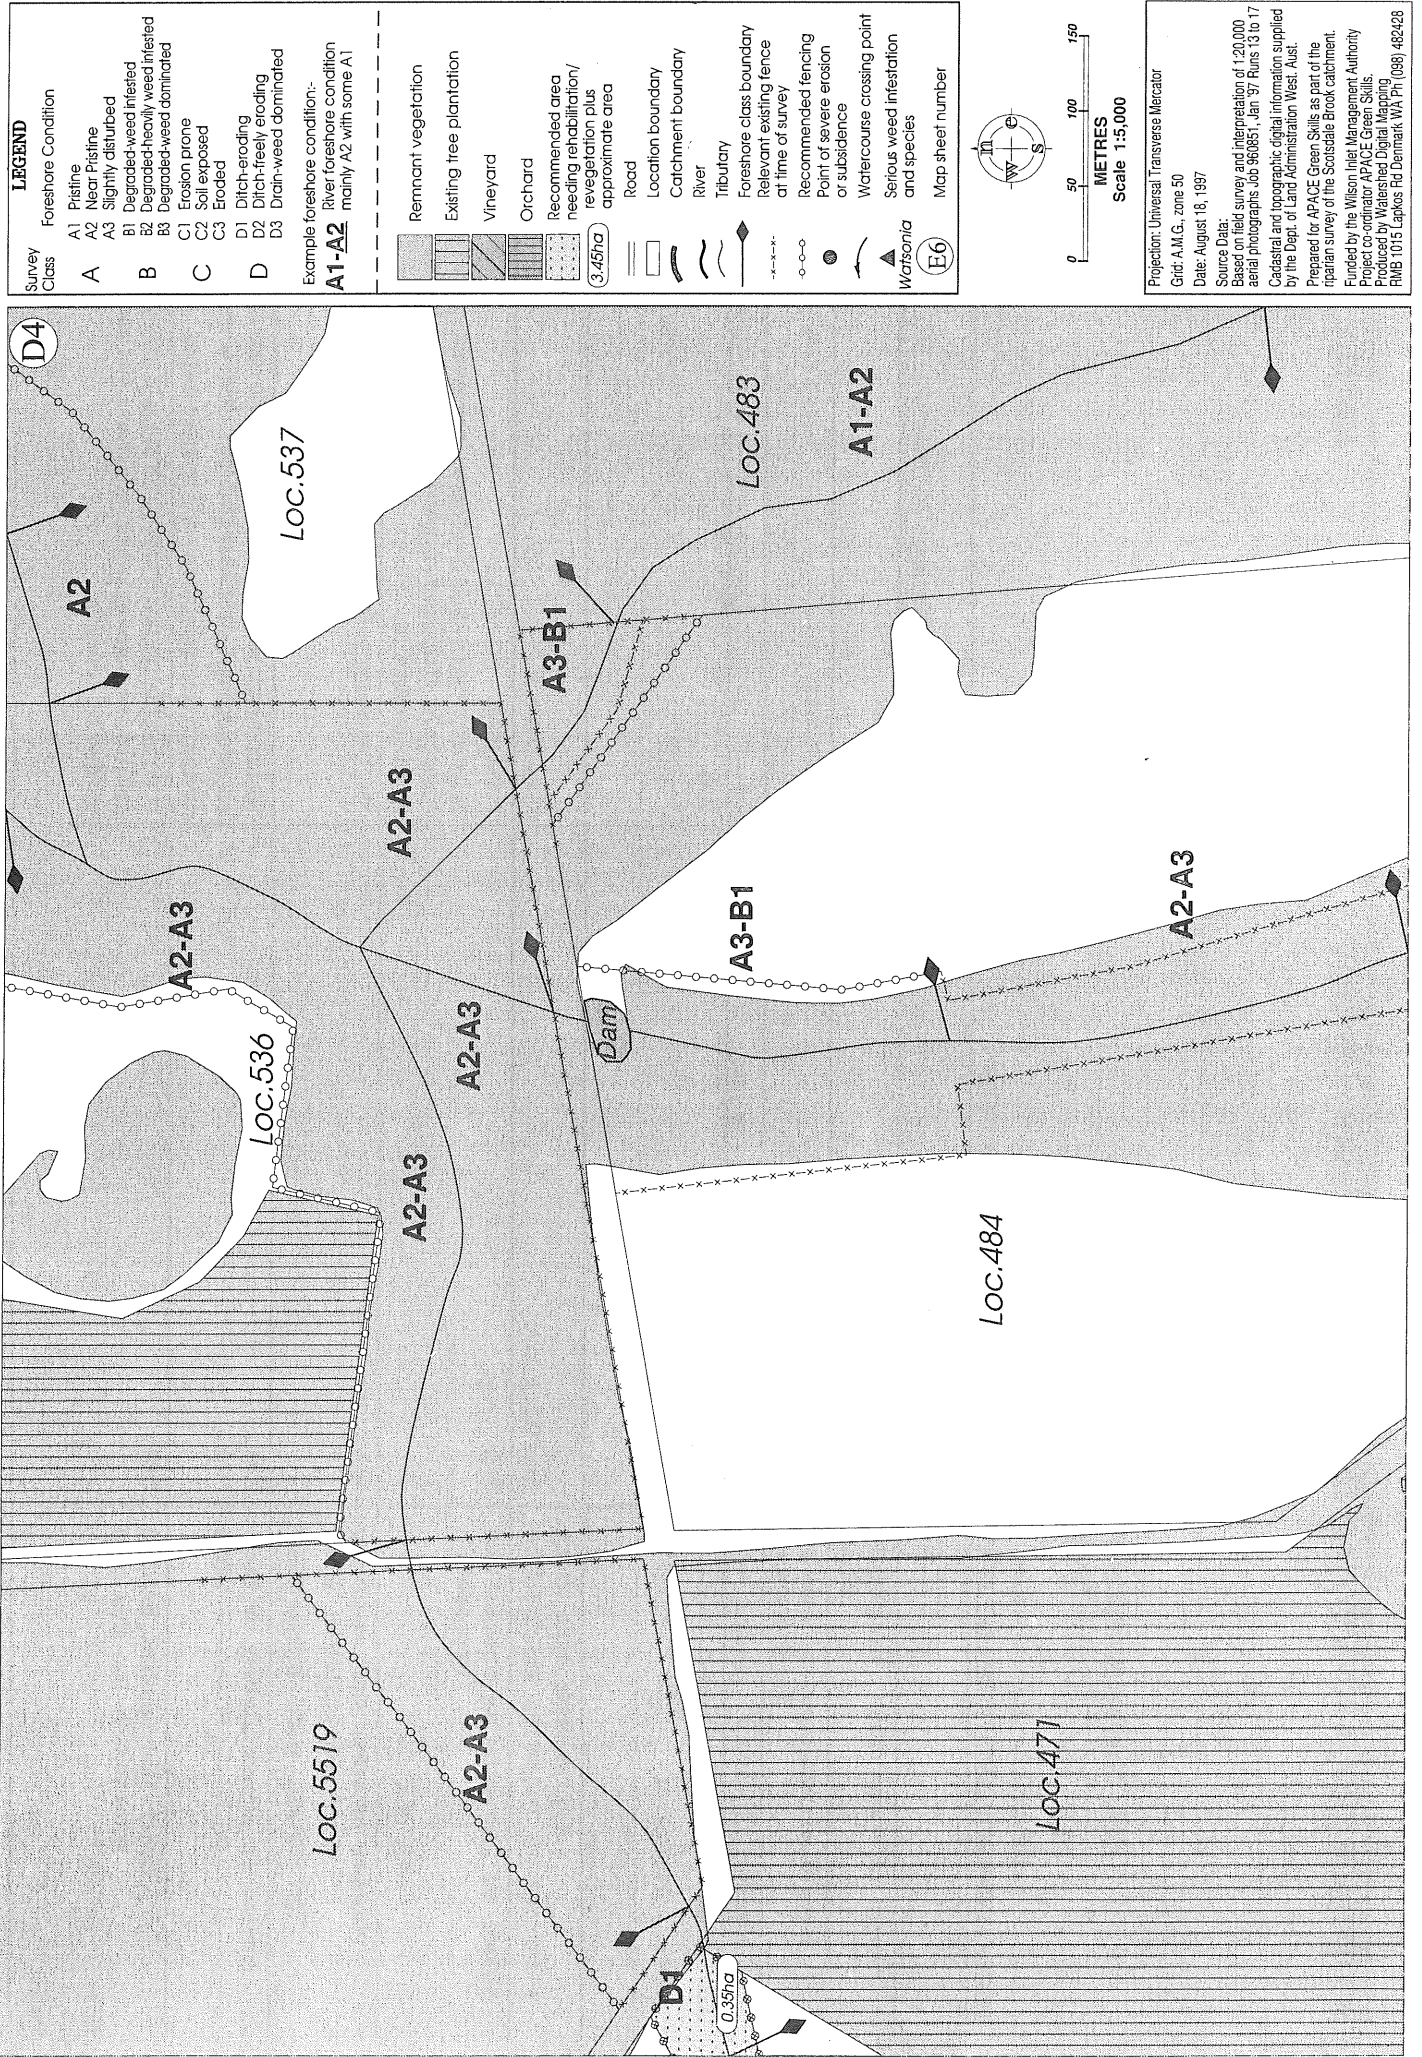
SCOTSDALE BROOK SURVEY- Map D4 (See Map 1.2 pg.4 for general location)

| Scotsdale Brook | | Tributaries/Tributary |
|---|---|---|
| Other Management Related Information for this map | | High quality remnant vegetation still remains along almost all waterways shown on this map. Action to ensure its continued integrity would be of value to the health of the catchment. |

| Scotsdale Brook | | Tributaries/Tributary |
|---|---|---|
| Advice on Rehabilitation of these sites | | Recommendation: Carefully treat Blackberry and monitor results. |
