HUTT RIVER FORESHORE ASSESSMENT

Prepared by
Regional Operations
Department of Environment

DEPARTMENT OF ENVIRONMENT
WATER RESOURCE MANAGEMENT SERIES
REPORT NO WRM 45
FEBRUARY 2005

February, 2005

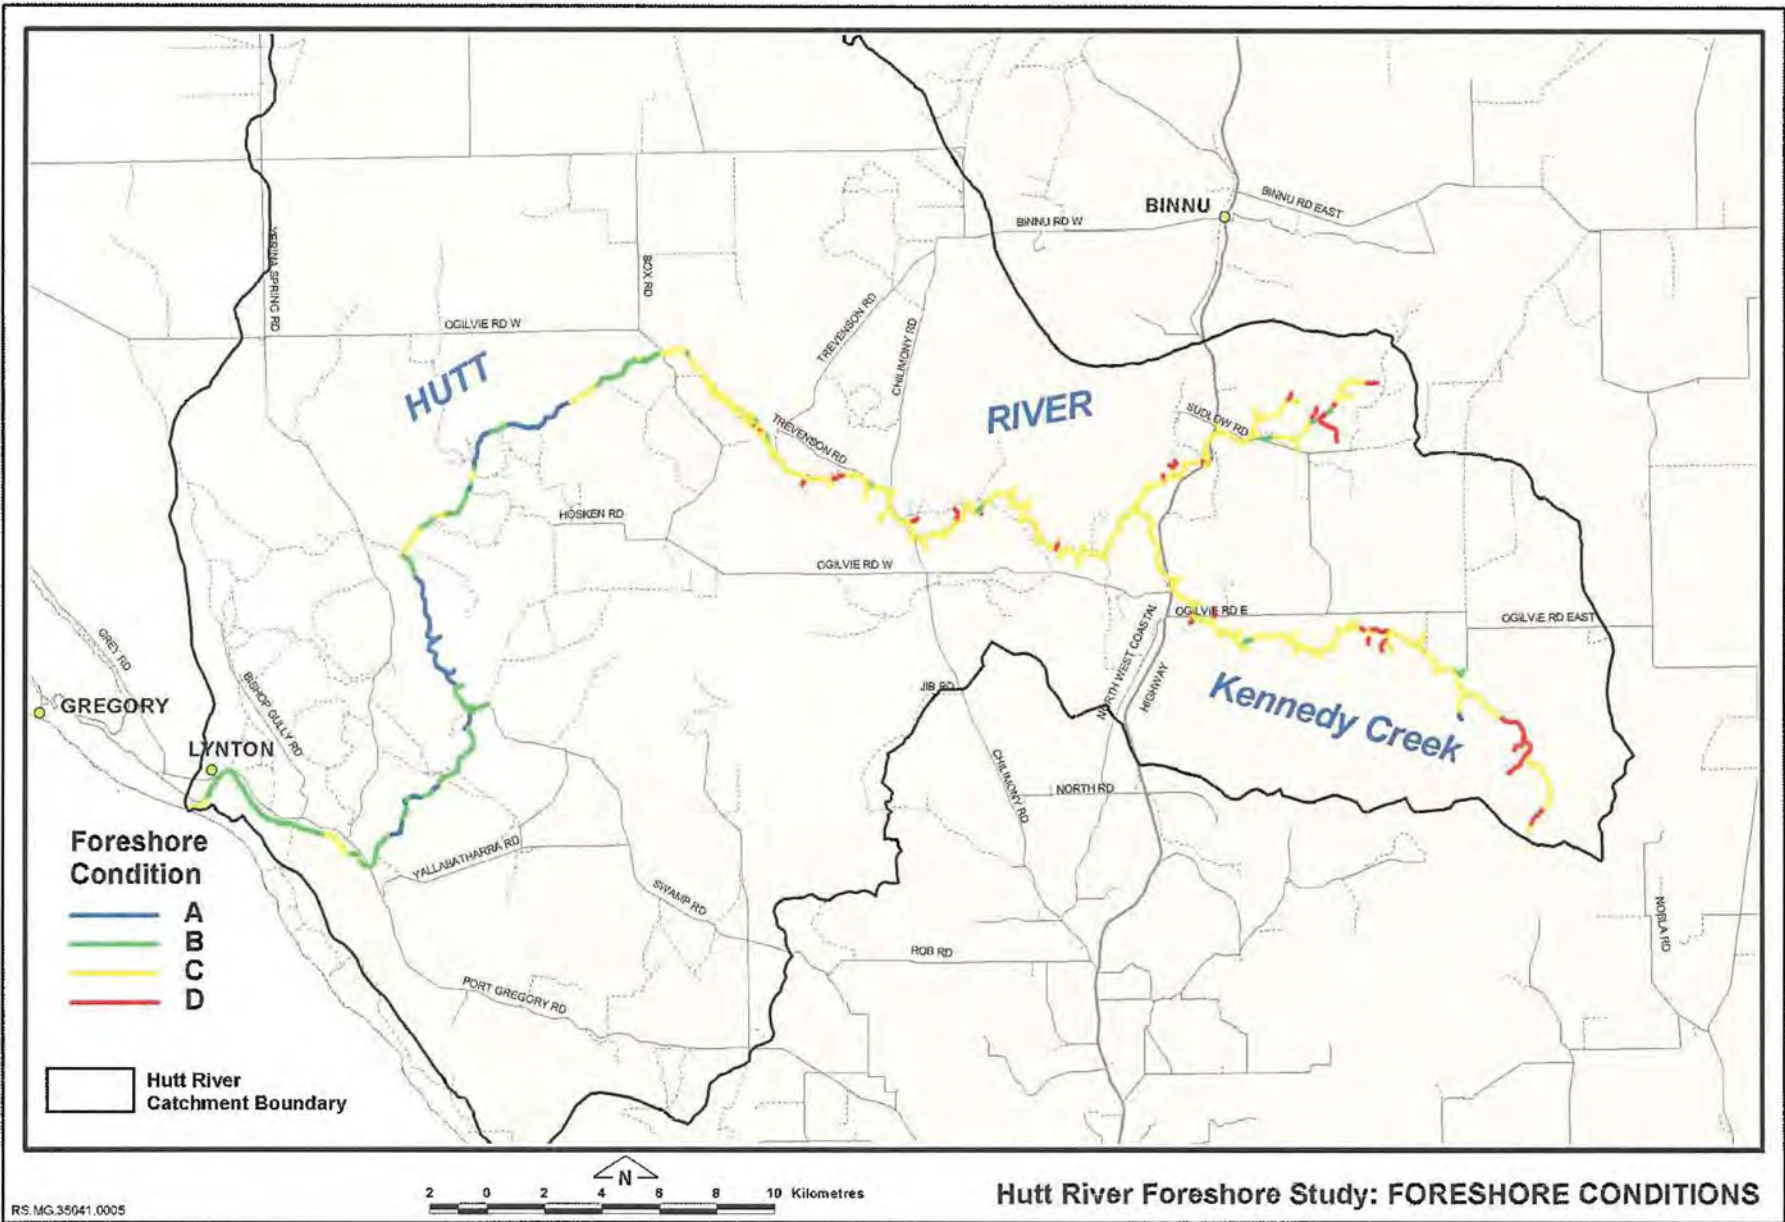
Figure 2: Summary of Foreshore Condition

Condition Rating	Total Length	Total %
A (Very Good)	10.7km	11%
B (Good)	22.7km	23%
C (Moderate)	57.9km	60%
D (Poor)	5.8km	6%
Total	97.1km	100%

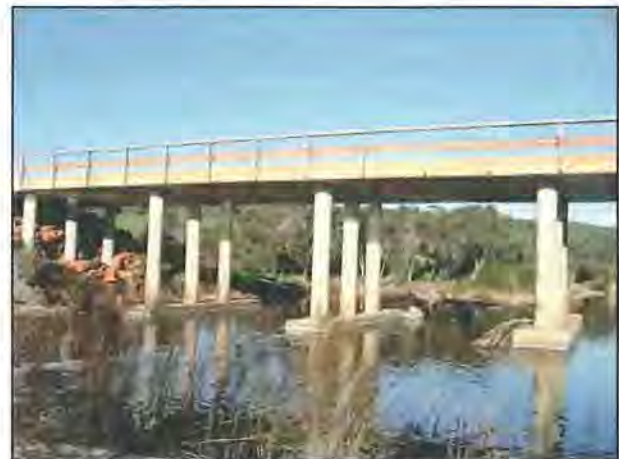
Photograph 4: The new Port Gregory Road bridge minimised disturbance to flow.

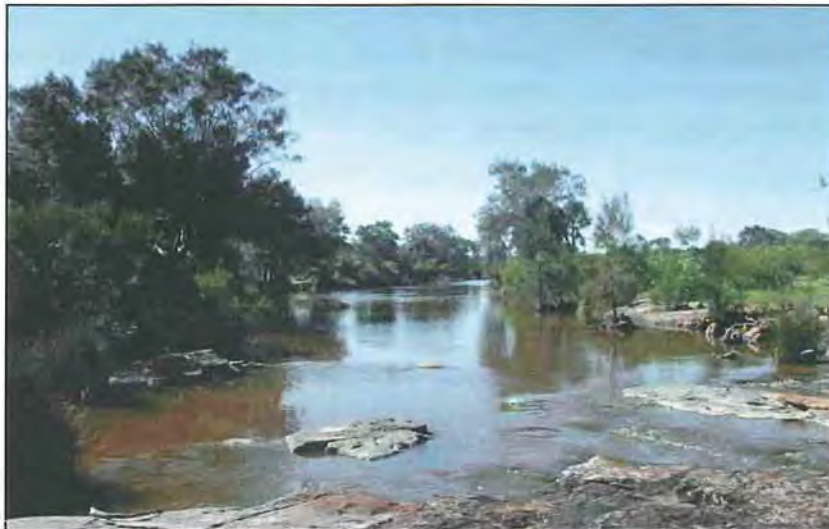
Photograph 6: Much of the Hutt River has a stable rock bed

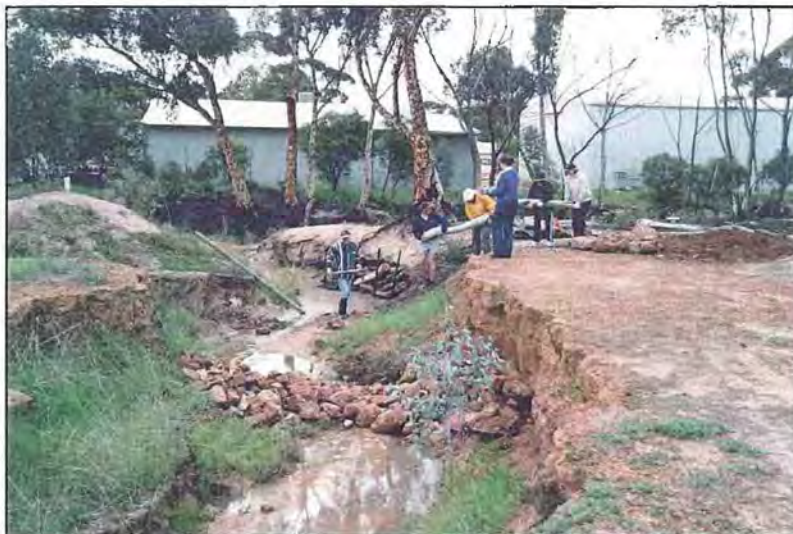
Photograph 13: Rock riffle structures and logs placed instream can arrest erosion and get a river on the road to recovery.
