## Foreshore and channel assessment of the Dale River South Branch

Water resource management series

Report No. WRM 50  
June 2008

Prepared by  
BlueSands Environmental for  
Department of Water

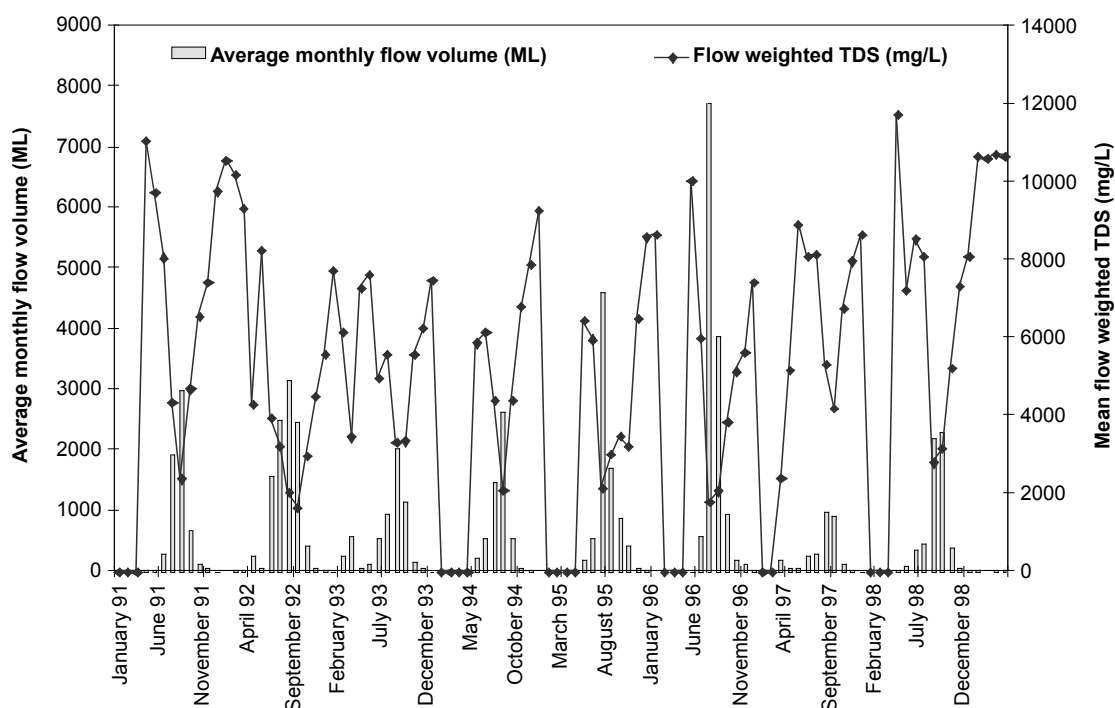
**Figure 1** Average monthly flow and flow-weighted salinity (total dissolved salts) for the Dale River South Branch at Brookton Highway

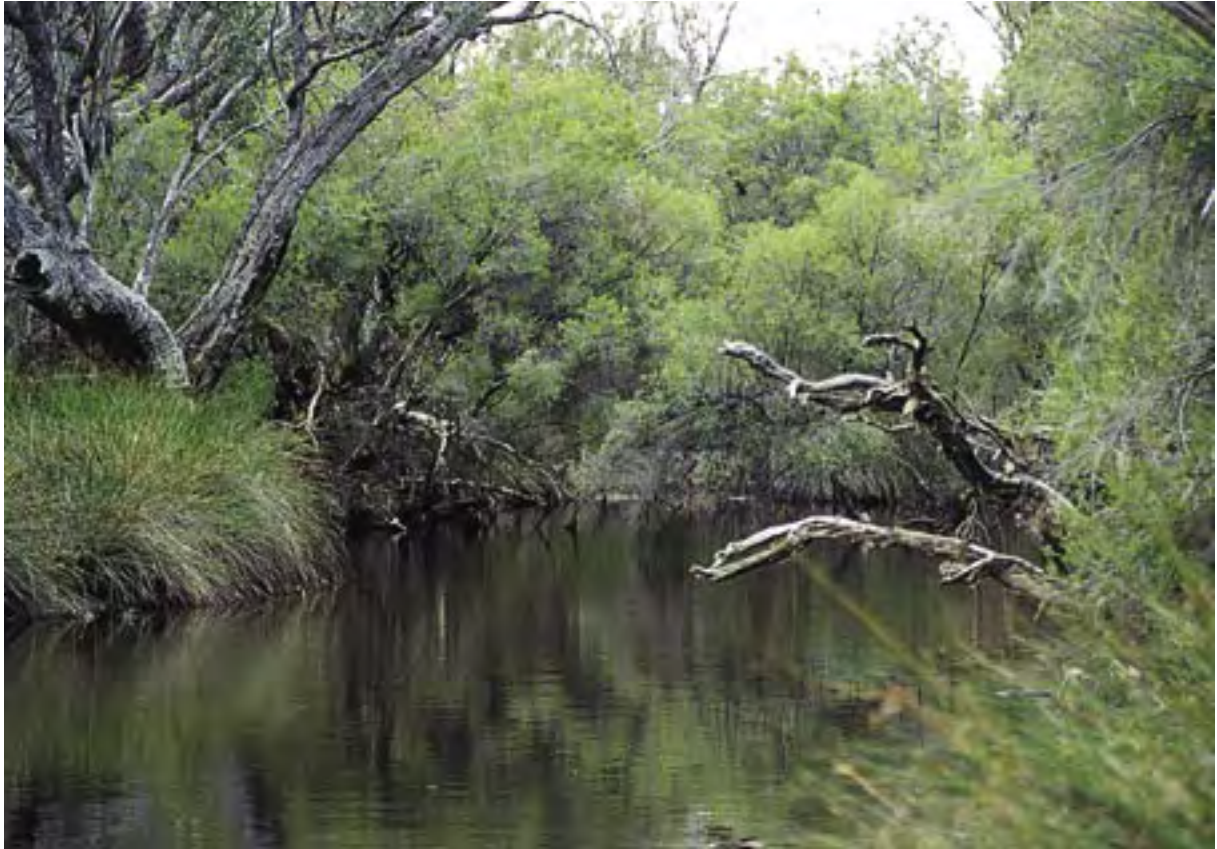
**Photo 1** An A-grade reach of the Dale River (Photo: K. Gole, Department of Water)

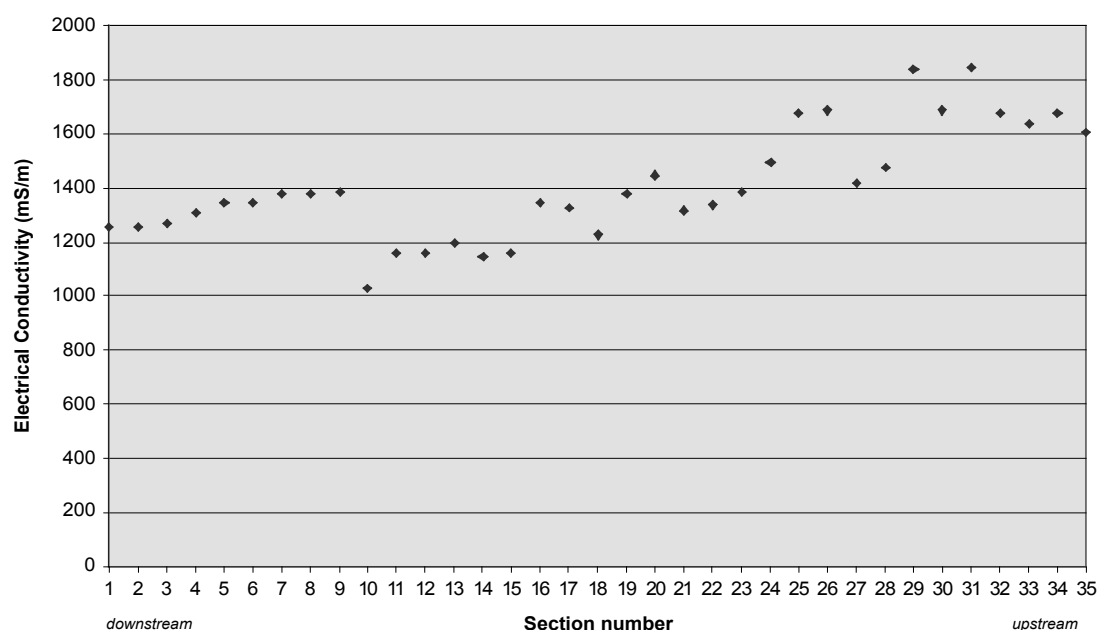
**Figure 2** Salinity levels recorded for each survey section on the Dale River South, June–July 2007 (Section number 1 indicates downstream end, 35 indicates upstream end)

Salinity levels generally increased upstream, although survey section DRS10 recorded a lower reading (1030 mS/m), probably because the sample was taken a week after the previous section, during which time there were a few days of rainfall.

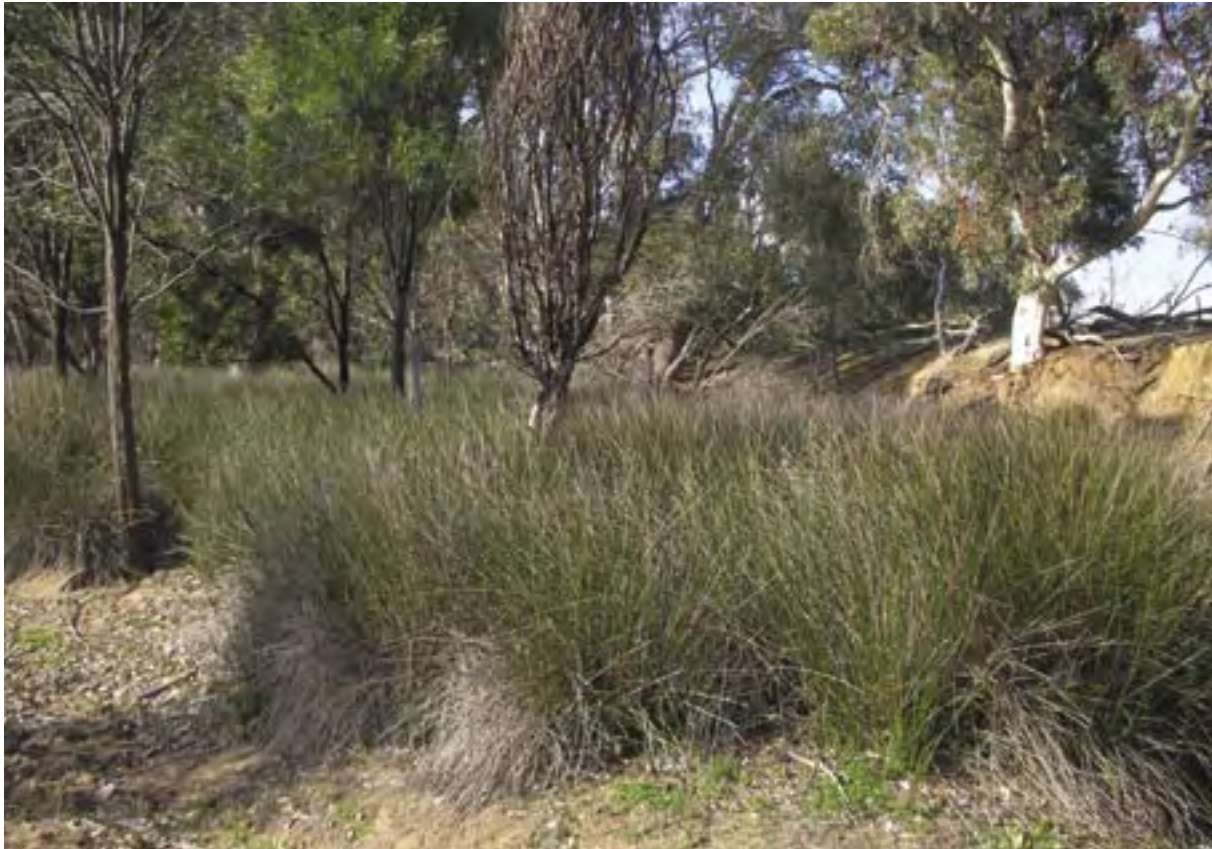
**Photo 12** Dense stand of shore rush (*Juncus kraussii*) in the floodway
