# POST INCIDENT ANALYSIS

## Bridgetown Complex

**Fire 23 (Peninsula)**

**Thursday January 15<sup>th</sup> 2009**  
**to**  
**Tuesday January 20<sup>th</sup> 2009**

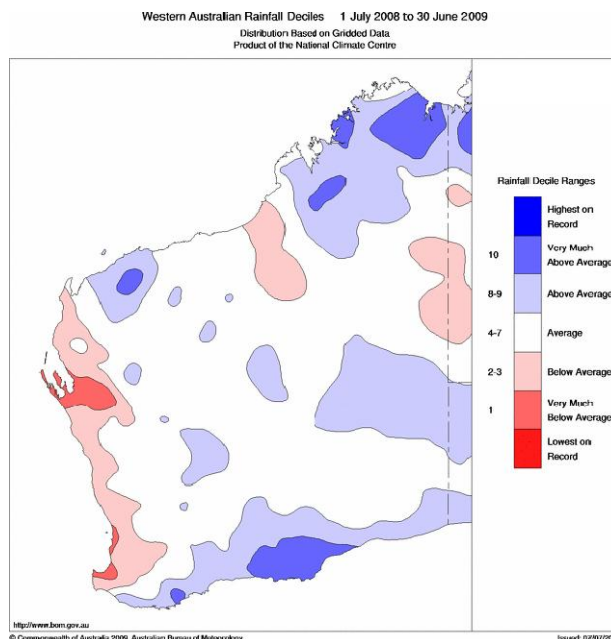
The 2008/09 bushfire season in the south-west had all the usual hallmarks with periods of hot, windy weather and protracted summer drought. Rainfall was very much below normal during late winter 2008 with many localities experiencing record dry conditions illustrates that the area around Bridgetown was unusually dry during the summer of 2008/09 (figure 1). Bridgetown received only 26 mm of rain in August breaking a record that had stood since 1925. Late spring rains in November and December replenished soil moisture and encouraged a late flush of grass growth, particularly in coastal areas. With the onset of warm dry weather in the latter part of December forest and grass fuels dried rapidly and were fully available by mid January.

**Figure 1.** Map of Rainfall Decile ranges provided by the Bureau of Meteorology.

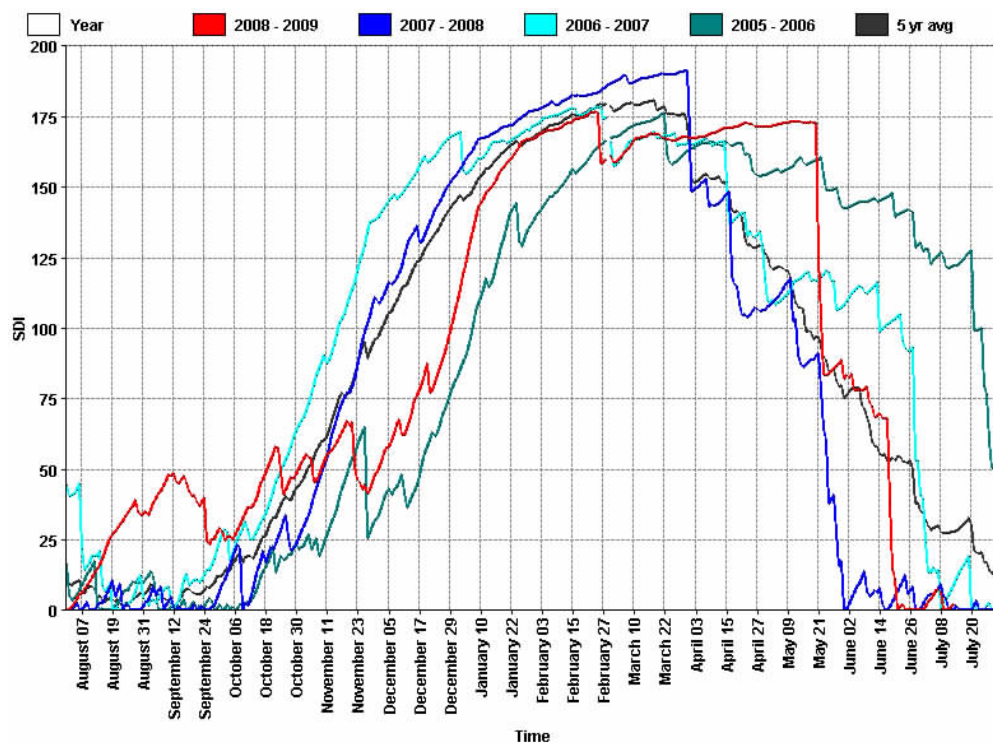
Figure 3 Soil Dryness Index for Bridgetown 2008/09

On Thursday 15<sup>th</sup> January 2009 the weather forecast issued by BOM at 0750 (attachment 1) forecast a maximum temperature of 35°C and a minimum Relative Humidity (RH) of 20% with winds out of the ENE, E and SSE between 20 and 24km/h. The Minimum Surface Moisture Content (SMC) was predicted to be 6 percent. SMC is a measure of the moisture content of the fine fuels (leaf litter and trash etc) and a reading below 10% indicates very dry fuels. The Grassland Fire Danger Index was HIGH. The Forest Fire Danger Index (FFDI) was 110 (High). The FFDI is an estimation of the rate of spread for a fire burning on flat ground in jarrah fuels of 8 tonnes/ha under the forecast minimum SMC and maximum wind speed for the day. It is used to indicate the difficulty of suppression. An FFDI of greater than 140 is considered to indicate extreme difficulty for suppression operations in forest fuels. The Soil Dryness Index (SDI) was 1424. SDI is an indication of the dryness of the large fuel components (logs and heavy branches etc). The SDI scale ranges between zero, when large fuels saturated with water such as might occur in the middle of winter, and 2000 when they contain no free water such as might occur at the very peak of the summer. An SDI over 1000 indicates that the heavy fuel components are available for consumption in a fire and will contribute to fire intensity, difficulty of suppression and likelihood that fires will continue burning overnight or re-ignite the following day. The graph of SDI at Bridgetown (figure 3) indicates a period of little rain over the preceding 3 months that allowed the larger fuels to dry early in the season.

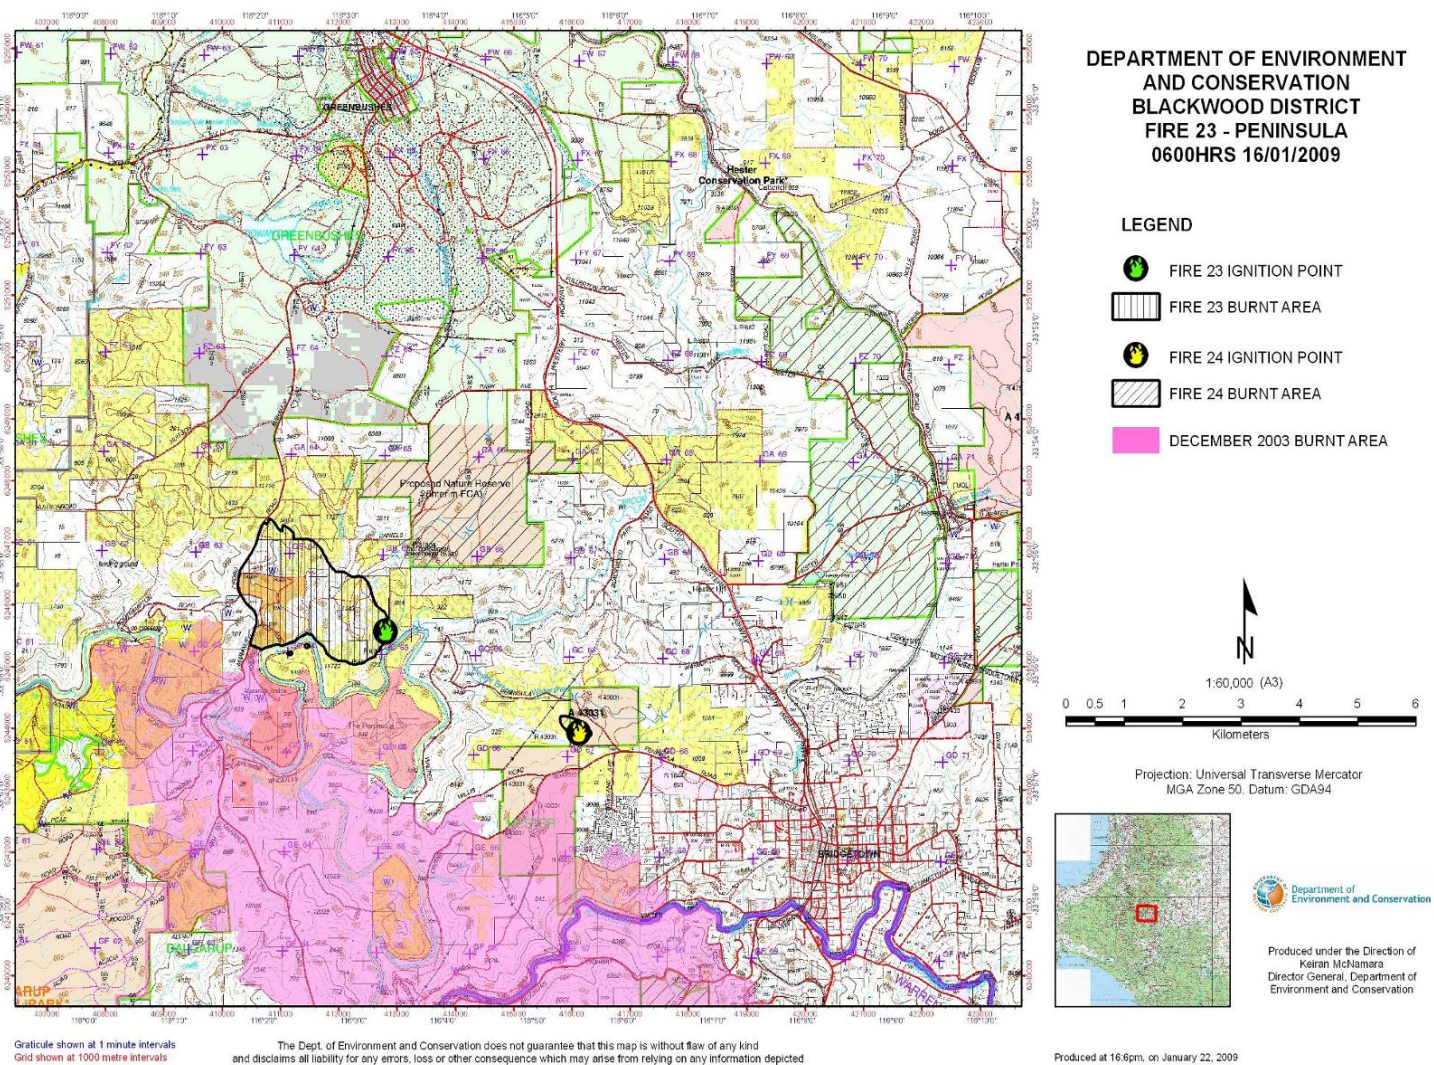
Figure 5. Extent of Fire 23 & 24 0600 hrs Friday 16<sup>th</sup> January 2009

Running fire had been stopped and containment operations were being undertaken north of the Blackwood River and east of the Marranup Ford Rd (figure 5.). The edge was very raw and a large mop up operation was initiated. The Peninsula fire had attained a size of approximately 190 ha with an approximate perimeter of 5.8 km.

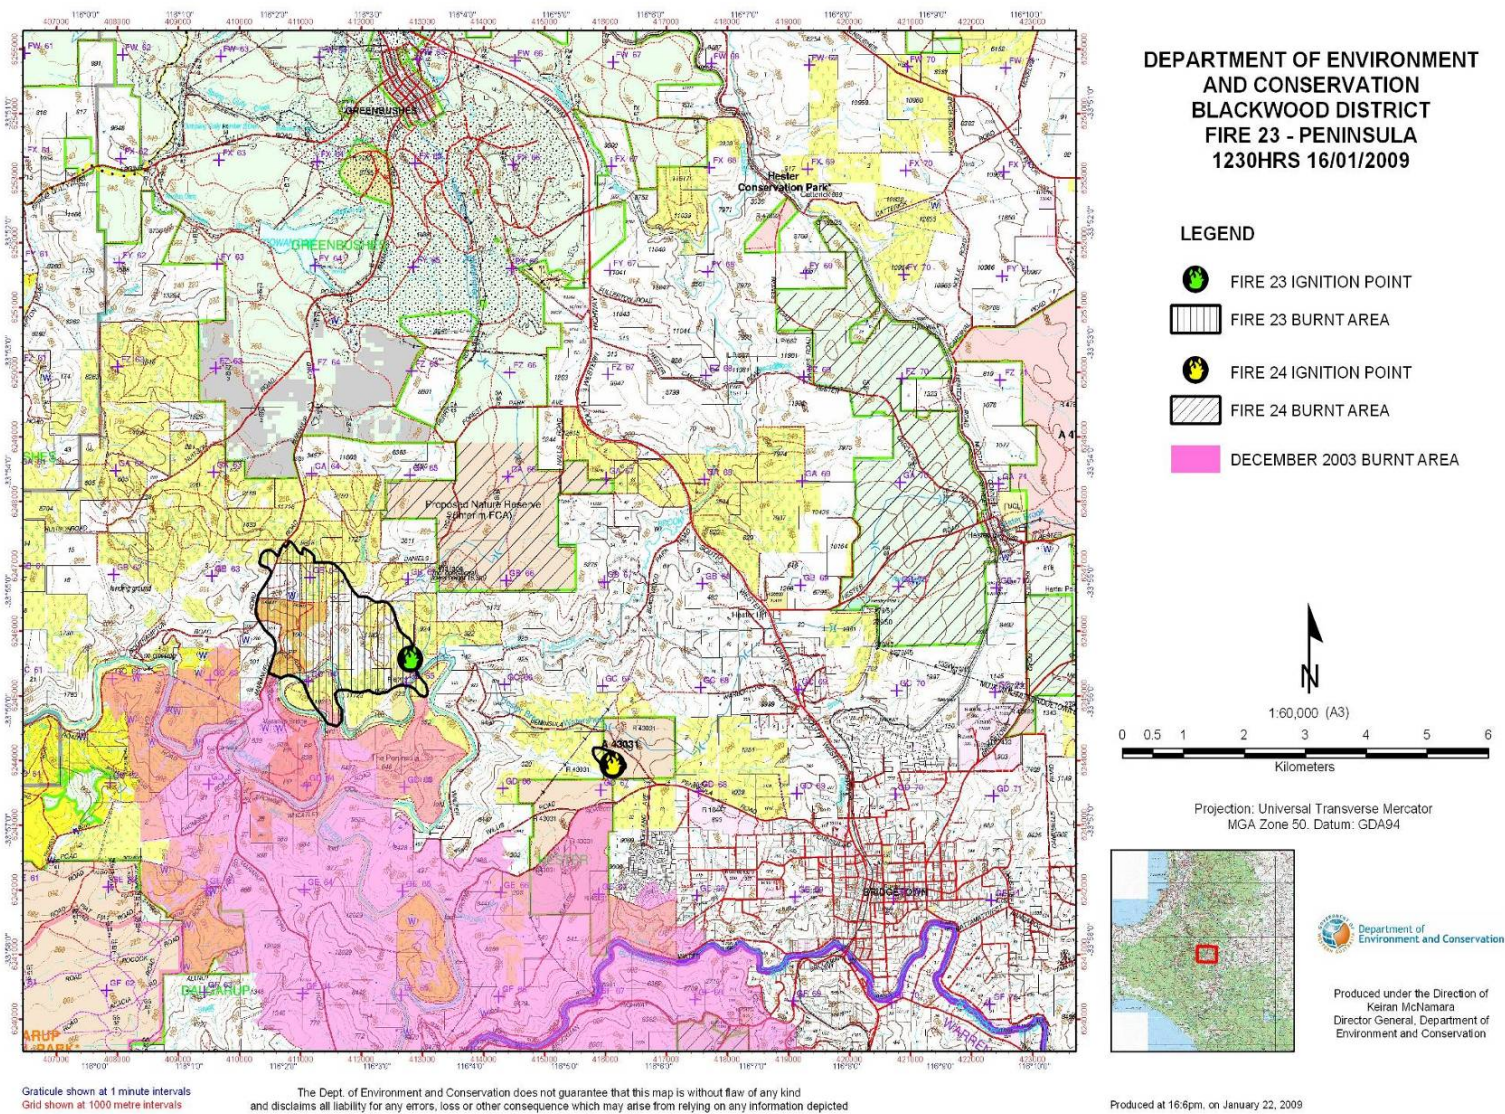
At approximately 1130 on Friday 16<sup>th</sup> under the influence of strong and hot NW winds Fire 23 broke containment lines in a number of places along its east, west and southern boundary (figure 6). At 1301 the IC was informed that the fire had escaped at two locations on the southern perimeter and had crossed the river and was burning strongly in a SE direction. The Greenbushes ICC was abandoned and re-established at the OP on Marranup Ford Rd.

Figure 6. Extent of Fire 23 & 24 1230 hrs Friday 16<sup>th</sup> January 2009 indicating escapes SE across the Blackwood River

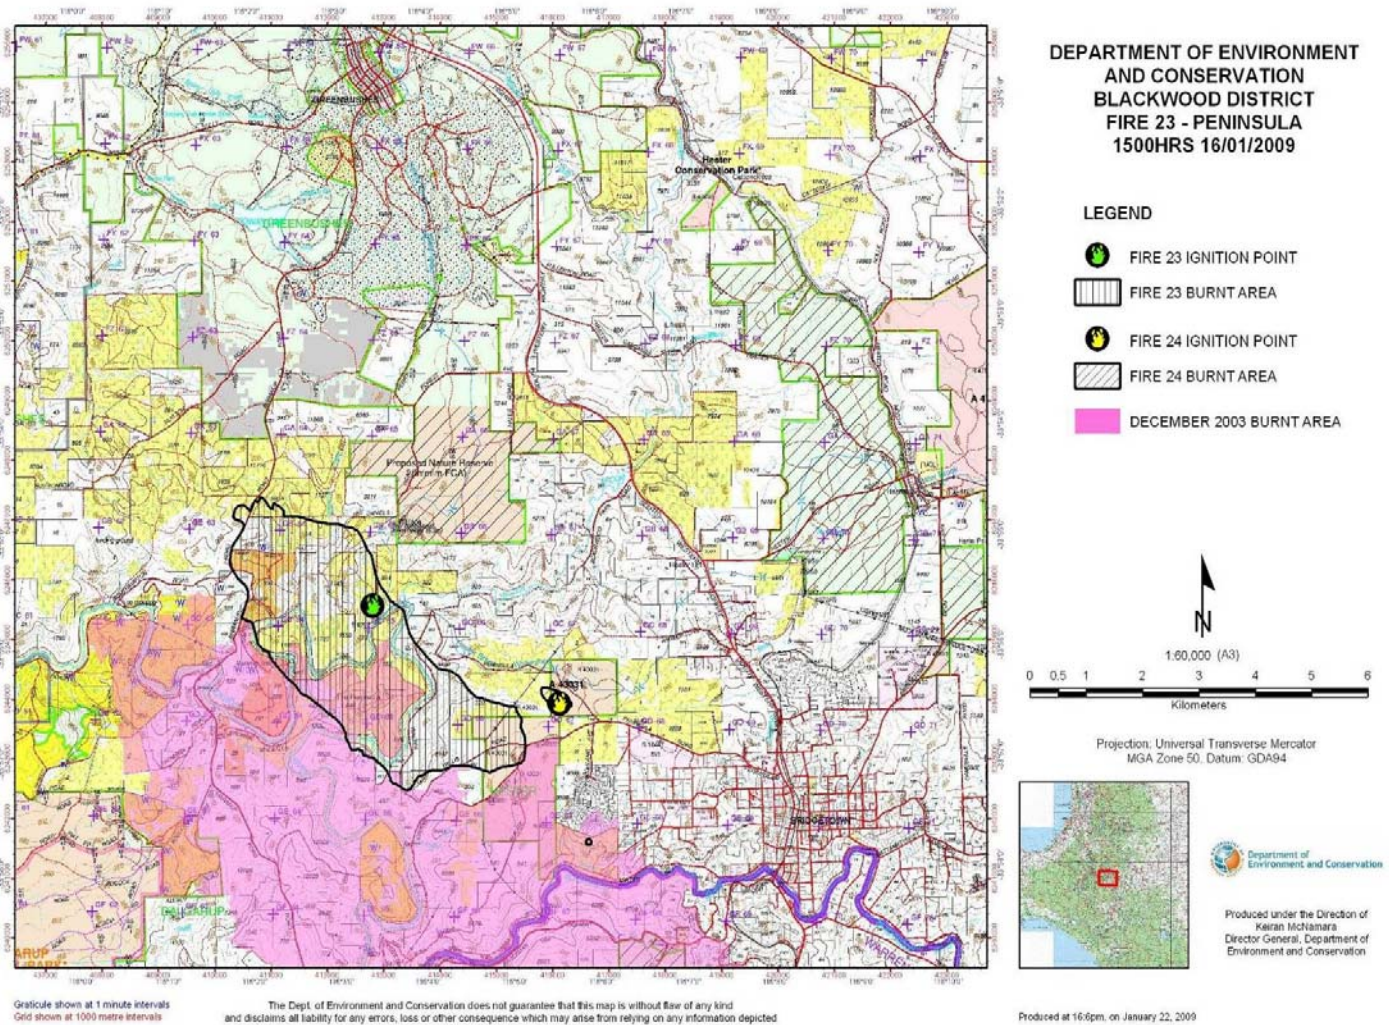
By 1500 hrs the fire had grown rapidly to approximately 1200 ha extending in a SE direction toward the outskirts of Bridgetown (figure 7). The fire straddled the Blackwood River and the limited existing access across the river became a significant impediment to mobilising resources around the fire. Spotting 3 km ahead of the main fire front into pasture fuels was reported. The rate of spread was estimated to average 1000m/hr with bursts of up to 3000m/hr.

Figure 7. Extent of Fire 23 & 24 1500 hrs Friday 16<sup>th</sup> January 2009 indicating fire growth to the SE across pasture and blue gum plantation. Note the spot fire on the outskirts of Bridgetown several kilometres in front of the main fire.

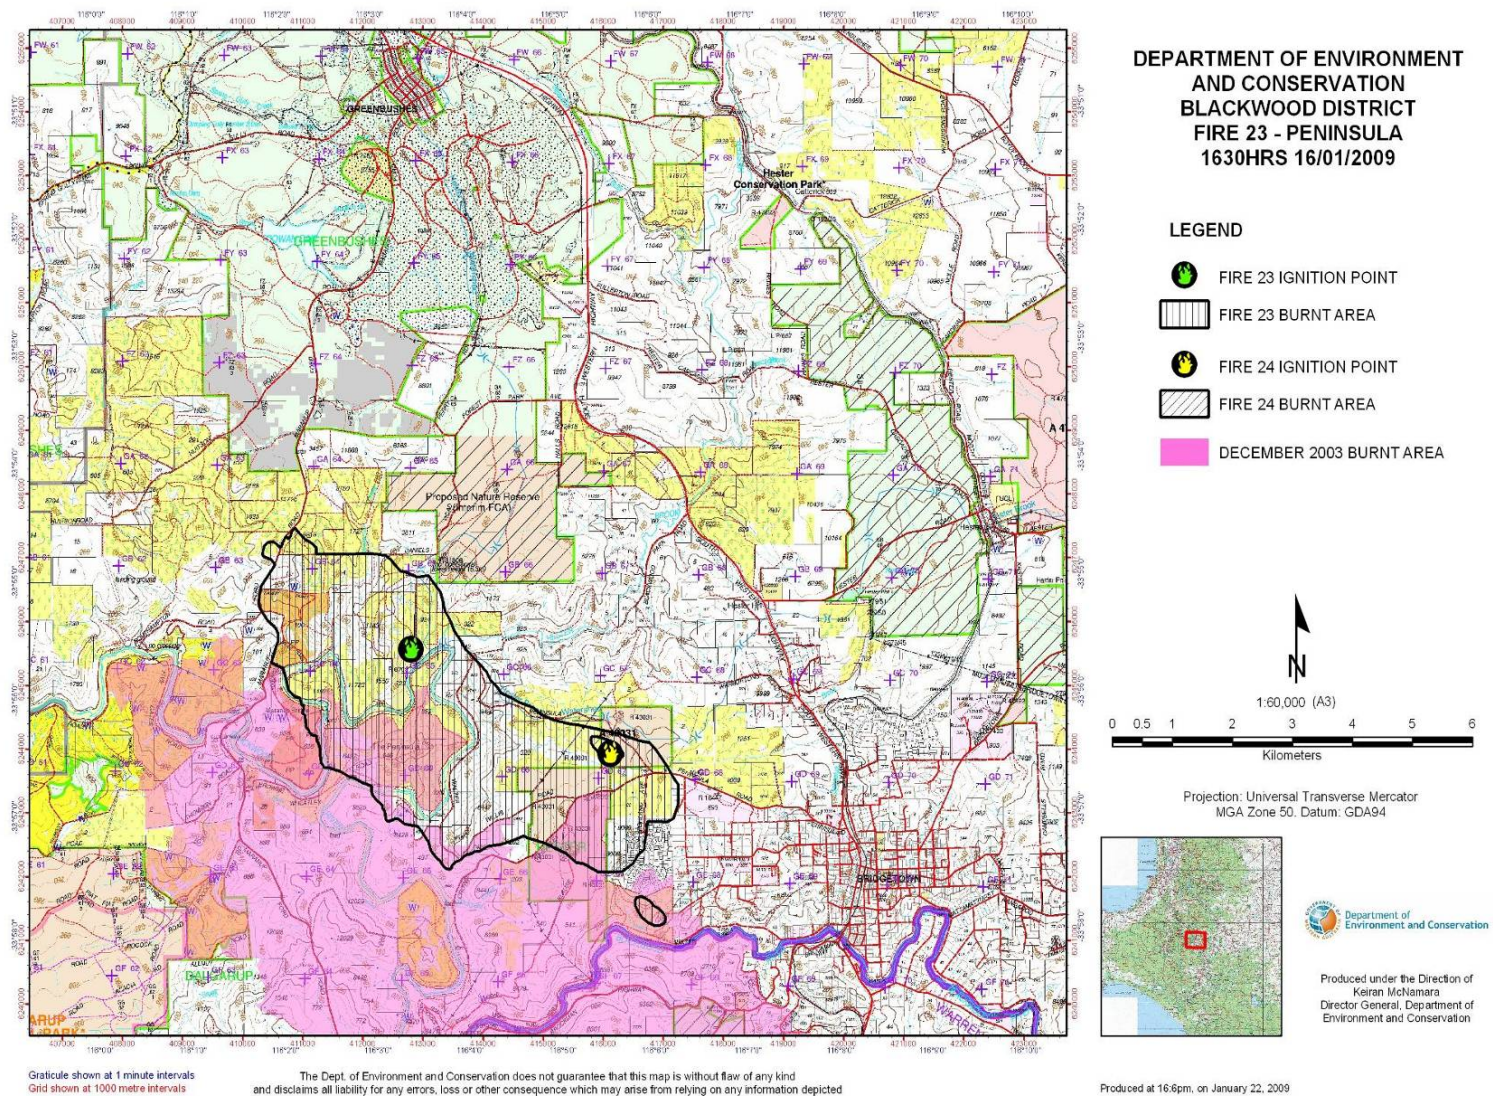
Figure 9 Extent of fire 23 1630 hrs Saturday 16<sup>th</sup> January 2009

By 1630 on Friday 16 January, the fire had burned into the Highlands Estate on the western outskirts of Bridgetown. A spot fire developed to the south of the Estate and north of the Blackwood River. This spot fire ultimately merged with the main body of the fire (figure 9). A house and several vehicles in Highlands Estate were destroyed by fire during this time (figure 10,11). The house was unoccupied at the time the fire arrived and was, therefore, not defended by the occupants. All other houses in the Estate were occupied and were defended by the occupants resulting in minimal loss and damage. Aerial water bombing was effective in saving a number of structures from impact by head and flank fires. Smoke affecting visibility made it difficult for pilots to drop near some structures.

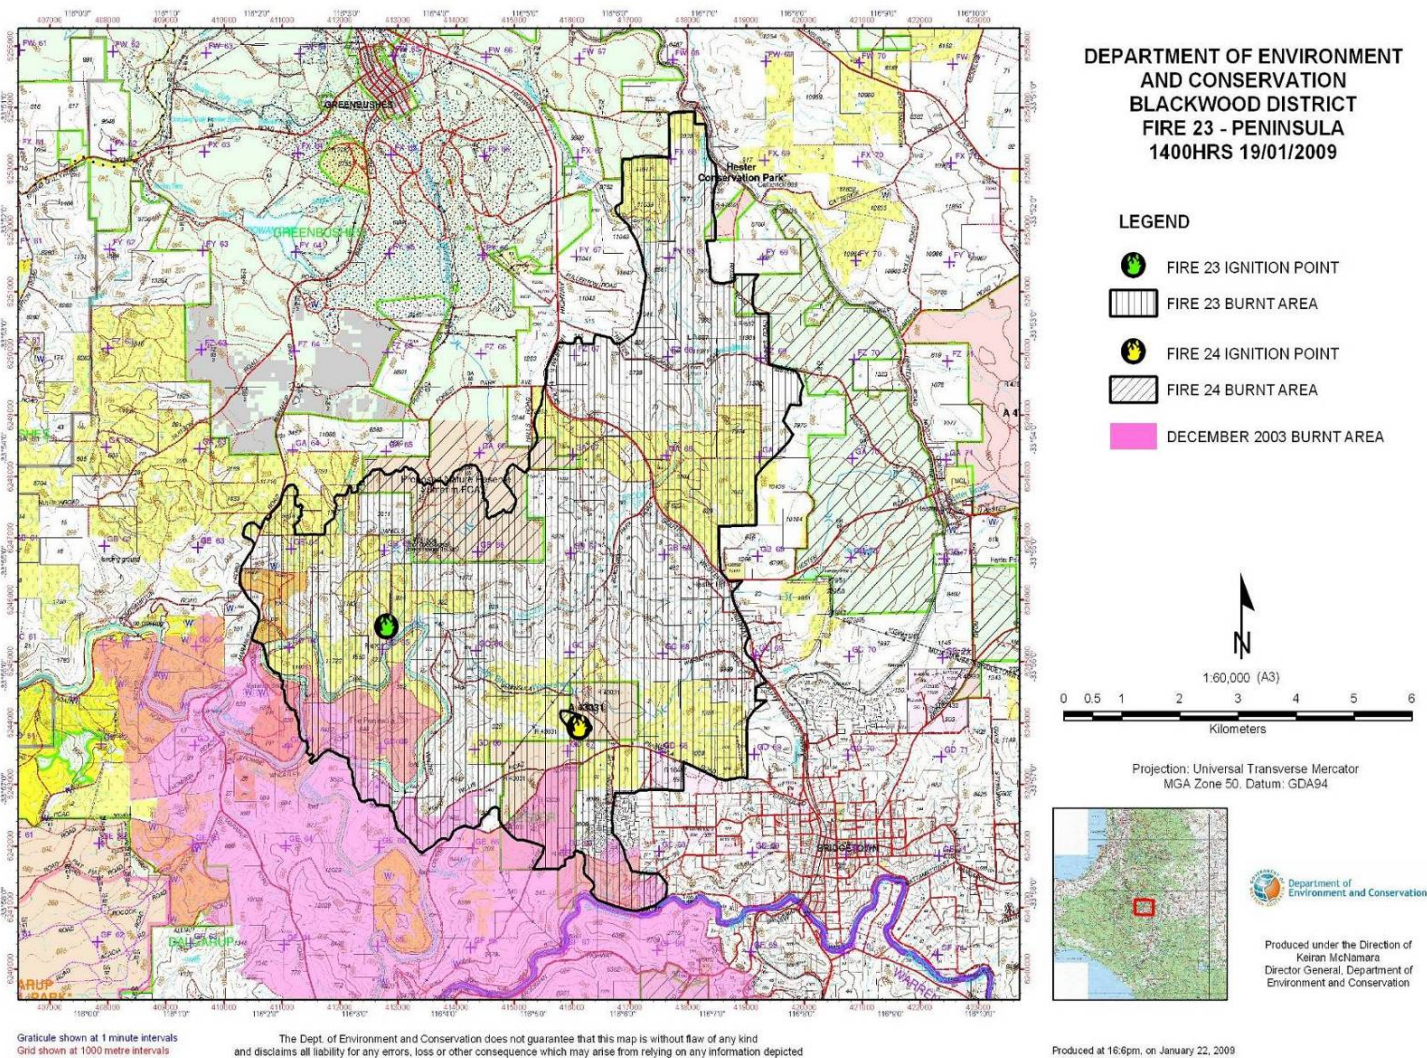
Figure 14 Final extent of fire 23 as at 1400 hrs Monday 19<sup>th</sup> January 2009

By Saturday morning the fire had burned a total area of 5,877 ha, of which 5,180 ha was private property and about 700 ha of DEC managed lands. The final fire perimeter was 52km. The fire destroyed 7 houses, 9 outbuildings, 5 vehicles, 50 km of fencing, 26 stock (9 sheep, 17 cattle), 400 ha of mature (28 to 33 year old) radiata pine plantation and a similar area of 8 year old Tasmanian bluegum tree farm. No lives were lost and no serious injuries were incurred.

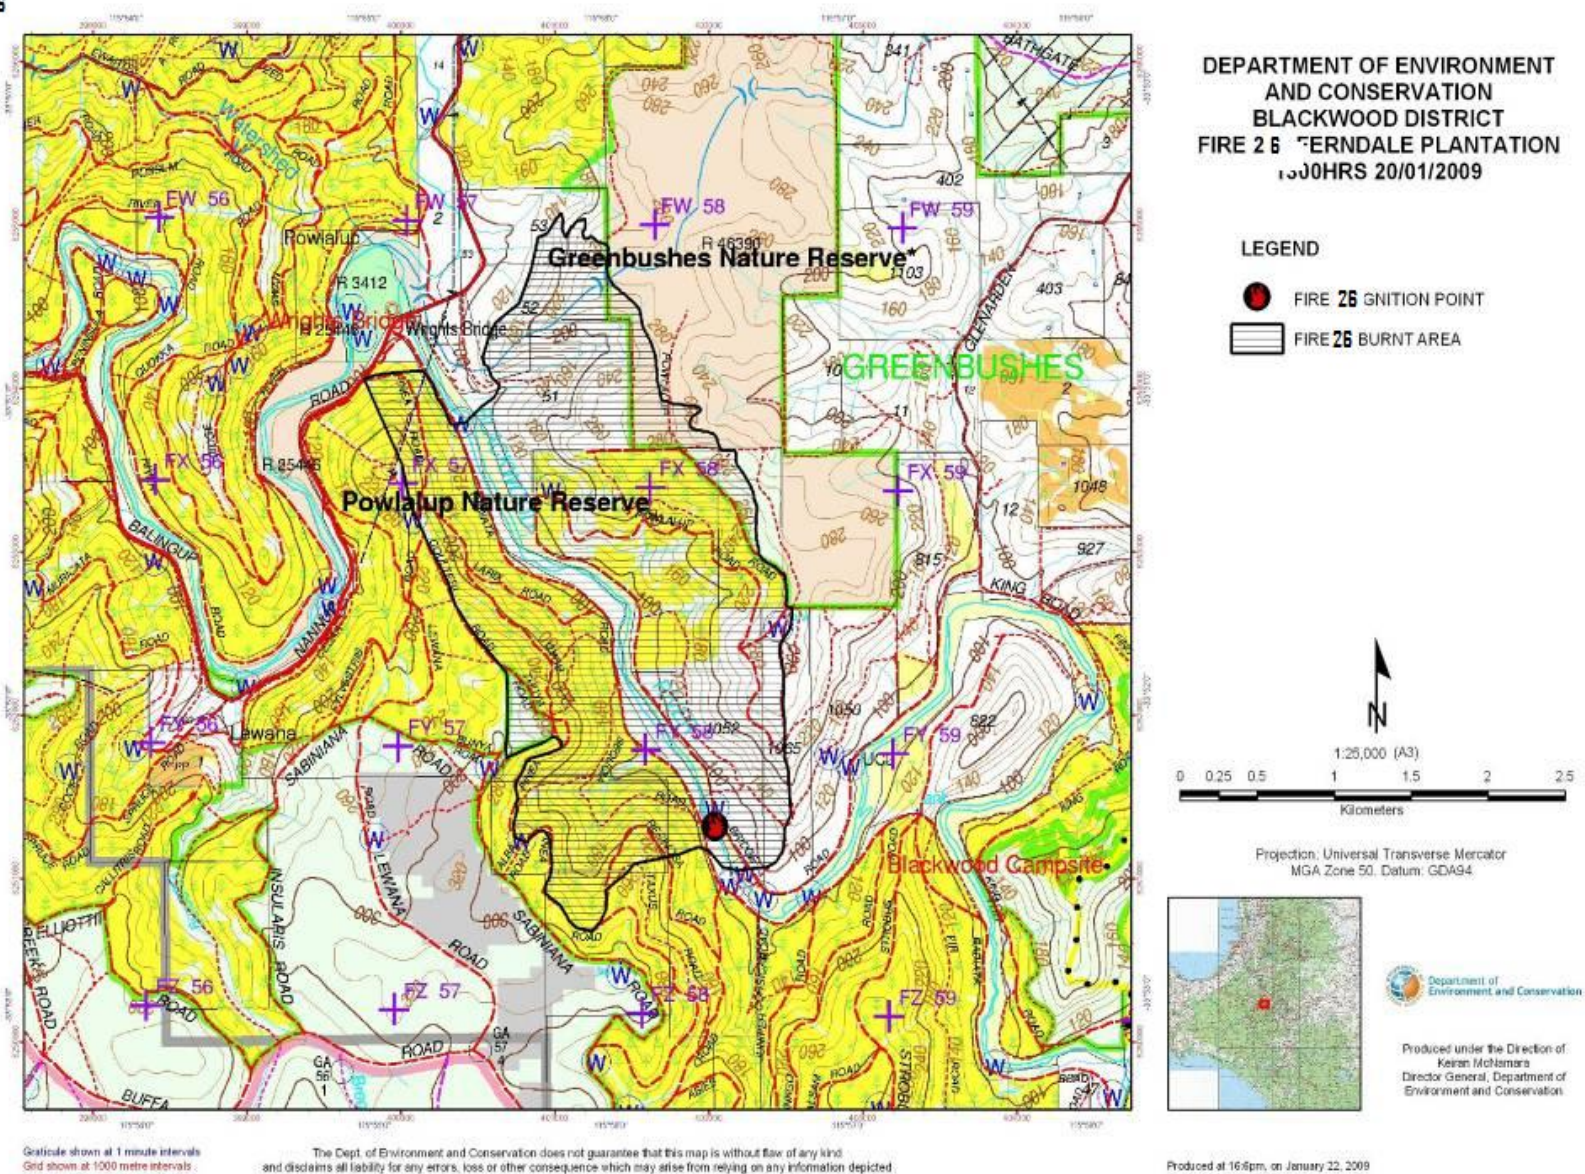
Figure 15. The final fire shape for Ferndale Fire 26

At 1255 on Monday 19<sup>th</sup> January 2009 a fire was reported by Styles Fire Tower and immediately confirmed by the Blackwood Spotter aircraft at Ferndale pine plantation SE of Wrights Bridge on the Blackwood River approximately 11 km south west of Balingup at Map Reference FY5822. This location was amended at 1305 hrs to FZ5838. This fire was designated Fire 26 – Ferndale (Figure 15).

The cause of the fire was determined to be deliberate arson with 9 distinct ignition points being located. The Police Arson Squad investigation determined that the arsonist set the fire some time during the previous evening (Sunday night) and that 7 of the 9 ignition points self extinguished during the night. Two ignitions continued to smoulder until flaming combustion occurred under the warmer and windier conditions present during the late morning.

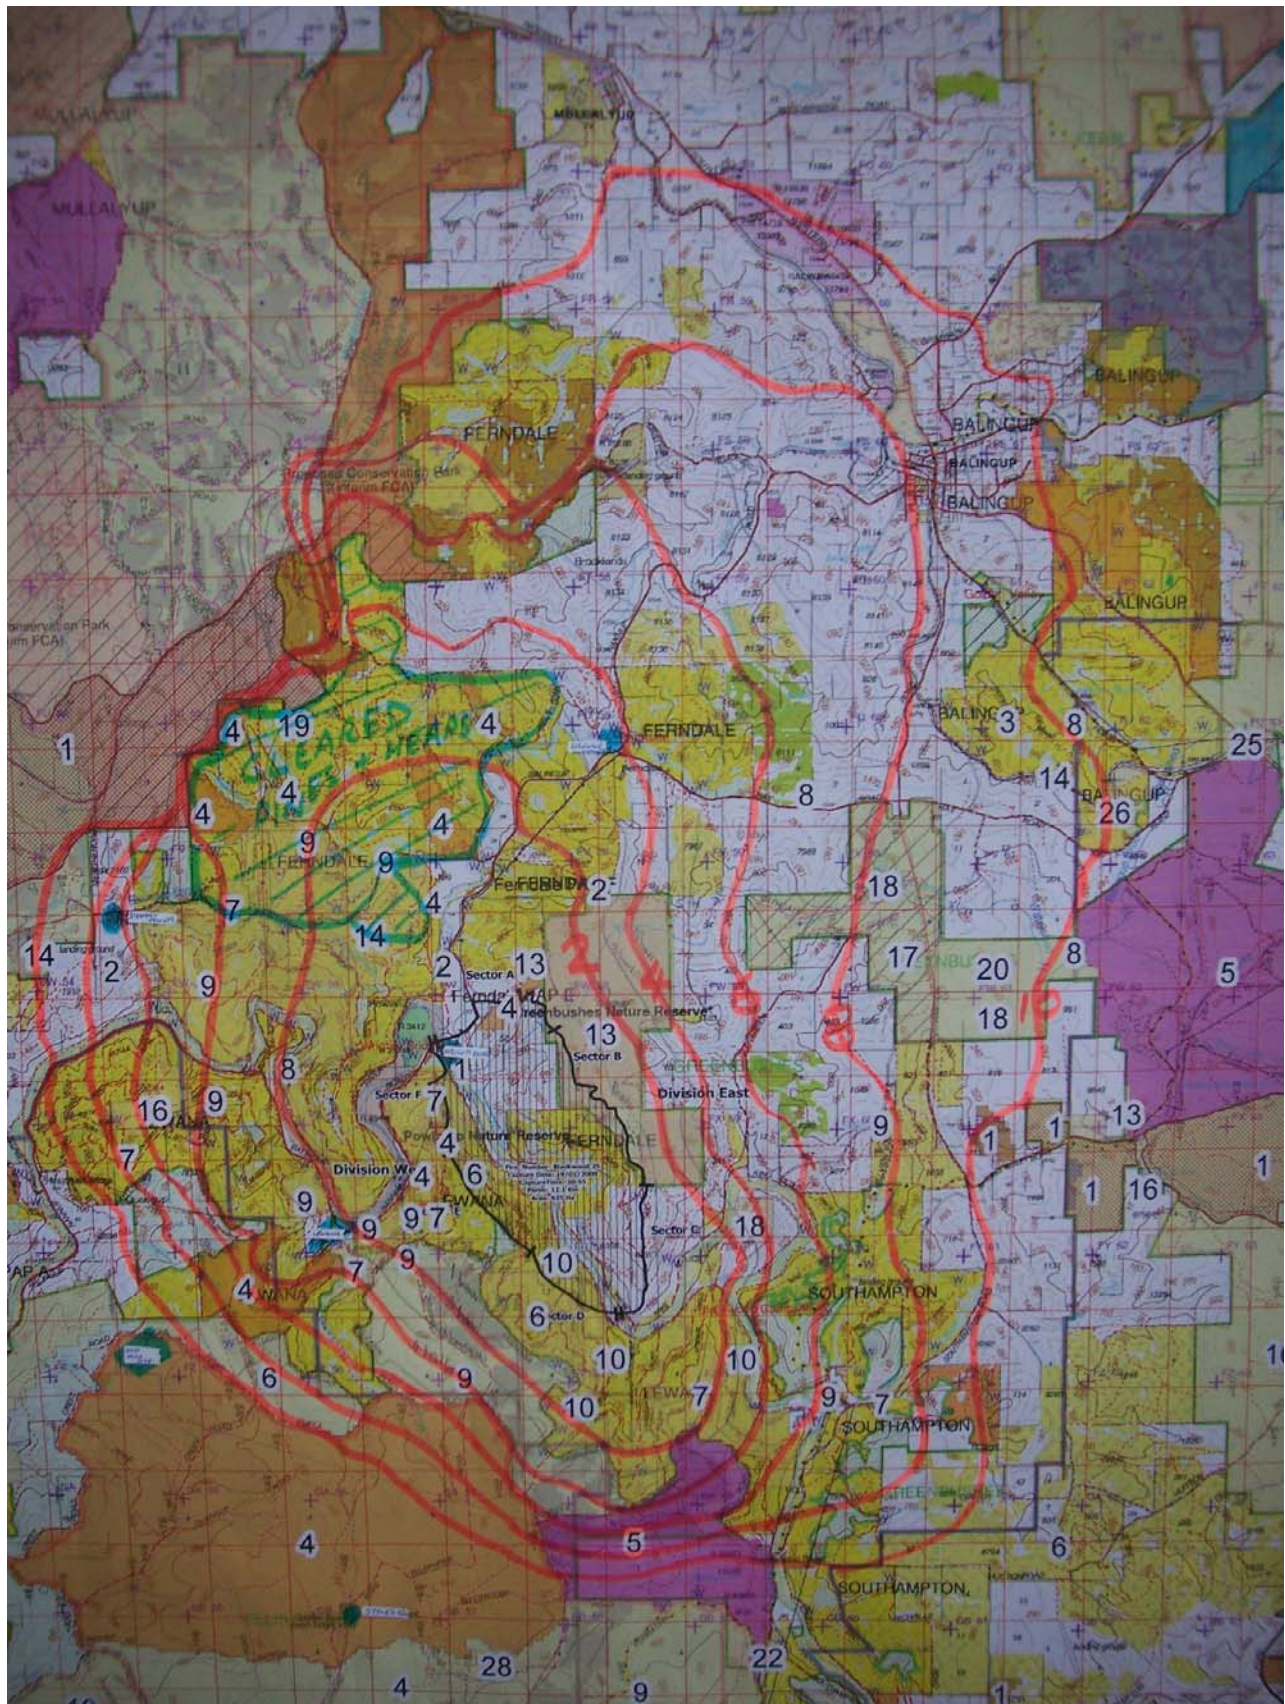
The fire had the potential to burn through private property to the NE containing many houses and outbuildings, pasture, plantations, horticultural crops and to impact the township of Balingup within six to eight hours (Figure 16).

Figure 16. Predicted spread of Ferndale Fire 26. Numbers show current fuel age in forest areas. Predicted fire boundary is shown at 2 hourly intervals. Note the retardation of headfire spread predicted for the strategically located one year old prescribed burn to the NW adjacent to Cundinup Rd.
