# **Restoring the Health of the Little River:**

**Riparian Survey and  
Management Recommendations  
for Repairing the Little River  
Catchment near Denmark, WA.**

by Apace Green Skills

December 1996

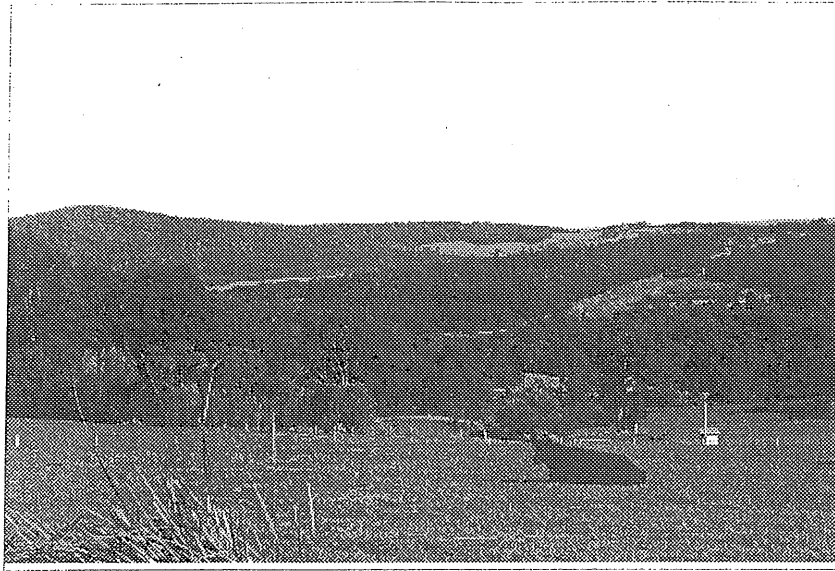
*General view over Little River Valley from Mt Shadforth Road, looking south, with Mt Hallowell in the background. Significant areas of high quality remnant forest remain in the catchment.*

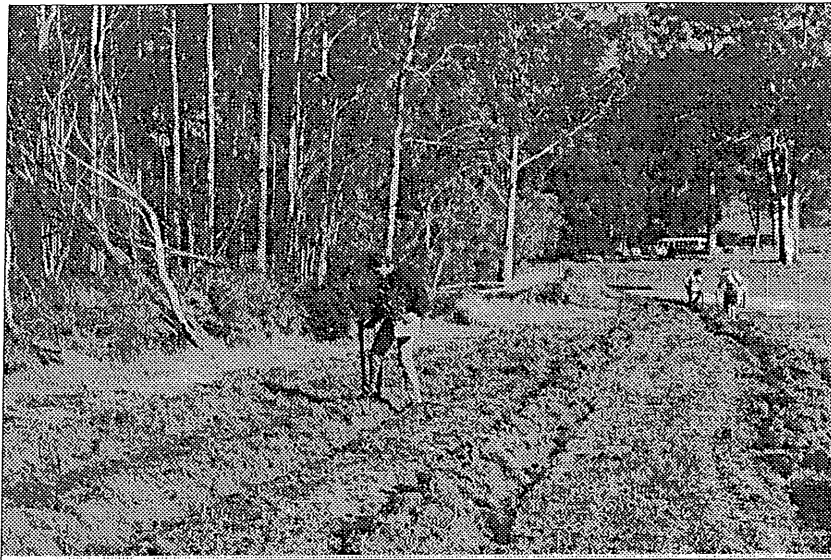
*Tree planting in progress on ripped, mounded and sprayed revegetation site next to the Little River, close to the Broken Bridge vineyard site (July 1994). Apace Green Skills and the Denmark Environment Centre established a range of native trees and shrubs on this site, including Karri (Eucalyptus diversicolor), Yate (Eucalyptus cornuta), Golden Wreath wattle (Acacia saligna) and WA Peppermint (Agonis flexuosa). Shire of Denmark fencing subsidies were used to assist the landholder with fencing material costs, and trees were provided through Greening Western Australia's Plants for Conservation Program.*

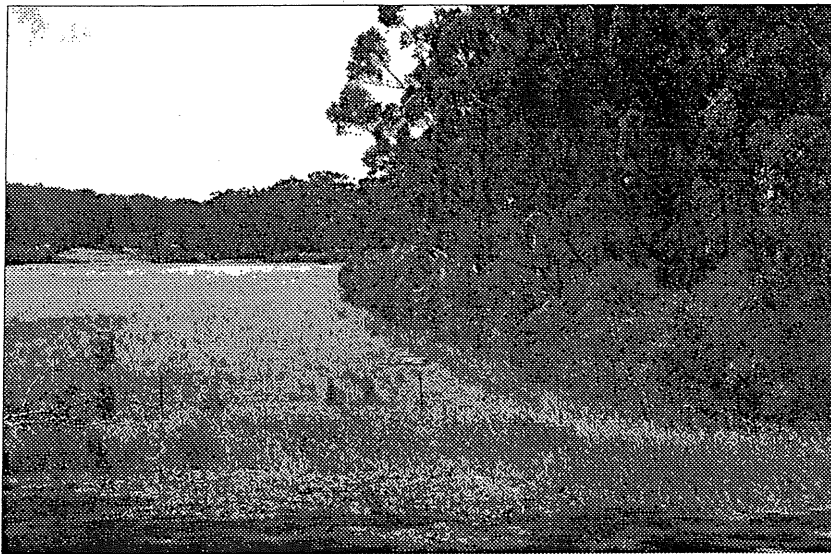
*The same site (from a different view), photographed 29 months later, showing successful survival and growth rates. (November 1996).*

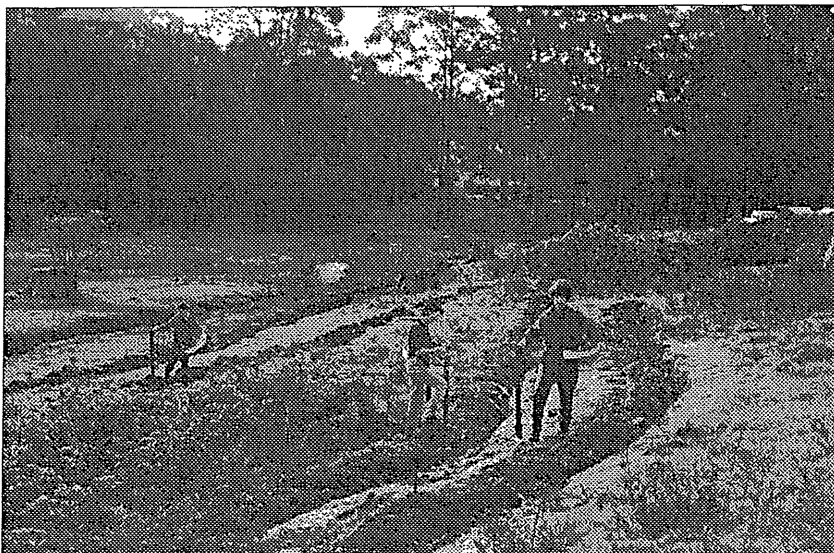
*Tree planting adjacent to Little River in July 1996, coordinated by Apace Green Skills, with assistance from the Shire of Denmark and Wilson Inlet Management Authority. This site provides a buffer between Broken Bridge vineyard and the river. A wide variety of local tree and shrub species, grown at the Shire revegetation nursery, was planted at that time.*

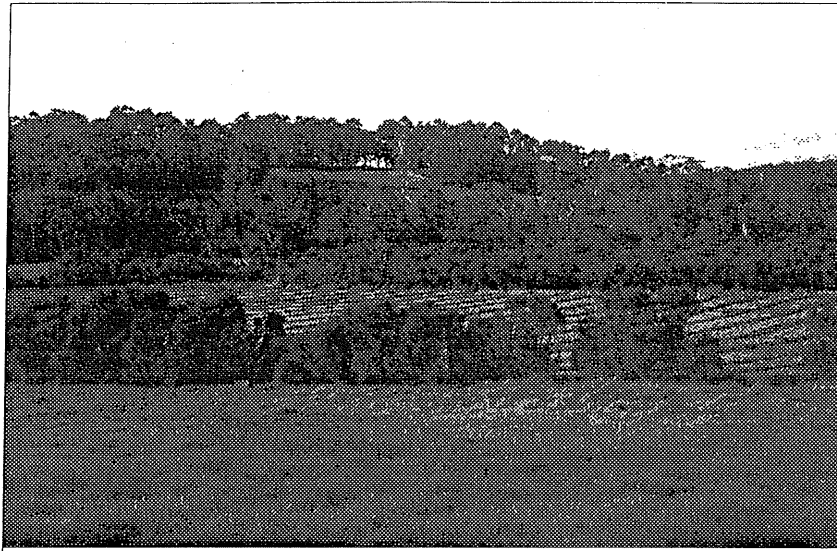
*Site preparation for plantation establishment beside the Little River, on a property on Wentworth Road. Planting took place in June 1994. A range of potential sawlog eucalypt species was planted on this site.*

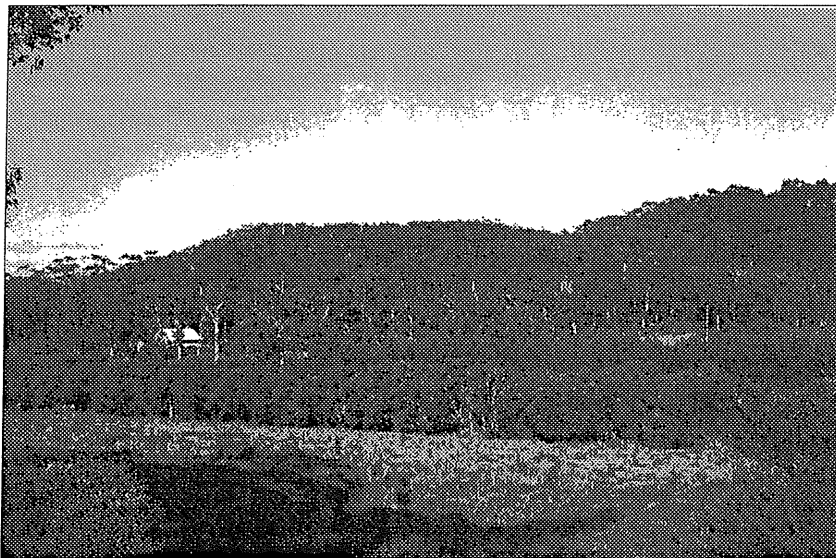
*The site, (from a slightly different view), two years later, showing successful establishment and rapid growth rates. Photograph taken in July 1996.*

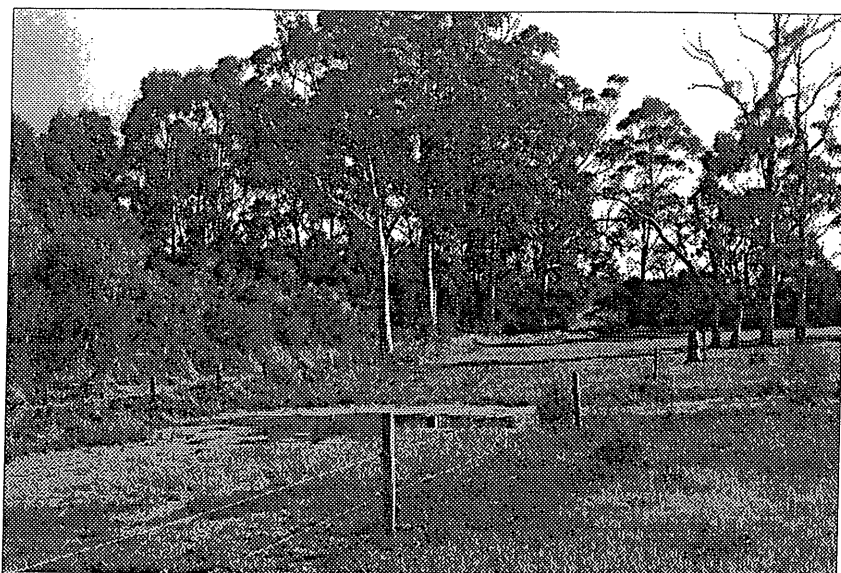
*Little river, with its narrow belt of fringing vegetation, and a small tributary, at the point where the river flows into a privately-owned bush block, adjacent to Ocean beach Road. This block performs a valuable bio-filter role.*

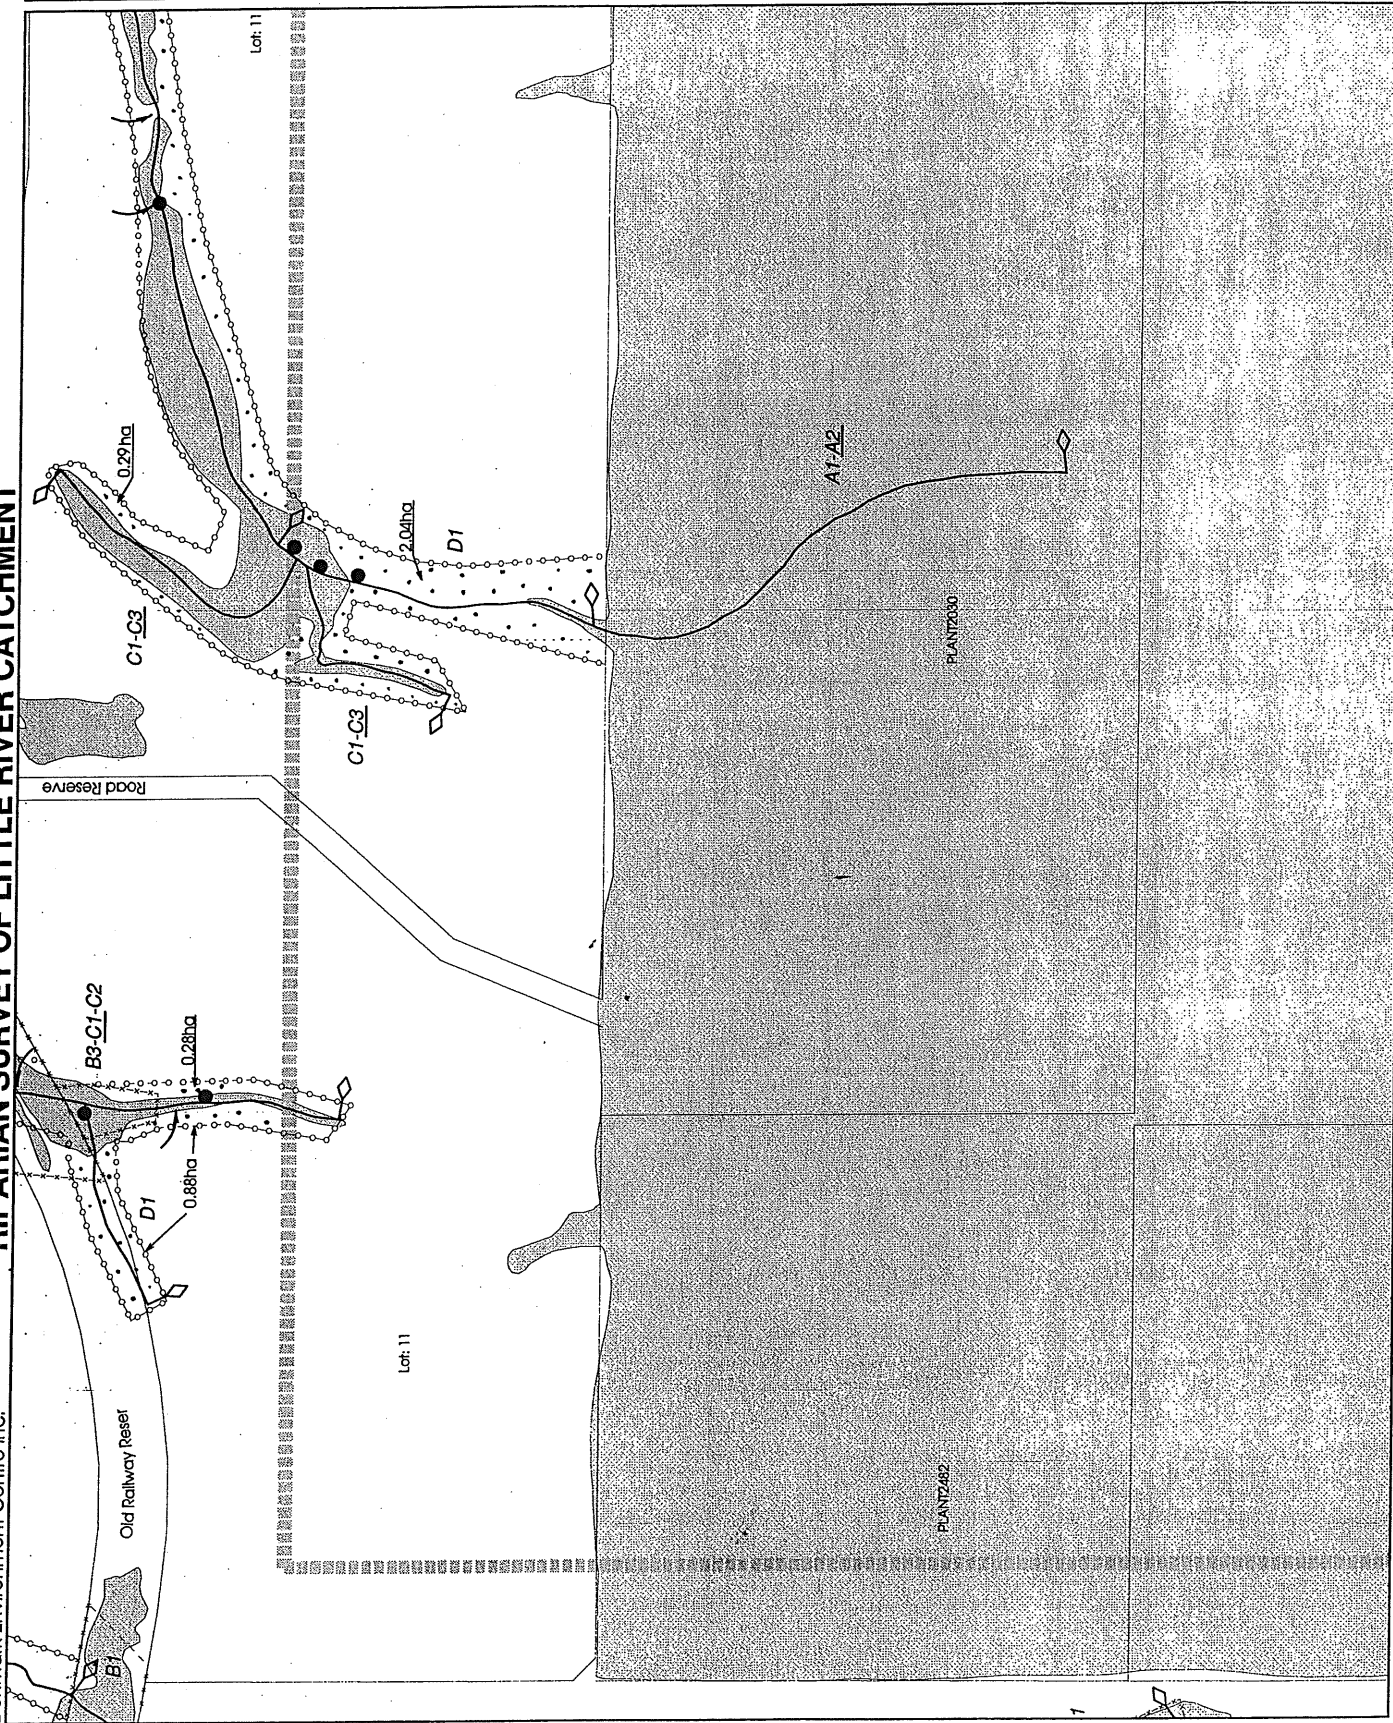
Loc. Numbers of Adjacent Properties: 402, 708, 403.

| | <b>Little River</b> | <b>Tributaries/Tributary</b> |
|---|---|---|
| Length of watercourse Fencing Recommended | N/A | 1975 Metres |

| | <b>Little River</b> | <b>Tributaries/Tributary</b> |
|---|---|---|
| Advice on remedial measures required for these sites | Recommendation:<br>N/A | Recommendation:<br>Exclude stock as soon as possible. Seek further on ground advice on how to rehabilitate. |
| Advice on Rehabilitation of these sites | Recommendation:<br>N/A | Recommendation:<br>Treat weeds in conjunction with watercourse rehabilitation work. |

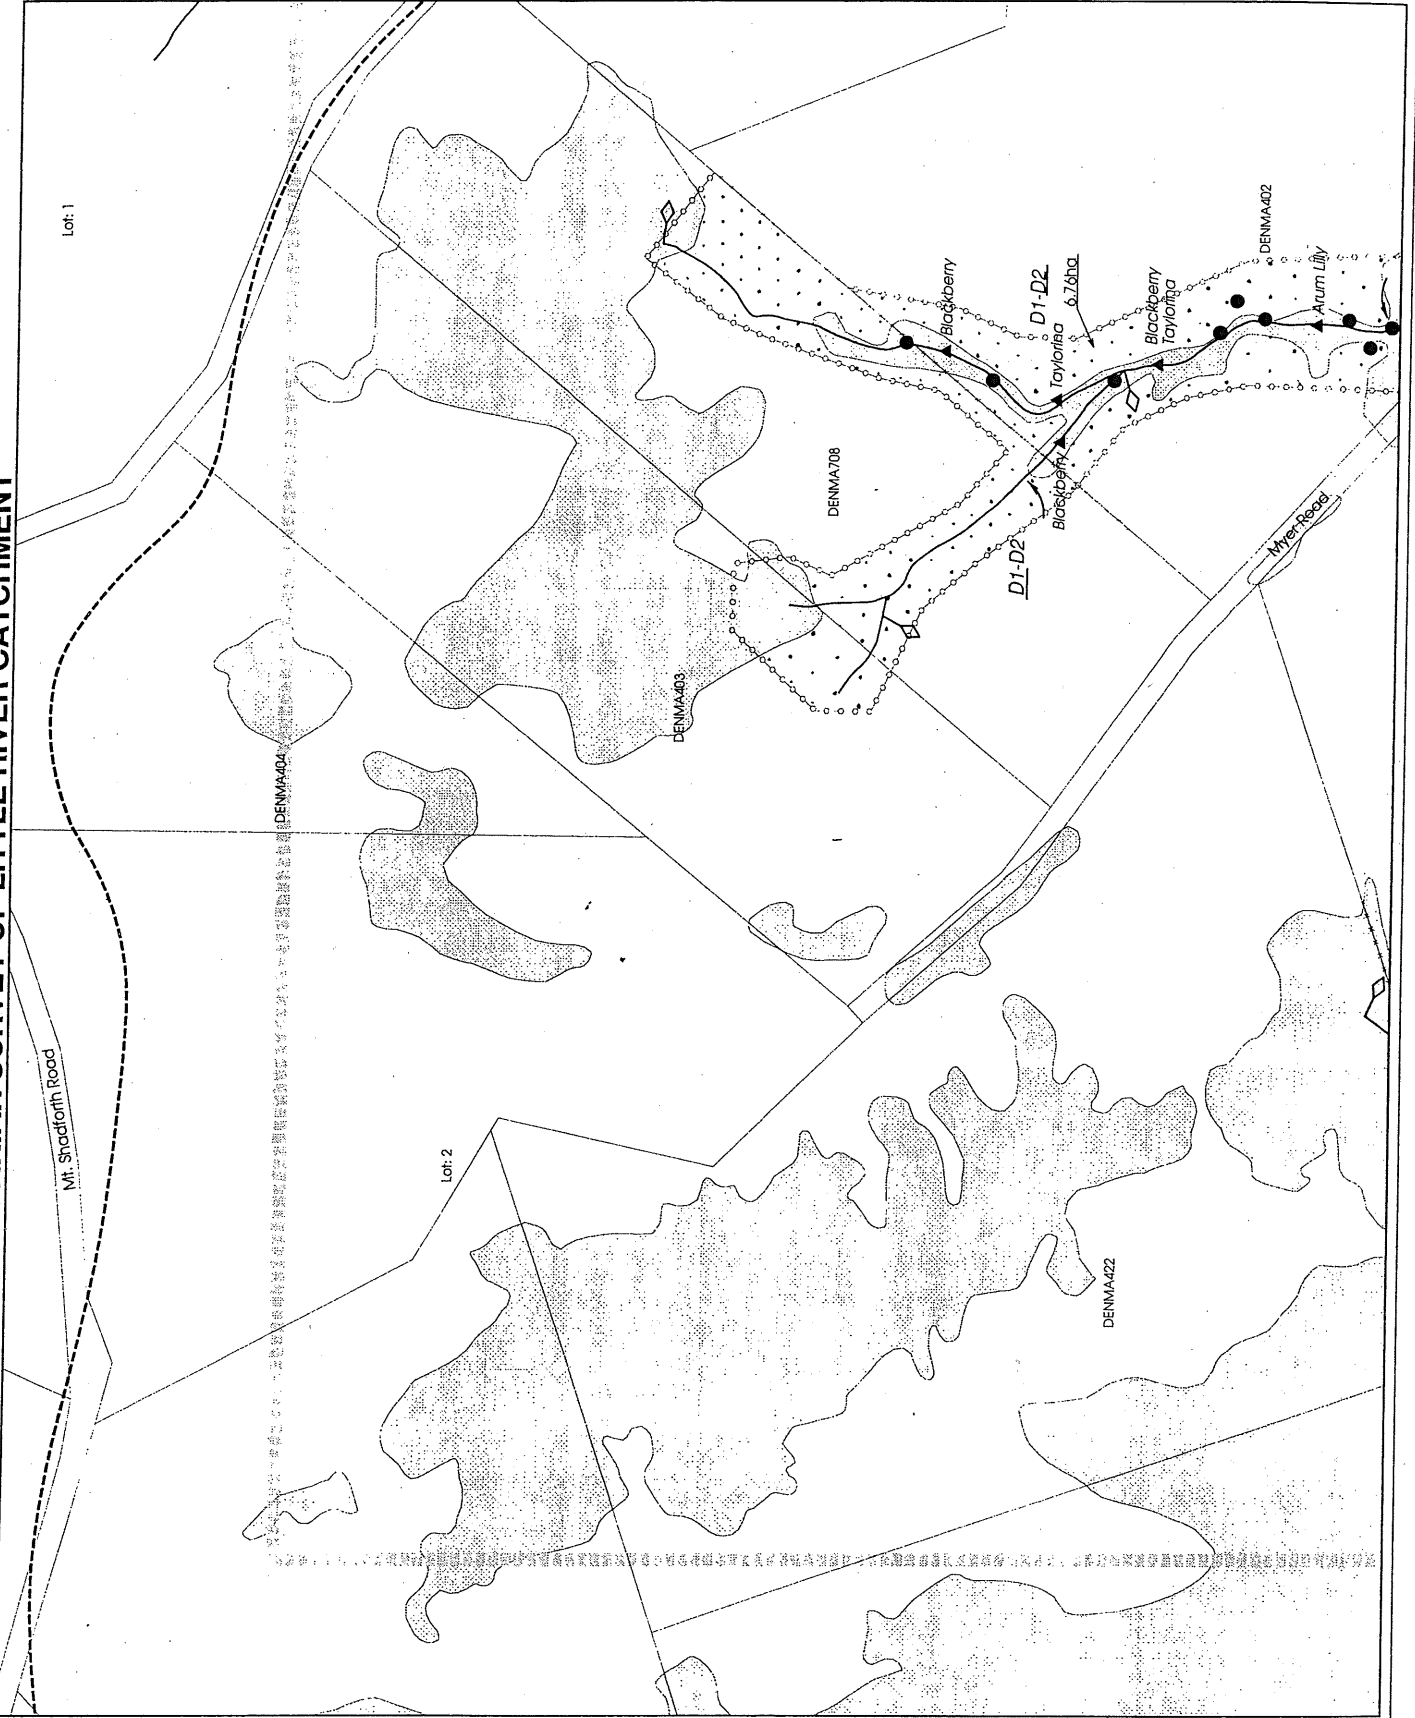
**LITTLE RIVER SURVEY- Map 18**

| | <b>Little River</b> | <b>Tributaries/Tributary</b> |
|---|---|---|
| Length of watercourse Fencing Recommended | 225 Metres<br>Comment: Nil | 3825 Metres<br>Comment: Includes relocating some existing fence. |

| | <b>Little River</b> | <b>Tributaries/Tributary</b> |
|---|---|---|
| Advice on remedial measures required for these sites | Recommendation:<br>Dam overflow channel needs a soft engineering solution to reduce erosion and allow for native fish migration upstream. For more details see report prepared by Angus MacKenzie (MacKenzie, 1996) for the Denmark Environment Centre | Recommendation:<br>Exclude stock from frequent use of crossing points. Brush, hand plant. Treat dam spill way and 3 eroding sections of channelised stream deepened with machinery, with soft engineering options (MacKenzie, 1996:6) |
| Advice on Rehabilitation of these sites | Recommendation:<br>N/A | Recommendation:<br>Treat weeds, allow natural regeneration. |

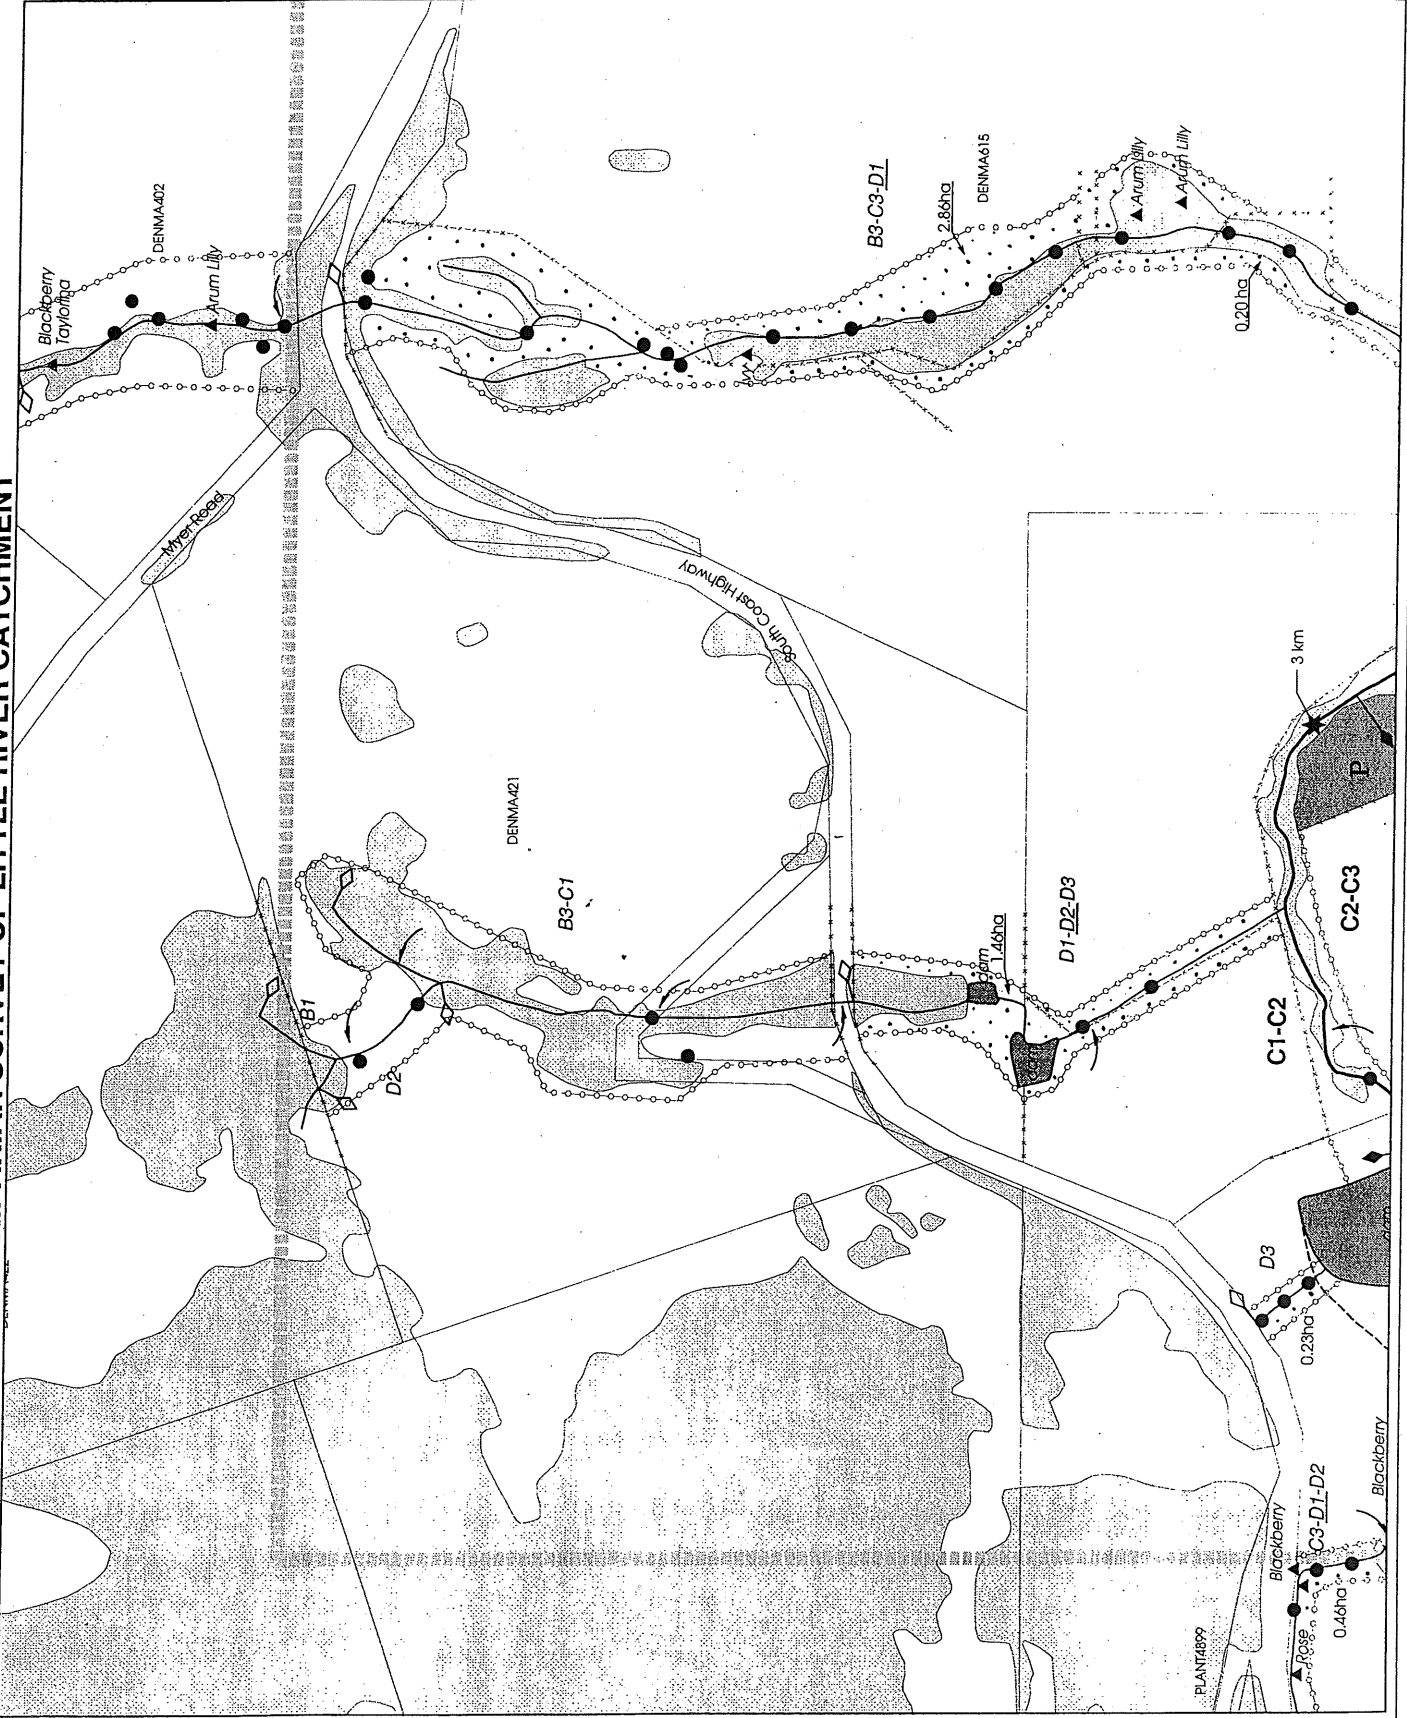
Loc. Numbers of Adjacent Properties: 1977, 615, lots 1, 10 & 11.

| | Little River | Tributaries/Tributary |
|---|---|---|
| Length of watercourse Fencing Recommended | 1,875 Metres<br>Comment: Includes relocating existing fence further out from channel. | 4,650 Metres<br>Comment: Includes relocating existing fence further out from channel. |

| | Little River | Tributaries/Tributary |
|---|---|---|
| Advice on remedial measures required for these sites | Recommendation:<br>Rehabilitation Treatment elsewhere in catchment should relieve erosive pressures on these sites. | Recommendation:<br>Exclude stock, brush, hand plant. |
| Advice on Rehabilitation of these sites | Recommendation:<br>Treat weeds, allow natural regeneration. | Recommendation:<br>N/A |

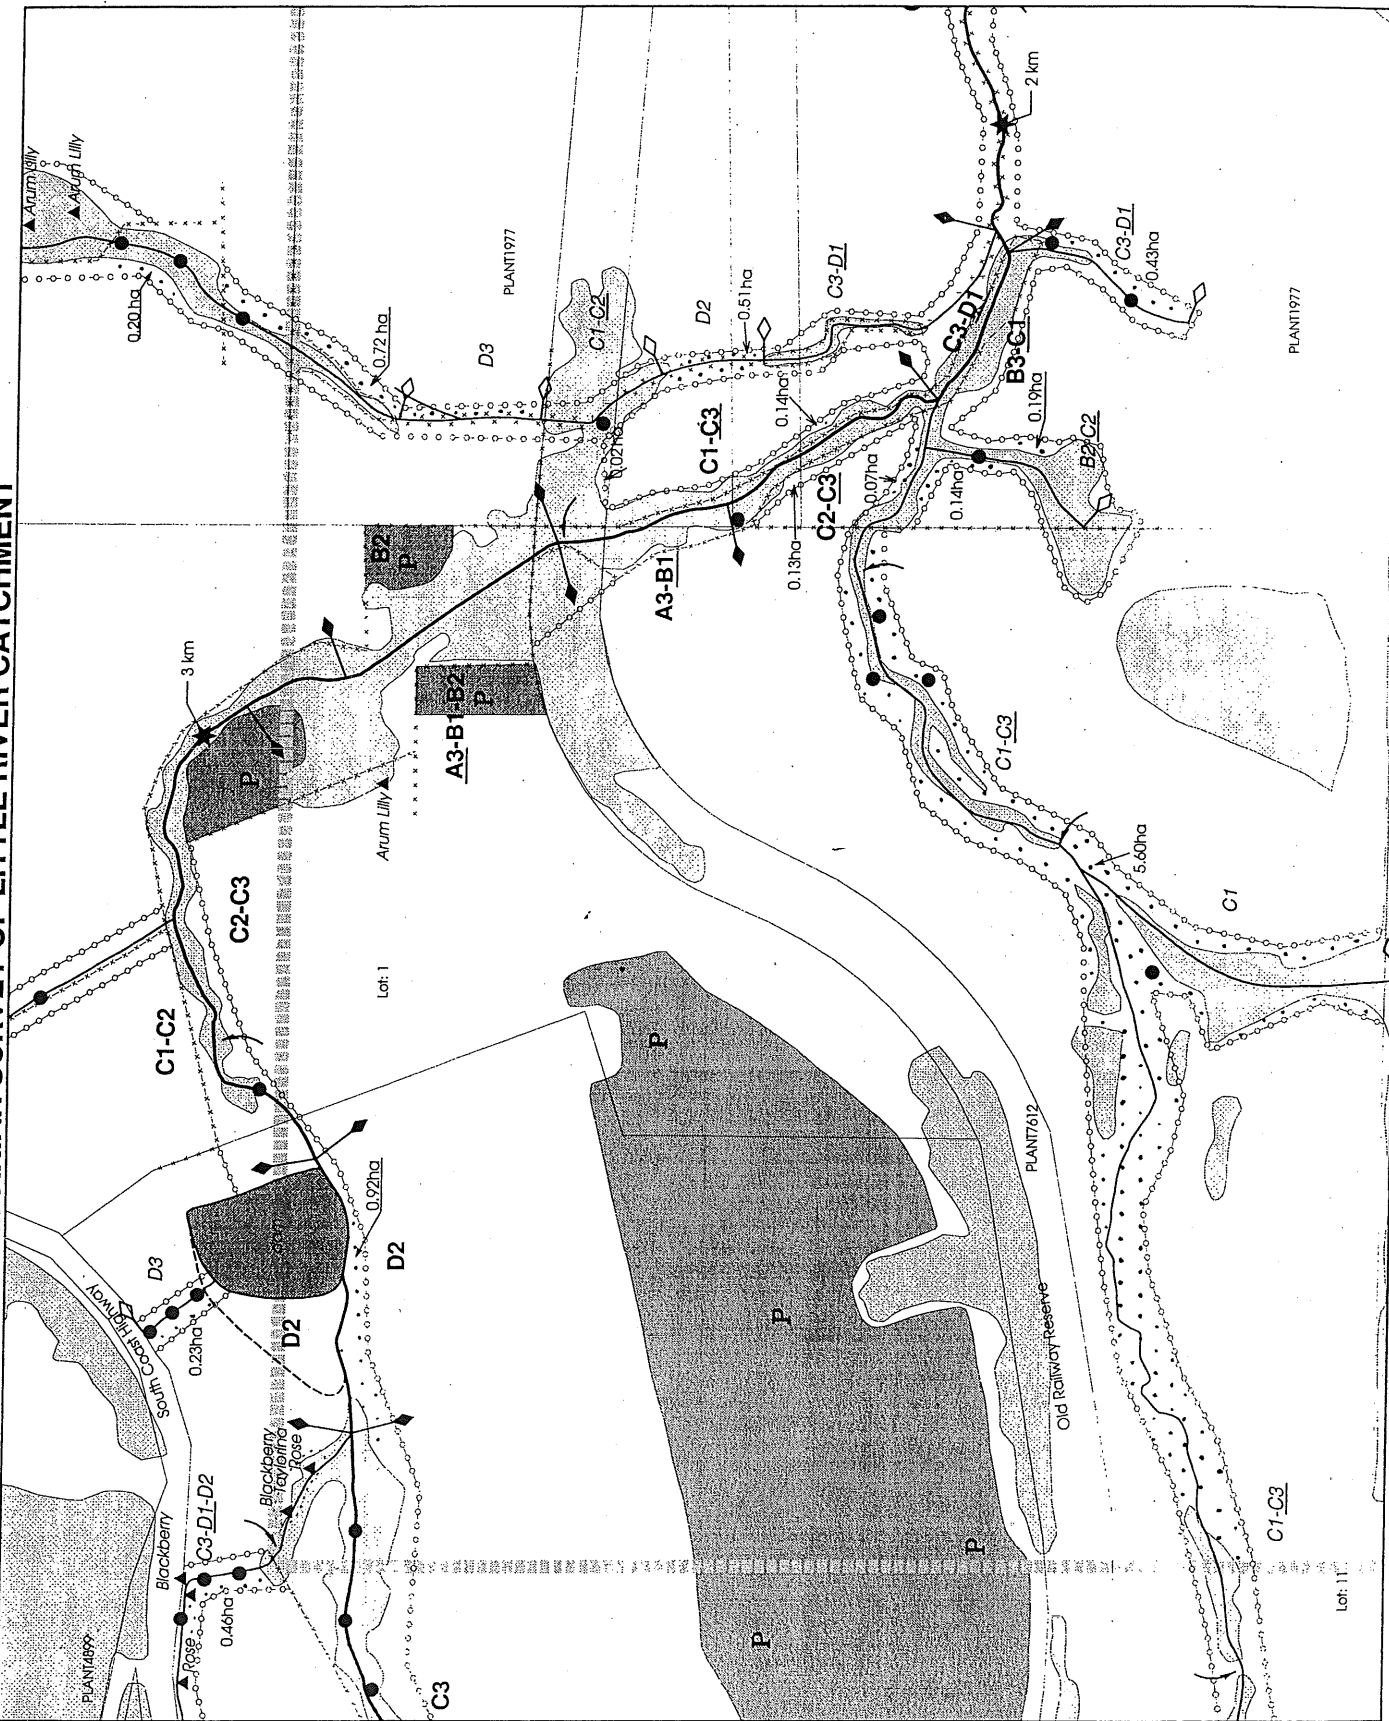
Loc. Numbers of Adjacent Properties: 2099, 616.

| | <b>Little River</b> | <b>Tributaries/Tributary</b> |
|---|---|---|
| Length of watercourse Fencing Recommended | N/A | 3025 Metres |

| | <b>Little River</b> | <b>Tributaries/Tributary</b> |
|---|---|---|
| Advice on remedial measures required for these sites | Recommendation:<br>N/A | Recommendation:<br>Exclude stock from frequent use of this crossing point. |
| Advice on Rehabilitation of these sites | Recommendation:<br>N/A | Recommendation:<br>Treat weeds, allow natural regeneration. |

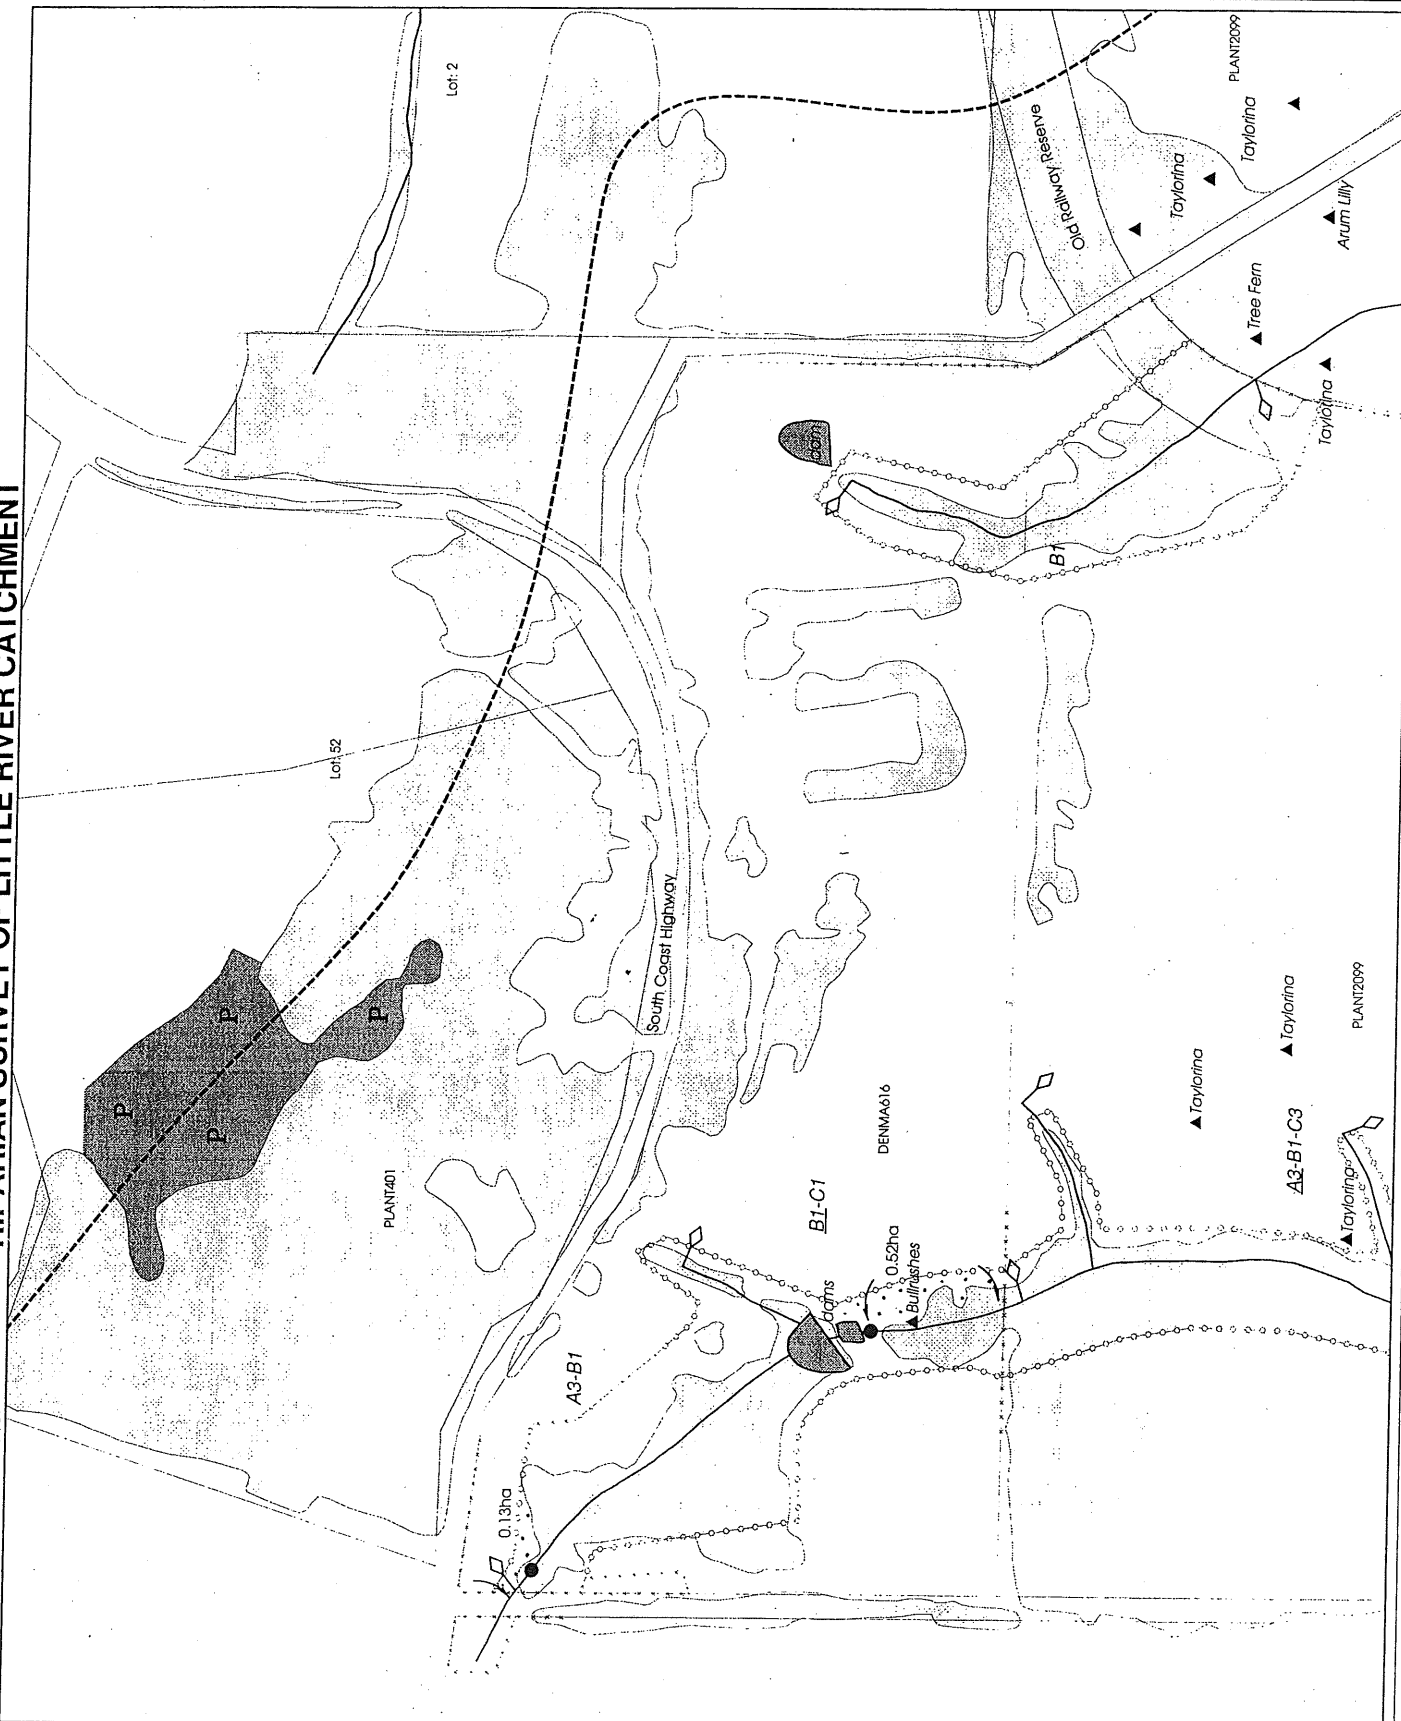
Loc. Numbers of Adjacent Properties: Lot 31, 2099, 2098, 1977.

| | Little River | Tributaries/Tributary |
|---|---|---|
| Length of watercourse Fencing Recommended | 1,600 metres<br>Comment: Includes relocating existing fence further out from channel. | 3,050 metres<br>Comment: Includes relocating existing fence on 'D' condition sections further out from channel. |

| | Little River | Tributaries/Tributary |
|---|---|---|
| Advice on remedial measures required for these sites | Recommendation:<br>Exclude stock from frequent use of these crossing points. | Recommendation:<br>Exclude stock from frequent use of these crossing points. |
| Advice on Rehabilitation of these sites | Recommendation:<br>Treat weeds, allow natural regeneration. | Recommendation:<br>Treat weeds, allow natural regeneration. |
