**THE CONDITION OF THE
KALGAN RIVER
FORESHORES 1992/93**

**Albany Waterways
Management Authority,
Oyster Harbour Catchment
Group and the Department of
Agriculture of WA**

**Waterways Commission
Report No 52
November 1994**

Dr Luke Pen

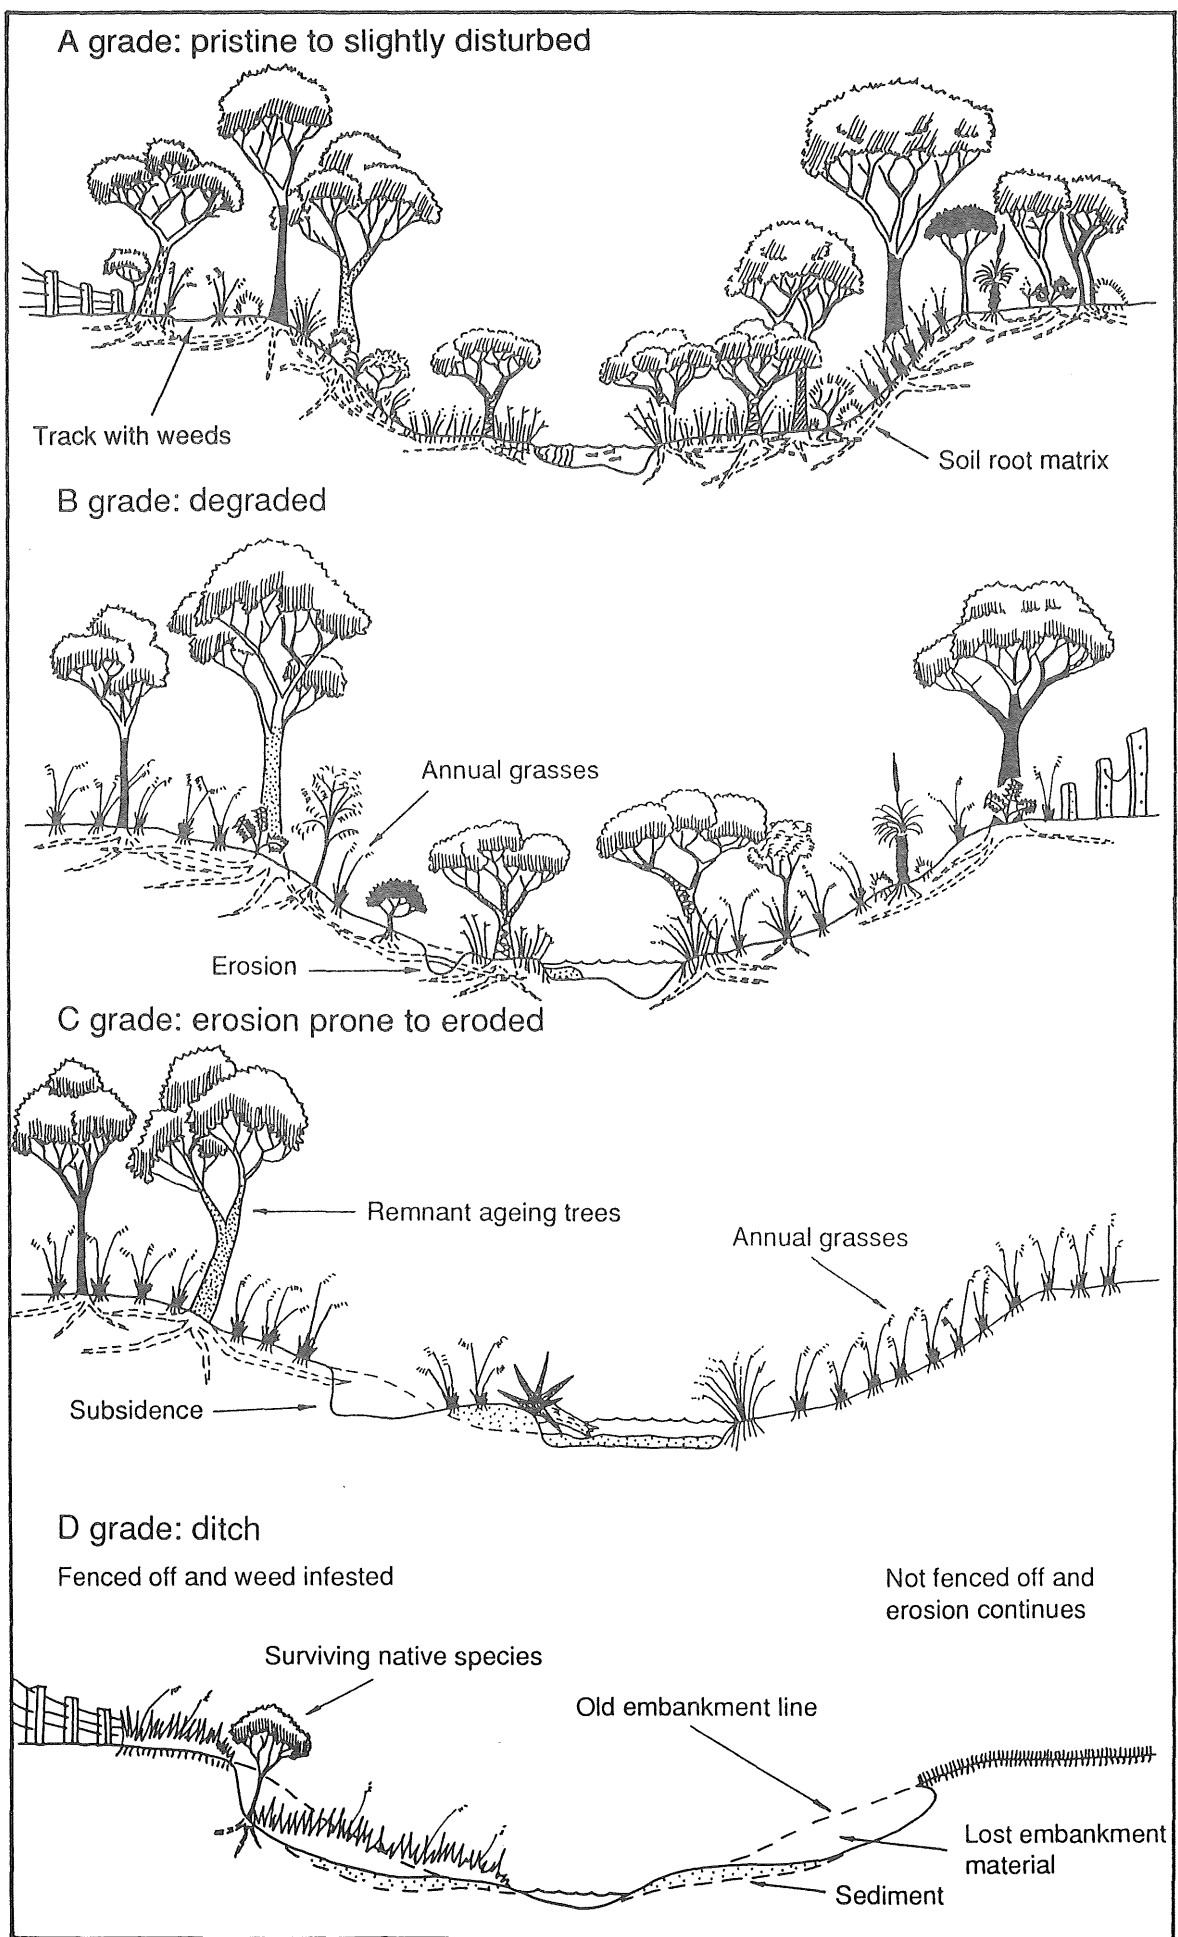
Figure 3.1: River foreshore condition divided into four stages or grades following the general process of river valley degradation, pristine river (A) to ditch (D).

No significant fringing vegetation remains and erosion is completely out of control (Fig. 3.1D). Undermined and subsided embankments are common, as are large sediment plumes along the river channel.

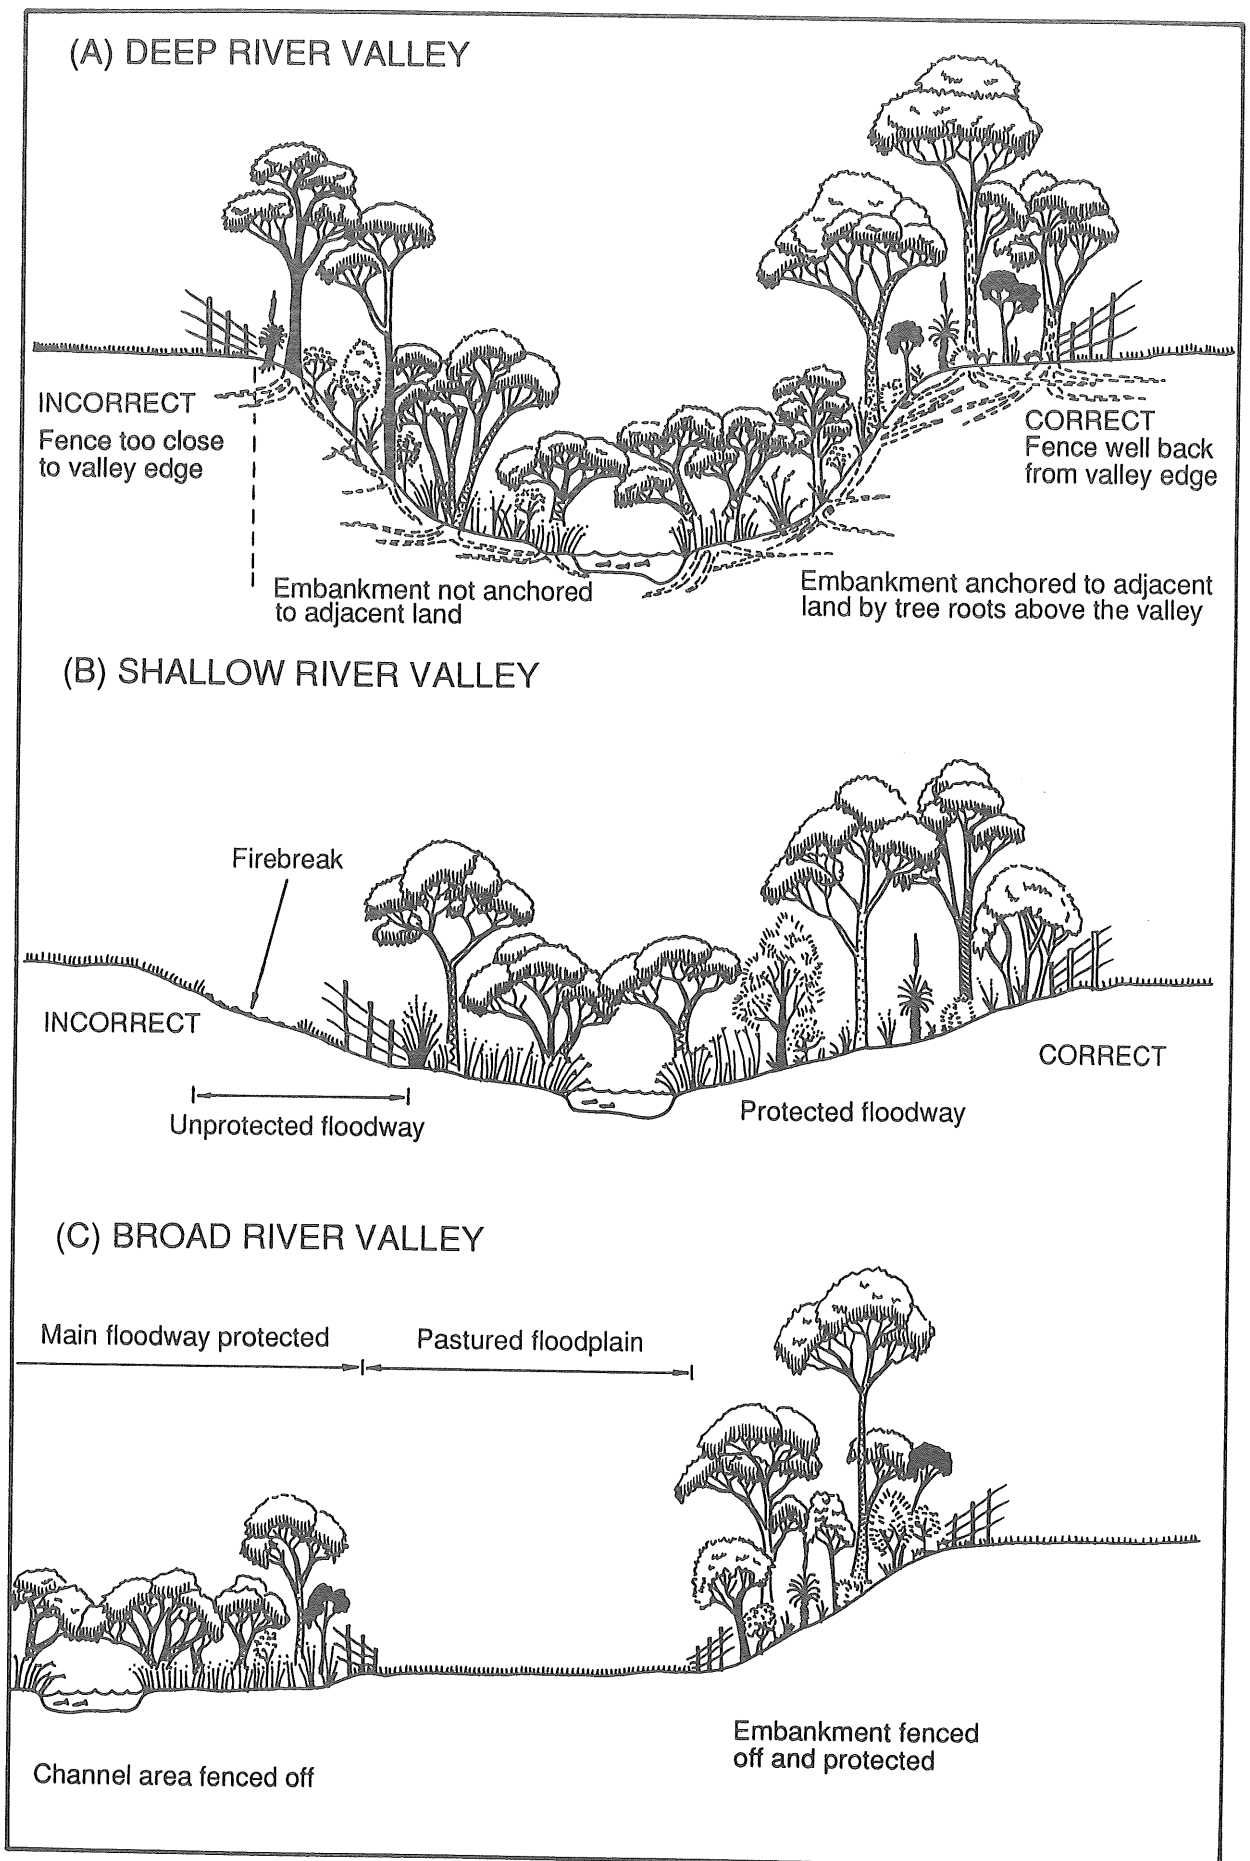
Figure 9.1: The correct and incorrect placement of fences in relation to the river valley: (A) the deep river valley, (B) the shallow river valley and (C) the broad river valley with broad floodplain.

Ideally, fences should be placed above the river valley (see Fig. 9.1). Depending on the steepness of the embankment, the fence should be placed 5m to 20m back from the edge of the river valley (Fig. 9.1A). Five metres is sufficient for a shallow valley a couple of metres deep but a broader zone, greater than ten metres, is required for valleys deeper than five metres. The purpose of fencing off the shoulders of the river is to enable trees on the upper part of the embankment and those above the river valley to anchor the embankments to the adjacent, land and thereby prevent subsidence. It should be mentioned that while much of the Kalgan River is fenced off, many fences are inappropriately placed to provide maximum support against subsidence.

In the case of shallow river valleys, there is little chance that embankments will subside. Nevertheless, fencelines should be located above the river valley (Fig. 9.1B). This is because fences and firebreaks located within the river valley will be damaged and eroded by floodwaters. As mentioned in Chapter 6.4, firebreak washouts can be very severe and contribute large quantities of sediment to the river system.

To protect riverine fringing vegetation and thereby maintain its biofiltering and erosion control functions, fencelines should be located above the river valley and, in the case of steep valley embankments, well above it.
