SURVEY OF RIVER FORESHORES  
IN THE  
OYSTER HARBOUR CATCHMENT  
1997

WATER AND RIVERS COMMISSION REPORT WRT 17  
1997

To assist with the process of catchment repair, the Albany Waterways Management Authority commissioned APACE Green Skills to carry out a survey to assess the condition of selected foreshores of some of the Oyster Harbour Catchment's tributaries. The survey commenced in February 1997 and concluded in May 1997.

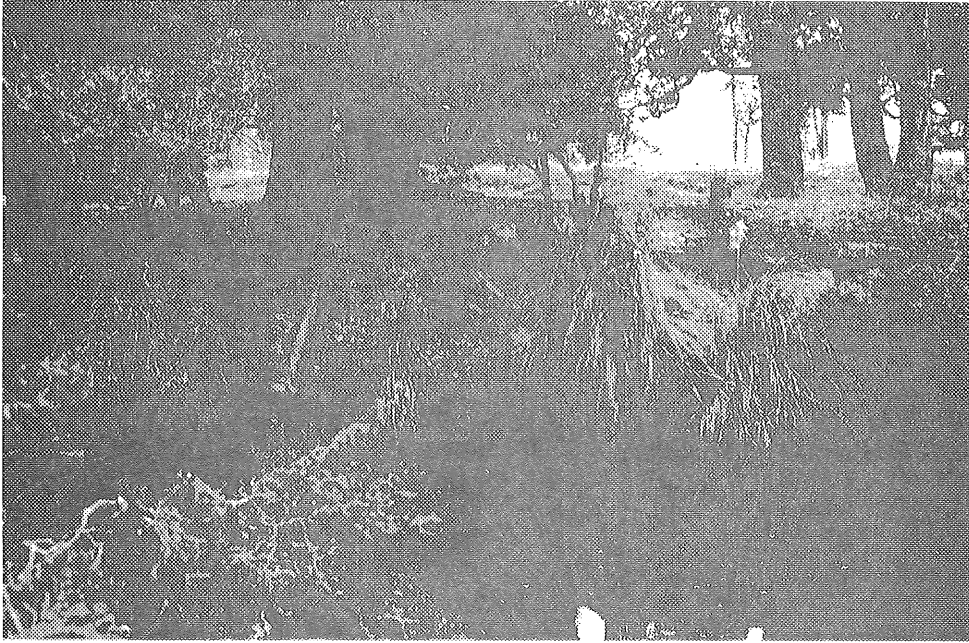
*C3 Grade Foreshore along the King River, showing bank slumping, and the pampas grass. Fencing off the river, careful weed control and revegetation would assist with preventing further erosion.*

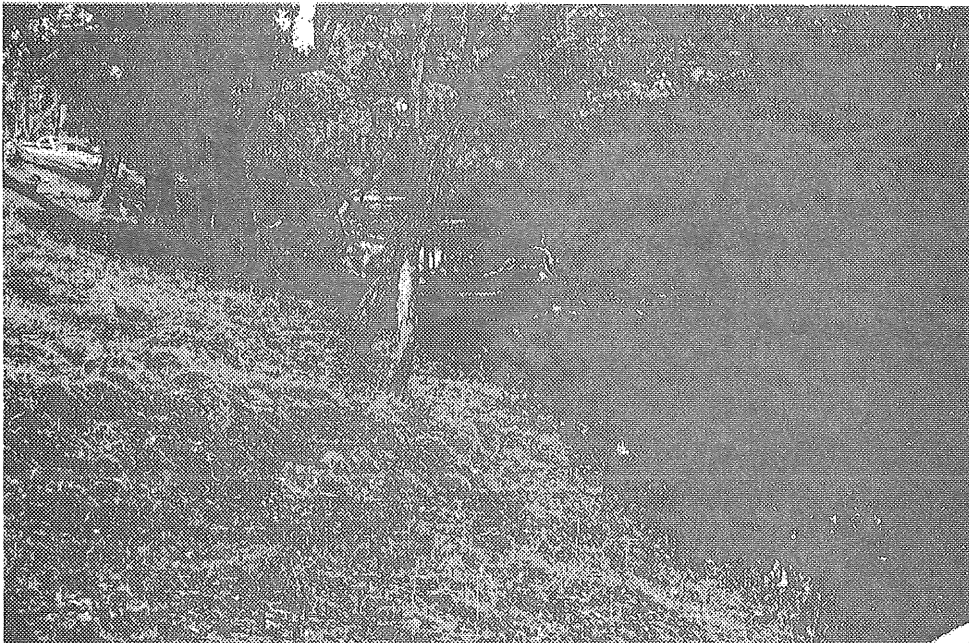
*C1 Grade (left bank) and A2 grade (right bank) along the Napier Creek. Regeneration of remnant vegetation on left bank will not be possible without total exclusion of stock.*

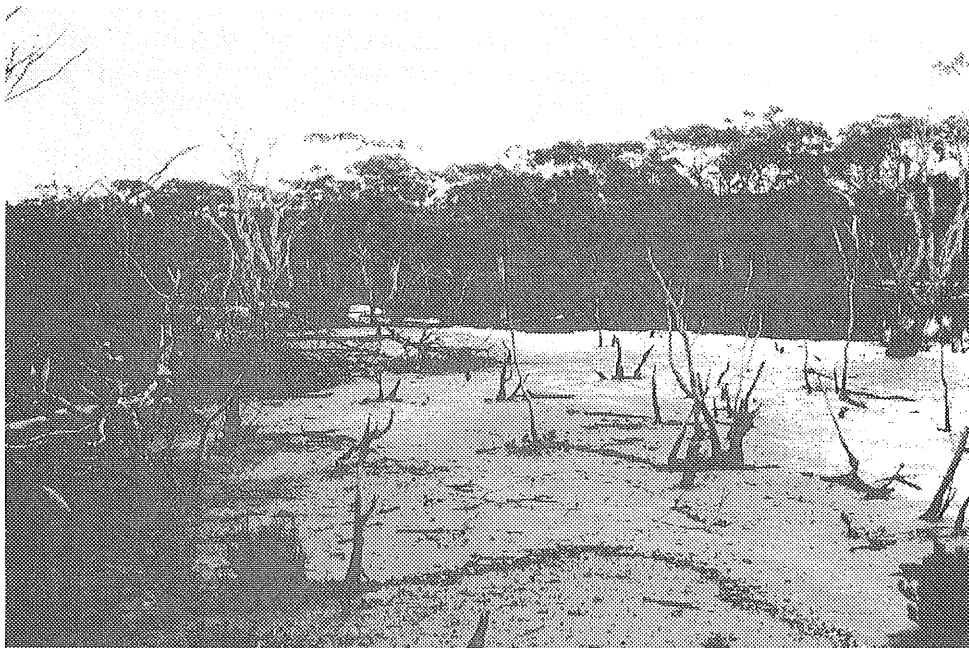
*Unfenced and salt affected C3 section (left bank) and fenced A2 section (right bank) of the Boonawarrup Creek.*

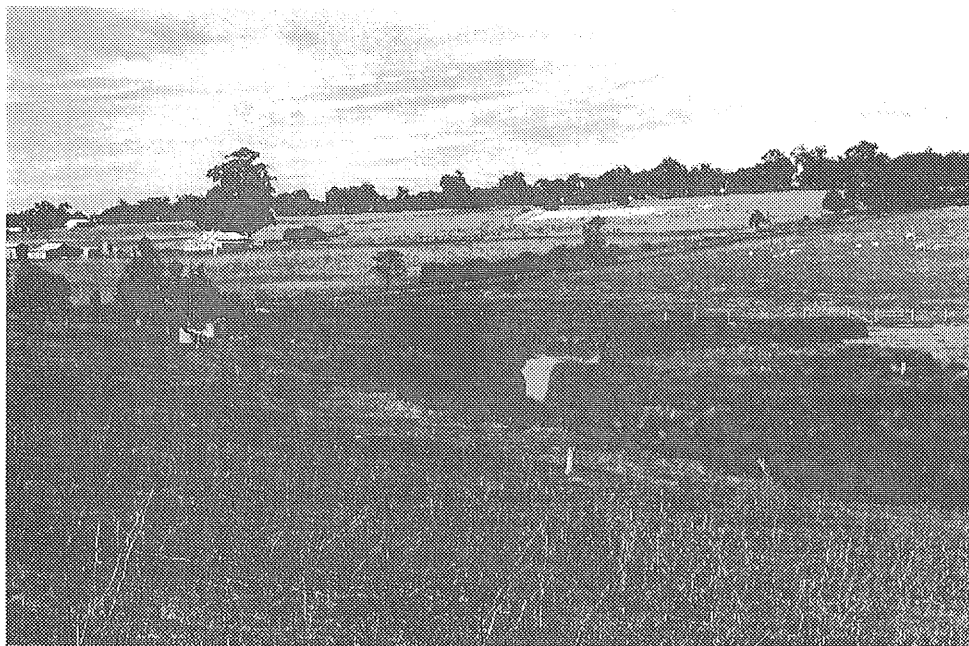
*C1 foreshores along the Upper Kalgan valley. Fencing and planting of local trees and shrubs would assist with providing a more effective riparian buffer along this waterway.*

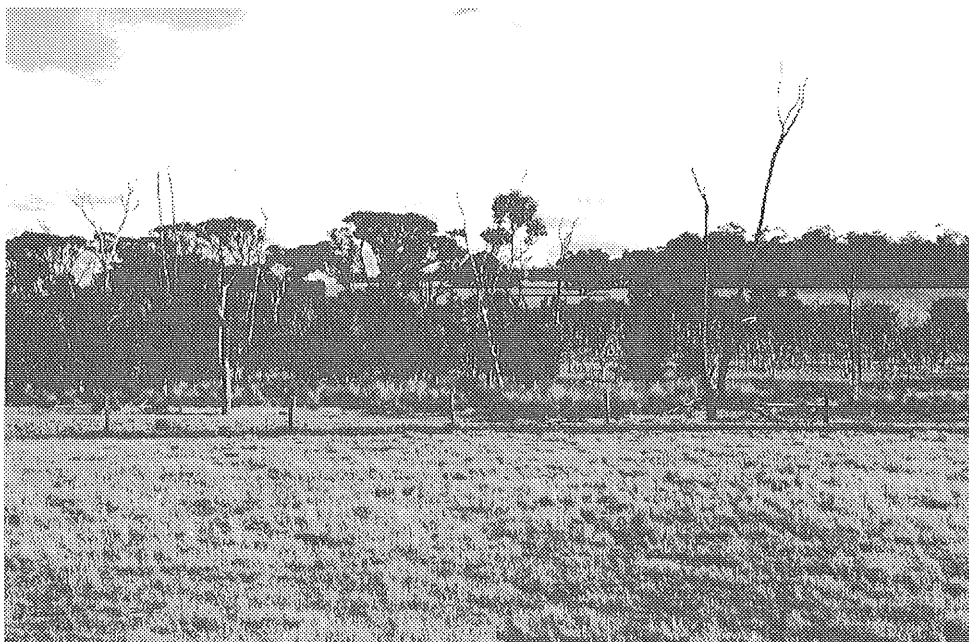
*Healthy and salt-affected remnant vegetation areas along the Upper Kalgan valley.*

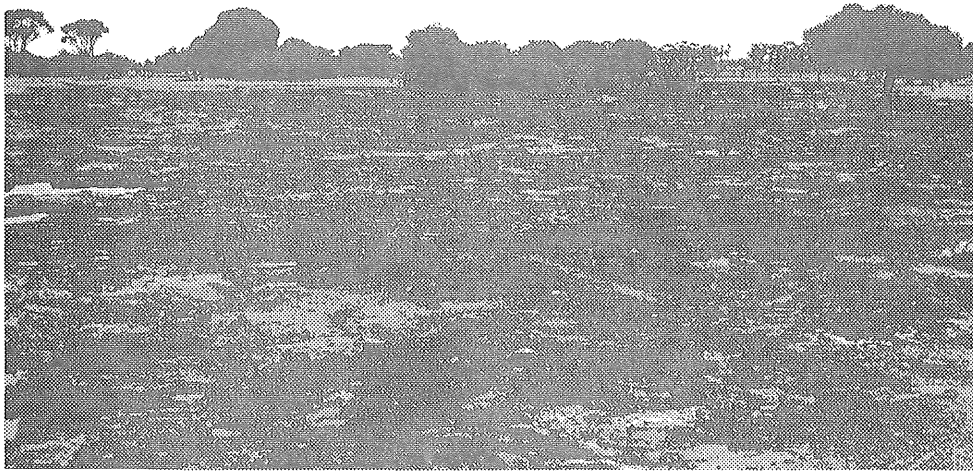
*Eroded floodway along the Stoney Creek. Rehabilitation work would involve fencing the area from stock, direct seeding, brushing and planting out seedlings of local species.*

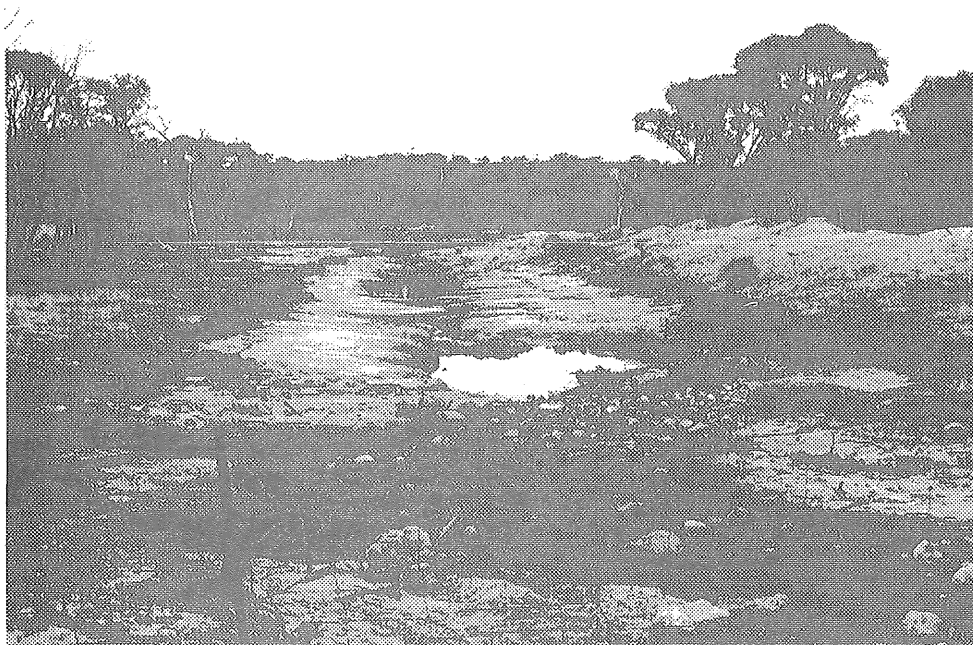
*Eroded and excavated section of the Stoney Creek affected by salinisation. D2 Foreshore. Such drainage works can increase sediment and nutrient loss, if vegetation cover is sparse.*

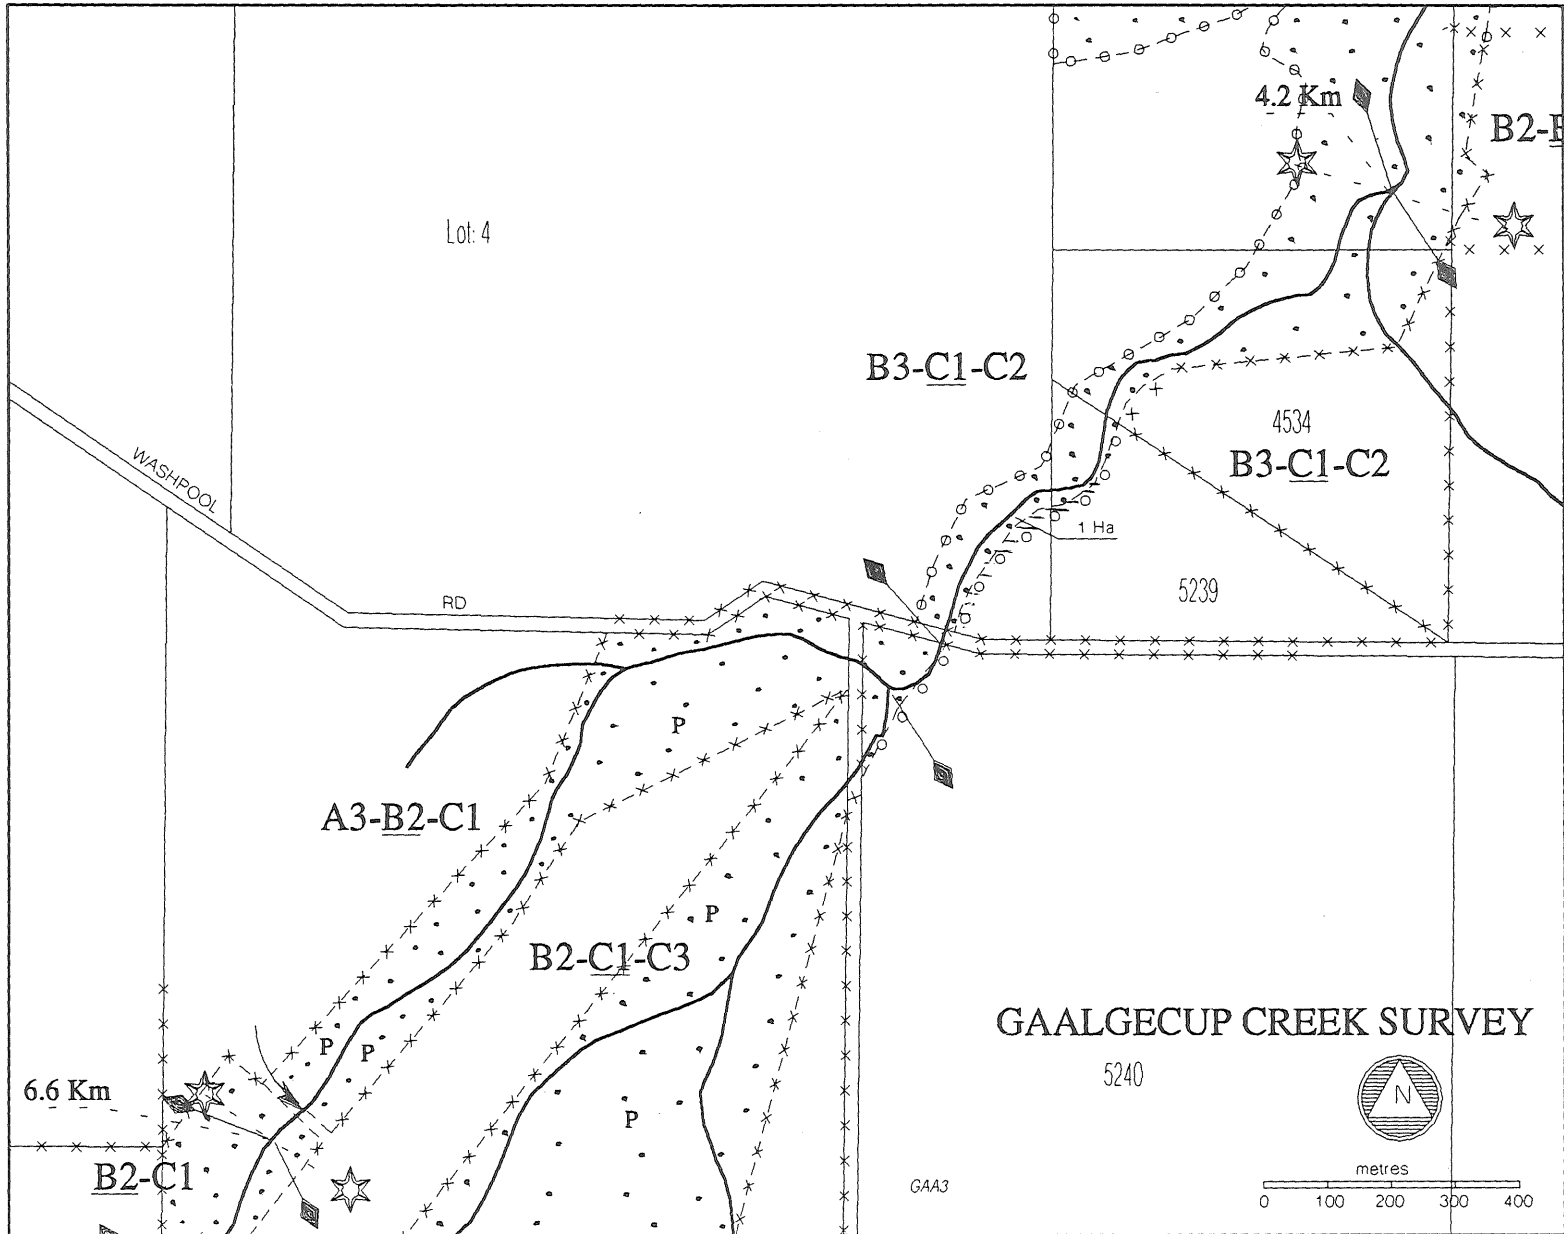
Left Bank	Right Bank
Length of Riverbank Fencing In Place :	1.7km	1.4km
Length of Riverbank Fencing Recommended :	500m	1km
Number of Sites showing severe erosion :	Most of main river channel is eroded.	Most of main river channel is eroded.
Advice on remedial measures required for these sites :	Exclude stock by fencing, replant/direct seed.	Exclude stock by fencing, replant/direct seed.
No. of sites and cumulative approximate area of these sites along riverbank requiring riverbank revegetation work :	No. of sites : 1	No. of sites : Nil
	Priority Urgent	Priority N/A
	Area (ha) : 1ha	Area (ha) :
Advice on revegetation species and preparation :	Select revegetation species from appropriate section of Appendix 1 of this report, including the following existing site Species: <i>E.rudis</i> , <i>E.decipiens</i> , <i>E.occidentalis</i> , <i>M.cuticularis</i> , <i>A.saligna</i> , rip and mound parallel with river. Scarify exposed areas and direct seed with samphire sp. and salt bush.

Number of other sites requiring rehabilitation work (ie serious weed infestations) :	Nil	Nil
Advice on rehabilitation of these sites :	N/A	N/A
Other management advice for this section :	Stabilise stock access to creek, or provide alternative nearby water source such as trough.	Stabilise stock access to creek, or provide alternative nearby water source such as trough.

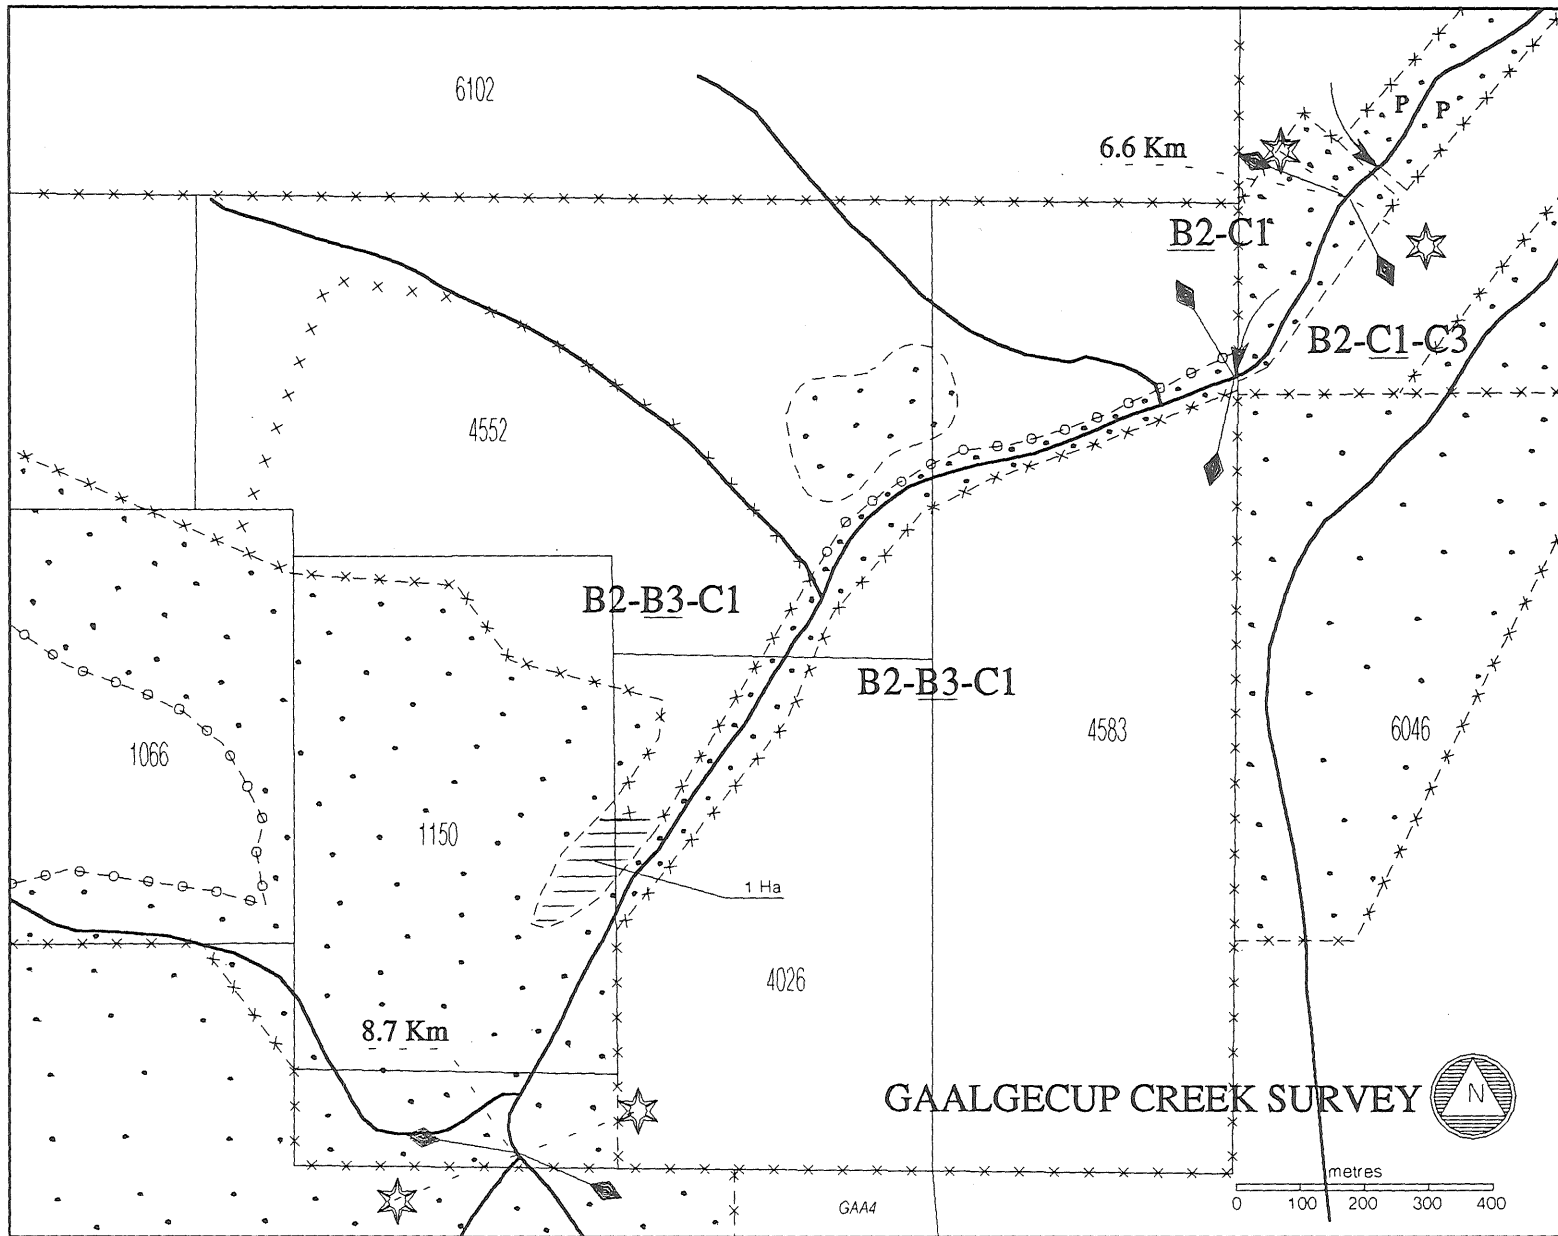
**GAALGEGUP CREEK SURVEY -GAAL4 See Map 1.2 (pg.4) for location**

Left Bank	Right Bank
Length of Riverbank Fencing In Place :	2.1km	1.35km
Length of Riverbank Fencing Recommended :	Nil	750m
Number of Sites showing severe erosion :	Most of main river channel is eroded.	Most of main river channel is eroded.
Advice on remedial measures required for these sites :	Exclude stock by fencing, replant/direct seed.	Exclude stock by fencing, replant/direct seed.
No. of sites and cumulative approximate area of these sites along riverbank requiring riverbank revegetation work :	No. of sites : Nil	No. of sites : 1
	Priority N/A	Priority Urgent
	Area (ha) :	Area (ha) : 1ha
Advice on revegetation species and preparation :		Select revegetation species from appropriate section of Appendix 1 of this report, including the following existing site Species: <i>E.rudis</i> , <i>E.decipiens</i> , <i>E.occidentalis</i> , <i>M.cuticularis</i> . Rip and mound parallel with river. Scarify exposed areas and direct seed with samphire sp. and salt bush.

Number of other sites requiring rehabilitation work (ie serious weed infestations) :	Nil	Nil
Advice on rehabilitation of these sites :	N/A	N/A
Other management advice for this section :

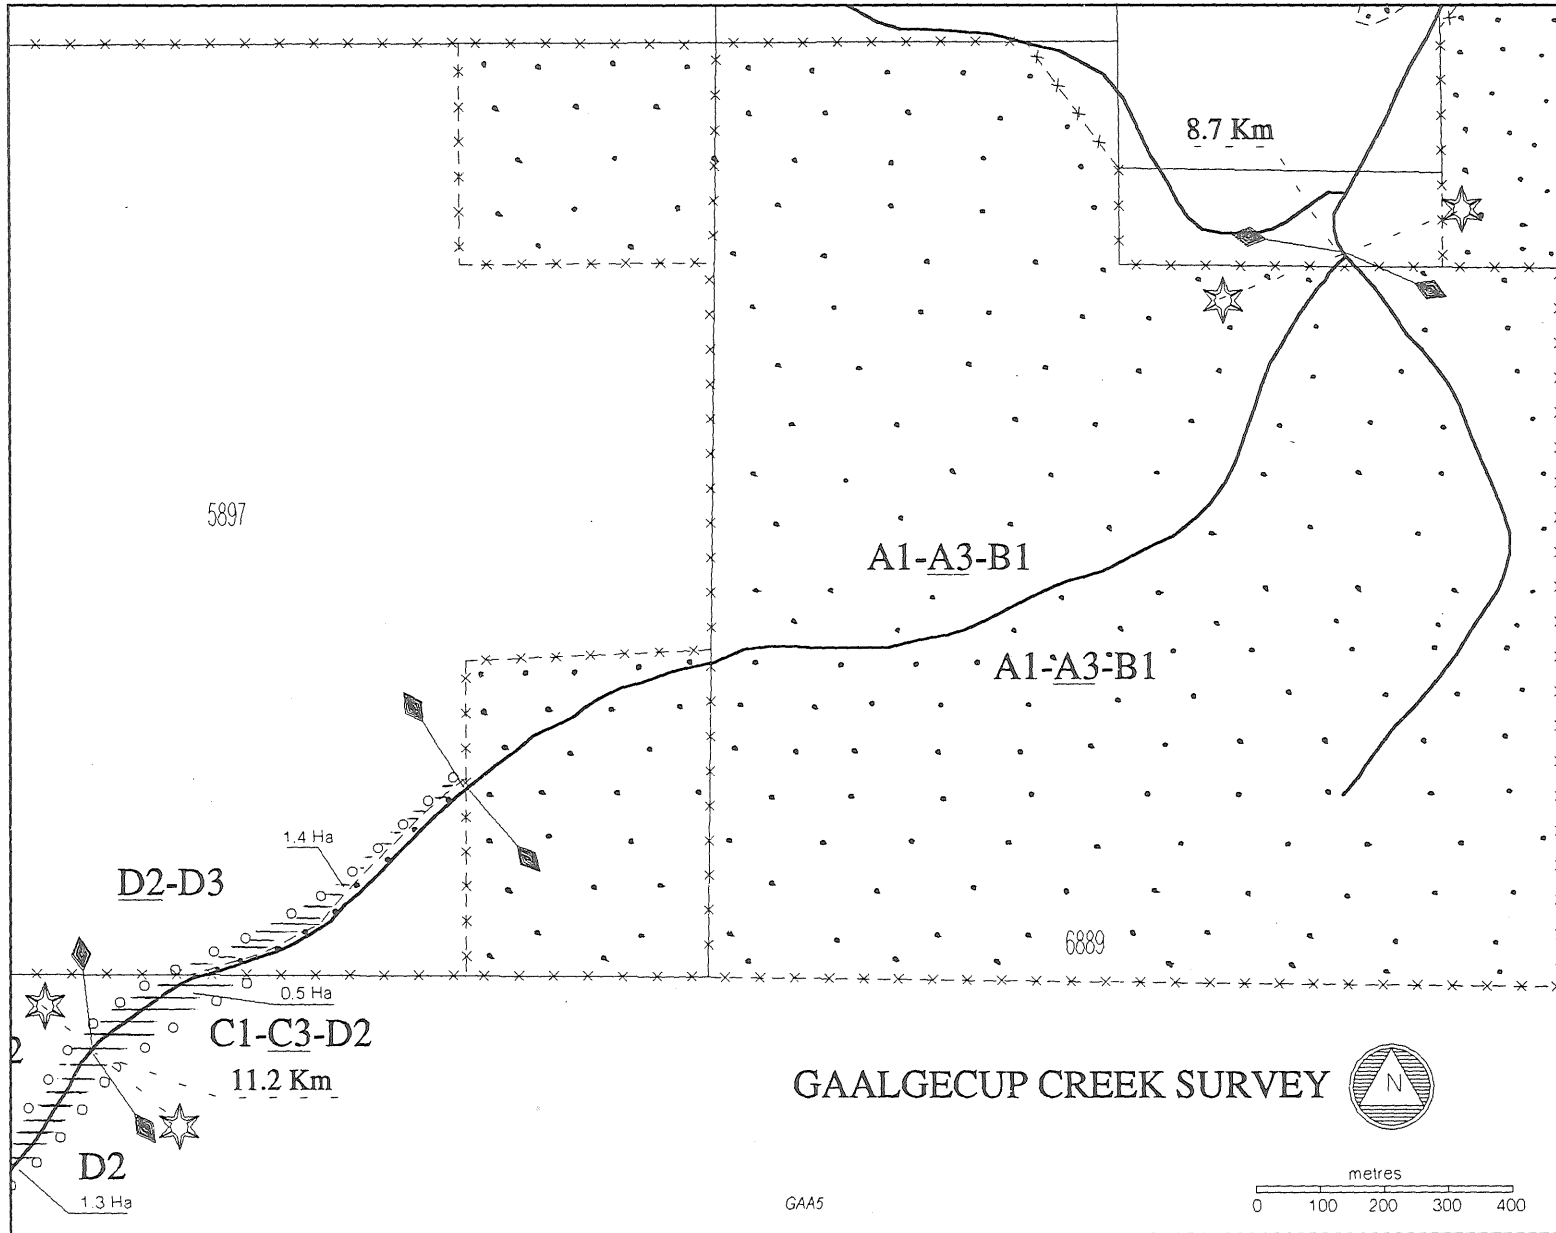
**GAALGEGUP CREEK SURVEY -GAAL5 See Map 1.2 (pg.4) for location**

Left Bank	Right Bank
Length of Riverbank Fencing In Place :	3.4km	2.2km
Length of Riverbank Fencing Recommended :	200m	700m
Number of Sites showing severe erosion :	Nil	Nil
Advice on remedial measures required for these sites :	N/A	N/A
No. of sites and cumulative approximate area of these sites along riverbank requiring riverbank revegetation work :	No. of sites : 1 Priority Urgent Area (ha) : 0.5ha	No. of sites : 1 Priority Urgent Area (ha) : 1.4ha
Advice on revegetation species and preparation :	Select revegetation species from appropriate section of Appendix 1 of this report, including the following existing site species : <i>E.occidentalis</i> , <i>M.cuticularis</i> , <i>Agonis parviceps</i> , <i>A.linearifolia</i> , rip and mound parallel with river	Select revegetation species from appropriate section of Appendix 1 of this report, including the following existing site species : <i>E.occidentalis</i> , <i>M.cuticularis</i> , <i>Agonis parviceps</i> , <i>A.linearifolia</i> , rip and mound parallel with river

Number of other sites requiring rehabilitation work (ie serious weed infestations) :	Nil	Nil
Advice on rehabilitation of these sites :	N/A	N/A
Other management advice for this section :

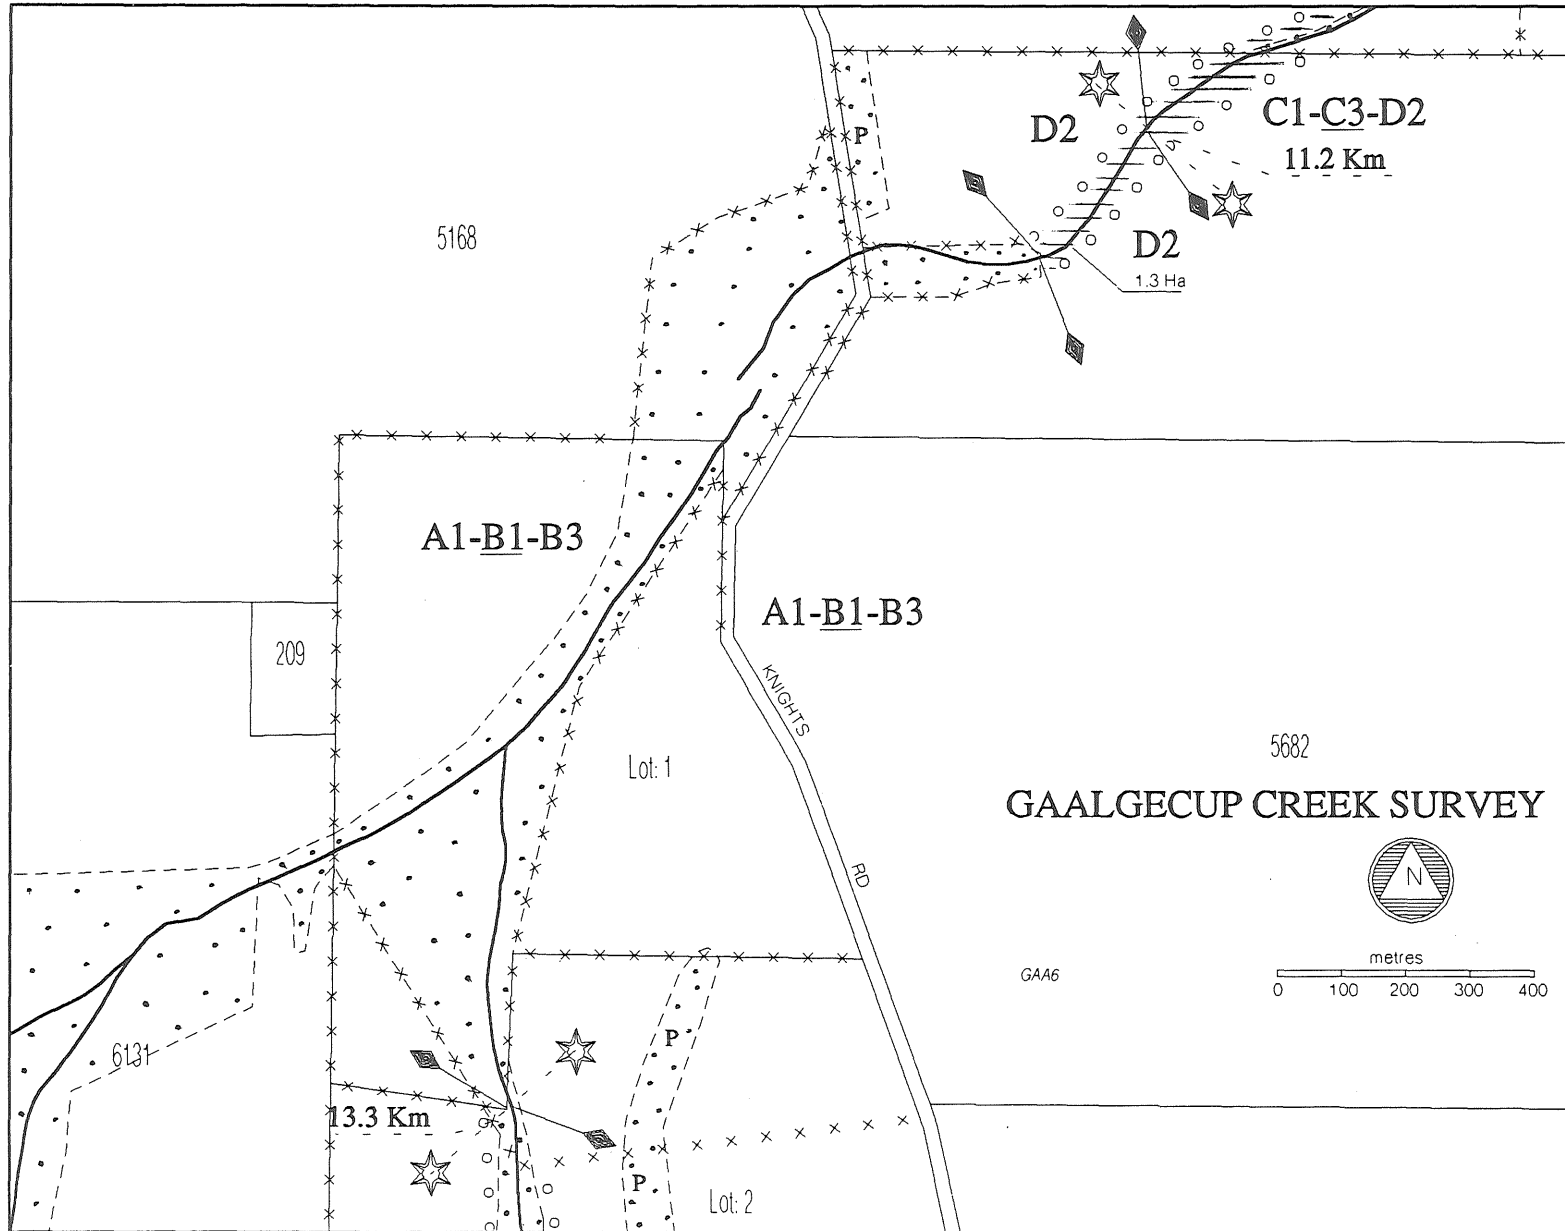
**GAALGEGUP CREEK SURVEY -GAAL6 See Map 1.2 (pg.4) for location**

<b>Left Bank</b>	<b>Right Bank</b>
<b>Length of Riverbank Fencing In Place :</b>	1.8km	2.1km
<b>Length of Riverbank Fencing Recommended :</b>	250m	250m
<b>Number of Sites showing severe erosion :</b>	Nil	Nil
<b>Advice on remedial measures required for these sites :</b>	N/A	N/A
<b>No. of sites and cumulative approximate area of these sites along riverbank requiring riverbank revegetation work :</b>	No. of sites : 1 Priority Urgent Area (ha) : 0.65ha	No. of sites : 1 Priority Urgent Area (ha) : 0.65ha
<b>Advice on revegetation species and preparation :</b>	Select revegetation species from appropriate section of Appendix 1 of this report, including the following existing site species : <i>E.occidentalis</i> , <i>M.cuticularis</i> , <i>Agonis parviceps</i> , <i>A.linearifolia</i> , rip and mound parallel with river	Select revegetation species from appropriate section of Appendix 1 of this report, including the following existing site species : <i>E.occidentalis</i> , <i>M.cuticularis</i> , <i>Agonis parviceps</i> , <i>A.linearifolia</i> , rip and mound parallel with river

<b>Number of other sites requiring rehabilitation work (ie serious weed infestations) :</b>	Nil	Nil
<b>Advice on rehabilitation of these sites :</b>	N/A	N/A
<b>Other management advice for this section :</b>	Section of creek has been excavated and forms a straight channel. This section requires some in stream structures such as rock riffle bars to reduce stream bed erosion. Seek expert advise on this.	Section of creek has been excavated and forms a straight channel. This section requires some in stream structures such as rock riffle bars to reduce stream bed erosion. Seek expert advise on this.

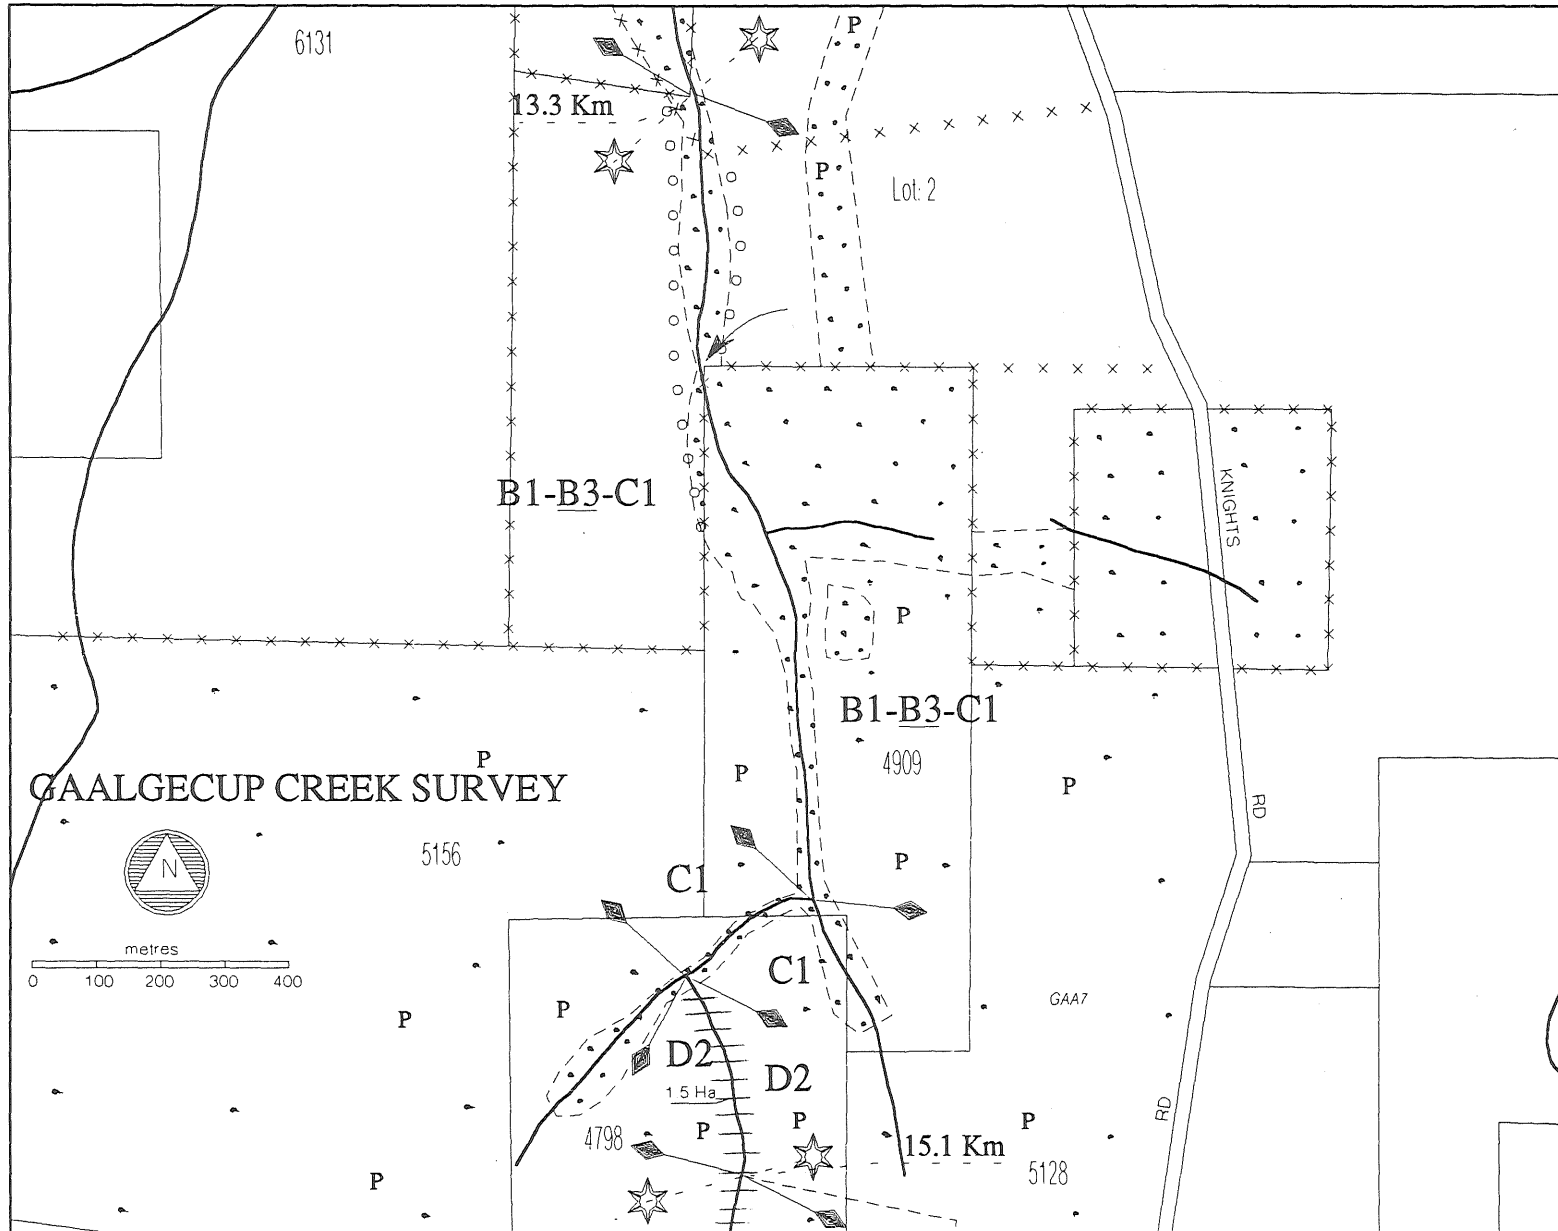
**GAALGEGUP CREEK SURVEY -GAAL7 See Map 1.2 (pg.4) for location**

Left Bank	Right Bank
Length of Riverbank Fencing In Place :	Nil	Nil
Length of Riverbank Fencing Recommended :	300m	700m
Number of Sites showing severe erosion :	Nil	Nil
Advice on remedial measures required for these sites :	N/A	N/A
No. of sites and cumulative approximate area of these sites along riverbank requiring riverbank revegetation work :	No. of sites : 1 Priority Urgent Area (ha) : 1.5ha	No. of sites : 1 Priority Urgent Area (ha) : 1.5ha
Advice on revegetation species and preparation :	Select revegetation species from appropriate section of Appendix 1 of this report, including the following existing site species : <i>E.calophylla</i> , <i>E.occidentalis</i> , <i>M.cuticularis</i> , <i>Agonis parviceps</i> , <i>A.linearifolia</i> , rip and mound parallel with river	Select revegetation species from appropriate section of Appendix 1 of this report, including the following existing site species : <i>E.calophylla</i> , <i>E.occidentalis</i> , <i>M.cuticularis</i> , <i>Agonis parviceps</i> , <i>A.linearifolia</i> , rip and mound parallel with river

Number of other sites requiring rehabilitation work (ie serious weed infestations) :	Nil	Nil
Advice on rehabilitation of these sites :	N/A	N/A
Other management advice for this section :	Stabilise stock access to creek, or provide alternative nearby water source such as trough. Most of remaining area is to be planted to blue gums, will not require management.	Stabilise stock access to creek, or provide alternative nearby water source such as trough. Most of remaining area is to be planted to blue gums, will not require management.

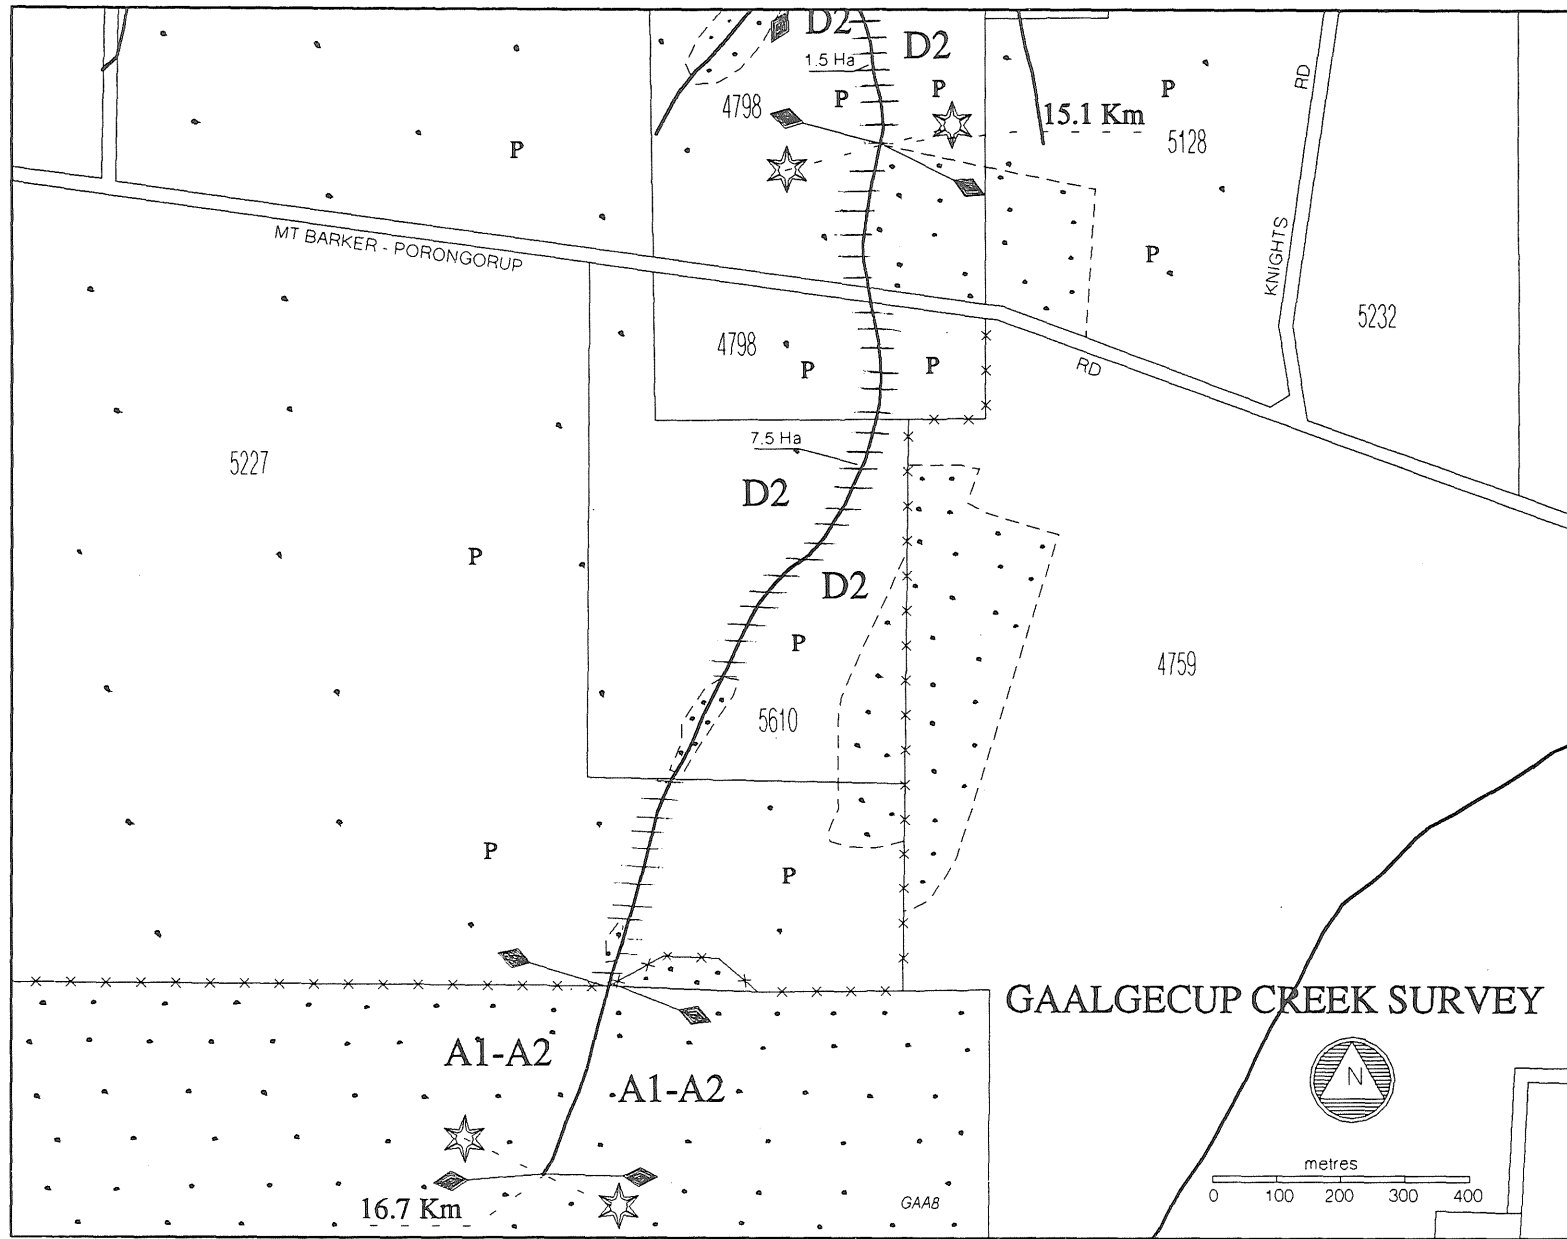
**GAALGEGUP CREEK SURVEY -GAAL8 See Map 1.2 (pg.4) for location**

Left Bank	Right Bank
Length of Riverbank Fencing In Place :	Nil	Nil
Length of Riverbank Fencing Recommended :	Nil	Nil
Number of Sites showing severe erosion :	Nil	Nil
Advice on remedial measures required for these sites :	N/A	N/A
No. of sites and cumulative approximate area of these sites along riverbank requiring riverbank revegetation work :	No. of sites : Whole site Priority Urgent Area (ha) :7.5ha	No. of sites : Whole site Priority Urgent Area (ha) :7.5ha
Advice on revegetation species and preparation :	Select revegetation species from appropriate section of Appendix 1 of this report, including the following existing site species : <i>E.calophylla</i> , <i>E.occidentalis</i> , <i>M.cuticularis</i> , <i>Agonis parviceps</i> , <i>A.linearifolia</i> , rip and mound in herring bone fashion, pointing upstream. Consult a local landcare technician in surveying in rip and mound lines.	Select revegetation species from appropriate section of Appendix 1 of this report, including the following existing site species : <i>E.calophylla</i> , <i>E.occidentalis</i> , <i>M.cuticularis</i> , <i>Agonis parviceps</i> , <i>A.linearifolia</i> , rip and mound in herring bone fashion, pointing upstream. Consult a local landcare technician in surveying in rip and mound lines.

Number of other sites requiring rehabilitation work (ie serious weed infestations) :	Nil	Nil
Advice on rehabilitation of these sites :	N/A	N/A
Other management advice for this section :	Most of area is to be planted to blue gums, will not require management.	Most of area is to be planted to blue gums, will not require management.

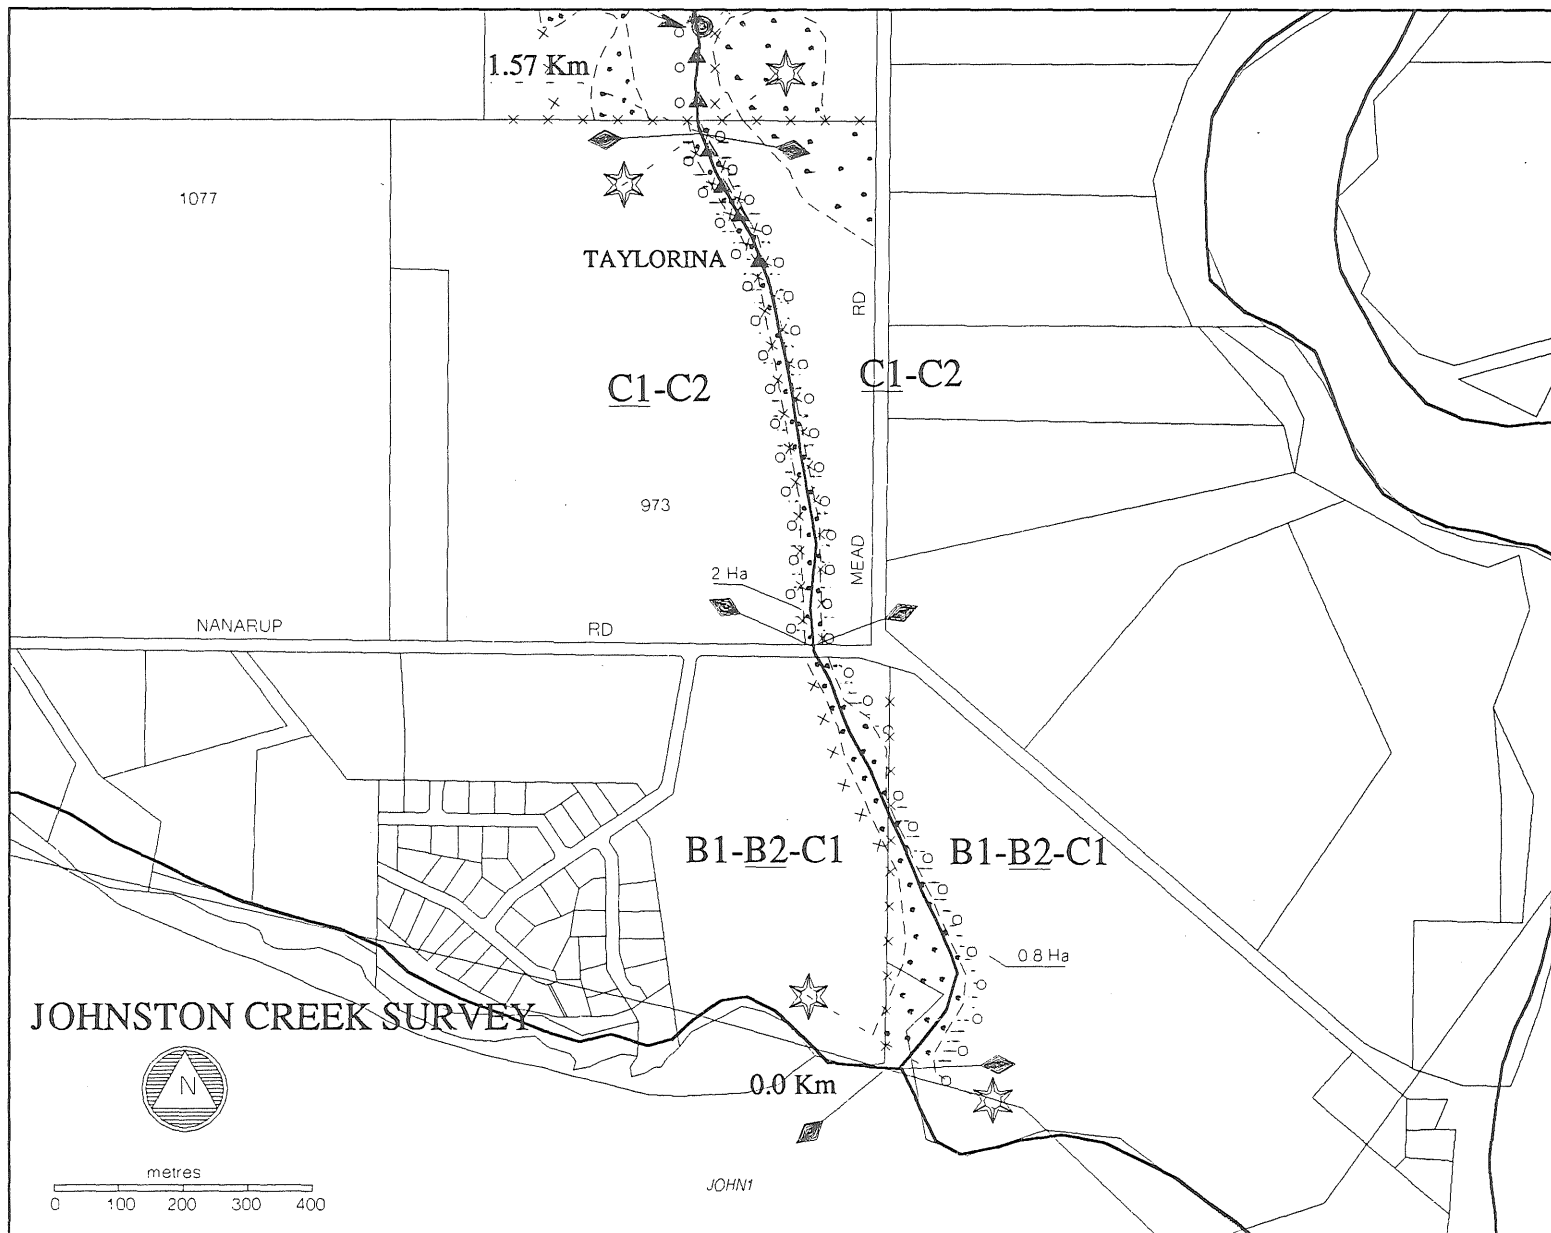
**JOHNSON CREEK RIVER SURVEY - JOHN 1 See Map 1.2 (pg.4) for location**

Left Bank	Right Bank
Length of Riverbank Fencing In Place :	1.27km	850m
Length of Riverbank Fencing Recommended :	850m	1.57km
Number of Sites showing severe erosion :	Nil	Nil
Advice on remedial measures required for these sites :	N/A	N/A
No. of sites and cumulative approximate area of these sites along riverbank requiring riverbank revegetation work :	No. of sites : 1 Priority 1 Area (ha) : 1ha	No. of sites : 2 Priority 1 Area (ha) : 1.8ha
Advice on revegetation species and preparation :	Select revegetation species from appropriate section of Appendix 1 of this report, including the following existing site species : <i>M. raphiophylla</i> , <i>A. parviceps</i> , <i>A. linearifolia</i> . Treat kikuyu the spring and summer before planting. Area needs ripping and mounding, parallel with creek.	Select revegetation species from appropriate section of Appendix 1 of this report, including the following existing site species : <i>M. raphiophylla</i> , <i>A. parviceps</i> , <i>A. linearifolia</i> . <i>E. marginata</i> , <i>E. calophylla</i> , <i>M. cuticularis</i> on section closer to estuary. Treat kikuyu the spring and summer before planting. Area needs ripping and mounding, parallel with creek.

Number of other sites requiring rehabilitation work (ie serious weed infestations) :	1	1
Advice on rehabilitation of these sites :	Taylorina needs removal by felling and spraying.	Taylorina needs removal by felling and spraying.
Other management advice for this section :
