SURVEY OF RIVER FORESHORES  
IN THE  
OYSTER HARBOUR CATCHMENT  
1997

WATER AND RIVERS COMMISSION REPORT WRT 17  
1997

To assist with the process of catchment repair, the Albany Waterways Management Authority commissioned APACE Green Skills to carry out a survey to assess the condition of selected foreshores of some of the Oyster Harbour Catchment's tributaries. The survey commenced in February 1997 and concluded in May 1997.

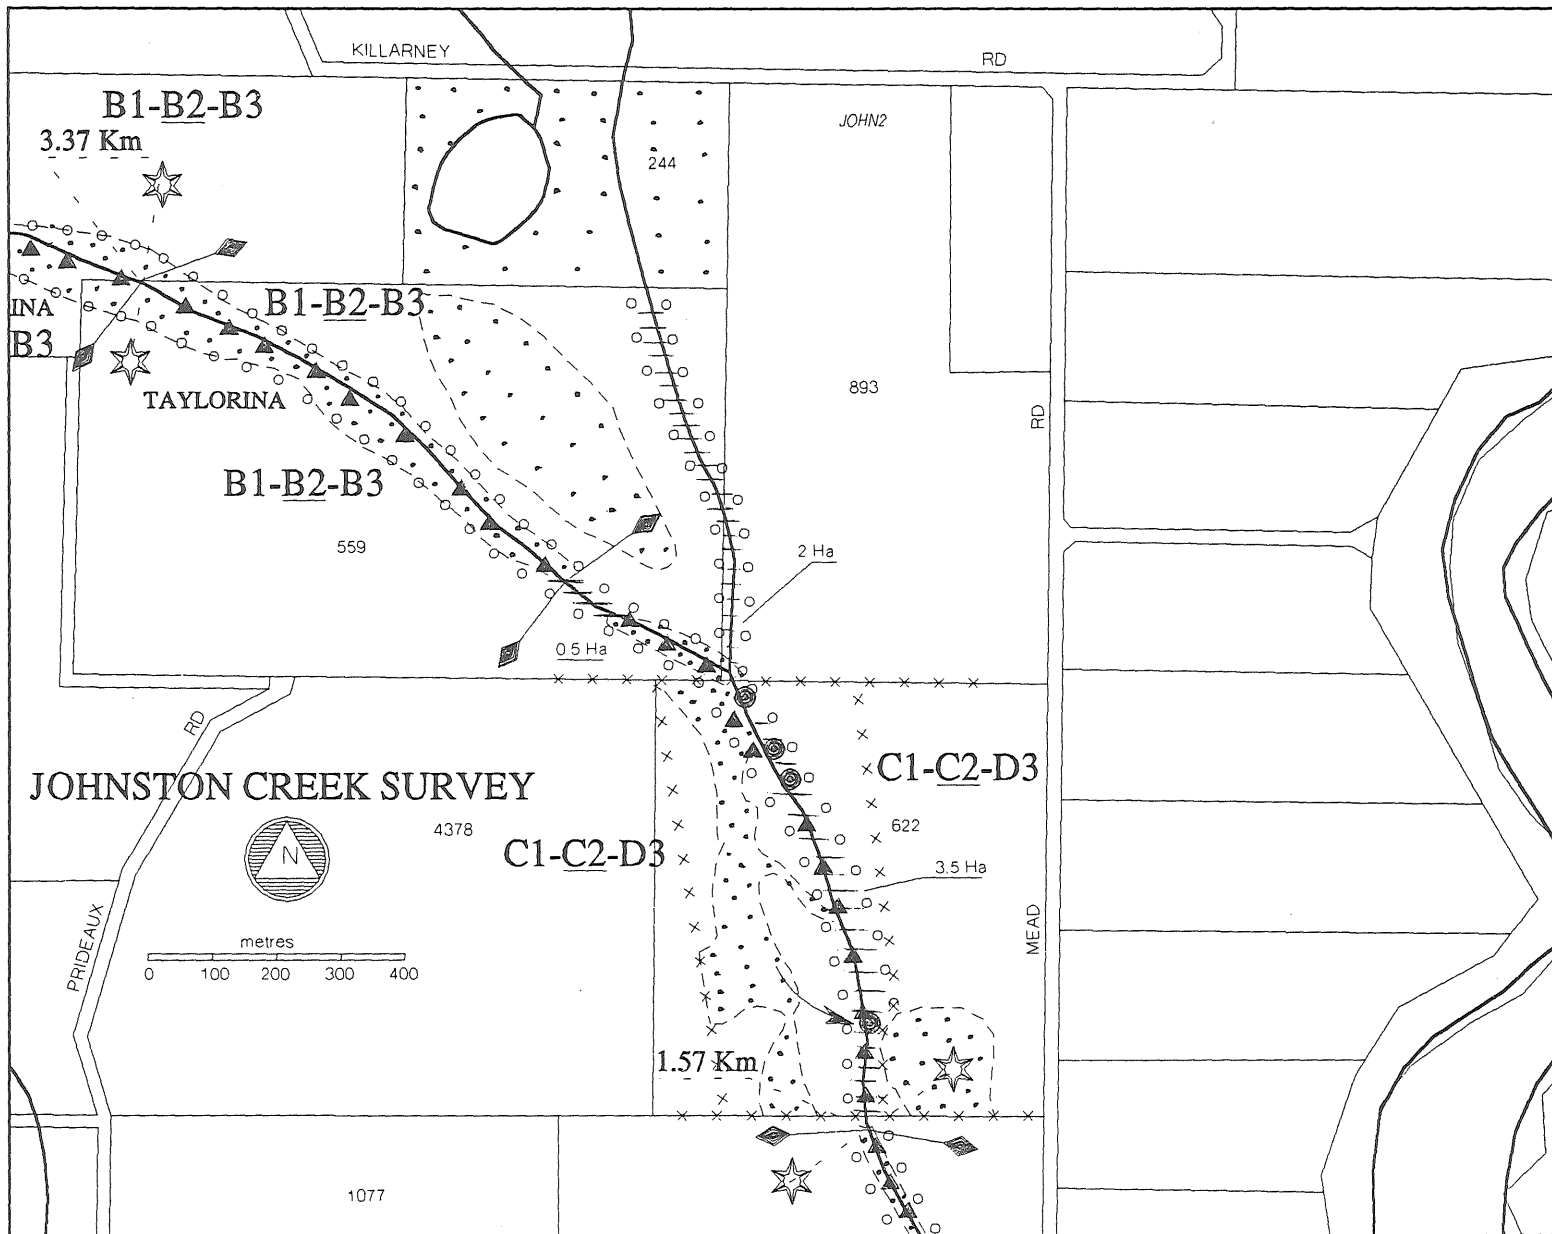
**JOHNSON CREEK RIVER SURVEY - JOHN 2 See Map 1.2 (pg.4) for location**

<b>Left Bank</b>	<b>Right Bank</b>
<b>Length of Riverbank Fencing In Place :</b>	Nil	170m
<b>Length of Riverbank Fencing Recommended :</b>	1.8km	1.63km
<b>Number of Sites showing severe erosion :</b>	7	7
<b>Advice on remedial measures required for these sites :</b>	Fence from stock and revegetate.	Fence from stock and revegetate.
<b>No. of sites and cumulative approximate area of these sites along riverbank requiring riverbank revegetation work :</b>	No. of sites : 2 Priority 1-urgent Area (ha) : 2ha	No. of sites : 2 Priority 1-urgent Area (ha) : 4ha
<b>Advice on revegetation species and preparation :</b>	Select revegetation species from appropriate section of Appendix 1 of this report, including the following existing site species : <i>M. raphiophylla</i> , <i>A. parviceps</i> , <i>A. linearifolia</i> . Treat kikuyu the spring and summer before planting. Area needs ripping and mounding, parallel with creek.	Select revegetation species from appropriate section of Appendix 1 of this report, including the following existing site species : <i>M. raphiophylla</i> , <i>A. parviceps</i> , <i>A. linearifolia</i> . Treat kikuyu the spring and summer before planting. Area needs ripping and mounding, parallel with creek.

<b>Number of other sites requiring rehabilitation work (ie serious weed infestations) :</b>	Entire length.	Entire length.
<b>Advice on rehabilitation of these sites :</b>	Taylorina needs removal by felling and spraying.	Taylorina needs removal by felling and spraying.
<b>Other management advice for this section :</b>	Provide stabilised access points to the creek for stock crossing and watering. Ideally provide alternative watering point such as a dam, or pump to a trough utilising solar, wind generated or nose pumps.	Provide stabilised access points to the creek for stock crossing and watering. Ideally provide alternative watering point such as a dam, or pump to a trough utilising solar, wind generated or nose pumps.

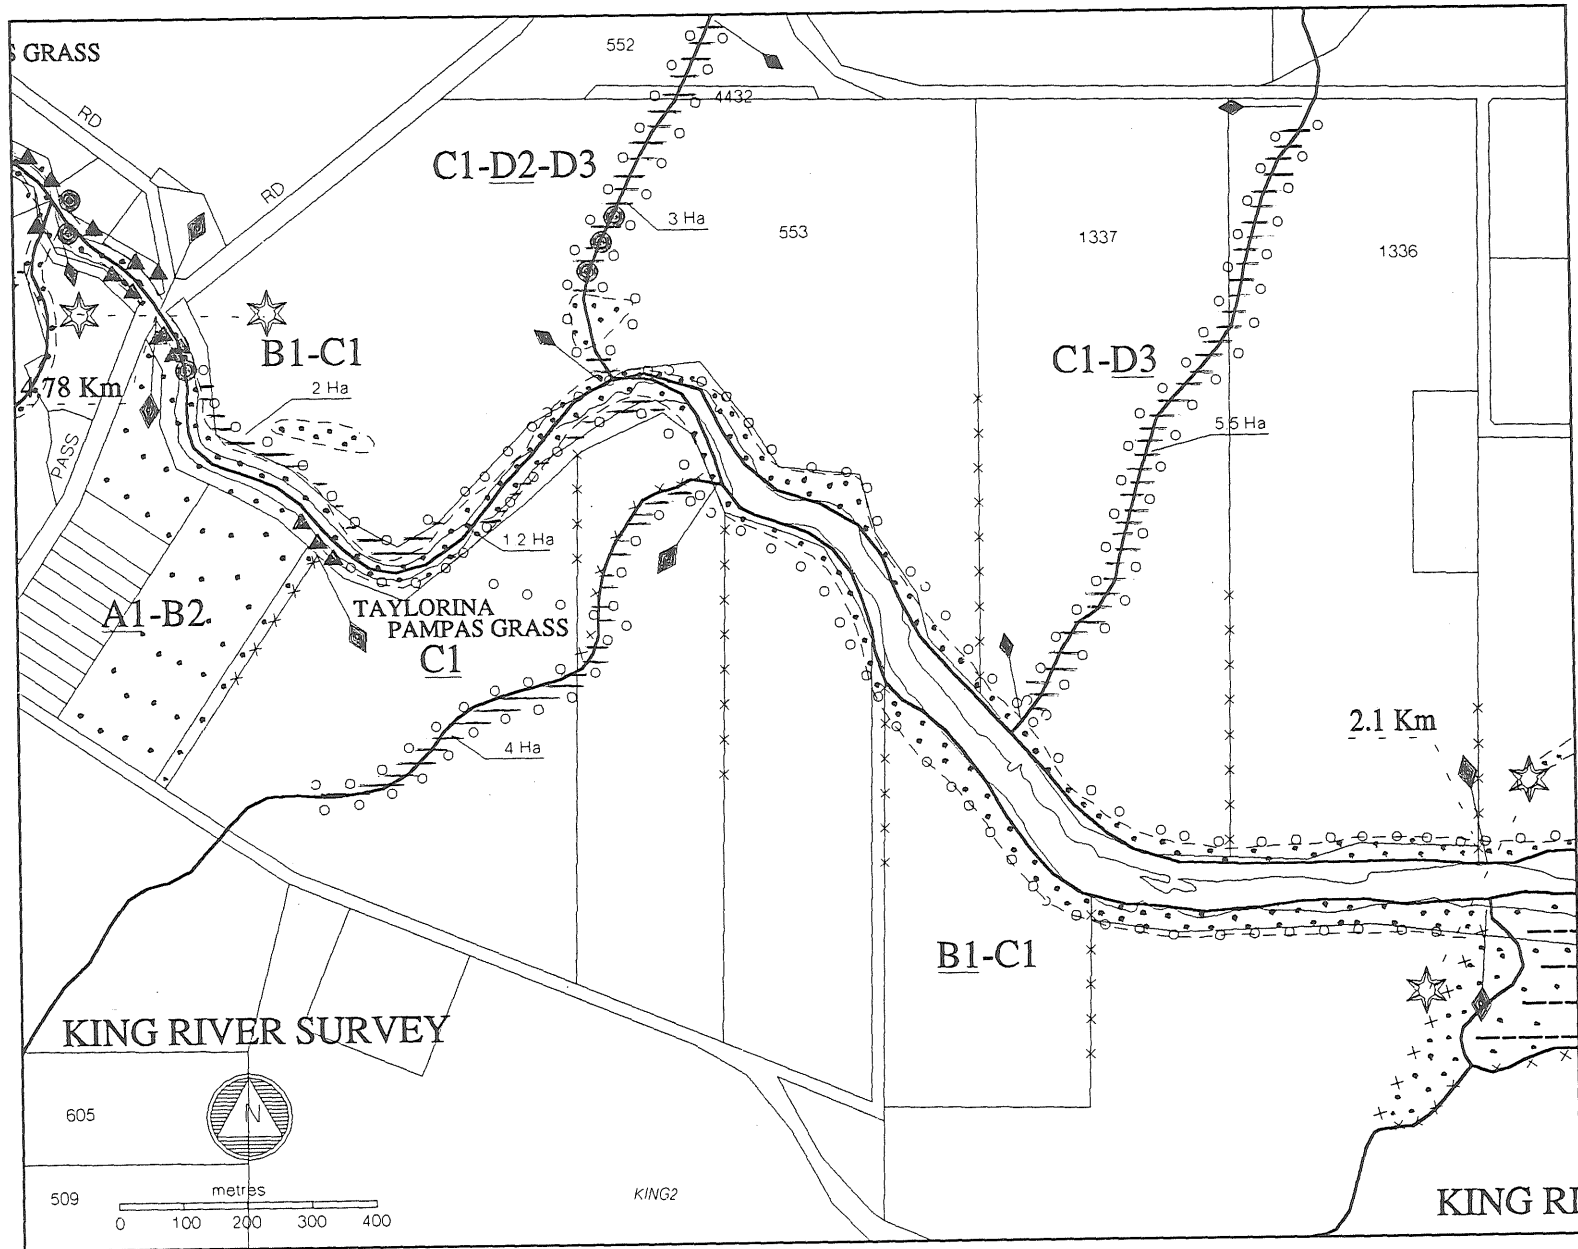
**KING RIVER SURVEY - KING 2 See Map 1.2 (pg.4) for location**

<b>Left Bank</b>	<b>Right Bank</b>
<b>Length of Riverbank Fencing In Place :</b>	Nil	100m
<b>Length of Riverbank Fencing Recommended :</b>	2.58km	1.78km
<b>Number of Sites showing severe erosion :</b>	1	3
<b>Advice on remedial measures required for these sites :</b>	Fence, install steps to water	Tributary on Loc 553, with severe erosion, requiring fencing, revegetation.
<b>No. of sites and cumulative approximate area of these sites along riverbank requiring riverbank revegetation work :</b>	No. of sites : 2 Priority 3 Area (ha) : 5.2ha	No. of sites : 3 Priority 1-urgent (tributary 553) Priority 2 (trib.1337) Priority 3(riverbank) Area (ha) :10.5ha (includes tributaries)
<b>Advice on revegetation species and preparation :</b>	Select revegetation species from appropriate section of Appendix 1 of this report, including the following existing site species: <i>Melaleuca raphiophylla</i> , <i>Agonis parviceps</i>	Select revegetation species from appropriate section of Appendix 1 of this report, including the following existing site species: <i>Melaleuca raphiophylla</i> , <i>Agonis parviceps</i>

<b>Number of other sites requiring rehabilitation work (ie serious weed infestations) :</b>	3 Priority 1	Nil
<b>Advice on rehabilitation of these sites :</b>	Remove pampas grass and taylorina.	N/A
<b>Other management advice for this section :</b>	Restrict vehicle access to river bank area by closing access track, encourage people to use steps from car park area.	Provide stabilised access points to the creek for stock crossing and watering. Ideally provide alternative watering point such as a dam, or pump to a trough utilising solar, wind generated or nose pumps.

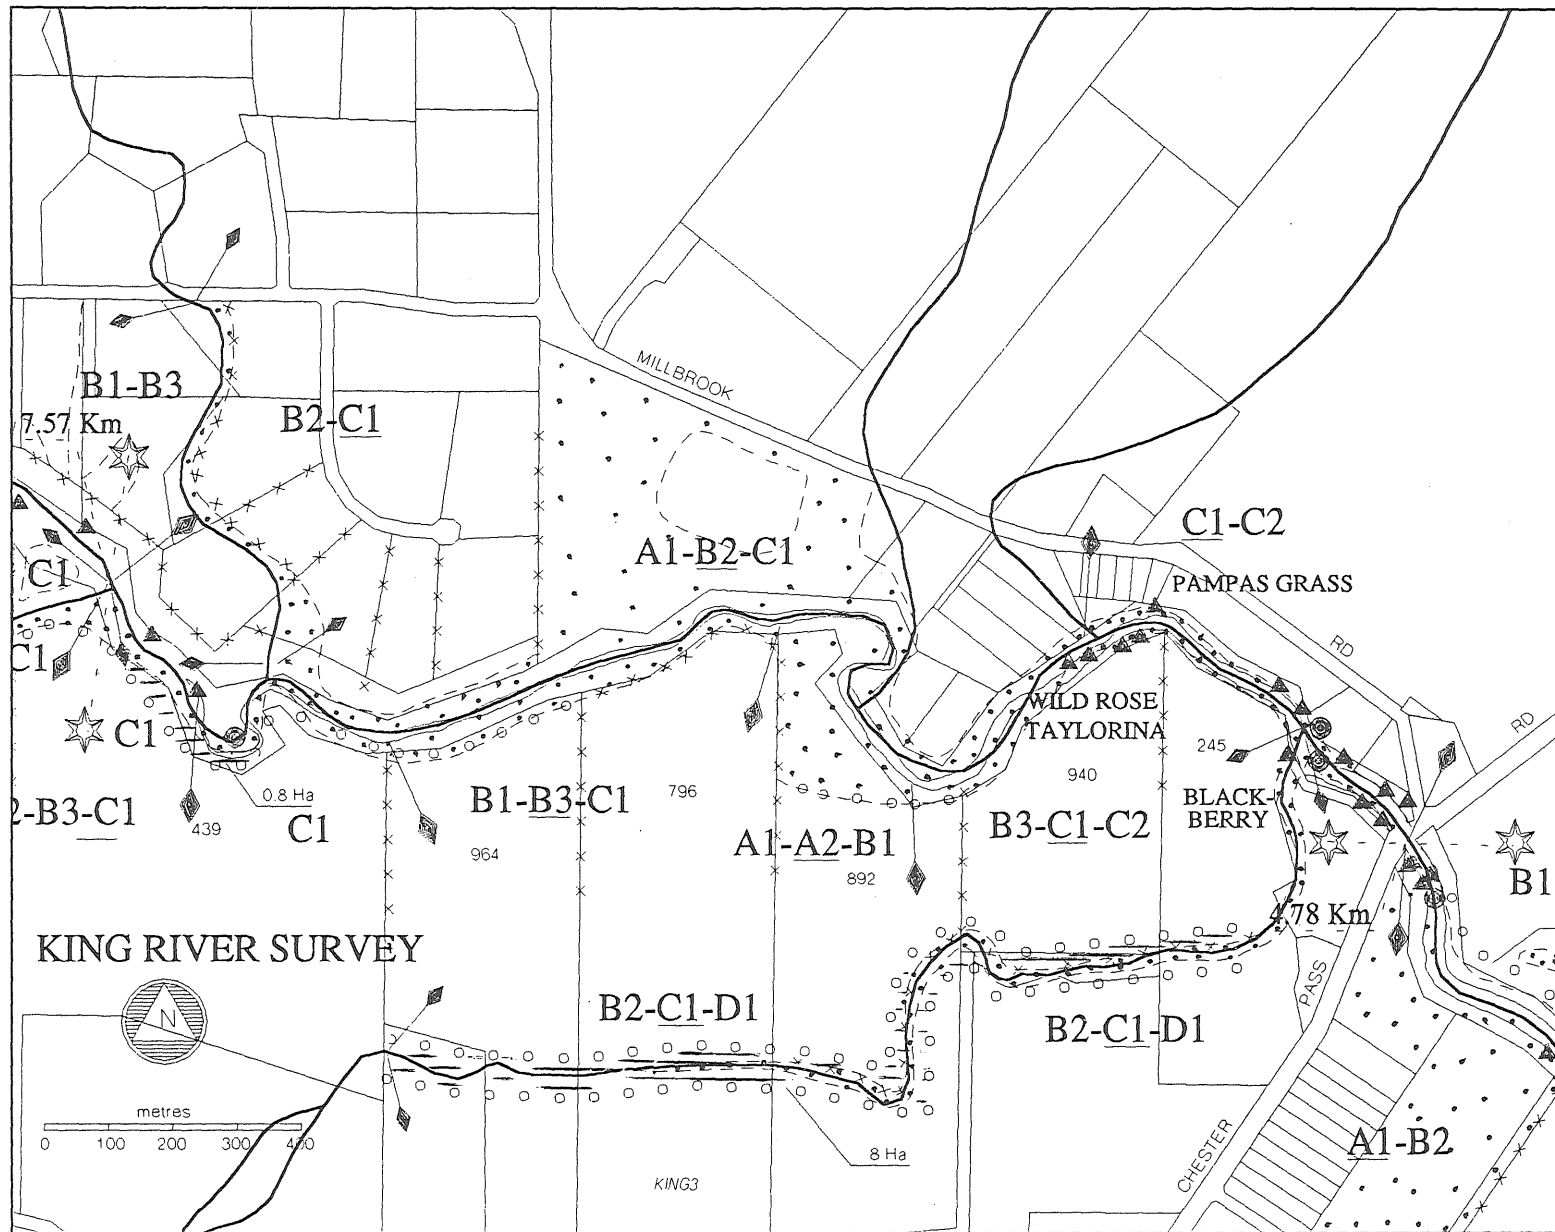
**KING RIVER SURVEY - KING 3 See Map 1.2 (pg.4) for location**

<b>Left Bank</b>	<b>Right Bank</b>
<b>Length of Riverbank Fencing In Place :</b>	350m	330m
<b>Length of Riverbank Fencing Recommended :</b>	1.14km	Nil
<b>Number of Sites showing severe erosion :</b>	2	1
<b>Advice on remedial measures required for these sites :</b>	Fence, revegetate -Loc 439 Fence, install steps-Loc 245	Build steps/jetty
<b>No. of sites and cumulative approximate area of these sites along riverbank requiring riverbank revegetation work :</b>	No. of sites : 2 Priority 1 Area (ha) : 8.8ha	No. of sites : Nil Priority : N/A Area (ha) : N/A
<b>Advice on revegetation species and preparation :</b>	Select revegetation species from appropriate section of Appendix 1 of this report, including the following existing site species for the tributaries: Agonis parviceps, A.linearifolia M, raphiophylla and local reed species. Rip and mound parallel to creek. For main River bank plantings, existing species include: E.calophylla, E.marginata, Callistachys lanceolata, A parviceps, Bosseia lineophylla, Rip and mound parallel to river, also spot spray and plant	N/A

<b>Number of other sites requiring rehabilitation work (ie serious weed infestations) :</b>	6 Priority 1	6 Priority 1
<b>Advice on rehabilitation of these sites :</b>	Remove pampas grass, treat for blackberry and taylorina.	As for left bank.
<b>Other management advice for this section :</b>	Care not to expose bank by weed removal.	As for left bank.

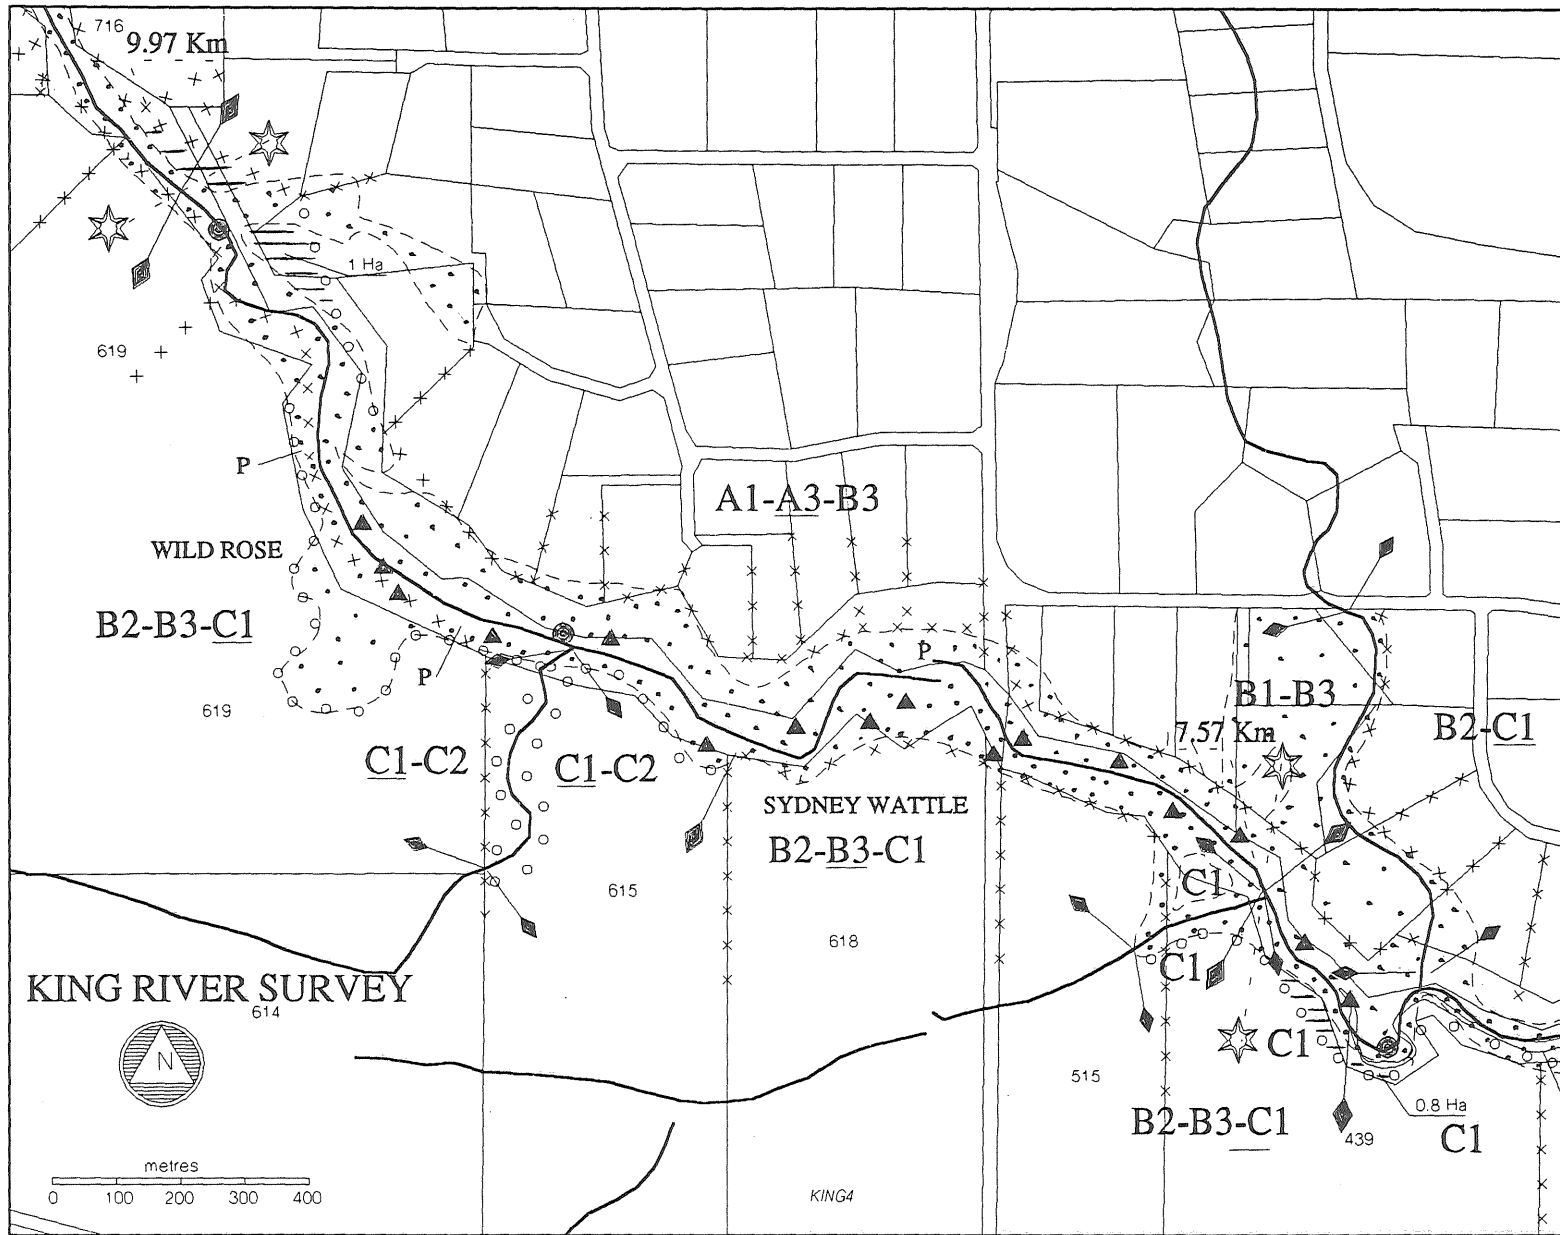
**KING RIVER SURVEY - KING 4 See Map 1.2 (pg.4) for location**

Left Bank	Right Bank
Length of Riverbank Fencing In Place :	1.67km	2km
Length of Riverbank Fencing Recommended :	1.7km+400m tributary.	Nil
Number of Sites showing severe erosion :	1	1
Advice on remedial measures required for these sites :	Fence from stock, revegetate.	Fence, create pathway for access.
No. of sites and cumulative approximate area of these sites along riverbank requiring riverbank revegetation work :	No. of sites :1 Priority 1 Area (ha) : .08ha	No. of sites : 1 Priority 1 Area (ha) : 1ha
Advice on revegetation species and preparation :	Select revegetation species from appropriate section of Appendix 1 of this report, including the following existing dominant site species: <i>Agonis parviceps</i> , and <i>M. raphiophylla</i> . Rip and mound to contour. Consult local landcare technician in surveying rip and mound lines.	Select revegetation species from appropriate section of Appendix 1 of this report, including the following existing dominant site species: <i>A. parviceps</i> , <i>A. linearifolia</i> , <i>E. calophylla</i> , <i>E. marginata</i> , <i>Bossea lineaphylla</i> . Rip and mound to contour. Consult local landcare technician in surveying rip and mound lines.

Number of other sites requiring rehabilitation work (ie serious weed infestations) :	1 Priority 1	Nil
Advice on rehabilitation of these sites :	Remove wild rose on loc 619	N/A
Other management advice for this section :	Provide stabilised access points to the creek for stock crossing and watering. Ideally provide alternative watering point such as a dam, or pump to a trough utilising solar, wind generated or nose pumps.	Provide stabilised access points to the creek for stock crossing and watering. Ideally provide alternative watering point such as a dam, or pump to a trough utilising solar, wind generated or nose pumps.

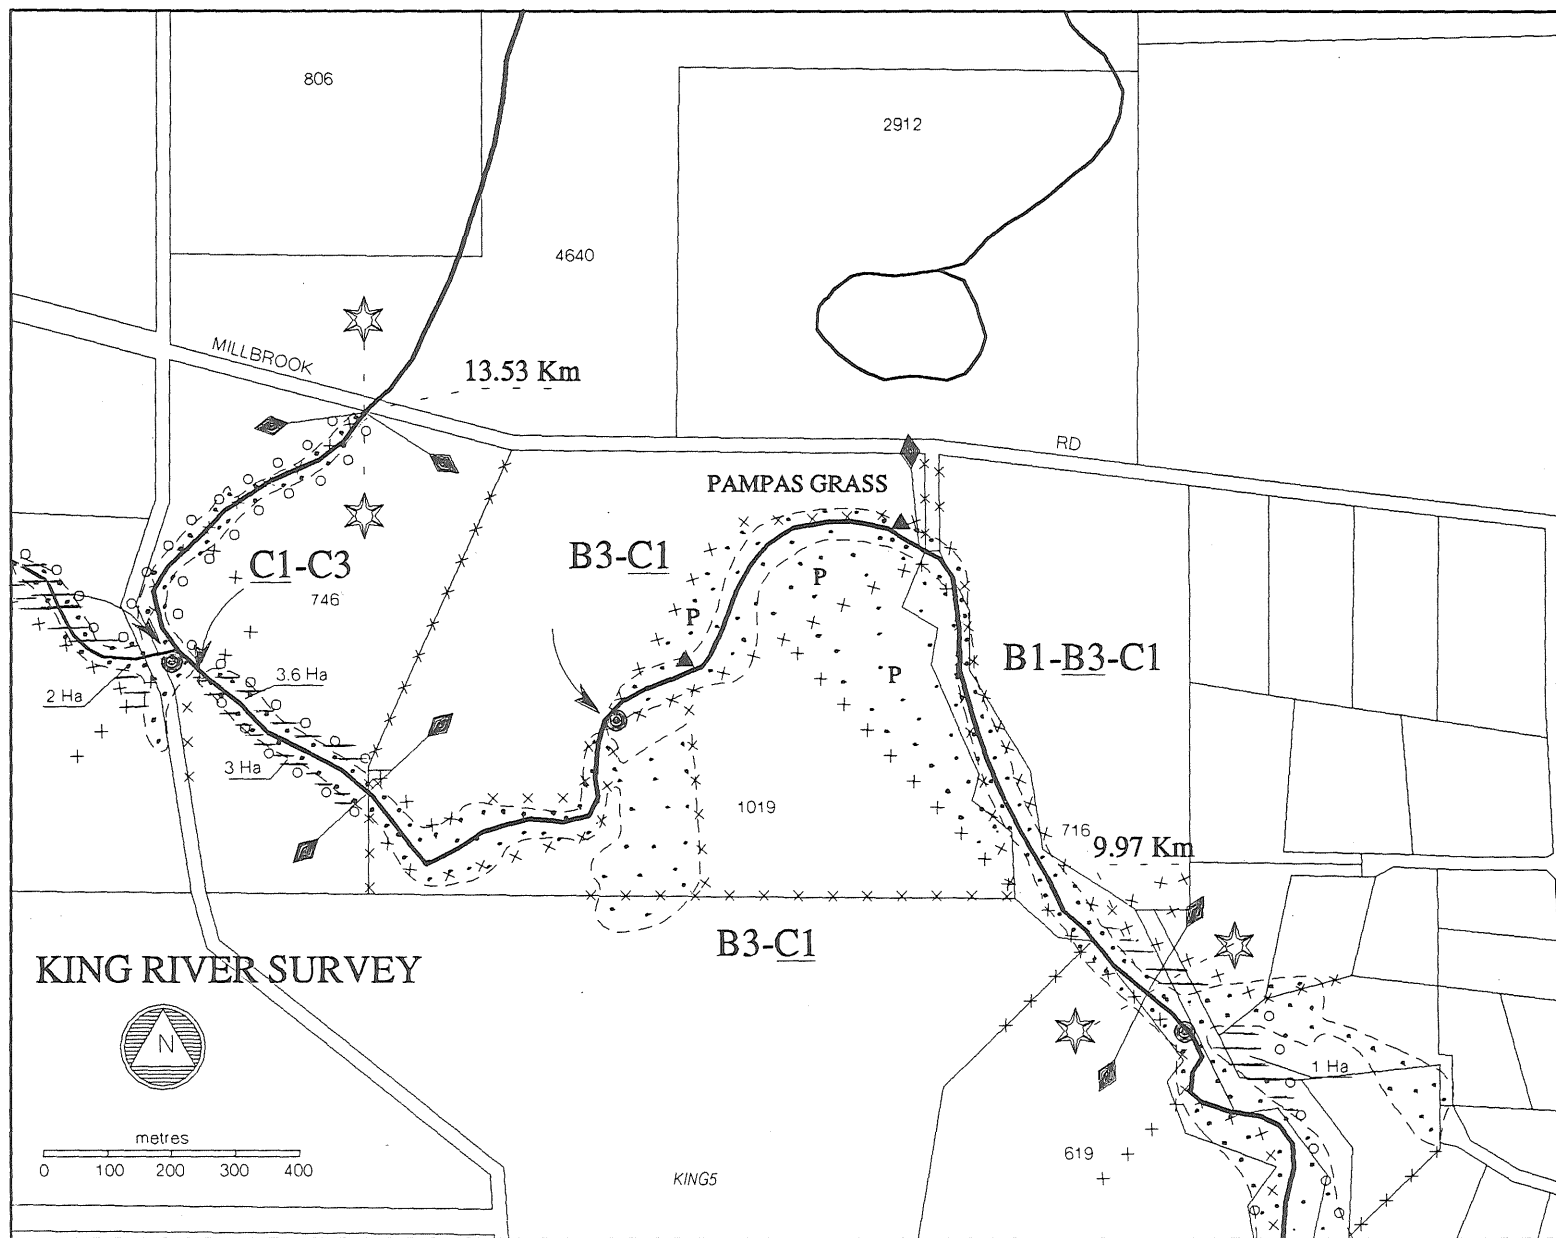
**KING RIVER SURVEY - KING 5 See Map 1.2 (pg.4) for location**

Left Bank	Right Bank
Length of Riverbank Fencing In Place :	2.5km	2.36km
Length of Riverbank Fencing Recommended :	410m+250m tributary	550m
Number of Sites showing severe erosion :	2	3
Advice on remedial measures required for these sites :	Fence from stock, revegetate	Place protective covering ie rocks, logs, along bank at crossing point
No. of sites and cumulative approximate area of these sites along riverbank requiring riverbank revegetation work :	No. of sites : 2 Priority 1-urgent Area (ha) : 5ha	No. of sites : 1 Priority 1-urgent Area (ha) : 3.6ha
Advice on revegetation species and preparation :	Select revegetation species from appropriate section of Appendix 1 of this report, including the following existing Flood plain - upper reaches site-species : <i>M.raphiophylla</i> , <i>A.parviceps</i> , <i>E.calophylla</i> , <i>E.marginata</i> .	Select revegetation species from appropriate section of Appendix 1 of this report, including the following existing Flood plain - upper reaches site-species : <i>M.raphiophylla</i> , <i>A.parviceps</i> , <i>E.calophylla</i> , <i>E.marginata</i> .

Number of other sites requiring rehabilitation work (ie serious weed infestations) :	Nil	1
Advice on rehabilitation of these sites :	N/A	Remove pampas grass
Other management advice for this section :	Provide stabilised access points to the creek for stock crossing and watering. Ideally provide alternative watering point such as a dam, or pump to a trough utilising solar, wind generated or nose pumps.	Provide stabilised access points to the creek for stock crossing and watering. Ideally provide alternative watering point such as a dam, or pump to a trough utilising solar, wind generated or nose pumps.

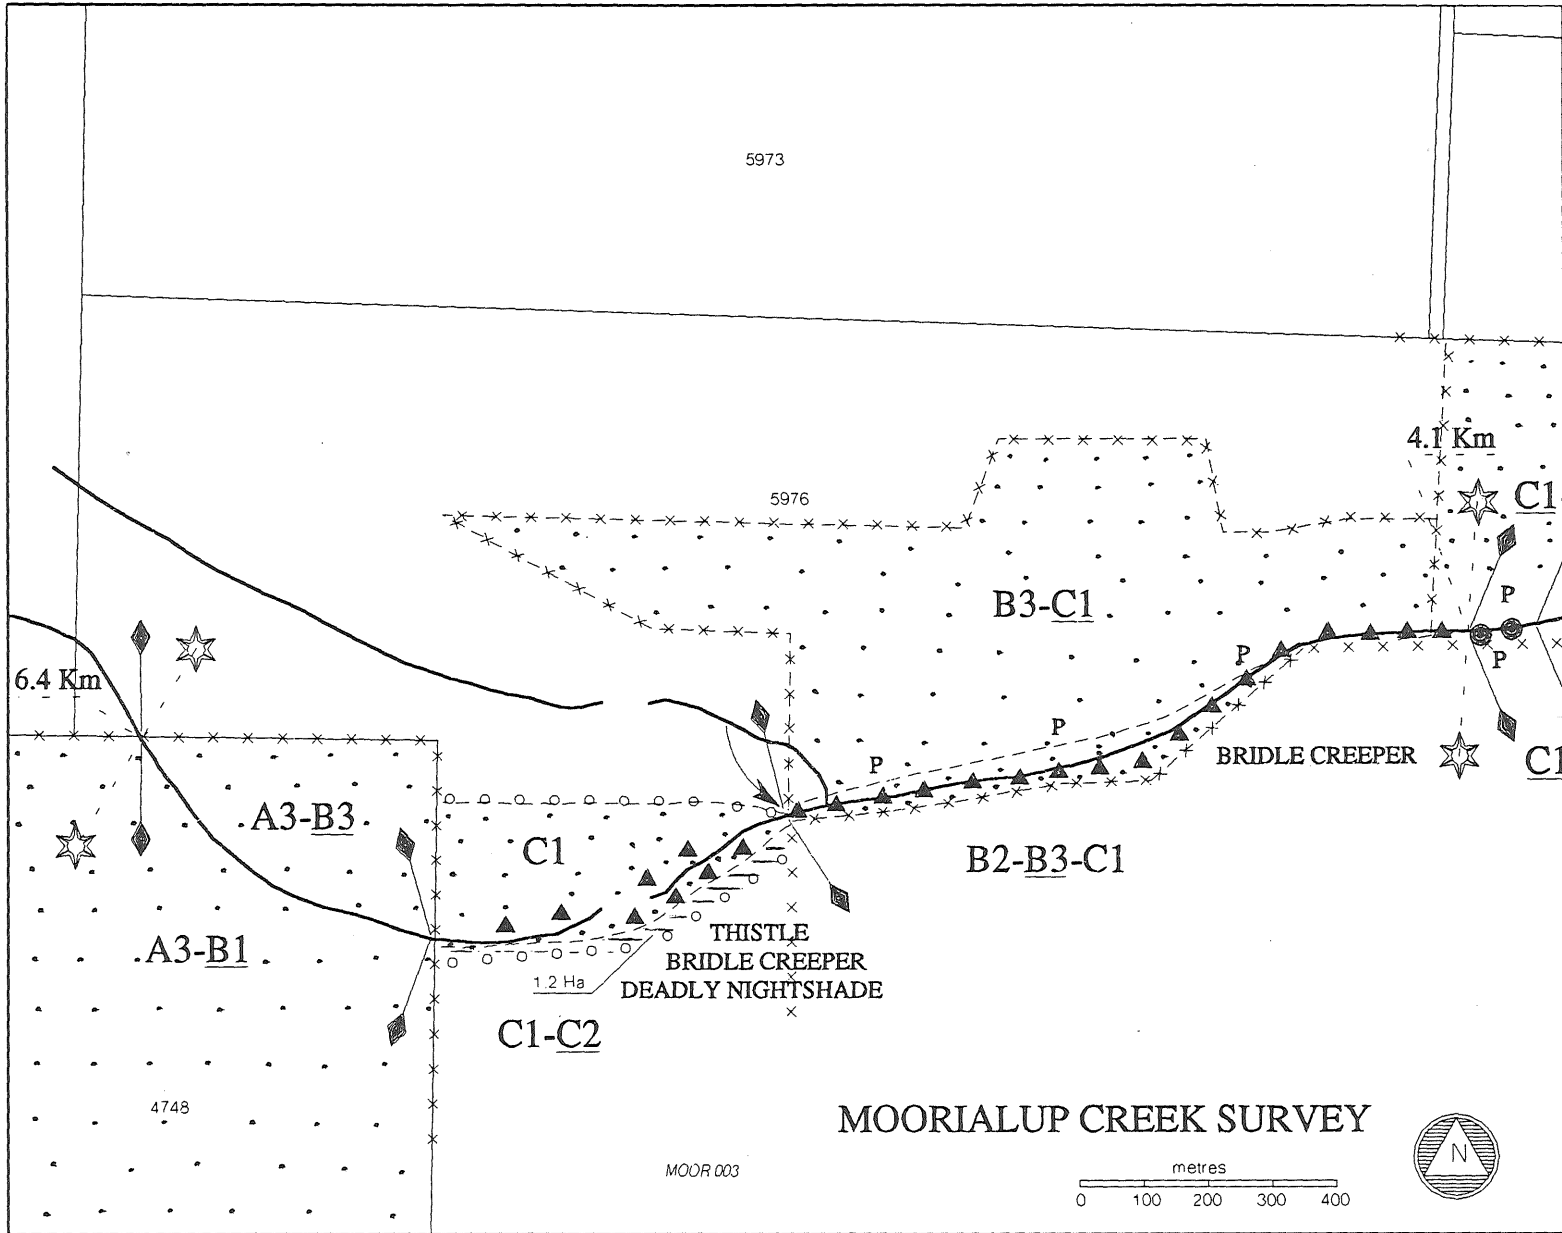
**MOORIALUP CREEK RIVER SURVEY - MOOR3 See Map 1.2 (pg.4) for location**

Left Bank	Right Bank
Length of Riverbank Fencing In Place :	1.8km	1.8km
Length of Riverbank Fencing Recommended :	500m	500m
Number of Sites showing severe erosion :	Nil	Nil
Advice on remedial measures required for these sites :	N/A	N/A
No. of sites and cumulative approximate area of these sites along riverbank requiring riverbank revegetation work :	No. of sites :1 Priority 1 Area (ha) : 1.2ha	No. of sites : Nil Priority N/A Area (ha) : N/A
Advice on revegetation species and preparation :	Select revegetation species from appropriate section of Appendix 1 of this report, including the following existing site species : <i>A.parviceps</i> , <i>A.linearifolia</i> , <i>M.raphiophylla</i> , <i>E.callophylla</i> . Rip and mound parallel with creek.	N/A
Number of other sites requiring rehabilitation work (ie serious weed infestations) :	The entire boundary fence for loc 5976 is infested with bridle creeper.	Several infestations in unfenced area at west of loc 5976.

Advice on rehabilitation of these sites :	Treat for bridle creeper, thistle and deadly nightshade.	Treat for bridle creeper, thistle and deadly nightshade.
Other management advice for this section :	Provide stabilised access points to the creek for stock crossing and watering. Ideally provide alternative watering point such as a dam, or pump to a trough utilising solar, wind generated or nose pumps.

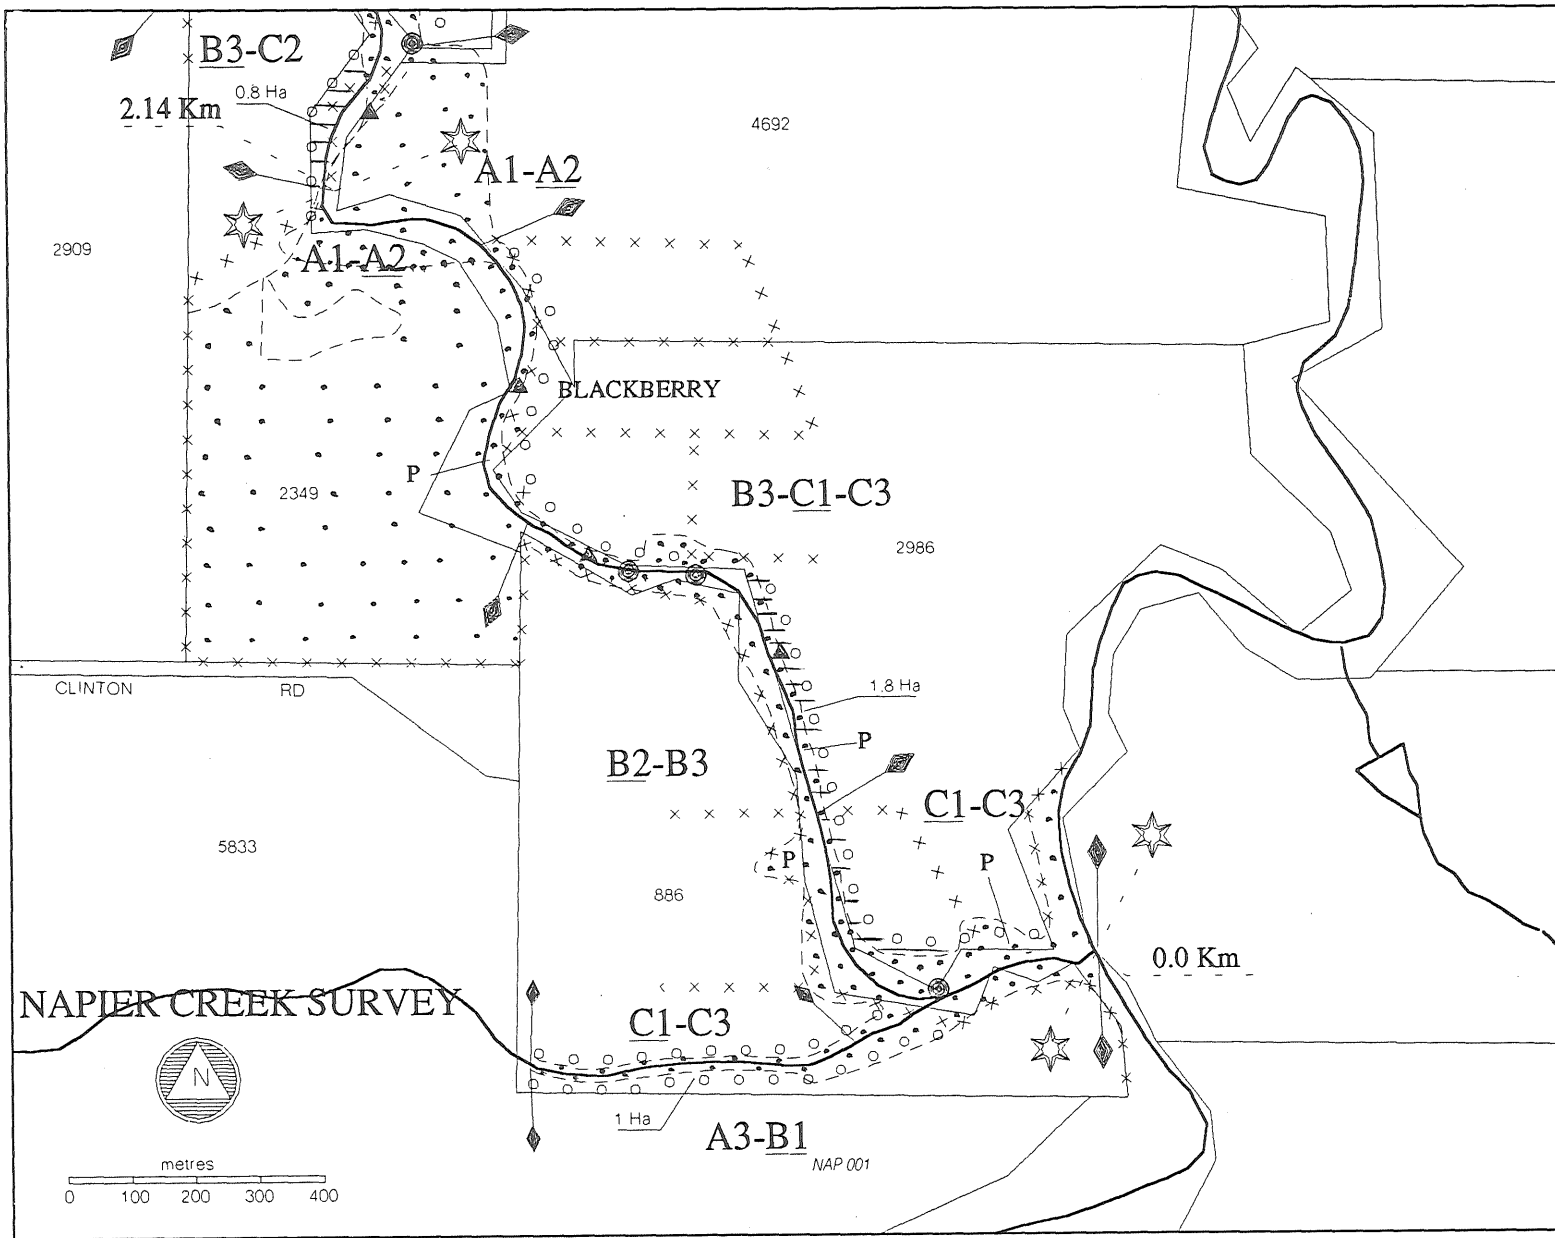
<b>Left Bank</b>	<b>Right Bank</b>
Length of Riverbank Fencing In Place :	2.14km	1.15km
Length of Riverbank Fencing Recommended :	Nil	700m
Number of Sites showing severe erosion :	Nil	3
Advice on remedial measures required for these sites :	N/A	Fence from stock, place brush along steep gully sides, rocks in gully base, revegetate with natives.
No. of sites and cumulative approximate area of these sites along riverbank requiring riverbank revegetation work :	No. of sites : Nil	No. of sites : 2
	Priority N/A	Priority 1
	Area (ha) :	Area (ha) : 1.8ha
Advice on revegetation species and preparation :	Tributary requires revegetating. Select revegetation species from appropriate section of Appendix 1 of this report, including the following existing site species : <i>E.calophylla</i> , <i>E.marginata</i> , <i>M.raphiophylla</i> , <i>Agonis parviceps</i> , <i>A.linearifolia</i> . Rip and mound parallel with creek line. Consult a local landcare technician in surveying rip and mound lines.	Select revegetation species from appropriate section of Appendix 1 of this report, including the following existing site species: <i>E.calophylla</i> , <i>E.marginata</i> , <i>M.raphiophylla</i> , <i>Banksia grandis</i> , <i>Agonis parviceps</i> , <i>A.linearifolia</i> . Rip and mound parallel with creek line. Consult a local landcare technician in surveying rip and mound lines.

Number of other sites requiring rehabilitation work (ie serious weed infestations) :	Nil	3
Advice on rehabilitation of these sites :	N/A	Treat blackberry.
Other management advice for this section :		Provide stabilised access points to the creek for stock crossing and watering. Ideally provide alternative watering point such as a dam, or pump to a trough utilising solar, wind generated or nose pumps. Do not remove woody snags, drag back to less than 40 degrees to bank to minimise erosion.

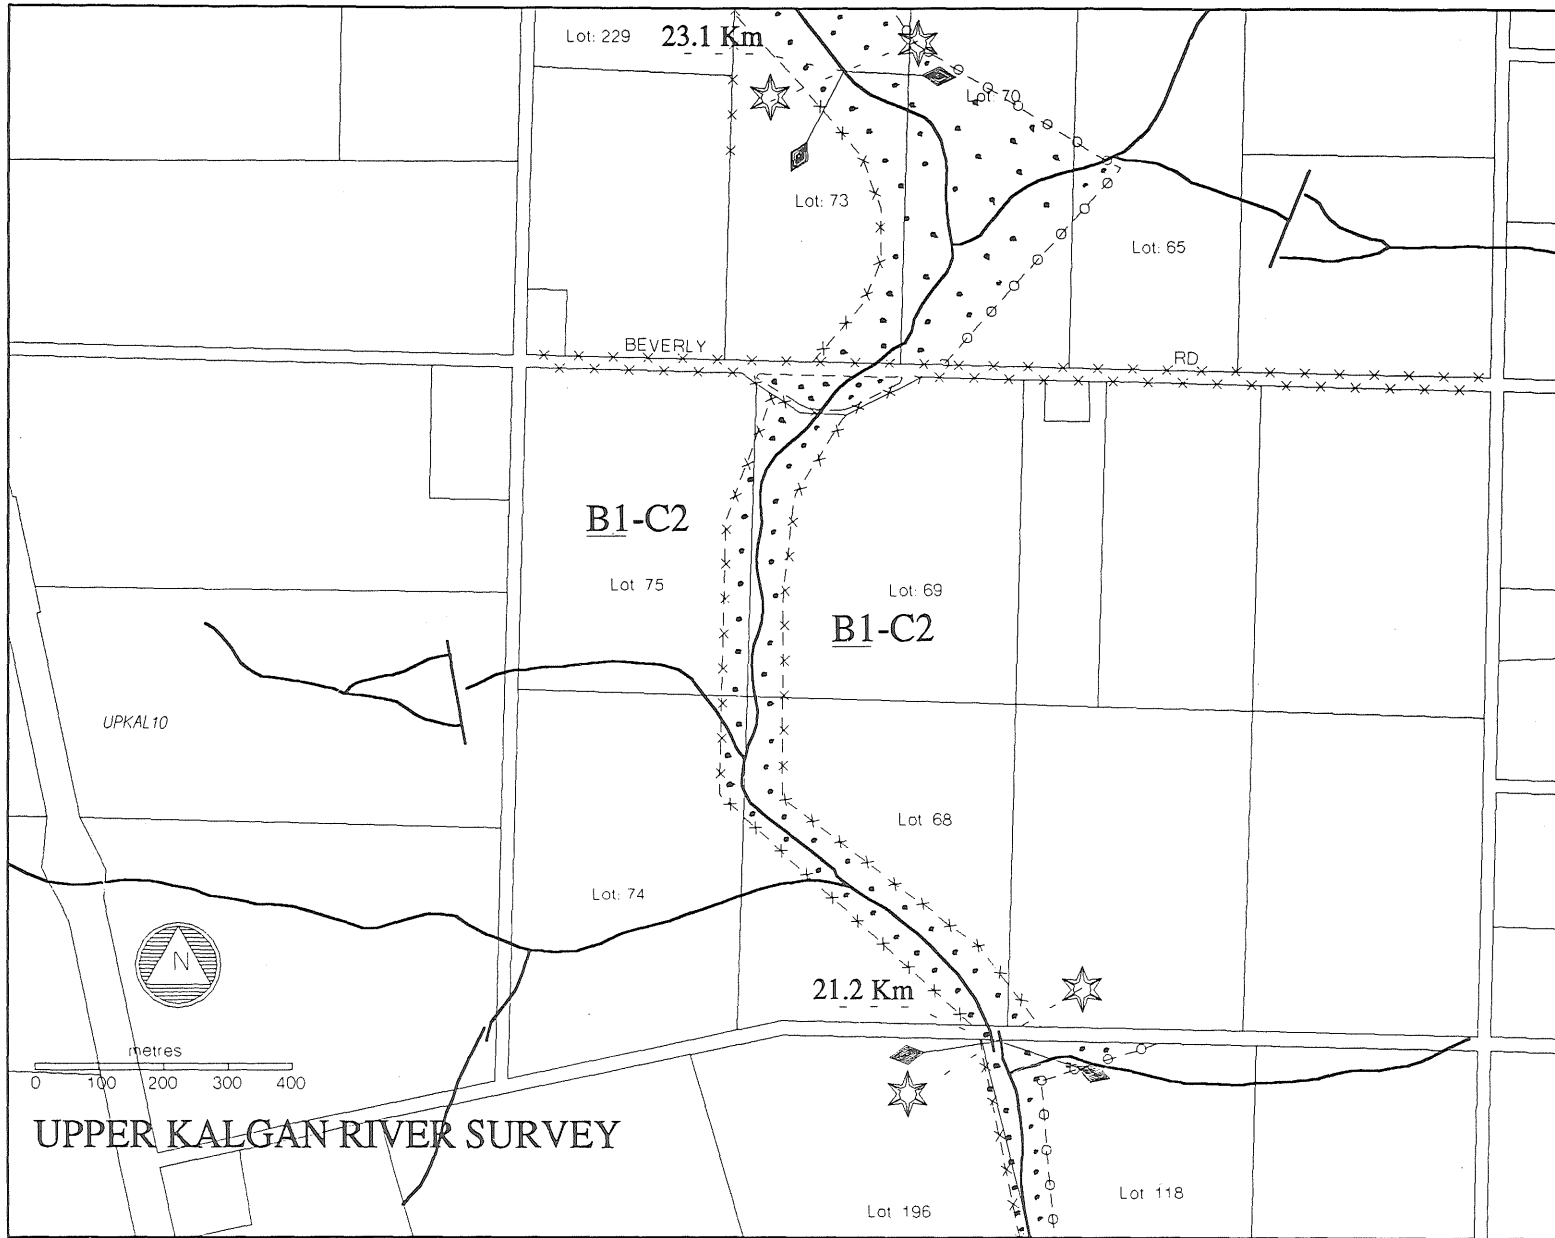
**UPPER KALGAN RIVER SURVEY - UPKAL10 See Map 1.2 (pg.4) for location**

<b>Left Bank</b>	<b>Right Bank</b>
<b>Length of Riverbank Fencing In Place :</b>	1.9km	1.1km
<b>Length of Riverbank Fencing Recommended :</b>	Nil	800m
<b>Number of Sites showing severe erosion :</b>	Numerous along whole site	Numerous along whole site
<b>Advice on remedial measures required for these sites :</b>	Fence from stock and revegetate.	Fence from stock and revegetate.
<b>No. of sites and cumulative approximate area of these sites along riverbank requiring riverbank revegetation work :</b>	No. of sites : Nil Priority N/A Area (ha) :	No. of sites : Nil Priority N/A Area (ha) :
<b>Advice on revegetation species and preparation :</b>	Select revegetation species from appropriate section of Appendix I of this report, including the following existing site species : <i>M.cuticularis</i> , <i>E.occidentalis</i> , <i>E.rudis</i> . Spot spray and spot plant in exposed areas. Direct seed samphire and salt bush on bare exposed salt patches. Ground for seeding will need to be scarified to break crust, and raked over once the seed has been cast.	Select revegetation species from appropriate section of Appendix 1 of this report, including the following existing site species : <i>M.cuticularis</i> , <i>E.occidentalis</i> , <i>E.rudis</i> . Spot spray and spot plant in exposed areas. Direct seed samphire and salt bush on bare exposed salt patches. Ground for seeding will need to be scarified to break crust, and raked over once the seed has been cast.

<b>Number of other sites requiring rehabilitation work (ie serious weed infestations) :</b>	Nil	Nil
<b>Advice on rehabilitation of these sites :</b>	N/A	N/A
<b>Other management advice for this section :</b>

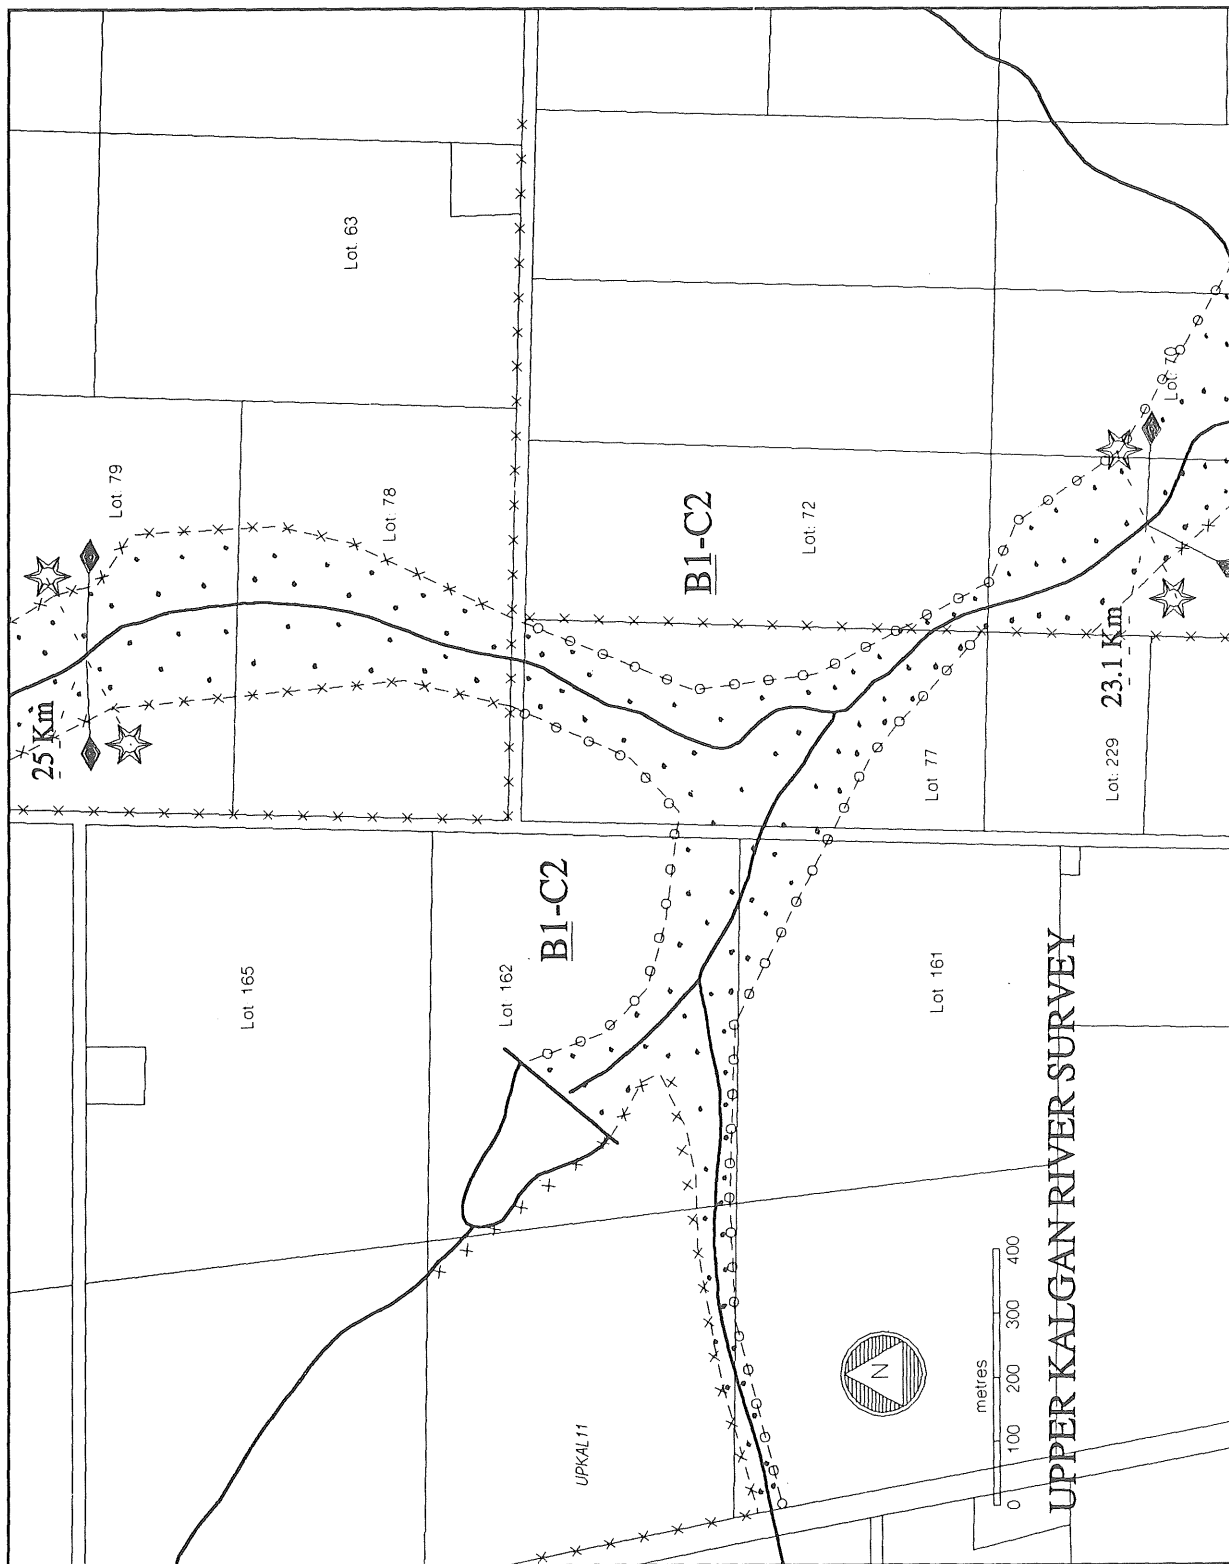
**UPPER KALGAN RIVER SURVEY - UPKAL11 See Map 1.2 (pg.4) for location**

Left Bank	Right Bank
Length of Riverbank Fencing In Place :	600m	600m
Length of Riverbank Fencing Recommended :	900m	1km
Number of Sites showing severe erosion :	Numerous along whole site	Numerous along whole site
Advice on remedial measures required for these sites :	Fence from stock and revegetate.	Fence from stock and revegetate.
No. of sites and cumulative approximate area of these sites along riverbank requiring riverbank revegetation work :	No. of sites : Nil	No. of sites : Nil
	Priority N/A	Priority N/A
	Area (ha) :	Area (ha) :
Advice on revegetation species and preparation :	Select revegetation species from appropriate section of Appendix 1 of this report, including the following existing site species : <i>M.cuticularis</i> , <i>E.occidentalis</i> , <i>E.rudis</i> . Direct seed samphire and salt bush on bare exposed salt patches. Area for planting should be ripped and mounded, herring bone fashion pointing towards the direction of flow. Ground for seeding will need to be scarified to break crust, and raked over once the seed has been cast.	Select revegetation species from appropriate section of Appendix 1 of this report, including the following existing site species : <i>M.cuticularis</i> , <i>E.occidentalis</i> , <i>E.rudis</i> . Direct seed samphire and salt bush on bare exposed salt patches. Area for planting should be ripped and mounded, herring bone fashion pointing towards the direction of flow. Ground for seeding will need to be scarified to break crust, and raked over once the seed has been cast.

Number of other sites requiring rehabilitation work (ie serious weed infestations) :	Nil	Nil
Advice on rehabilitation of these sites :	N/A	N/A
Other management advice for this section :	Provide stabilised access points to the creek for stock crossing and watering. Ideally provide alternative watering point such as a dam, or pump to a trough utilising solar, wind generated or nose pumps.	Provide stabilised access points to the creek for stock crossing and watering. Ideally provide alternative watering point such as a dam, or pump to a trough utilising solar, wind generated or nose pumps.
