SURVEY OF RIVER FORESHORES  
IN THE  
OYSTER HARBOUR CATCHMENT  
1997

WATER AND RIVERS COMMISSION REPORT WRT 17  
1997

To assist with the process of catchment repair, the Albany Waterways Management Authority commissioned APACE Green Skills to carry out a survey to assess the condition of selected foreshores of some of the Oyster Harbour Catchment's tributaries. The survey commenced in February 1997 and concluded in May 1997.

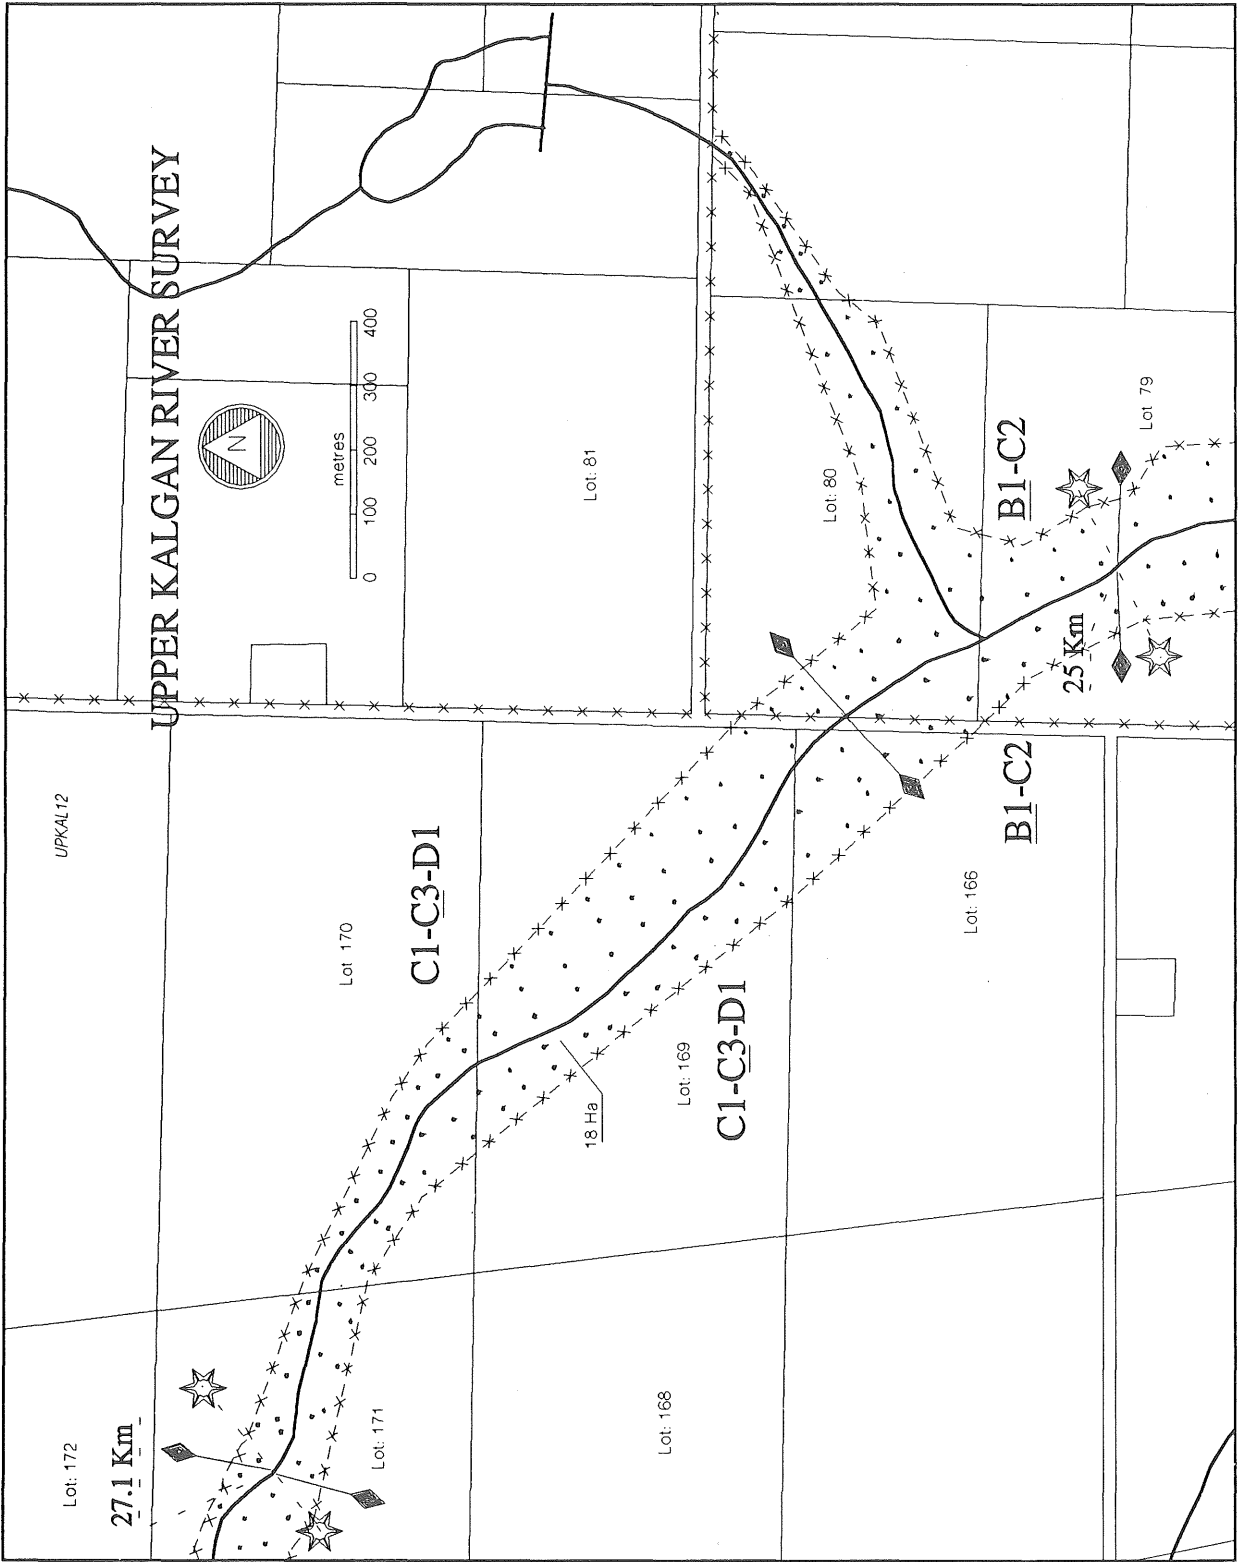
**UPPER KALGAN RIVER SURVEY - UPKAL12 See Map 1.2 (pg.4) for location**

Left Bank	Right Bank
Length of Riverbank Fencing In Place :	2.1km	2.1km
Length of Riverbank Fencing Recommended :	Nil	Nil
Number of Sites showing severe erosion :	Numerous along whole site	Numerous along whole site
Advice on remedial measures required for these sites :	Fence from stock and revegetate.	Fence from stock and revegetate.
No. of sites and cumulative approximate area of these sites along riverbank requiring riverbank revegetation work :	No. of sites : 1 Priority 1-urgent Area (ha) :18ha	No. of sites : 1 Priority 1-urgent Area (ha) :18ha
Advice on revegetation species and preparation :	Select revegetation species from appropriate section of Appendix 1 of this report, including the following existing site species : <i>M.cuticularis</i> , <i>E.occidentalis</i> , <i>E.rudis</i> . Direct seed samphire and salt bush on bare exposed salt patches. Area for planting should be ripped and mounded, herring bone fashion pointing towards the direction of flow. Ground for seeding will need to be scarified to break crust, and raked over once the seed has been cast.	Select revegetation species from appropriate section of Appendix 1 of this report, including the following existing site species : <i>M.cuticularis</i> , <i>E.occidentalis</i> , <i>E.rudis</i> . Direct seed samphire and salt bush on bare exposed salt patches. Area for planting should be ripped and mounded, herring bone fashion pointing towards the direction of flow. Ground for seeding will need to be scarified to break crust, and raked over once the seed has been cast.

Number of other sites requiring rehabilitation work (ie serious weed infestations) :	Nil	Nil
Advice on rehabilitation of these sites :	N/A	N/A

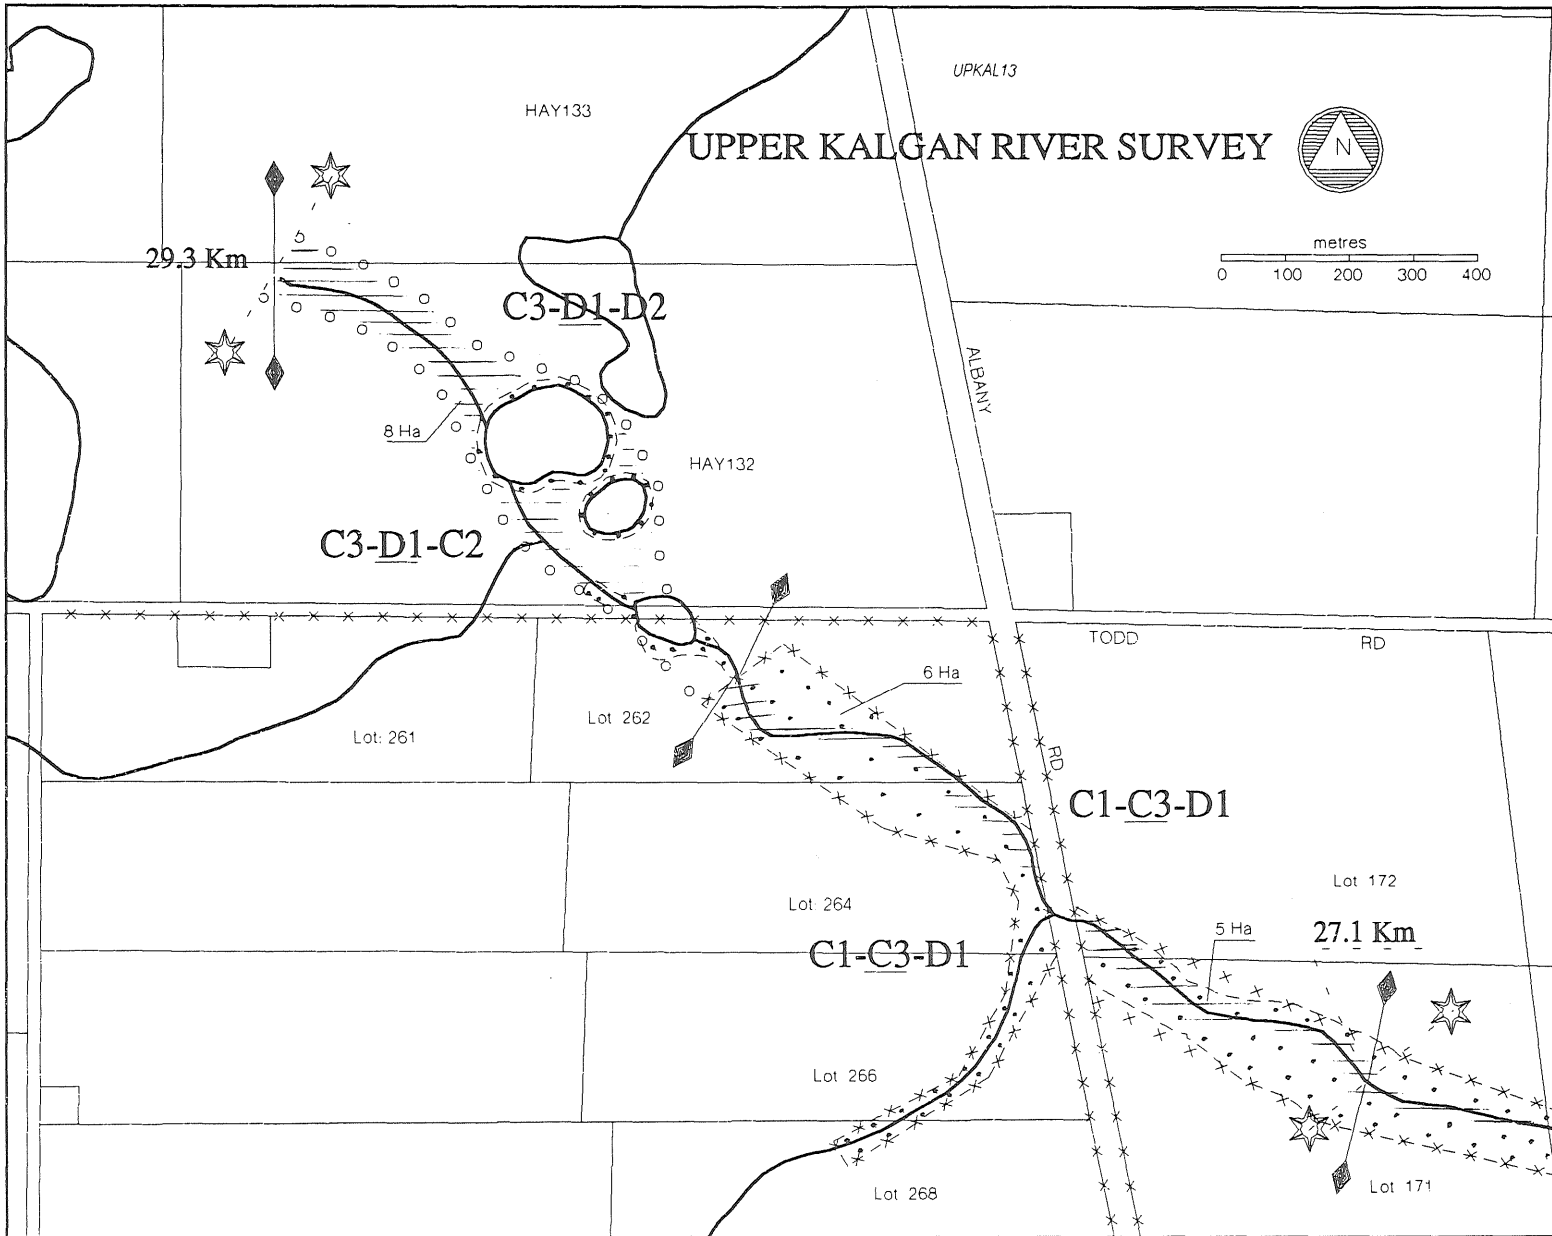
**UPPER KALGAN RIVER SURVEY - UPKAL13 See Map 1.2 (pg.4) for location**

<b>Left Bank</b>	<b>Right Bank</b>
<b>Length of Riverbank Fencing In Place :</b>	1.3km	1.1km
<b>Length of Riverbank Fencing Recommended :</b>	1km	950m
<b>Number of Sites showing severe erosion :</b>	Numerous along whole site	Numerous along whole site
<b>Advice on remedial measures required for these sites :</b>	Fence from stock and revegetate.	Fence from stock and revegetate.
<b>No. of sites and cumulative approximate area of these sites along riverbank requiring riverbank revegetation work :</b>	No. of sites : 3	No. of sites : 3
	Priority 1-urgent	Priority 1-urgent
	Area (ha) :19ha	Area (ha) :19ha
<b>Advice on revegetation species and preparation :</b>	Select revegetation species from appropriate section of Appendix 1 of this report, including the following existing site species : <i>M.cuticularis</i> , <i>E.occidentalis</i> , <i>E.rudis</i> . Direct seed samphire and salt bush on bare exposed salt patches. Area for planting should be ripped and mounded, herring bone fashion pointing towards the direction of flow. Ground for seeding will need to be scarified to break crust, and raked over once the seed has been cast.	Select revegetation species from appropriate section of Appendix 1 of this report, including the following existing site species : <i>M.cuticularis</i> , <i>E.occidentalis</i> , <i>E.rudis</i> . Direct seed samphire and salt bush on bare exposed salt patches. Area for planting should be ripped and mounded, herring bone fashion pointing towards the direction of flow. Ground for seeding will need to be scarified to break crust, and raked over once the seed has been cast.

<b>Number of other sites requiring rehabilitation work (ie serious weed infestations) :</b>	Nil	Nil
<b>Advice on rehabilitation of these sites :</b>	N/A	N/A
<b>Other management advice for this section :</b>

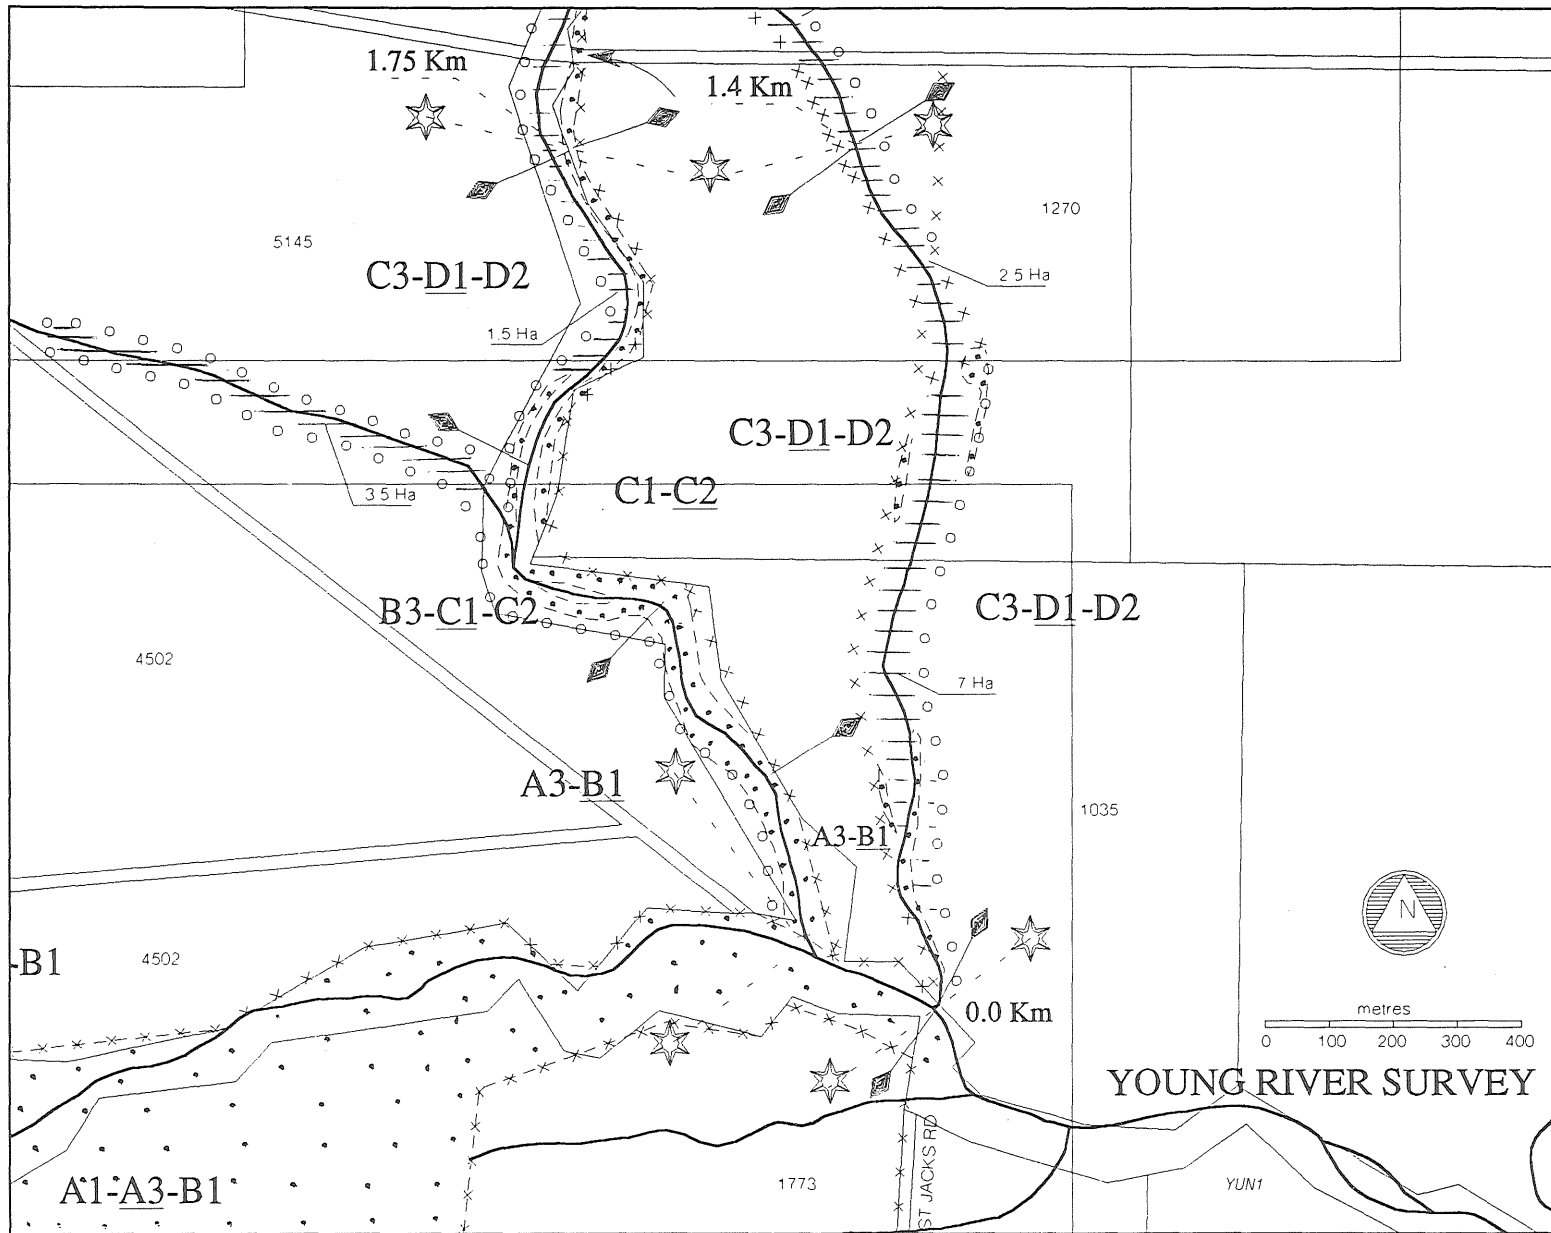
**YOUNG RIVER SURVEY -YOU1      See Map 1.2 (pg.4) for location**

<b>Left Bank</b>	<b>Right Bank</b>
<b>Length of Riverbank Fencing In Place :</b>	Left arm : Nil Right arm : 1.5km	Left arm : 1.5km Right arm : 150m
<b>Length of Riverbank Fencing Recommended :</b>	Left arm : 3km Right arm : Nil	Left arm : Nil Right arm : 1.3km
<b>Number of Sites showing severe erosion :</b>	Most of river flat is eroded	Most of river flat is eroded
<b>Advice on remedial measures required for these sites :</b>	Exclusion of stock, direct seeding of salt tolerants, planting seedlings.	Exclusion of stock, direct seeding of salt tolerants, planting seedlings.
<b>No. of sites and cumulative approximate area of these sites along riverbank requiring riverbank revegetation work :</b>	No. of sites : 4	No. of sites : 2
	Priority 1-urgent	Priority 1-urgent
	Area (ha) : 8.5ha	Area (ha) : 6ha
<b>Advice on revegetation species and preparation :</b>	Select revegetation species from appropriate section of Appendix 1 of this report, including the following existing site species: <i>M.cuticularis</i> , <i>E.occidentalis</i> , <i>E.decipiens</i> . Rip and mound parallel with river, not in eroded river channel. Direct seed eroded areas with samphire sp. and saltbush. These sites will need scarifying to break up the surface crust, and raked over once the seed has been cast.	Select revegetation species from appropriate section of Appendix 1 of this report, including the following existing site species: <i>M.cuticularis</i> , <i>E.occidentalis</i> , <i>E.decipiens</i> . Rip and mound parallel with river, not in eroded river channel. Direct seed eroded areas with samphire sp. and saltbush. These sites will need scarifying to break up the surface crust, and raked over once the seed has been cast.

<b>Number of other sites requiring rehabilitation work (ie serious weed infestations) :</b>	Nil	Nil
<b>Advice on rehabilitation of these sites :</b>	N/A	N/A
<b>Other management advice for this section :</b>	Provide stabilised access points to the creek for stock crossing and watering. Ideally provide alternative watering point such as a dam, or pump to a trough utilising solar, wind generated or nose pumps.	Provide stabilised access points to the creek for stock crossing and watering. Ideally provide alternative watering point such as a dam, or pump to a trough utilising solar, wind generated or nose pumps.

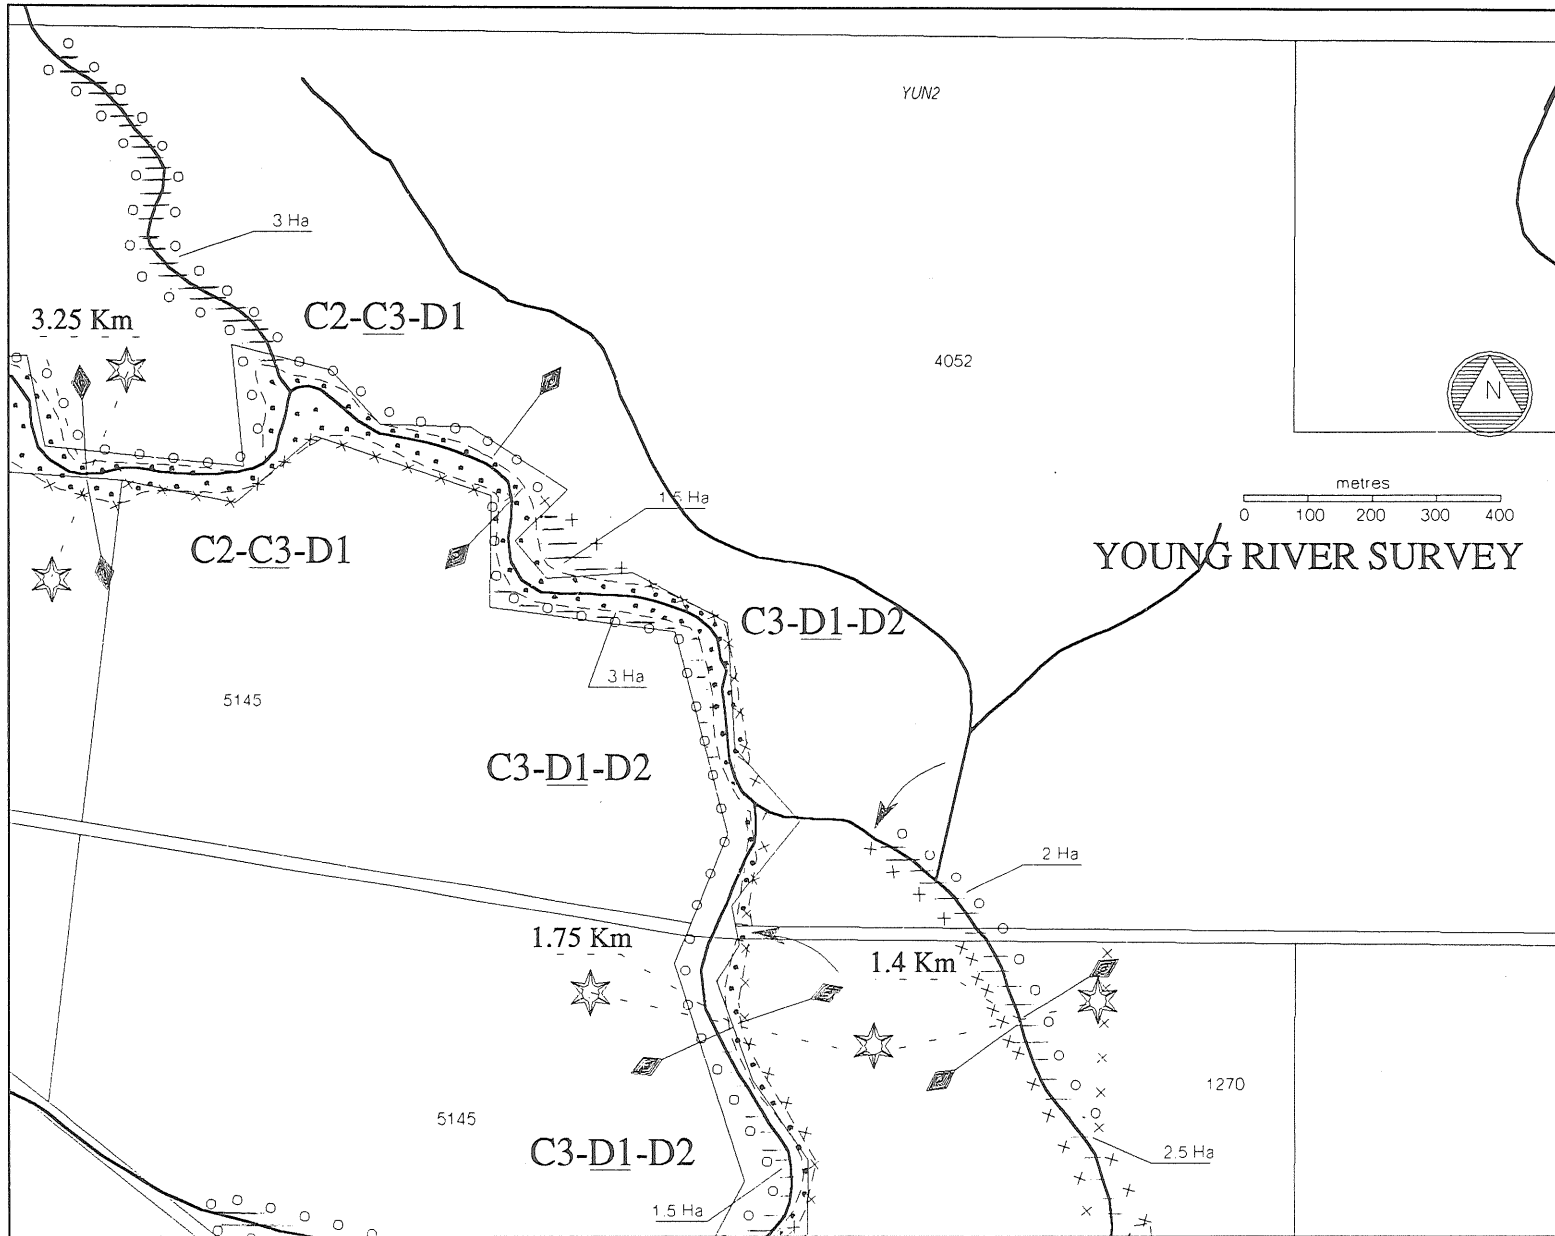
**YOUNG RIVER SURVEY -YOU2      See Map 1.2 (pg.4) for location**

<b>Left Bank</b>	<b>Right Bank</b>
<b>Length of Riverbank Fencing In Place :</b>	800m	1km
<b>Length of Riverbank Fencing Recommended :</b>	1km	2.2km
<b>Number of Sites showing severe erosion :</b>	Most of river flat is eroded	Most of river flat is eroded
<b>Advice on remedial measures required for these sites :</b>	Exclusion of stock, direct seeding of salt tolerants, planting seedlings.	Exclusion of stock, direct seeding of salt tolerants, planting seedlings.
<b>No. of sites and cumulative approximate area of these sites along riverbank requiring riverbank revegetation work :</b>	No. of sites : 1	No. of sites :3
	Priority 1-urgent	Priority 1-urgent
	Area (ha) : 3ha	Area (ha) : 6.5ha
<b>Advice on revegetation species and preparation :</b>	Select revegetation species from appropriate section of Appendix 1 of this report, including the following existing site species: <i>M.cuticularis</i> , <i>E.occidentalis</i> , <i>E.decipiens</i> . Rip and mound parallel with river, not in eroded river channel. Direct seed eroded areas with samphire sp. and saltbush. These sites will need scarifying to break up the surface crust, and raked over once the seed has been cast.	Select revegetation species from appropriate section of Appendix 1 of this report, including the following existing site species: <i>M.cuticularis</i> , <i>E.occidentalis</i> , <i>E.decipiens</i> . Rip and mound parallel with river, not in eroded river channel. Direct seed eroded areas with samphire sp. and saltbush. These sites will need scarifying to break up the surface crust, and raked over once the seed has been cast.

<b>Number of other sites requiring rehabilitation work (ie serious weed infestations) :</b>	Nil	Nil
<b>Advice on rehabilitation of these sites :</b>	N/A	N/A
<b>Other management advice for this section :</b>	Provide stabilised access points to the creek for stock crossing and watering. Ideally provide alternative watering point such as a dam, or pump to a trough utilising solar, wind generated or nose pumps.	Provide stabilised access points to the creek for stock crossing and watering. Ideally provide alternative watering point such as a dam, or pump to a trough utilising solar, wind generated or nose pumps.

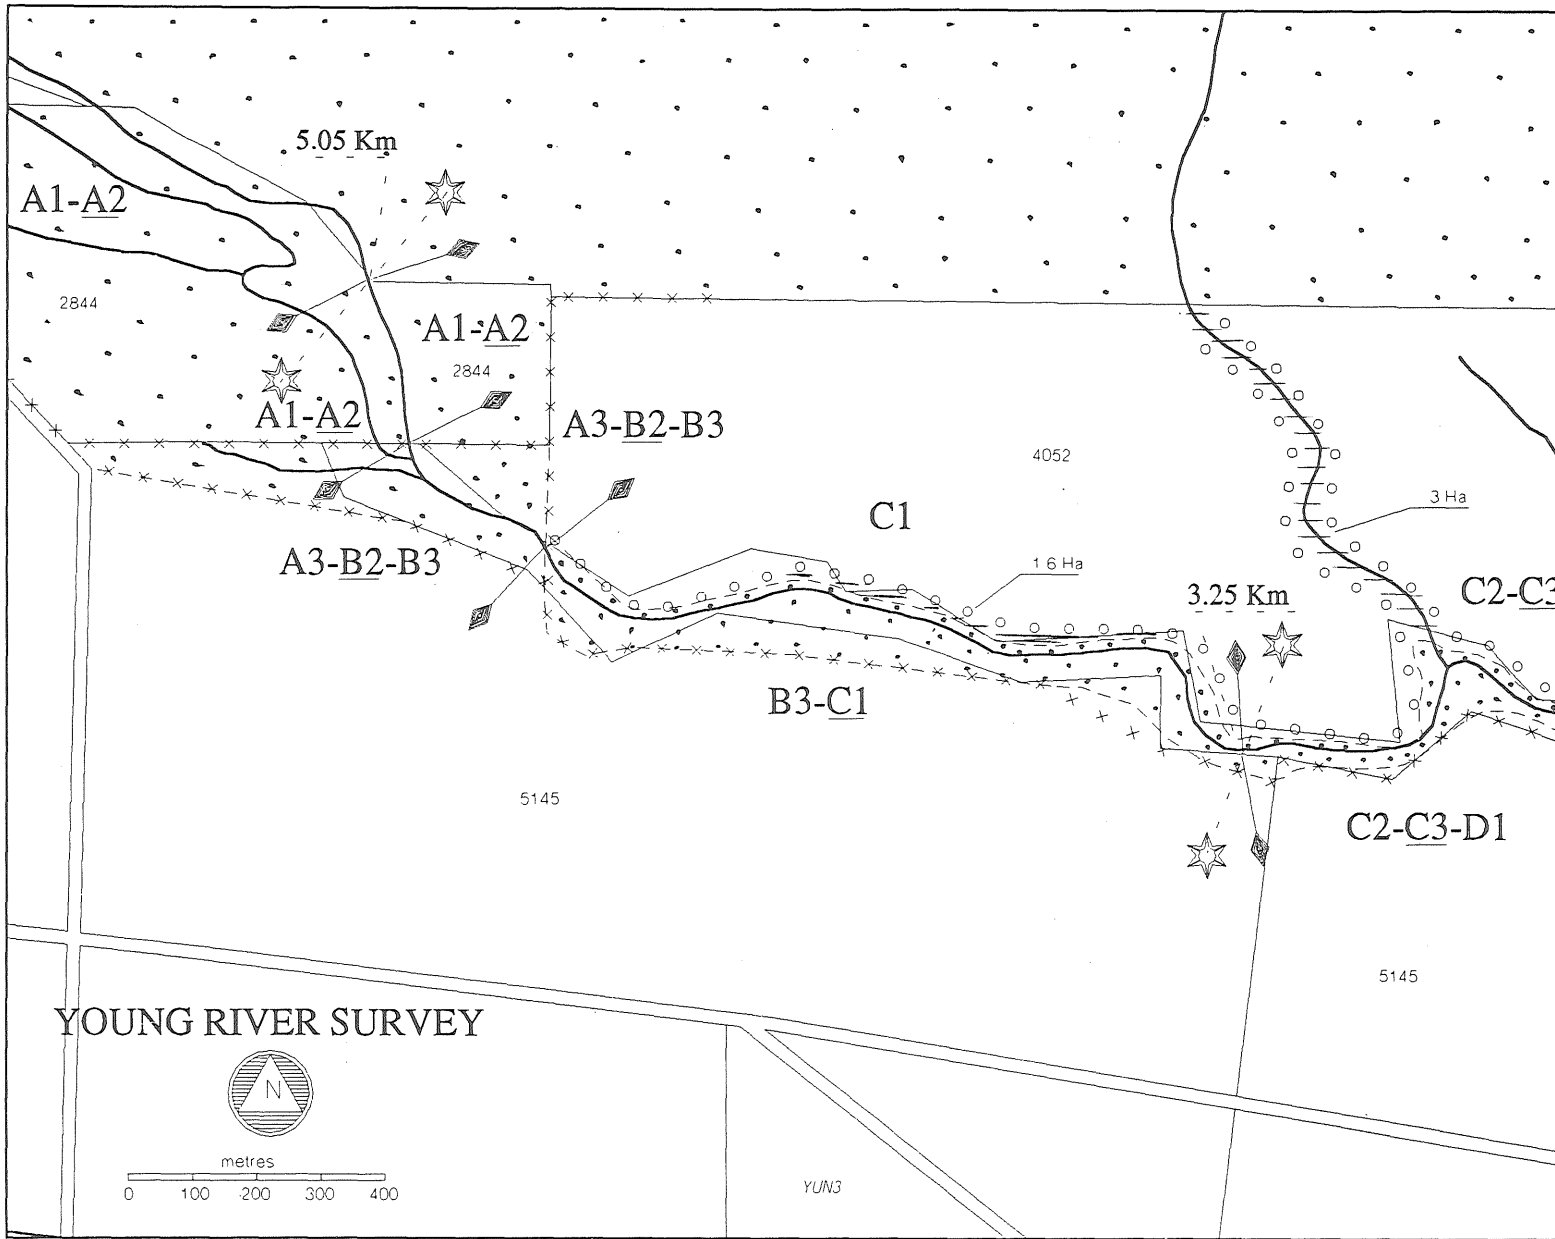
**YOUNG RIVER SURVEY -YOU3      See Map 1.2 (pg.4) for location**

Left Bank	Right Bank
Length of Riverbank Fencing In Place :	1.8km	350m
Length of Riverbank Fencing Recommended :	Nil	1.45km
Number of Sites showing severe erosion :	Most of lower river channel is eroded	Most of lower river channel is eroded
Advice on remedial measures required for these sites :	Exclusion of stock.	Exclusion of stock, direct seeding of salt tolerants, planting seedlings.
No. of sites and cumulative approximate area of these sites along riverbank requiring riverbank revegetation work :	No. of sites : Nil	No. of sites : 1
	Priority N/A	Priority 1-urgent
	Area (ha) :	Area (ha) : 1.6ha
Advice on revegetation species and preparation :	N/A	Select revegetation species from appropriate section of Appendix 1 of this report, including the following existing site species: <i>M.cuticularis</i> , <i>E.occidentalis</i> , <i>E.decipiens</i> . Rip and mound parallel with river, not in eroded river channel. Direct seed eroded areas with samphire sp. and saltbush. These sites will need scarifying to break up the surface crust, and raked over once the seed has been cast.

Number of other sites requiring rehabilitation work (ie serious weed infestations) :	Nil	Nil
Advice on rehabilitation of these sites :	N/A	N/A
Other management advice for this section :	Provide stabilised access points to the creek for stock crossing and watering. Ideally provide alternative watering point such as a dam, or pump to a trough utilising solar, wind generated or nose pumps.	Provide stabilised access points to the creek for stock crossing and watering. Ideally provide alternative watering point such as a dam, or pump to a trough utilising solar, wind generated or nose pumps.

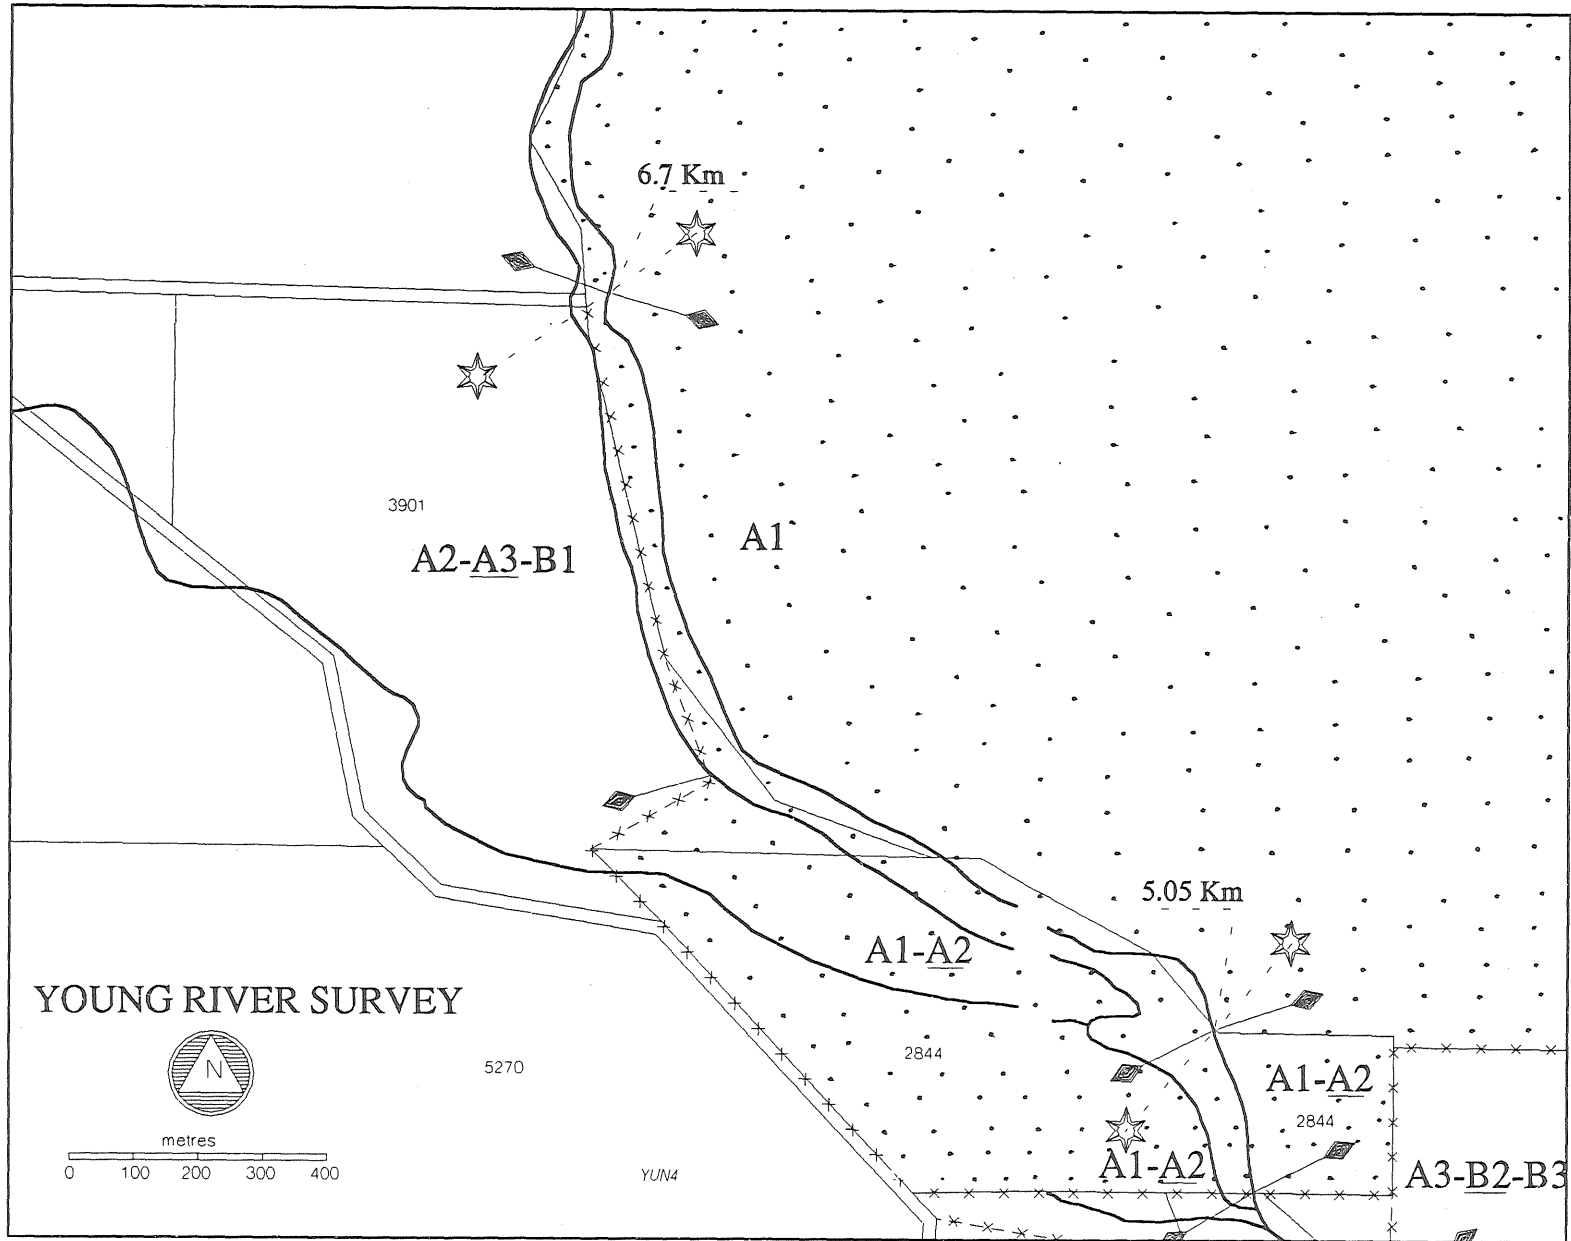
**YOUNG RIVER SURVEY -YOU4 See Map 1.2 (pg.4) for location**

<b>Left Bank</b>	<b>Right Bank</b>
<b>Length of Riverbank Fencing In Place :</b>	2.25km	1.75km
<b>Length of Riverbank Fencing Recommended :</b>	Nil	Nil
<b>Number of Sites showing severe erosion :</b>	Nil	Nil
<b>Advice on remedial measures required for these sites :</b>	N/A	N/A
<b>No. of sites and cumulative approximate area of these sites along riverbank requiring riverbank revegetation work :</b>	No. of sites : Nil	No. of sites : Nil
	Priority N/A	Priority N/A
	Area (ha) :	Area (ha) : Nil
<b>Advice on revegetation species and preparation :</b>	N/A	N/A
<b>Number of other sites requiring rehabilitation work (ie serious weed infestations) :</b>	Nil	Nil
<b>Advice on rehabilitation of these sites :</b>	N/A	N/A
<b>Other management advice for this section :</b>
