# FORESHORE AND CHANNEL ASSESSMENT OF THE TOODYAY BROOK

WATER AND RIVERS COMMISSION REPORT WRM 22

2001

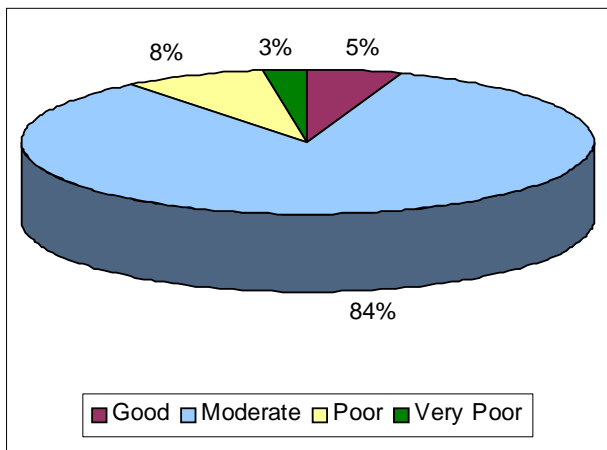
**Figure 11. Vegetation cover along Toodyay Brook**

Figure 11 depicts results collated for stream cover during a survey to determine the Overall Stream Environmental Rating. 84% of the sections were rated as having a moderate stream cover, meaning that there is some permanent shade and overhanging vegetation with some instream cover (Pen and Scott, 1995). 8% were rated as poor, 5% as good and 3% as having very poor stream cover. No sites were recorded as having an excellent stream cover.
