FORESHORE AND CHANNEL ASSESSMENT OF TALBOT BROOK

Cover Photograph: Channel and foreshore condition along Talbot Brook (Patricia Janssen, 2001).

WATER AND RIVERS COMMISSION
REPORT NO. WRM 29
2002

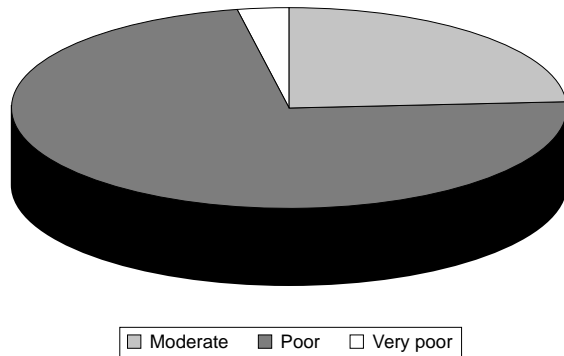
Figure 1. Bank stability and sedimentation ratings for Talbot Brook

Results indicate that the majority of sections were recorded as having sedimentation and poor bank stability when rated in terms of the overall stream environmental health.

Figure 1 shows that 24% of surveyed sections were rated as having moderate bank stability and erosion. The majority of sections (73%) were classified as poor and 3% as very poor. 9% of the surveyed sections were utilising artificial stabilisation techniques along the banks, meaning that techniques, such as log and rock walling, have been employed along the banks to protect degraded areas from further erosion and undercutting. There were also some locations (ie. road bridges) where channel stabilisation had been undertaken as part of engineering structures for safety reasons and to support the construction of such features.

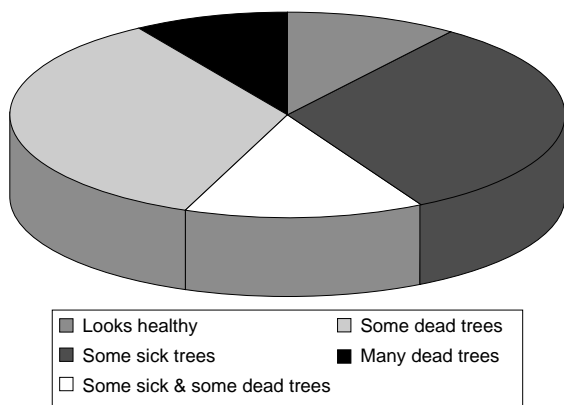
Figure 3. Vegetation health

Vegetation health was determined to be moderate along most of Talbot Brook and tree death was obvious in many areas. As described above, there was a lack of middle- storey plants in most areas and the ground cover was dominated in most instances by weed species.

Figure 3 shows that 32% of surveyed sections recorded some sick trees among the foreshore vegetation, while 35% of sites had some dead trees. Only 10% of sites were recorded as having healthy looking vegetation (ie. lots of leaves, natural regeneration of native species, lack of weeds, diversity of native species and a low level of disease and insects).

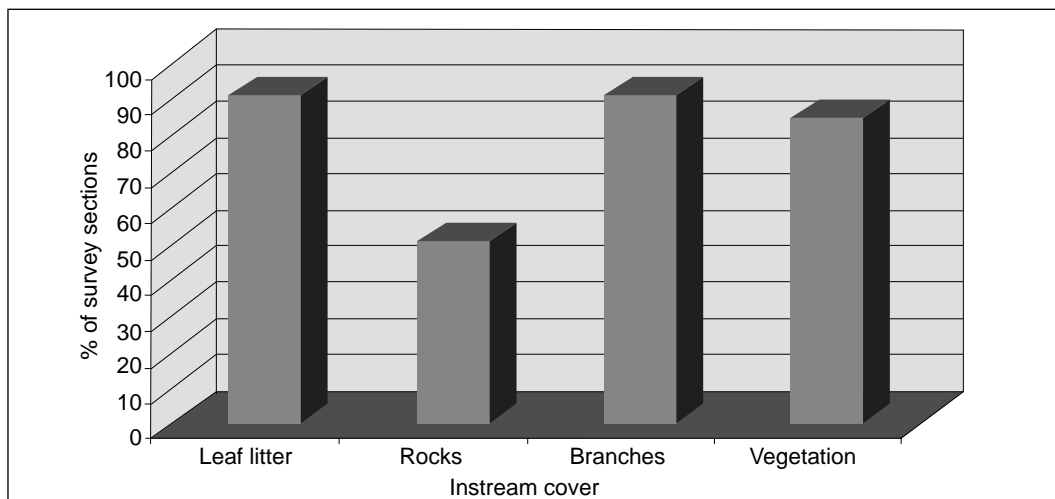
Figure 4. Proportion of instream cover

Instream cover was moderate in 65% of sections when determined as part of the overall stream environmental health rating. There was often a mixture of leaf litter, rocks, branches and vegetation. Figure 4 shows the proportion of sites that had instream cover.

Figure 4 shows that leaf litter and branches were the most common form of instream cover and habitat type, occurring in 91% of sites, followed by vegetation which was recorded at 85% of sections.

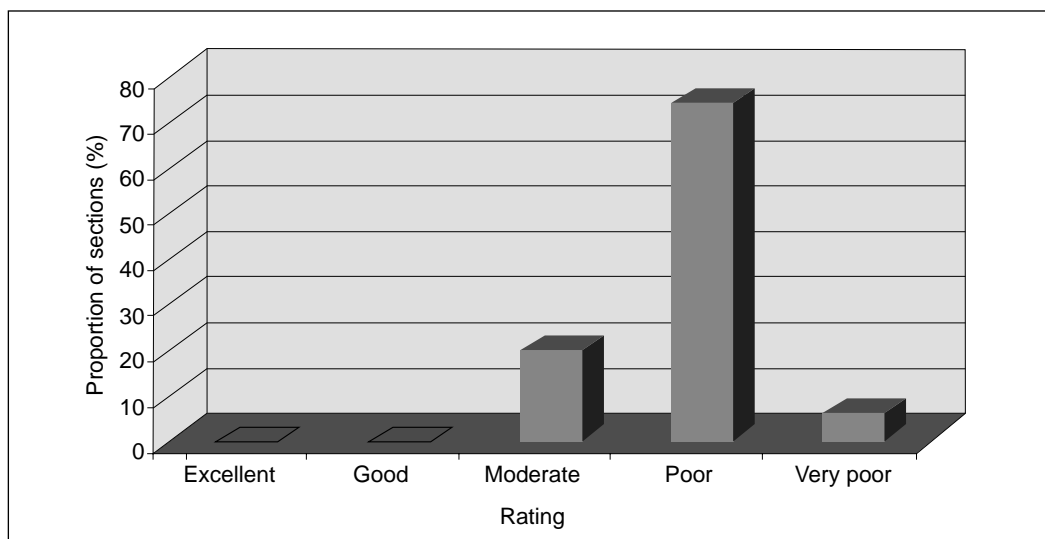
Figure 5. Overall stream environmental health ratings

The results in Figure 5 show that only 20% of the surveyed sections were classified as having a moderate stream health, 74% as poor and 6% as having very poor stream health. The dominantly poor health rating of the brook was mainly due to poor ratings in all categories with the exception of stream cover and habitat diversity of which 65% and 88% of sites respectively were rated as moderate, as shown in Table 7. Appendix 4 provides a description of each factor at each level of health.

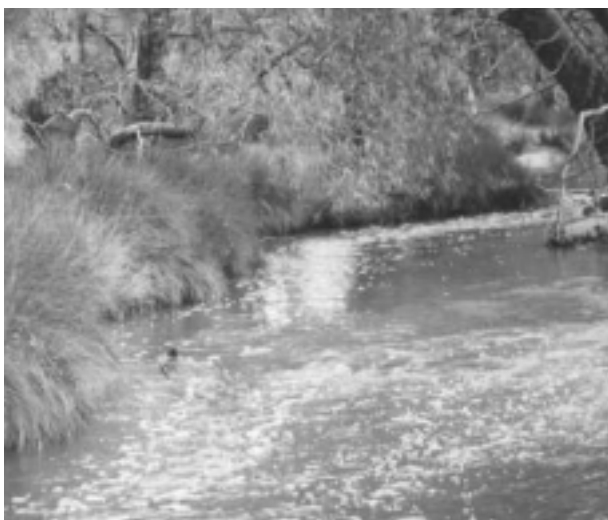
Fringing vegetation provides shade and habitat, and also filters water entering the waterway

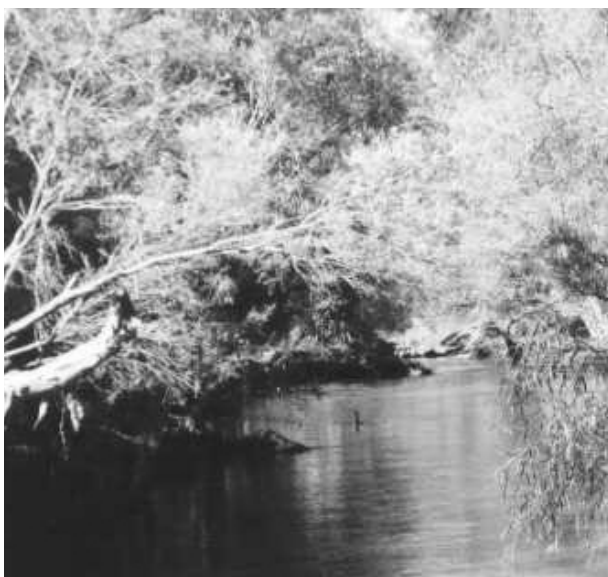
Overhanging vegetation provides shade and habitat for a range of aquatic and terrestrial fauna

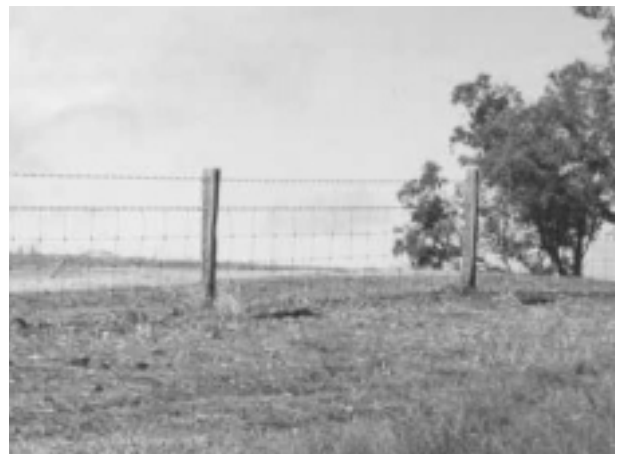
Fence condition: GOOD
