Foreshore and channel assessment of Jimperding Brook

Water resource management series

Report No. WRM 48
February 2008

Prepared by Viv Read & Associates for Department of Water
and the Avon Waterways Committee

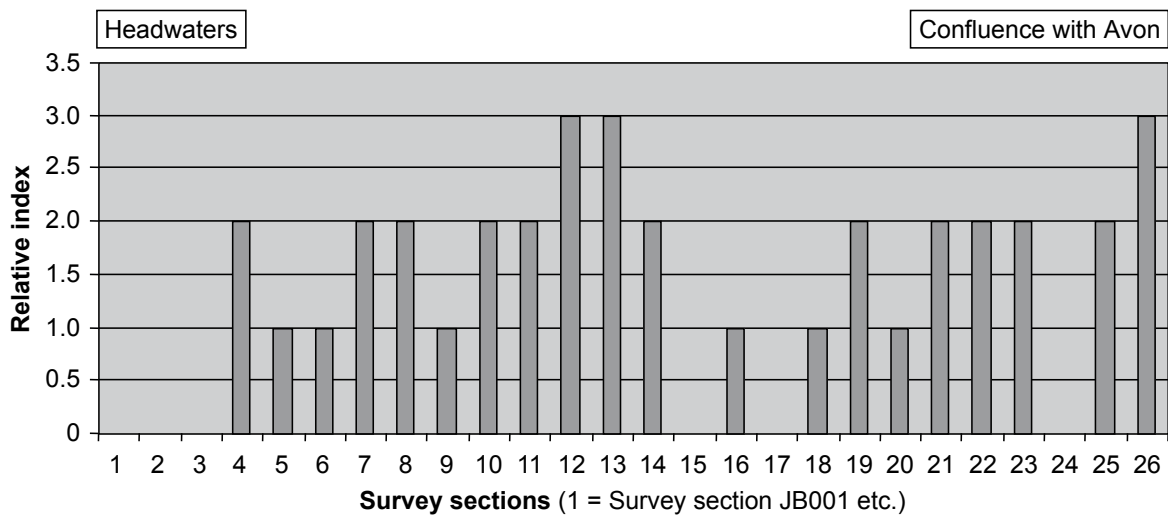
Figure 5 Relative index for sedimentation of Jimperding Brook survey sections

The occurrence of sediments was recorded for each section during the survey. Figure 5 shows that most sections had a medium level of sediment and there was a higher level for three sections (JB012, JB013 and JB026). However, observations of sediment did not provide estimates of volume. In most sections, there were only minimal amounts of sediment and pools, although small, were not filled with sediment.

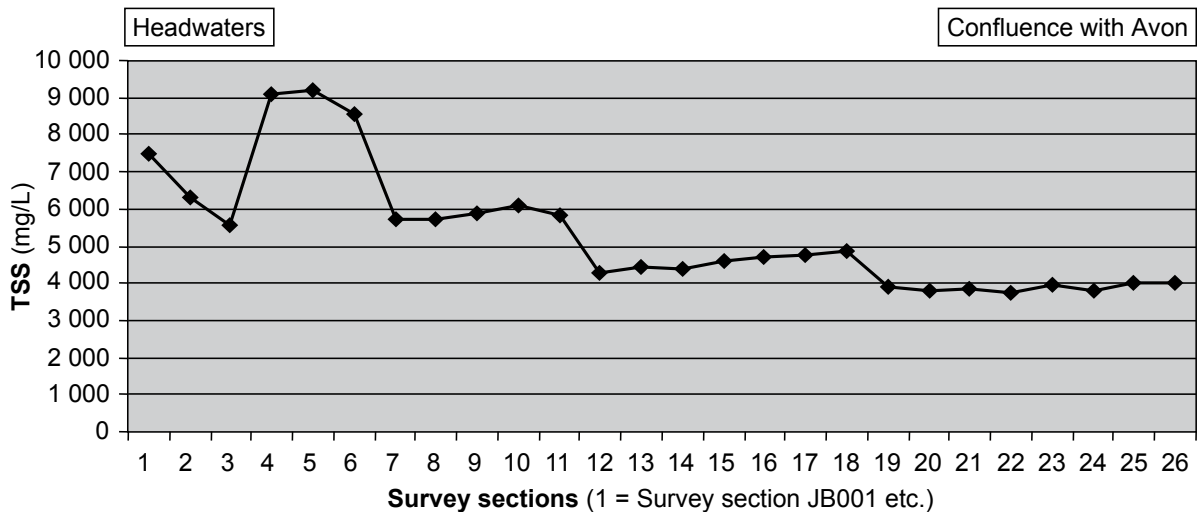
Figure 6 Stream flow salinity of Jimperding Brook survey sections

Stream flow salinity was measured at the downstream end of each section (Appendix 6, Table 5.4). The results shown in Figure 6 indicated a generally declining trend with the distinct exception for sections JB004-6. These were high due to saline groundwater discharge. In section JB006, salinity was exacerbated by intrusive bedrock.

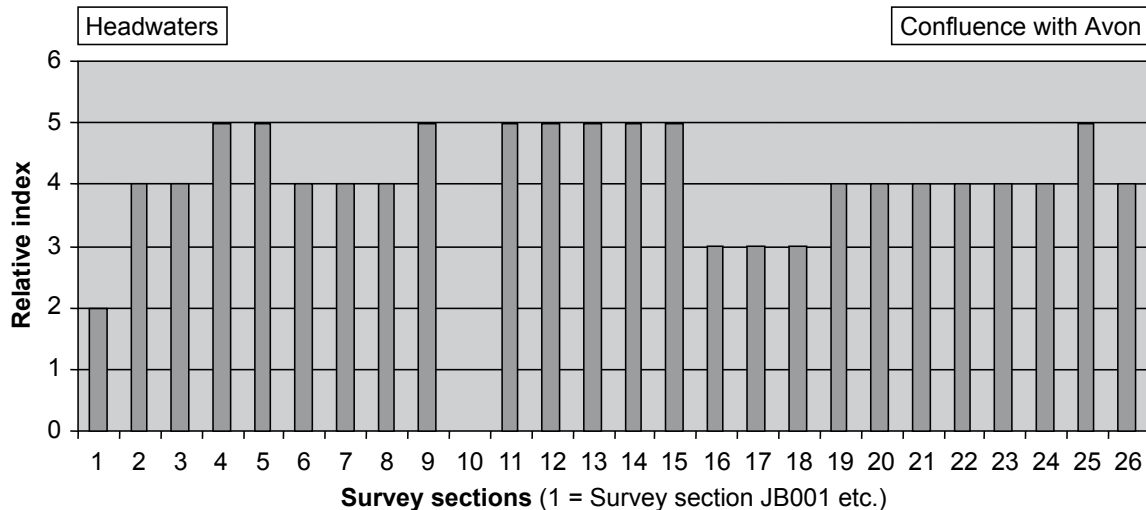
Figure 7 Riparian zone vegetation health of Jimperding Brook survey sections

A subjective assessment was made of vegetation health. This was shown in Figure 7. In general, the dominant species were quite healthy. Salinity was affecting riparian vegetation in section JB001 (all trees in the riparian zone were dead), JB002 and JB006. Jarrah Leaf Miner (*Perthida glyphopa*), an insect that causes significant foliage damage to flooded gums (*Eucalyptus rudis*), has inflicted such damage downstream from section JB016.

Note: 5 = 'looks healthy'; 4 = 'some sick trees'; 3 = 'many sick trees'; 2 = 'some dead trees'; 1 = 'many dead trees'; 0 = no vegetation.

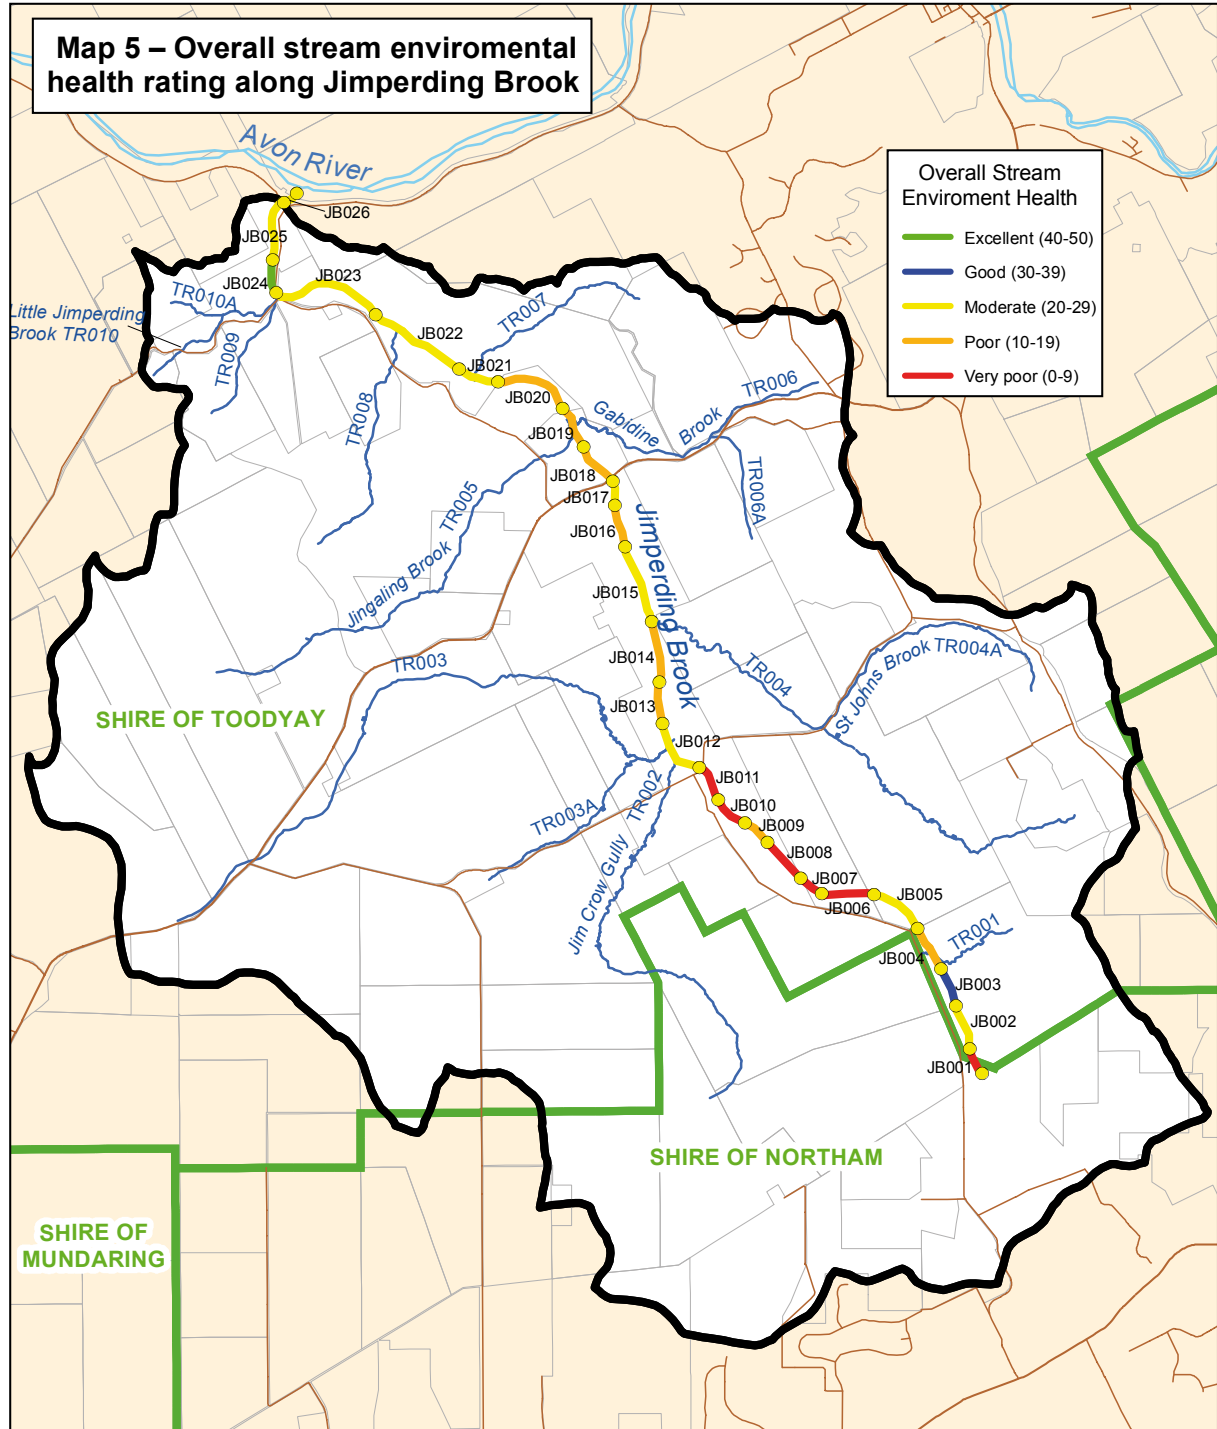
Map 5 – Overall stream environmental health rating along Jimperding Brook

Map 5 shows the rating for each of the sections. There was no clear trend in environmental health for the whole river system. It showed the first section to be poor compared with the two immediate downstream sections. The set of sections from JB006 to JB011 were consistently of poor environmental health with JB010 having an exceptionally low score (2).

While section JB018 was of poor environmental health, there was a steadily increasing health trend downstream to section JB024 which was rated as 'excellent' with a score of 42 (the maximum possible score is 55). The relatively low score for section JB025 reflected its previous degraded condition. This section was recovering as a result of good river management (fencing and revegetation) activities.
