Foreshore and channel assessment of Monjerducking Gully

Report no. WRM 53
March 2009

Prepared by
BlueSands Environmental
for Department of Water

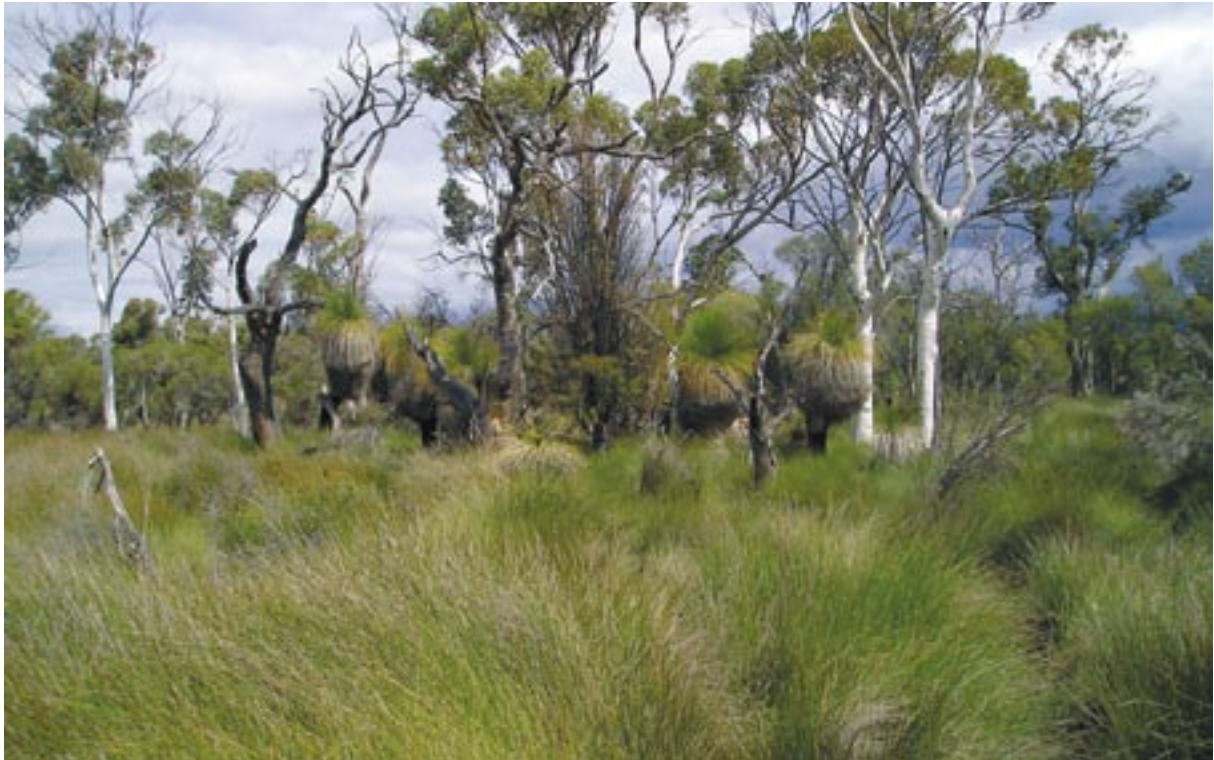
For a section to be rated as A-grade, the riparian zone must be vegetated entirely with native species (Photo 4). Some weeds may be present but native species still dominate the understorey and there is little or no evidence of disturbance from human activities or introduced animals. This general rating is further divided to reflect the level of weed invasion and disturbance.

Photo 4 An A-grade reach of a tributary of Christopher Brook in the Dale River catchment (note the well vegetated channel along the right hand side and an absence of weeds)

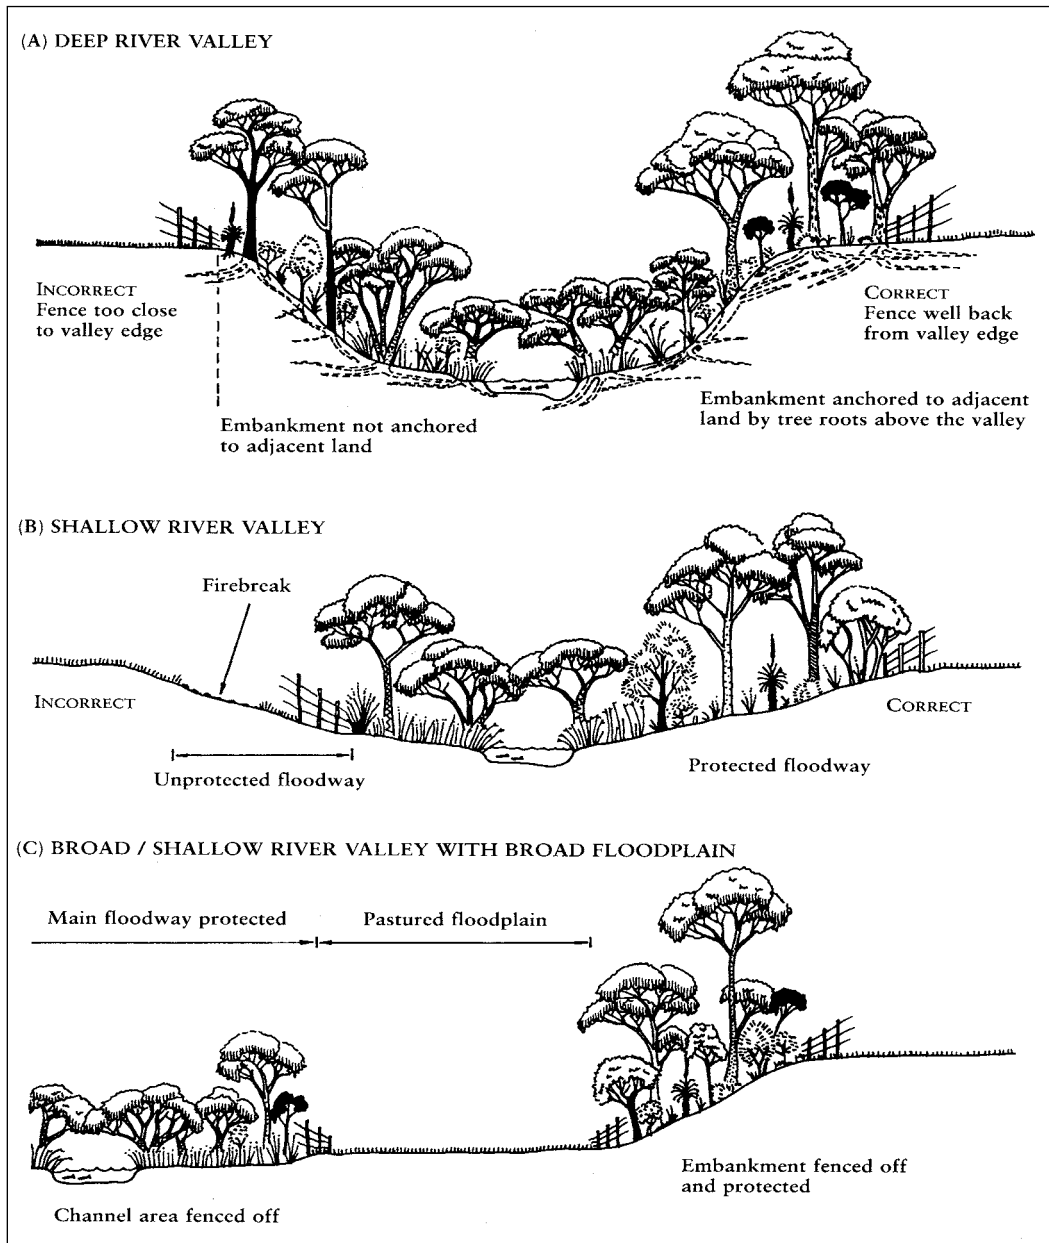
Monjerducking Gully has a broad river valley. Figure 2 indicates the most appropriate location of fencing in these waterways. It is important to fence the channel and floodway, but it is acknowledged that due to the large floodplains of broad waterways it is often difficult to fence the entire valley. However, where there are salt lakes or salt scalds in the floodplain, these should be incorporated in the fenced area.

Figure 2 Ideal fence placement along river floodways

Fences can be constructed to resist flood damage by constructing them with the lowest height that gives adequate stock control. Posts should also be located as close together as possible and placed into the ground as firmly as possible. Fences crossing waterways also require regular maintenance to prevent damage from accumulating woody debris (Department of Environment, 2006).

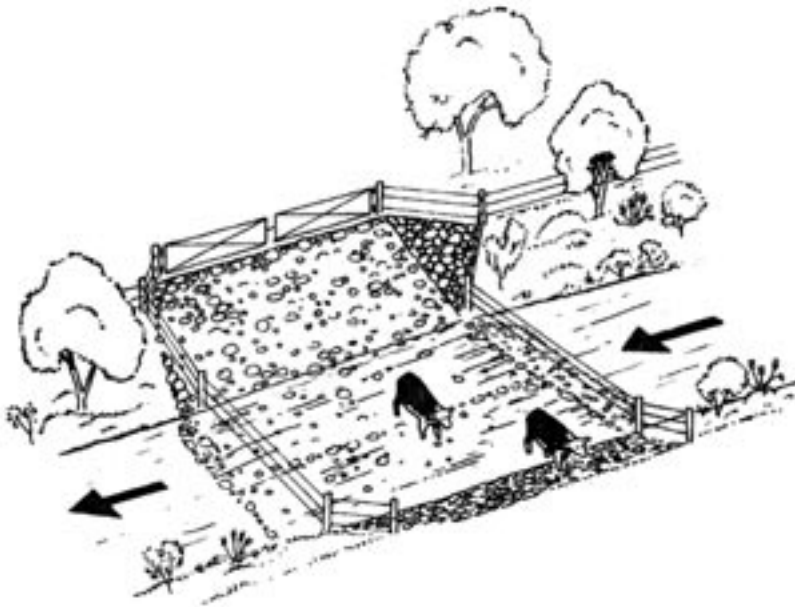
Figure 3 Basic geometry of a livestock crossing
(Source: Water and Rivers Commission, 2000b)

straight stretch of the waterway, where the bed is naturally high and the banks are not too steep. If the bed is soft, it should be hardened up with rock or field stone (not gravel, as this will be washed away). This rocky crossing will also act as a riffle and help to trap sediment and provide a habitat for aquatic fauna. Figure 3 illustrates the correct placement of crossings and fences on waterways.

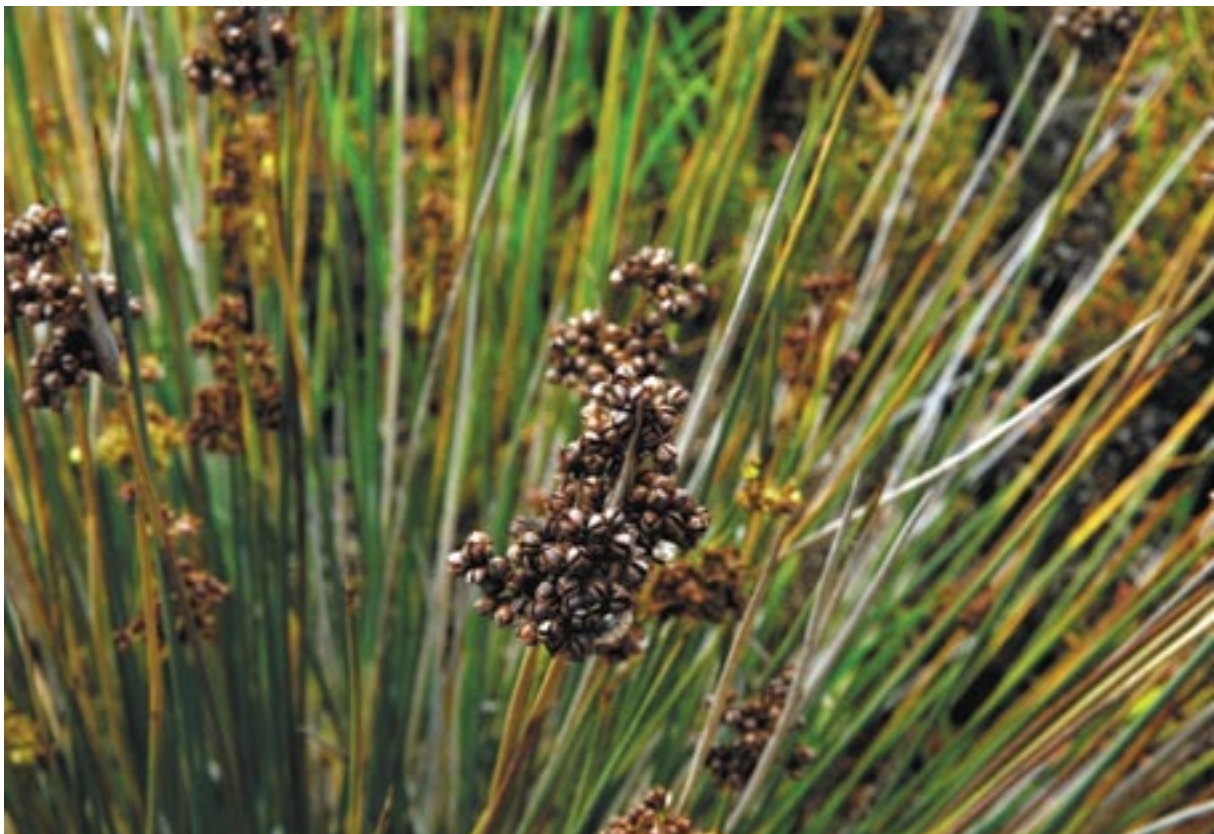
This species has been mistaken for a native rush by many landowners and as such, has been left untreated. Photos 11 and 12 illustrate the growth form and seed heads of sharp rush (*Juncus acutus*).

Photo 12 Sharp rush (Juncus acutus) seed head (Photo: Kate Gole, Department of Water)

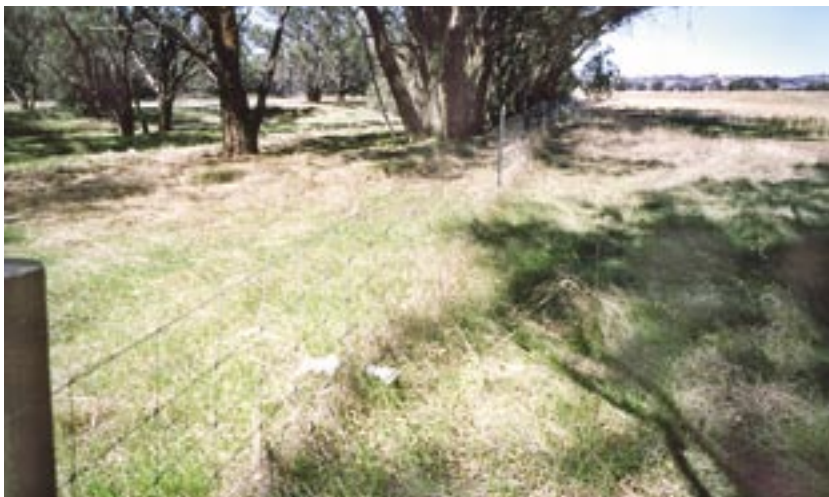
Fence in good condition
