Lower Avon river recovery plan: Incorporating foreshore and channel assessment

River recovery plan series

Report No. RRP 13
June 2008

Prepared by Viv Read & Associates for
Department of Water and the Avon Waterways Committee.

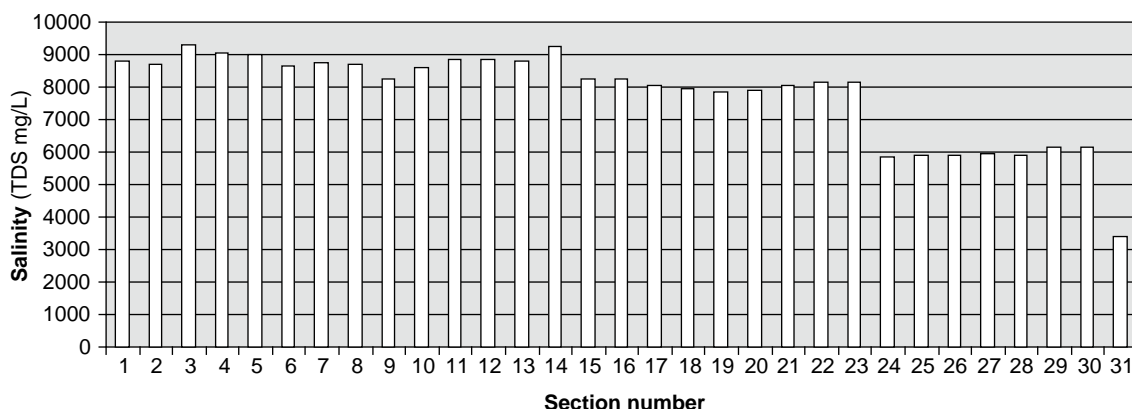
Figure 4.4 Streamflow salinity (total dissolved salts in mg/L) for survey sections of the lower Avon River

The salinity of streamflow was measured at the downstream end of each river section (listed in Appendix 6). Figure 4.4 shows the declining salinity trend downstream. Streamflow salinity is relatively consistent (at approximately 9000 mg/L TDS) for the first 14 river sections. It decreases in Section LA15 due to fresh inflow from Red Swamp Brook. Salinity declines significantly in Section LA24 with inflow from the Brockman River (measured at 5775 mg/L TDS at the time of survey) and there is further significant decline in Section LA31 with inflow from Wooroloo Brook.

There are several sections where fringing vegetation appears to be affected by high streamflow salinity, however, there is generally very little evidence of environmental impact from increased streamflow salinity as a result of clearing native vegetation in the Avon River catchment for agriculture. This assessment does not account for ecological change that may have occurred within the pool and riffle aquatic ecosystems.

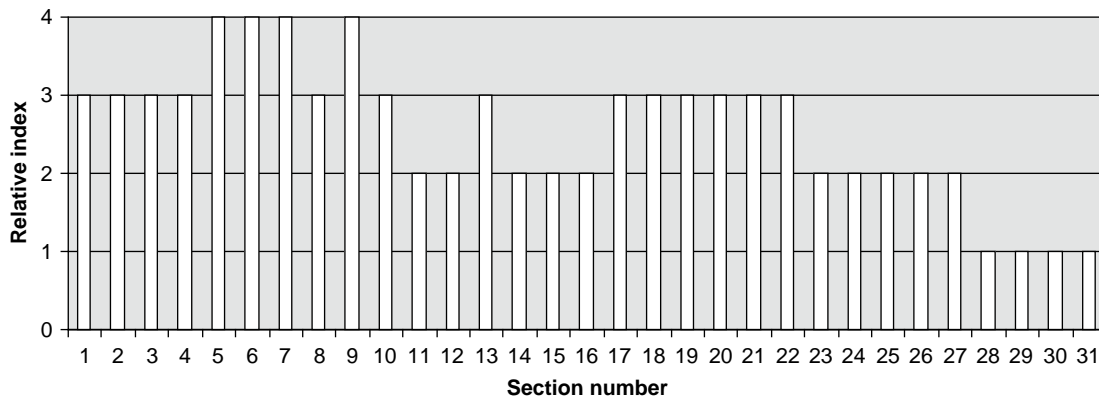
Figure 4.7 Soil disturbance caused by wild pigs in survey sections of the lower Avon River

Wild pigs have been introduced to the landscapes of the Lower Avon river section. Small groups of wild pigs forage in the moist floodways and banks of the river, causing very substantial disturbance to the sedimentary soils of the river environment. The pigs range along the length of the river so disturbance is extensive on both sides. From observations made during the river survey, it was clear that soil disturbance occurs frequently, with recent disturbance a common occurrence.

Figure 4.7 shows that four river sections have severe soil disturbance and a further 13 sections have significant disturbance. Over 50% of the Lower Avon river section has significant or severe soil disturbance caused by pigs. Minimal disturbance occurs only in the four downstream survey sections (LA28–31).

With significant soil disturbance for prolonged periods in floodways, levees and banks of the river, the potential for erosion and sediment transport during high flow events is high. Increasing river levels by just 50 cm from winter base flow would cause erosion. These medium to fine grained sediments are considered to be relatively high in nutrients compared with coarse sand sediments, as coarse sediments have a lower surface area and therefore lower potential for nutrient adsorption. Therefore, these sediments may contribute to nutrient enrichment in upper reaches of the Swan River where streamflow velocity is reduced and sediments are deposited.

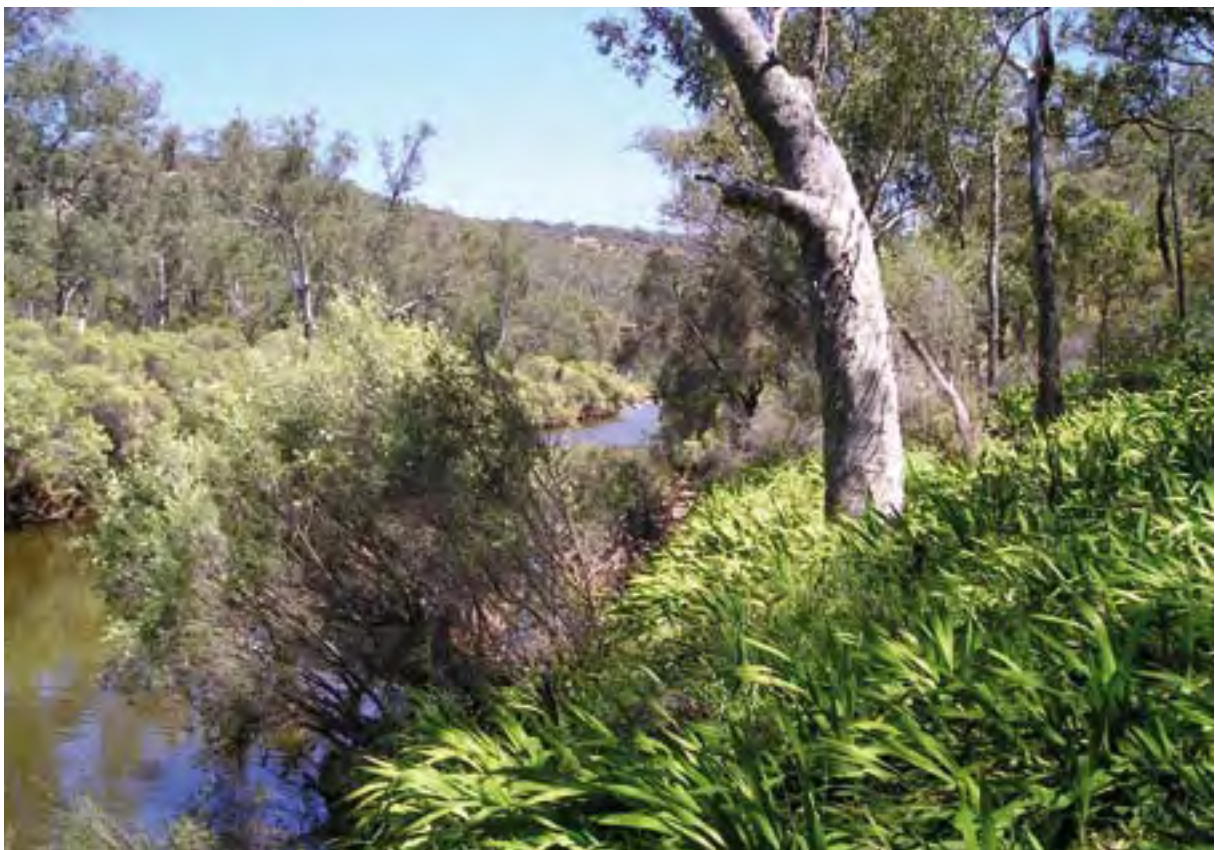
Photo 17 Watsonia (Watsonia bulbillifera)

upstream. This weed occurs in isolated patches with vigorous regeneration in response to soil disturbance by pigs.

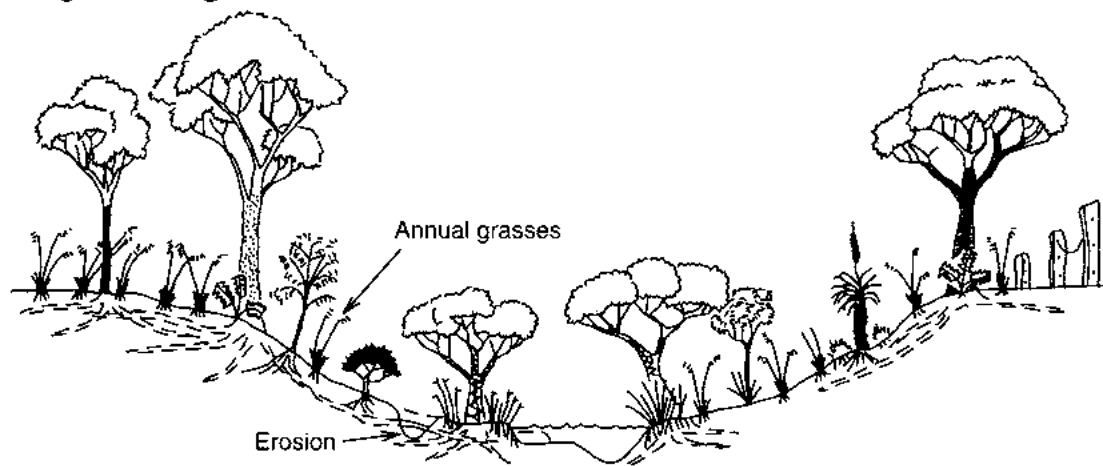
B grade: degraded

B-grade - The foreshore vegetation had been invaded by weeds, mainly grasses, and looks similar to typical roadside vegetation:

B1. Degraded – weed infested – Weeds have become a significant component of the understorey vegetation. Native species are still dominant but a few have been replaced by weeds.

B2. Degraded – heavily weed infested – Understorey weeds are nearly as abundant as native species. The regeneration of trees and large shrubs may have declined.

B3. Degraded – weed dominant – Weeds dominate the understorey, but many native species remain. Some trees and large shrubs may have disappeared.

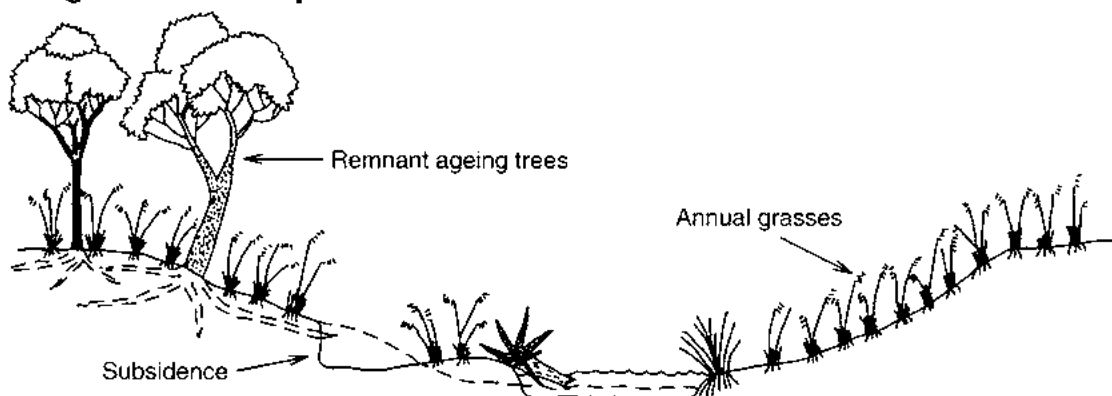
C grade: erosion prone to eroded

C-grade - The foreshore supports only trees over weeds or pasture. Bank erosion and subsidence may occur in localised areas:

C1. Erosion prone – Trees remain with some large shrubs or tree grasses and the understorey consists entirely of weeds (i.e. annual grasses). There is little or no evidence of regeneration of tree species. River embankment and floodway are vulnerable to erosion due to the shallow-rooted weedy understorey providing minimal soil stabilisation and support.

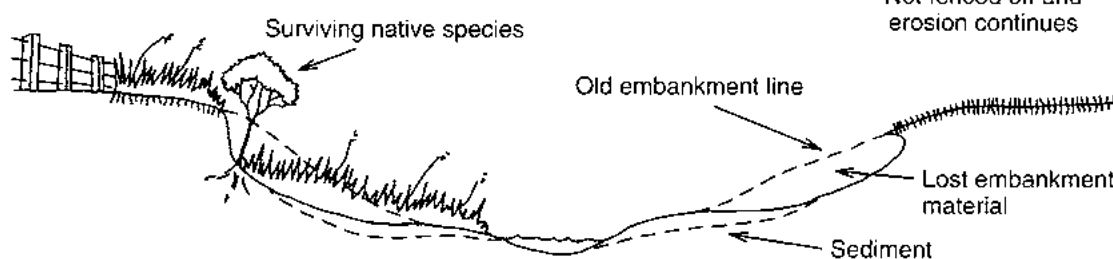
D grade: ditch

Fenced off and weed infested

D-grade - The stream is little more than an eroding ditch or a weed infested drain:

D1. Ditch – eroding – There is not enough fringing vegetation to control erosion. Remaining trees and shrubs act to impede erosion in some areas, but are doomed to be undermined eventually.
