Groundwater study of the Bencubbin townsite

ISSN 0729-3135
November 2001

Resource Management Technical Report 205

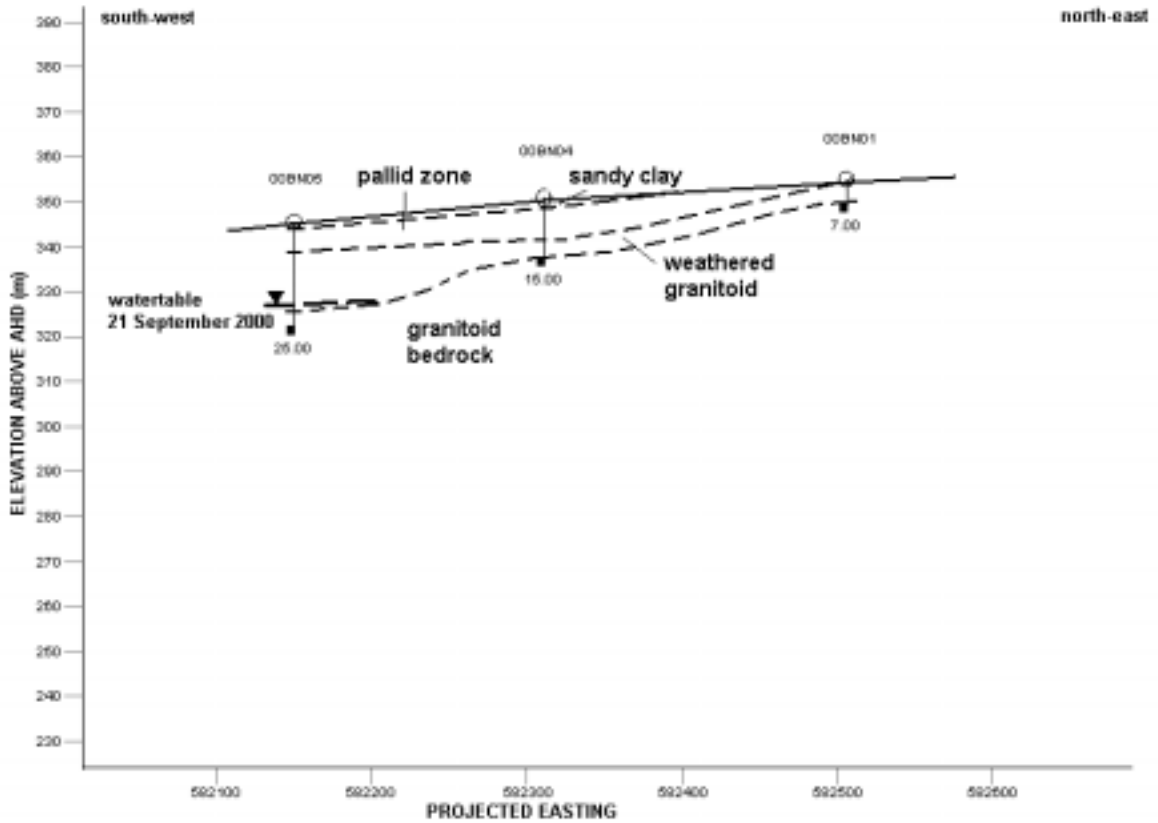
Figure 2-2. Cross-section from south-west to north-east (see Figure 2-1 for location)

Detailed drill logs are available at <http://www.agric.wa.gov.au/environment/links/RMtechreports/> and the main components of the profiles are illustrated in Figures 2-2 and 2-3.

The regolith at most sites was predominantly residuum of mottled and pallid zone clays overlying a weathering rock zone (Figures 2-2 and 2-3). Colluvial clays, sands and gravels were several metres thick at three sites (00BN03, 00BN08 (Figure 2-3) and 00BN09).

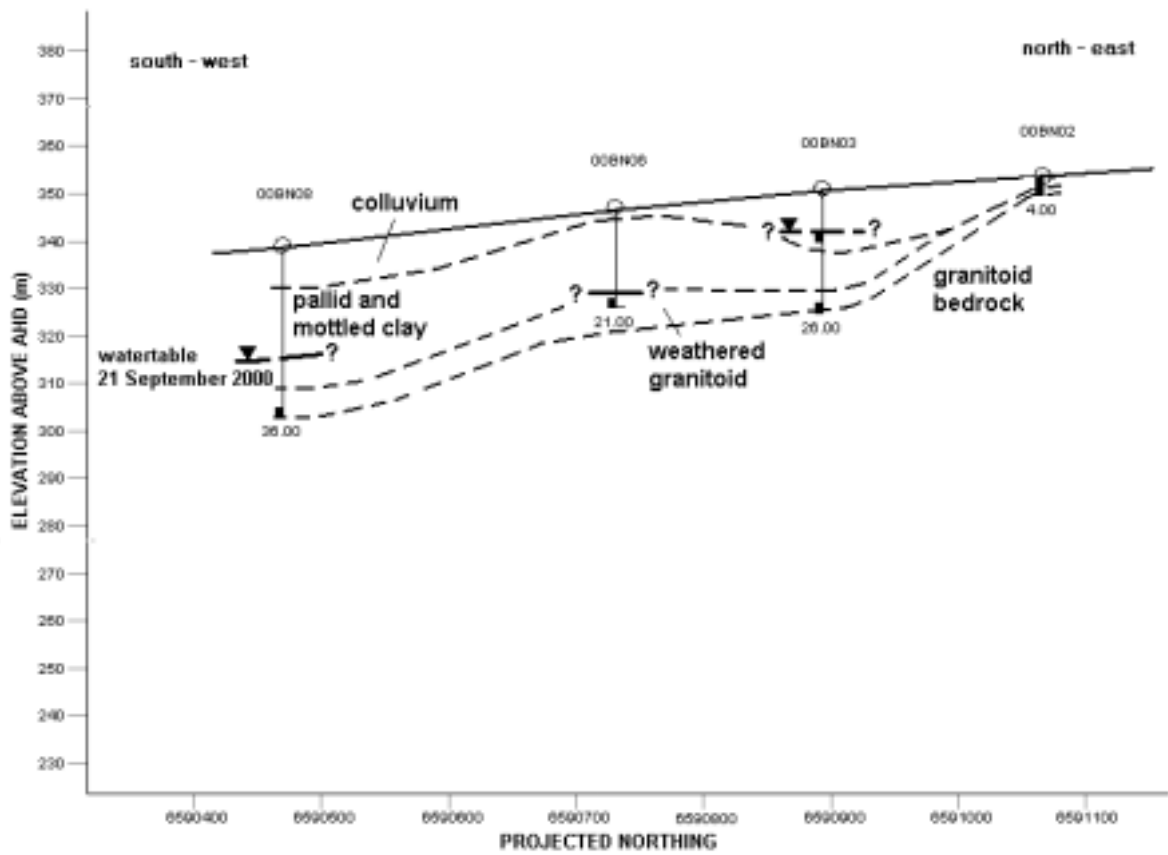
Figure 2-3. Cross-section from south-west to north-east (see Figure 2-1 for location)

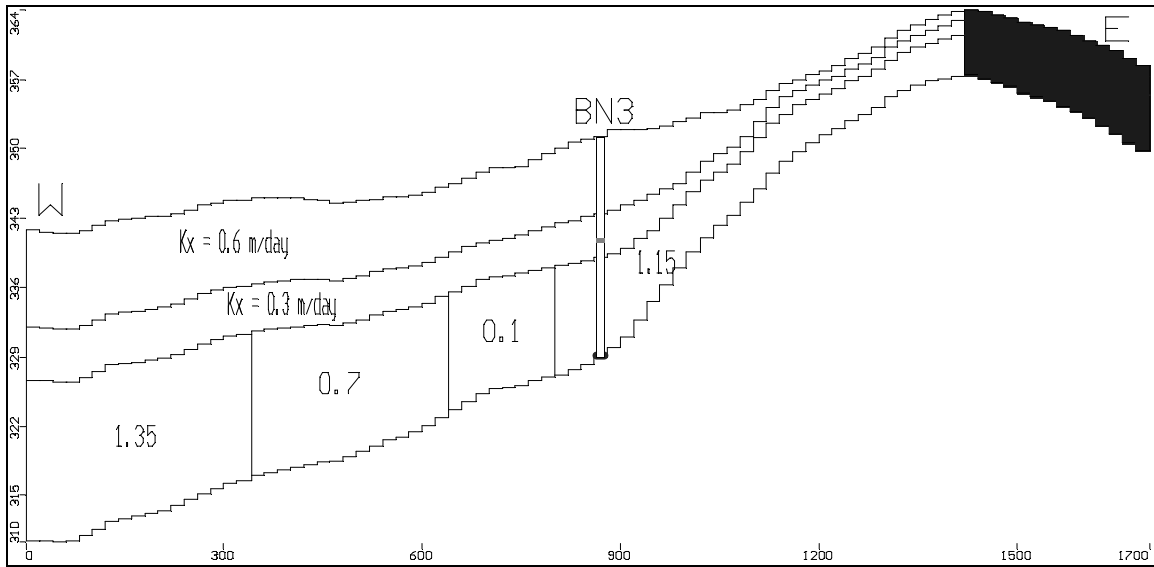
Figure 3-2. Hydraulic conductivity zones used in model calibration (in metres per day; axis scales are in metres) along a west-east cross-section through site 00BN03 (labelled BN3)

The initial hydraulic conductivities for all three layers were estimated using the soil and lithological descriptions from the drilling program (Section 2). Based on the lithological descriptions, the hydraulic conductivity values used for the three modelled layers varied spatially depending on topography and the landform characteristics (Figure 3-2).

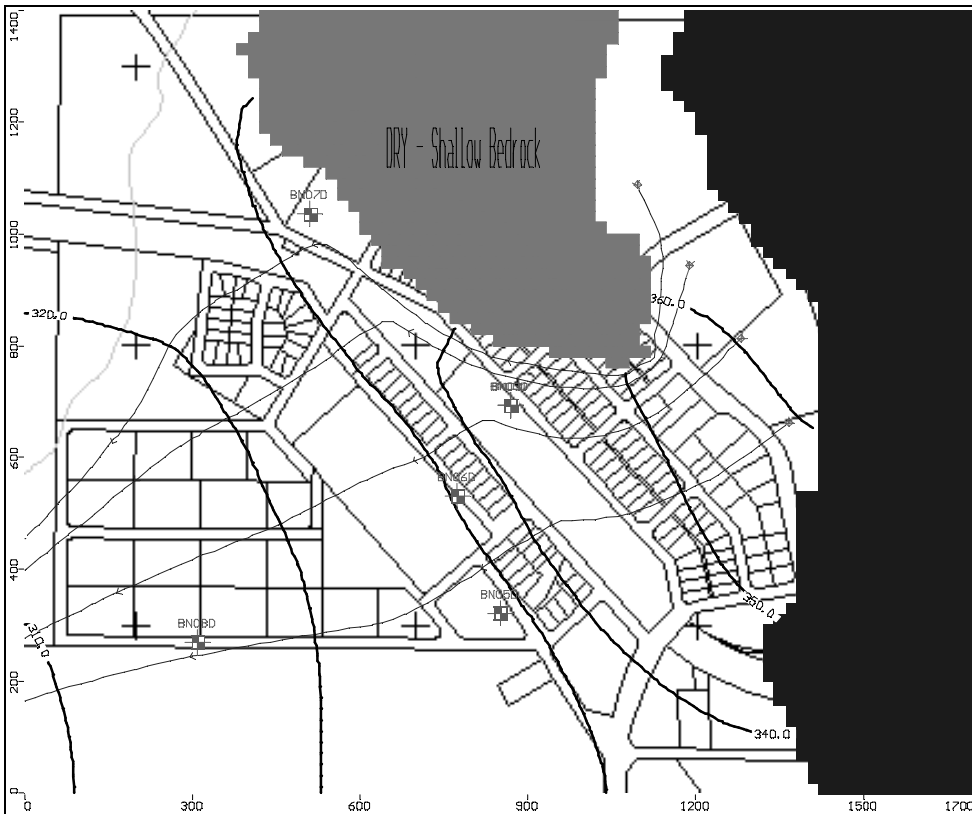
Figure 3-4. Shallow groundwater levels in metres above AHD and travel paths for the calibrated model (boundary scales in metres, top of map is north)

Simulated depths to the watertable for the calibrated model are shown in Figure 3-3. The model implied that the groundwater levels were between 3 and 20 m deep. Modelled groundwater travel paths are shown in Figure 3-4 and indicated that the travel time from the north-east to south-west beneath the townsite was about 20 years.

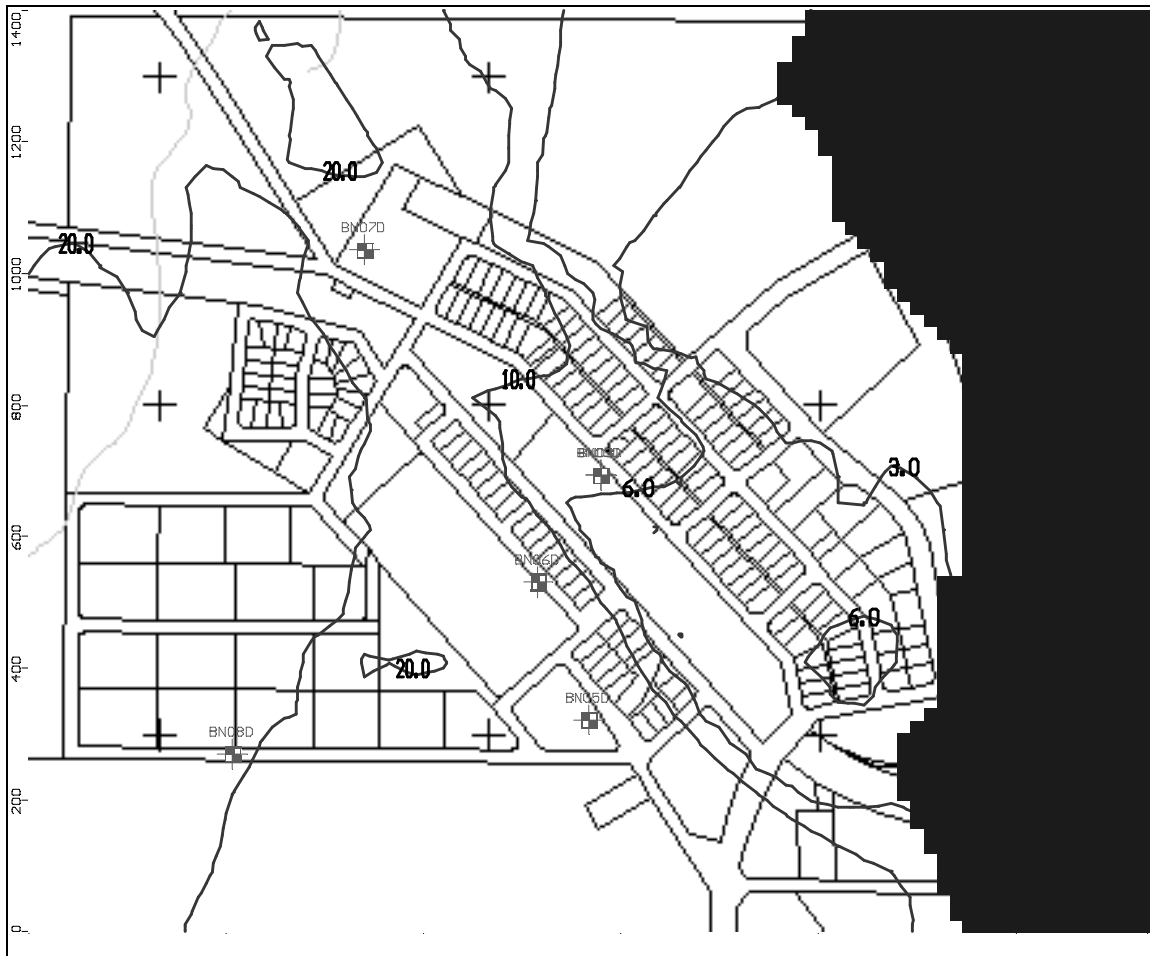
Figure 3-5. Depth to watertable (in metres) after 30 years under the 'do nothing differently' strategy (boundary scales in metres, top of map is north)

The 'do nothing differently' scenario implies that no management of the groundwater system will take place and, therefore, the watertable would be recharged at the average calibrated rate of 20 mm/year over 30 years.

Under current management practices, it was predicted that the watertable below the town would not come within 3 m of ground level within the next 30 years (Figure 3-5).
