PEEL INLET MANAGEMENT AUTHORITY

Reserve 40109 Draft management plan

RESERVE 40109 DRAFT MANAGEMENT PLAN

Report No 41,
September, 1993

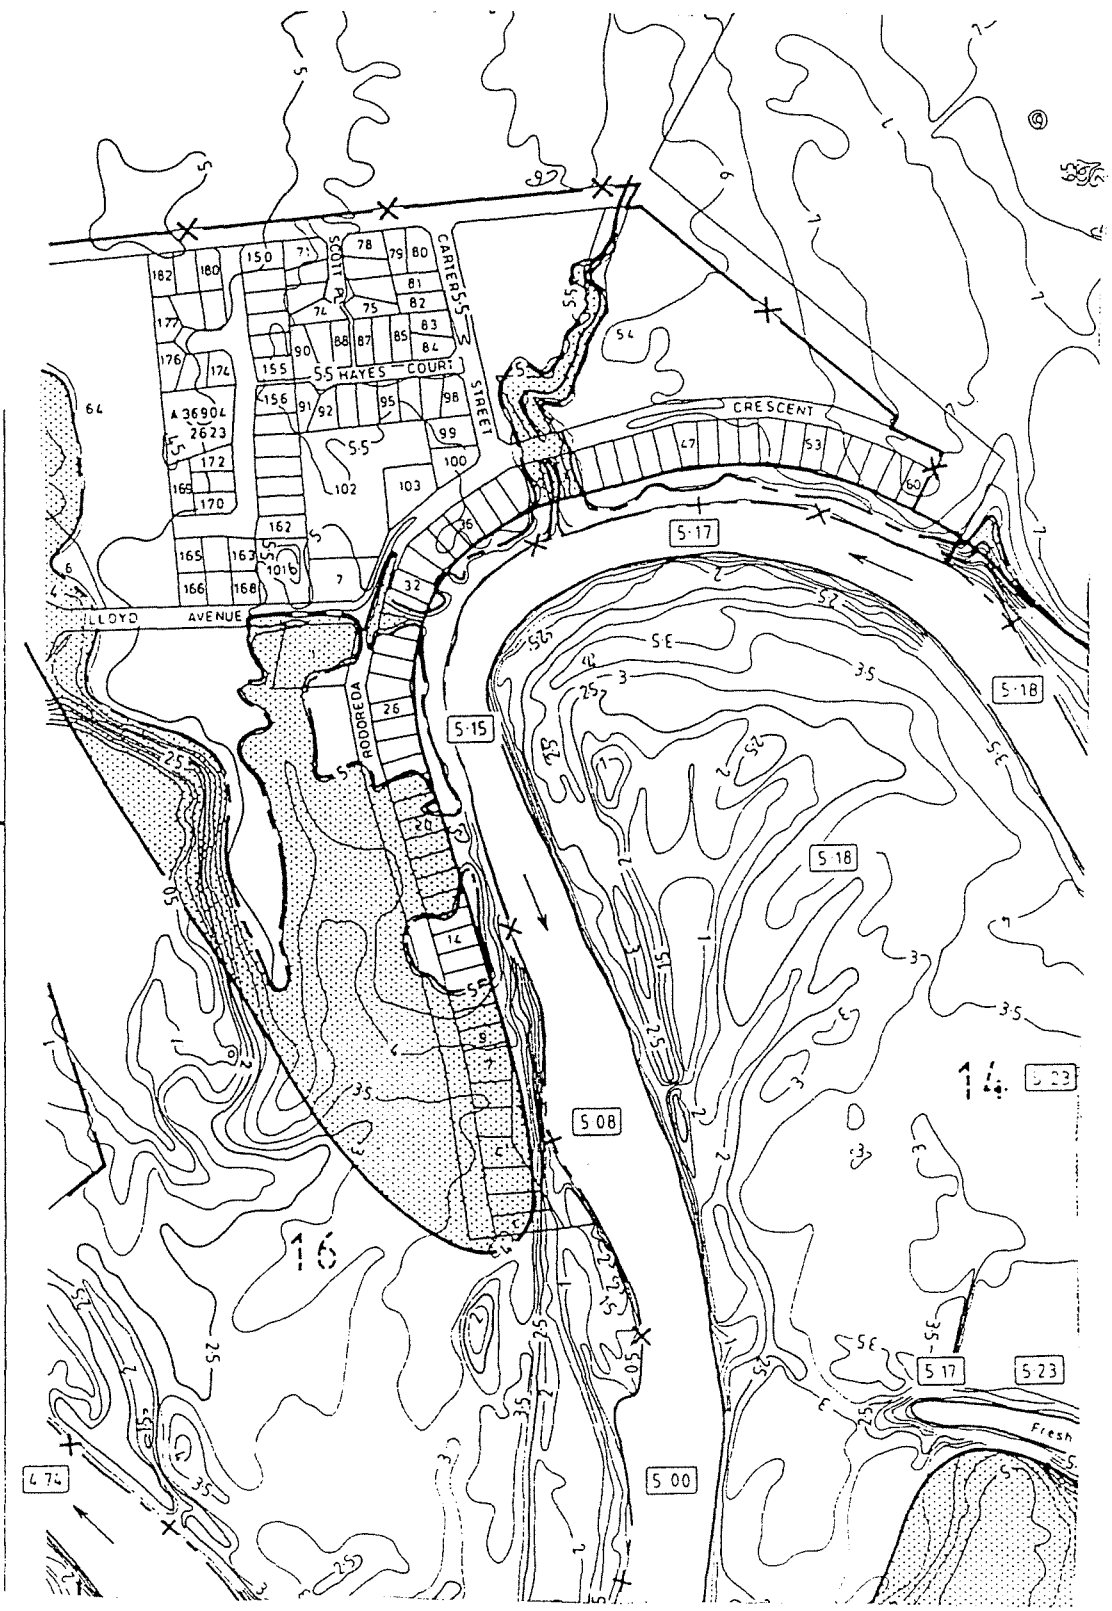
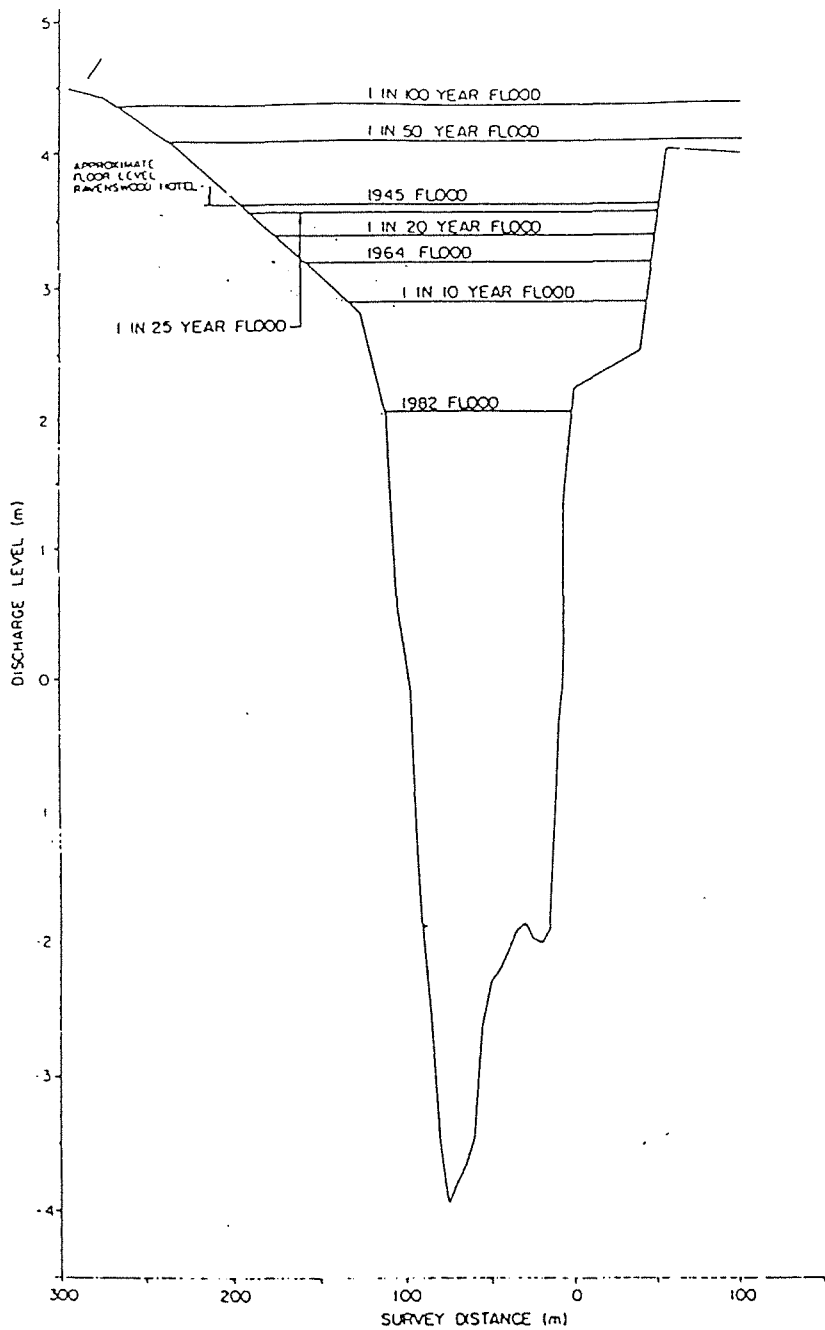
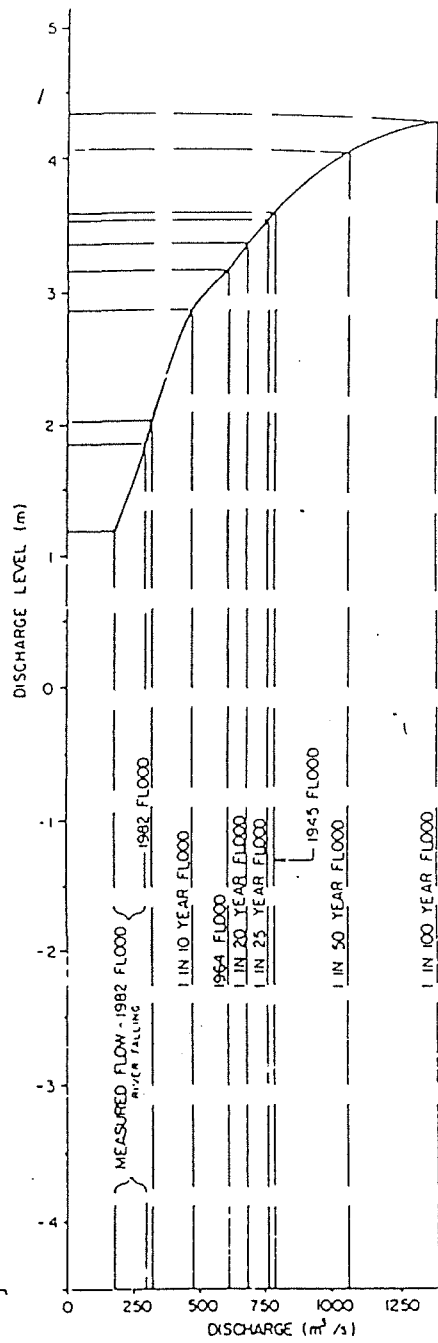
FIGURE 2.3

CROSS SECTION UPSTREAM OF RAVENSWOOD BRIDGE (WATERWAY DISTANCE 7690 m)

SHEET NO. 1 MURRAY RIVER DATUM	SCALES AS SHOWN	DESIGN CALC CHECKED	BOOK & FILE BOOK	PUBLIC WORKS DEPARTMENT — WESTERN AUSTRA MURRAY RIVER FLOOD STUDY WEST MURRAY AREA STAGE DISCHARGE RELATIONSHIPS
	DRAWN TO/D TRACED	CHECKED / N/S	CHECKED	
A.H.D.	SUBMITTED DATE 1-1-83	APPROVED DATE 17-6-83	P.W.D. W.A. 51796-5-2	
	<i>David L. Sney</i> DESIGN ENGINEER LTD	<i>Bob Williams</i> CHIEF DESIGN ENGINEER

The Rodoreda Crescent section of the Murray River experiences a 1 in 100 year flood level of about + 5.1m AHD and the associated flood prone areas are shown in Figure 2.1. The backwater curve for this section of the Murray River is such that the 1 in 100 year flood level at the Ravenswood Bridge is + 4.3m AHD as shown in Figure 2.2. Flood levels for other recurrence intervals are shown in Figure 2.3, but they are only valid at the Ravenswood Bridge. The flood levels for other recurrence intervals at Rodoreda Crescent were determined using the difference in the 1 in 100 year flood level between the bridge and Rodoreda Crescent.

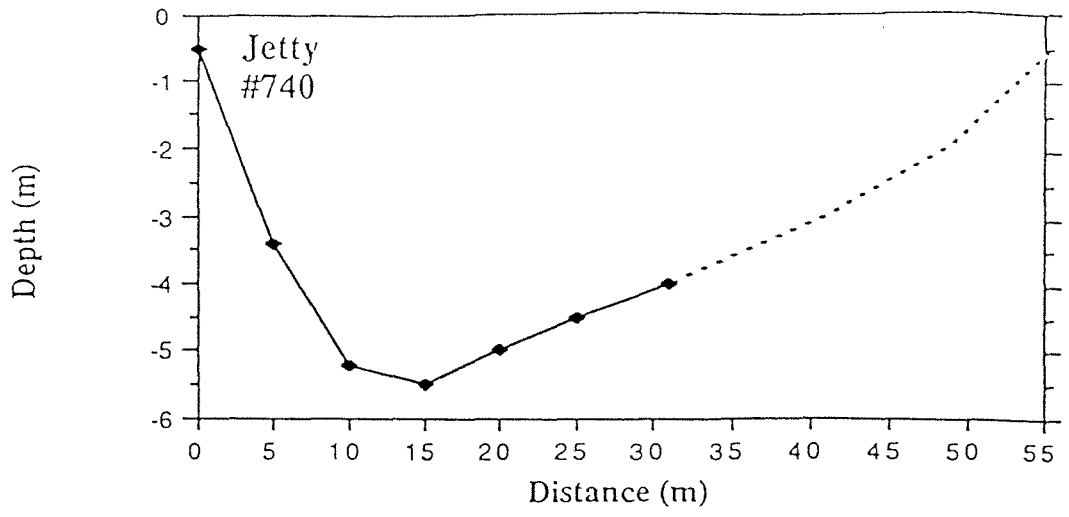
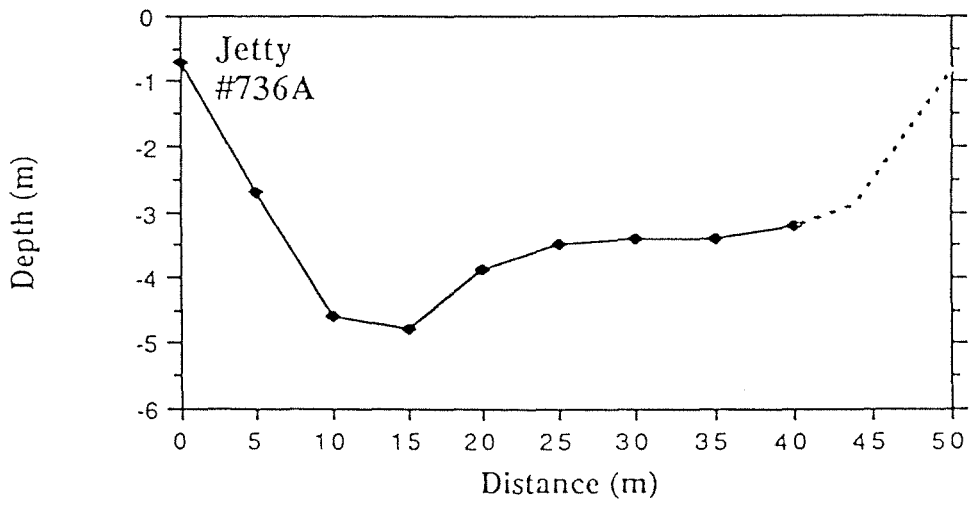
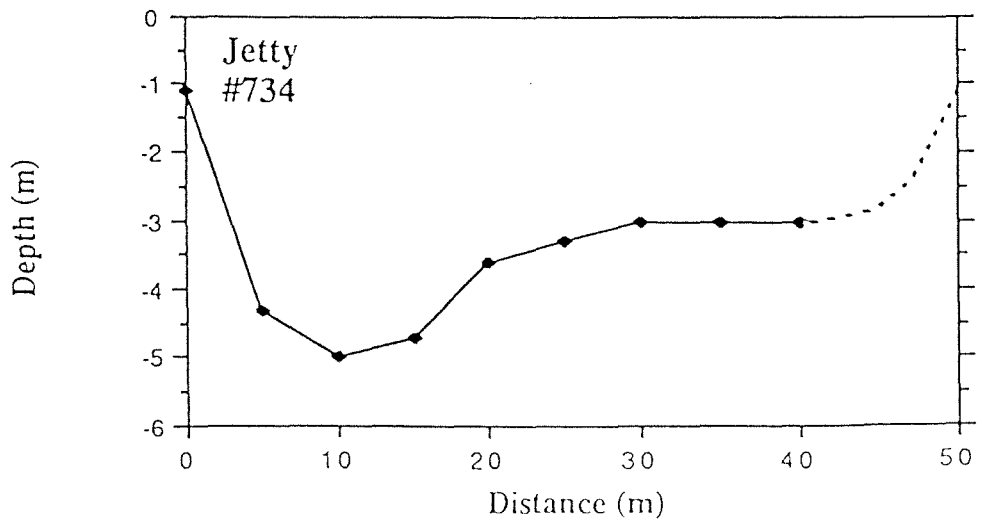
FIGURE 3.1

"RIVER BED PROFILES"

The signature of a helical flow structure through the Rodoreda Crescent bend of the Murray River can be identified from a series of river bed cross sections which were measured from the face of several jetties as shown in Figure 2.4. The measured profiles are presented in Figures 3.1 - 3.4 wherein it can be seen that a deep flow channel has been scoured out near the outer bank in the bend, and the outer bank slope is steeper. Further downstream, the bed profile is more uniform and consequently the bank slope is flatter.

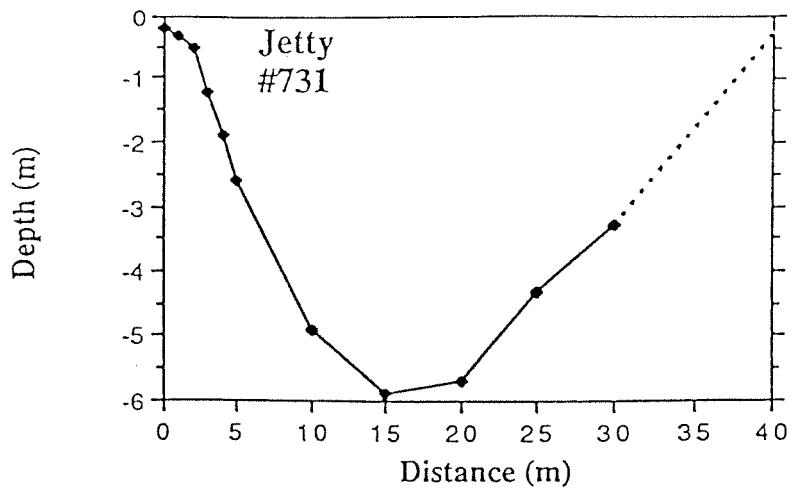
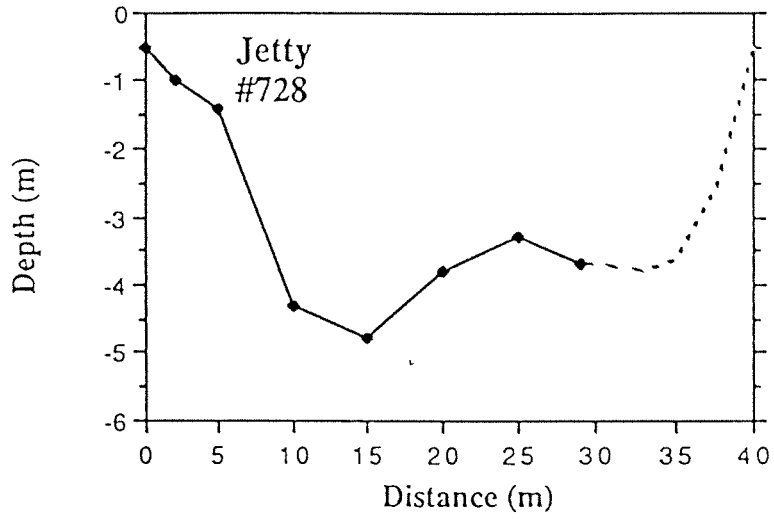
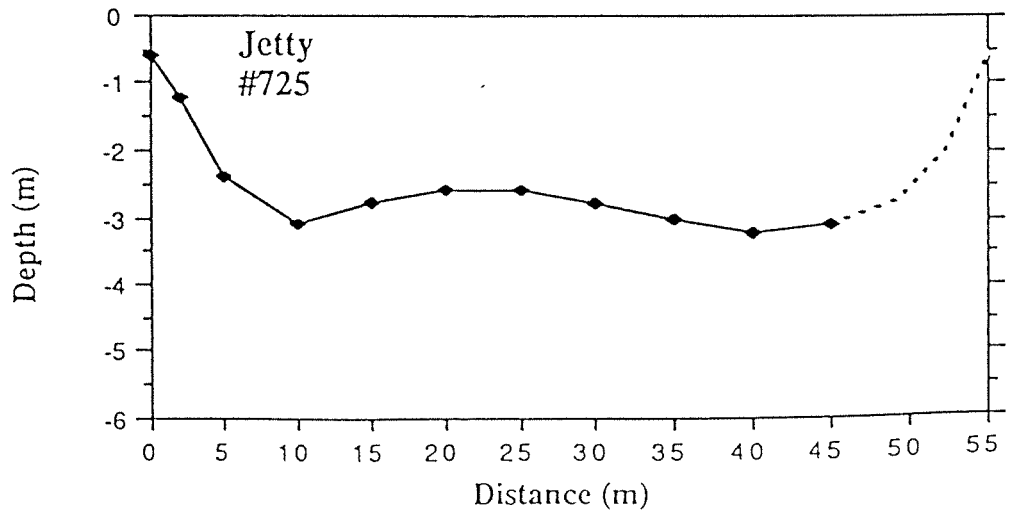
FIGURE 3.2

"RIVER BED PROFILES"

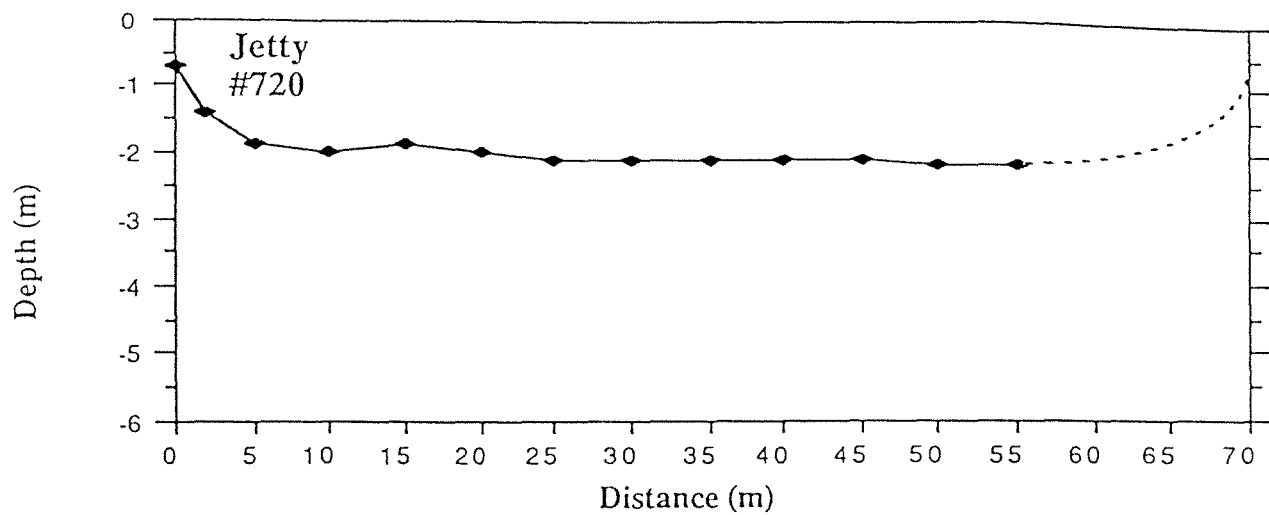
FIGURE 3-3

"RIVER BED PROFILES"

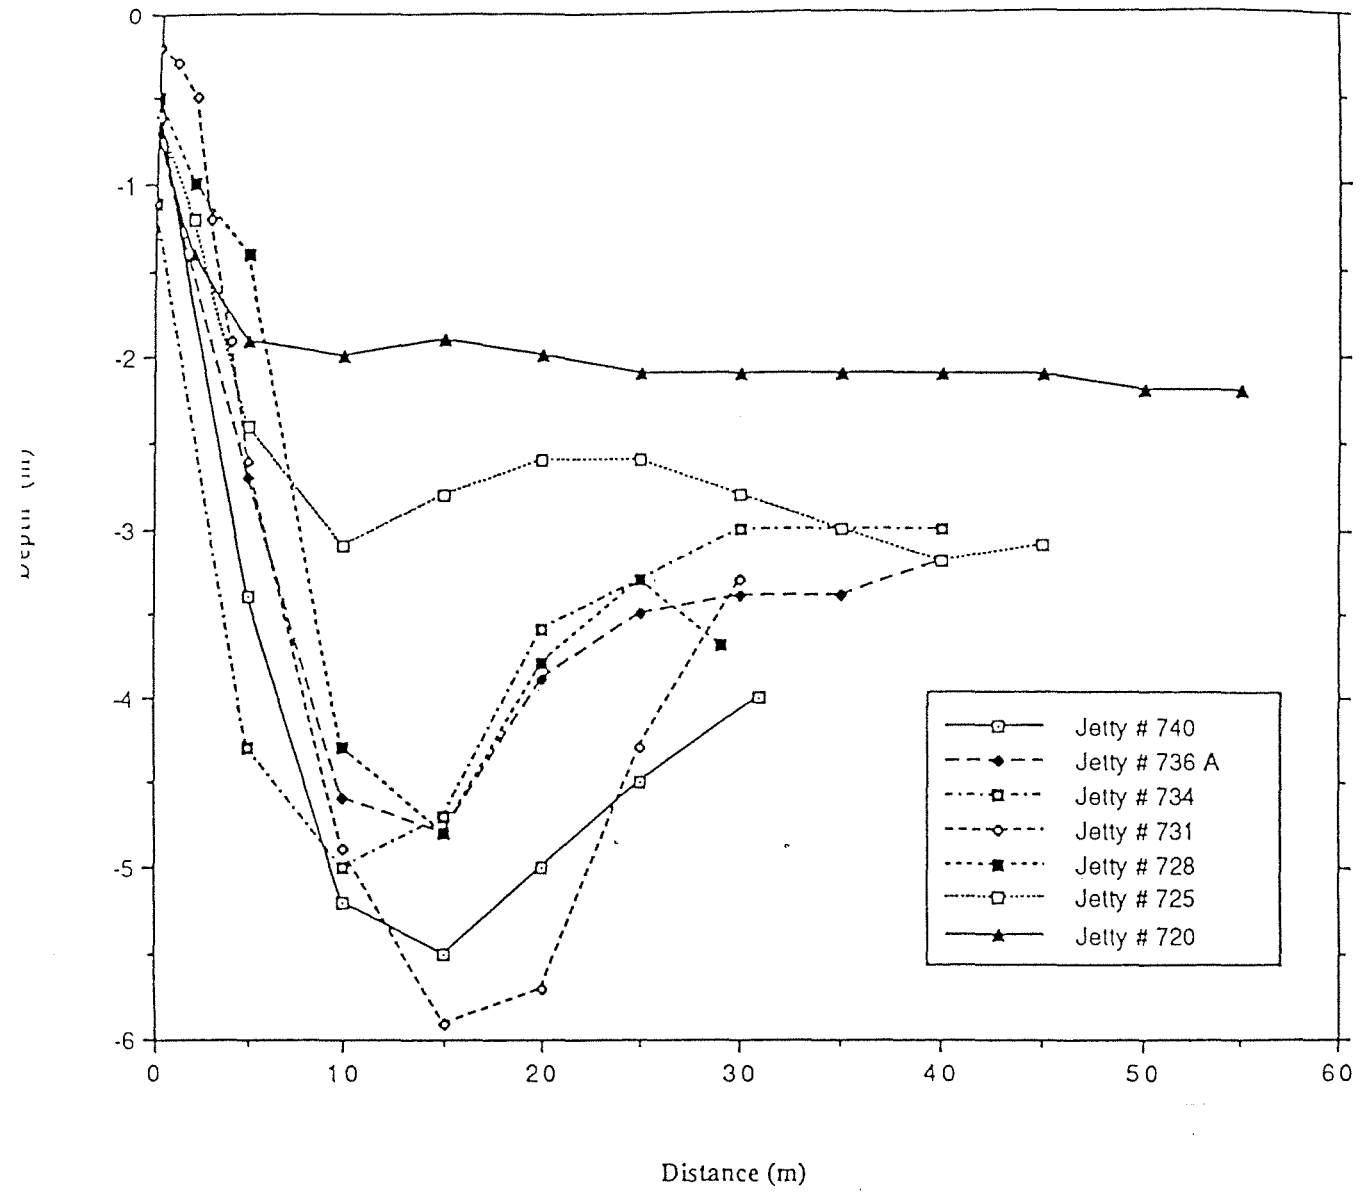
Figure 3.4

Depth Profiles taken from Jetty Face at Rodoreda Crescent.

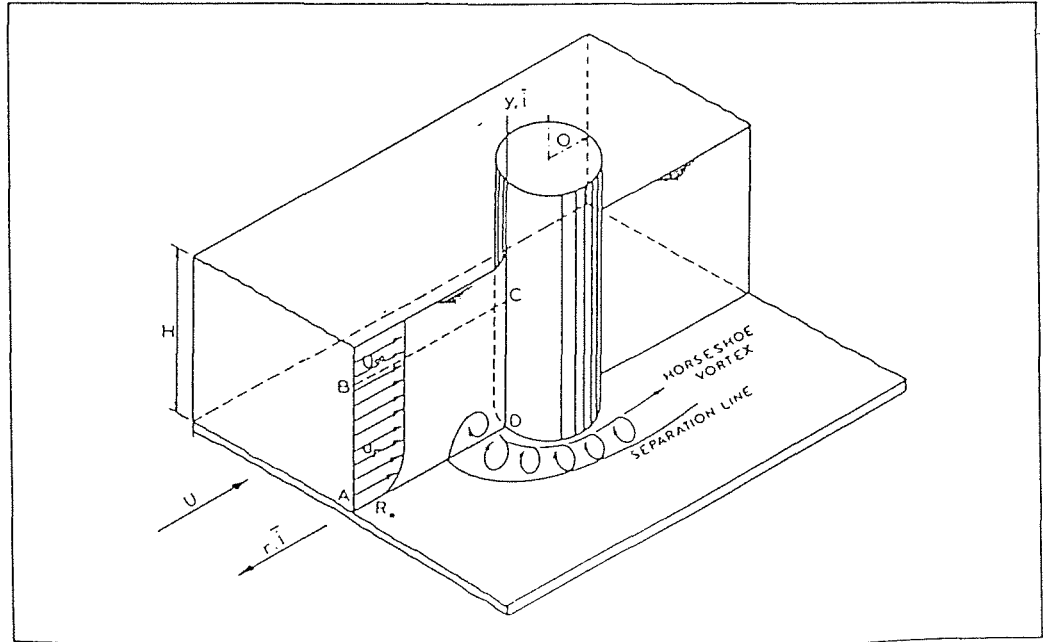
FIGURE 4.3 LOCAL SCOURING CAUSED BY AN OBSTRUCTION IN A STREAM FLOW

The upper bank slope should not exceed 1:2 and longitudinal regularity should be maintained so that flood flows do not encounter any abrupt changes in slope. Likewise, any man-made structures (except licensed jetties) should be removed to minimise the number of obstructions and prevent local scouring under flood flow conditions. The local scouring process caused by flows around an obstacle is illustrated in Figure 4.3.
