PRACTICALITIES

The impact of trees on groundwater levels in a discharge area of the Merredin catchment

by Dawit Berhane

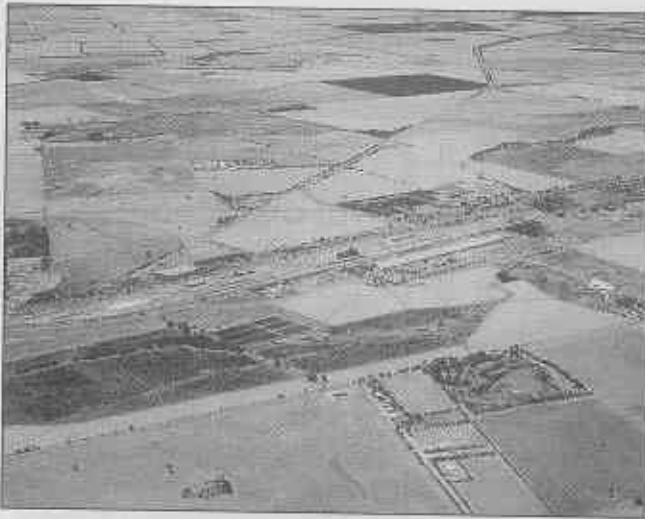
Planting site from the air (photo: D. Saunders).
