GREENOUGH RIVER FORESHORE ASSESSMENT

WATER AND RIVERS COMMISSION
WATER RESOURCE MANAGEMENT SERIES
REPORT No WRM 24
OCTOBER 2001

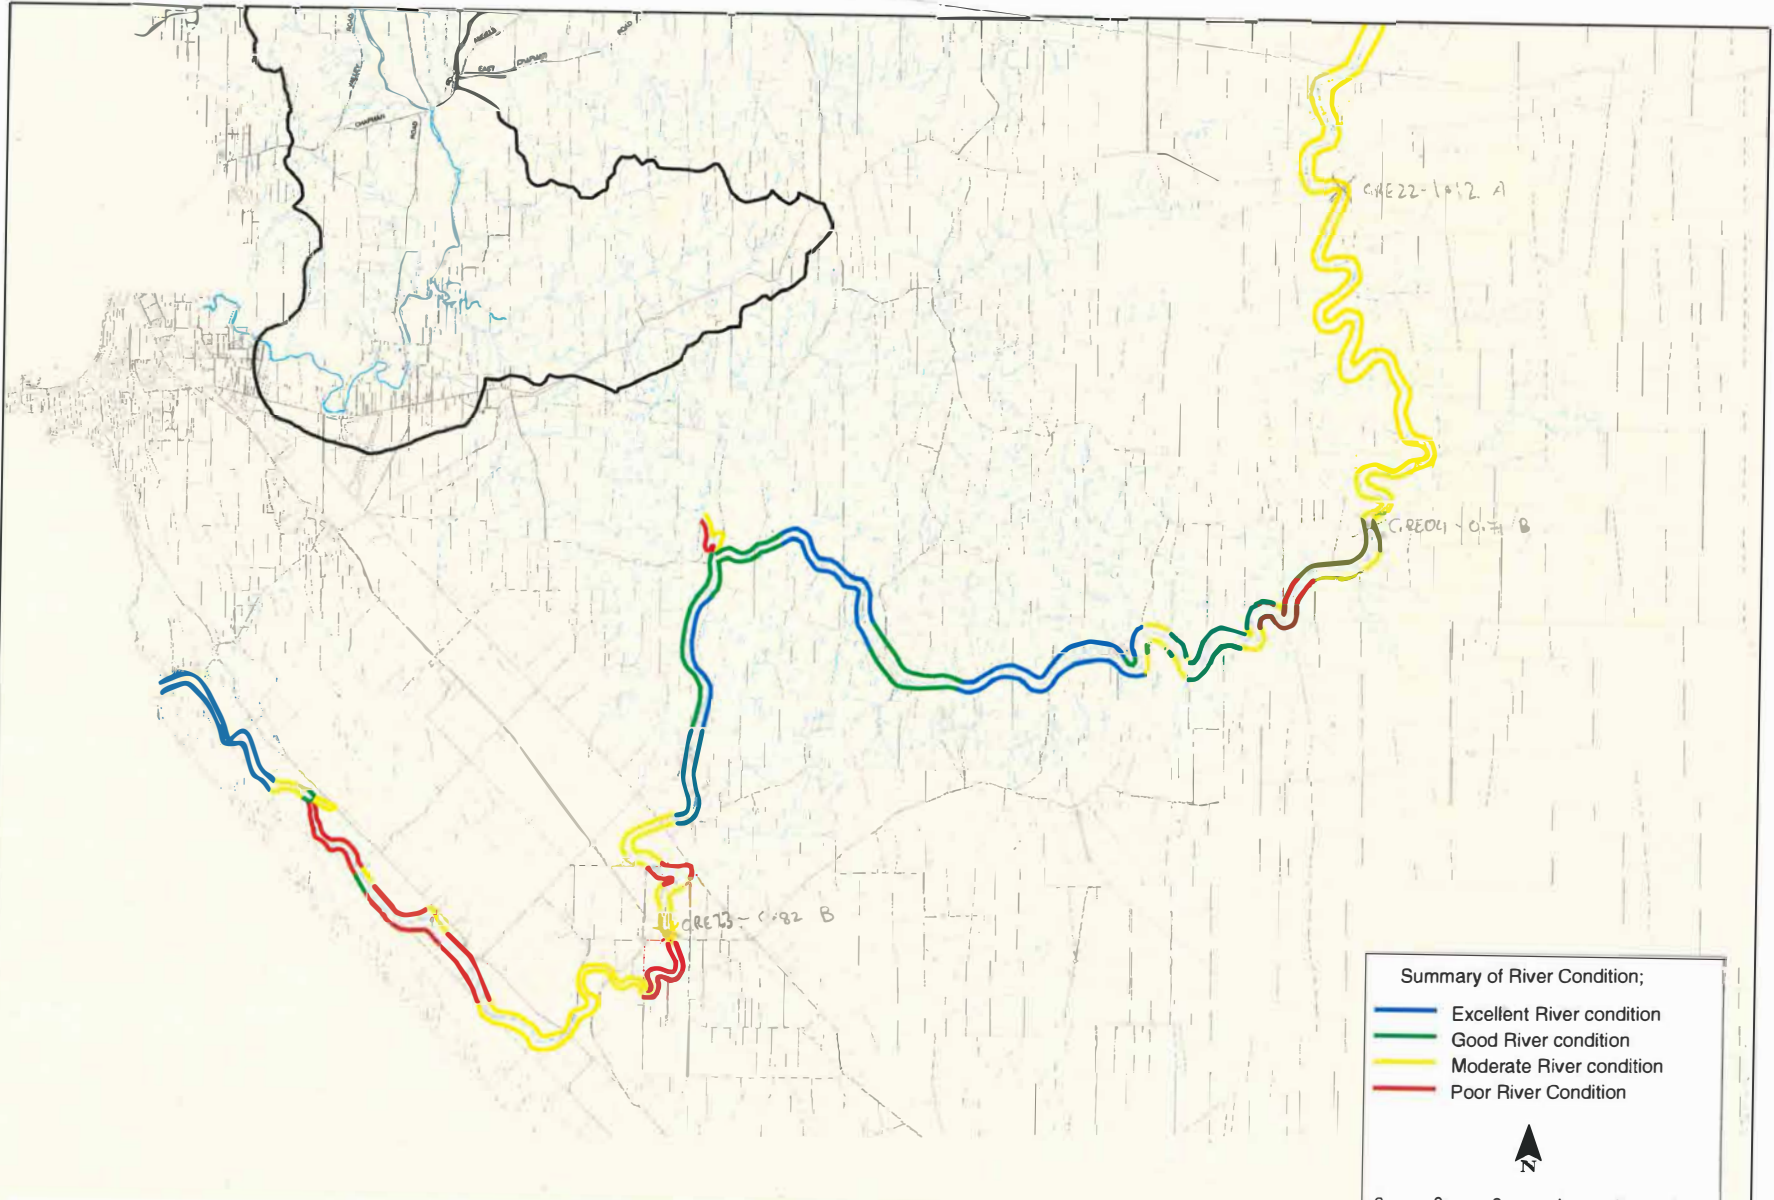
Summary of Foreshore Condition, Map 1 - Greenough River

Summary of River Condition;

- Excellent River condition
- Good River condition
- Moderate River condition
- Poor River Condition

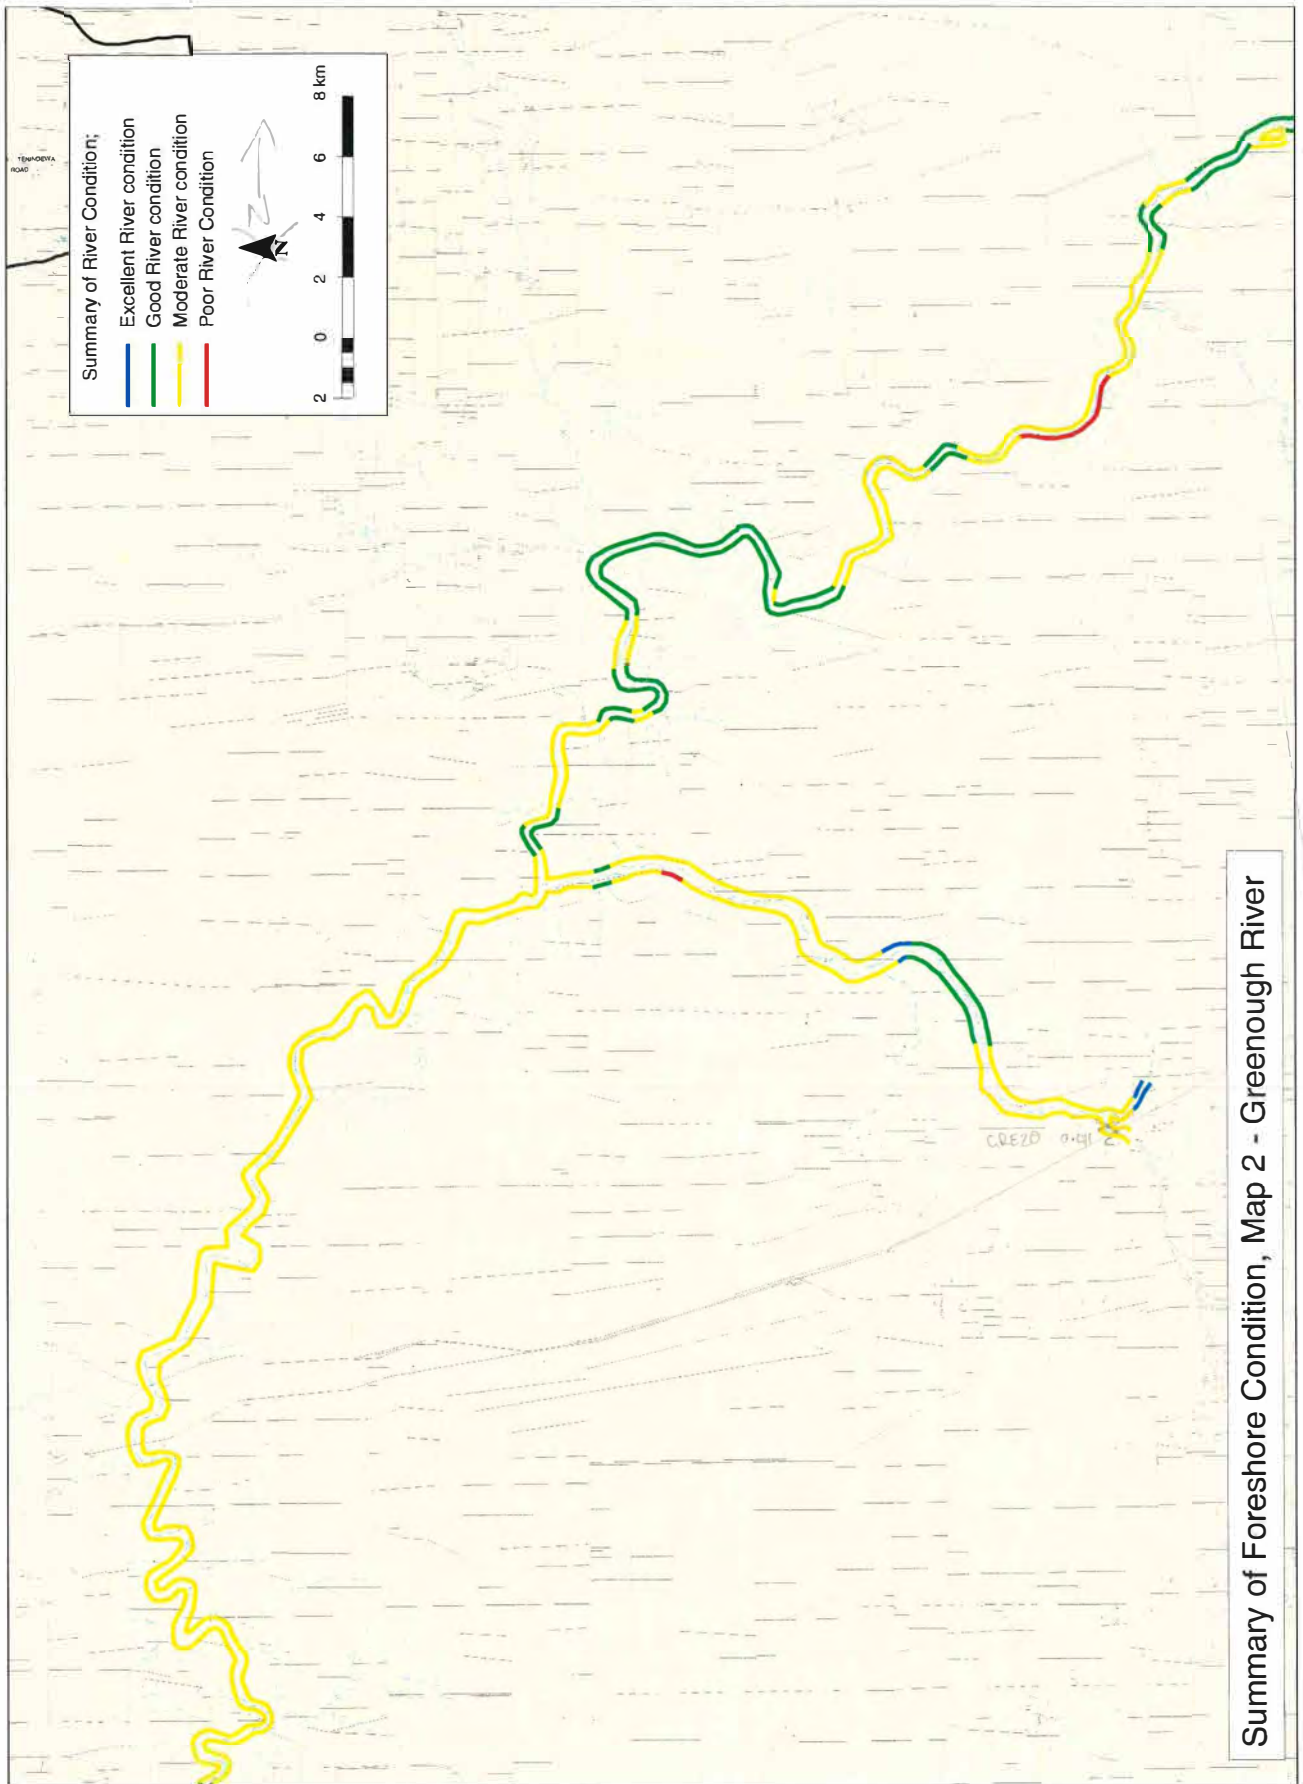
Summary of River Condition;

- Excellent River condition
- Good River condition
- Moderate River condition
- Poor River Condition

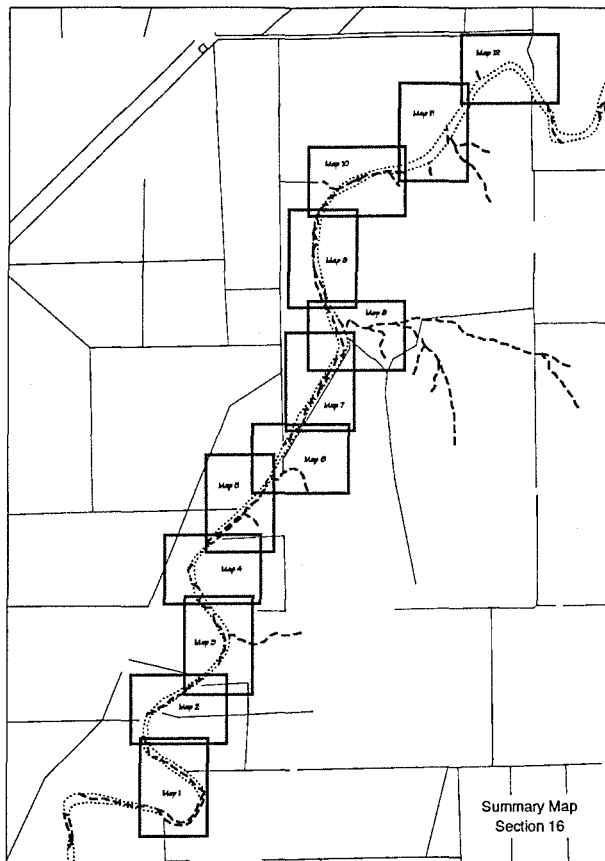
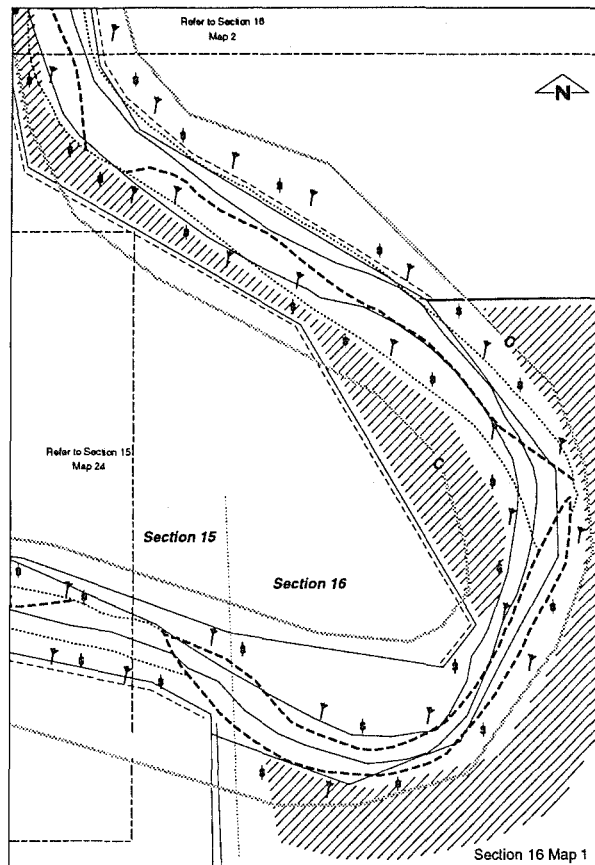
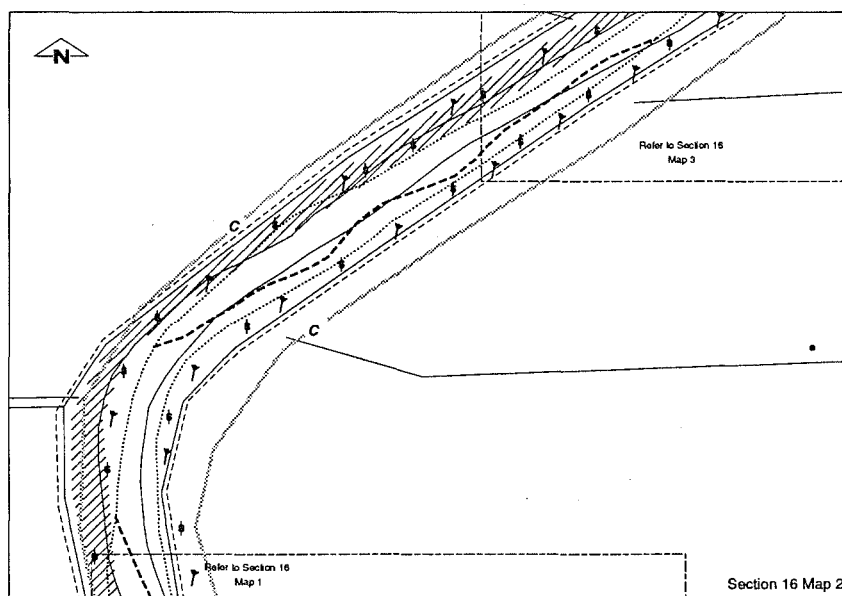
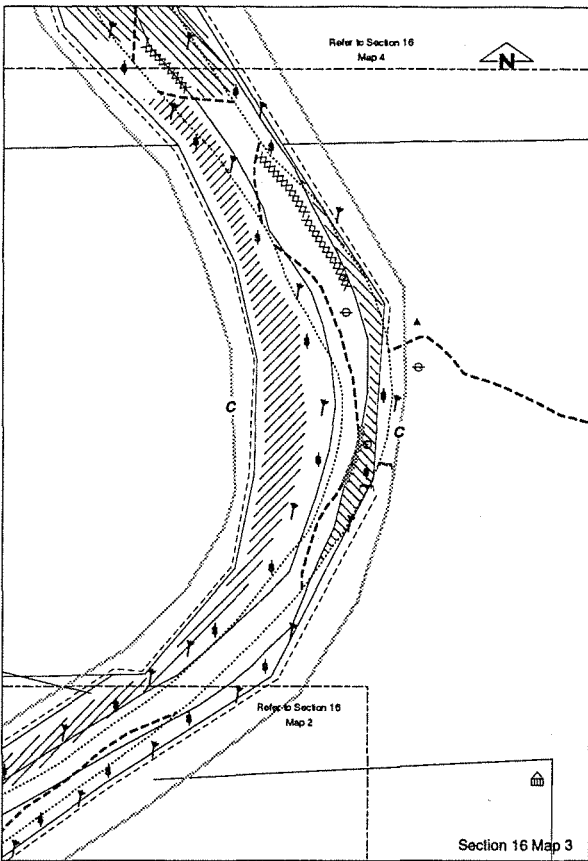
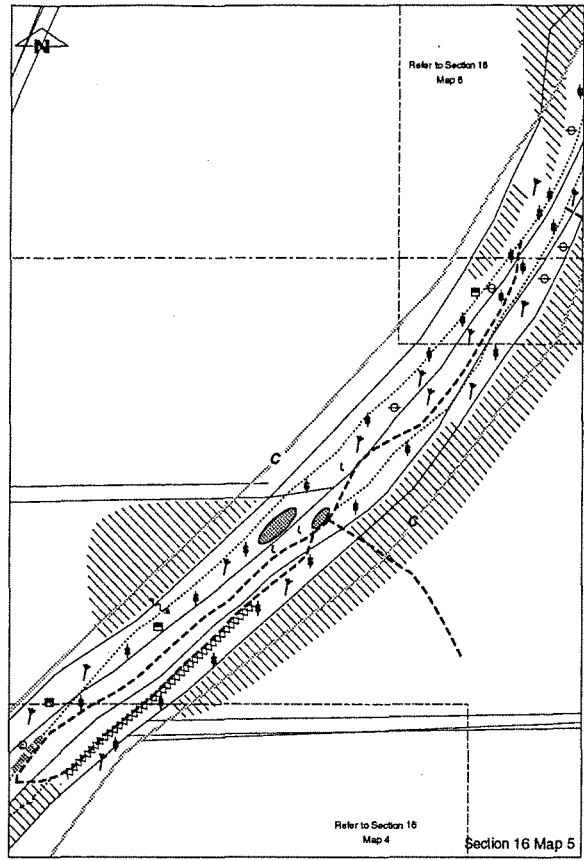
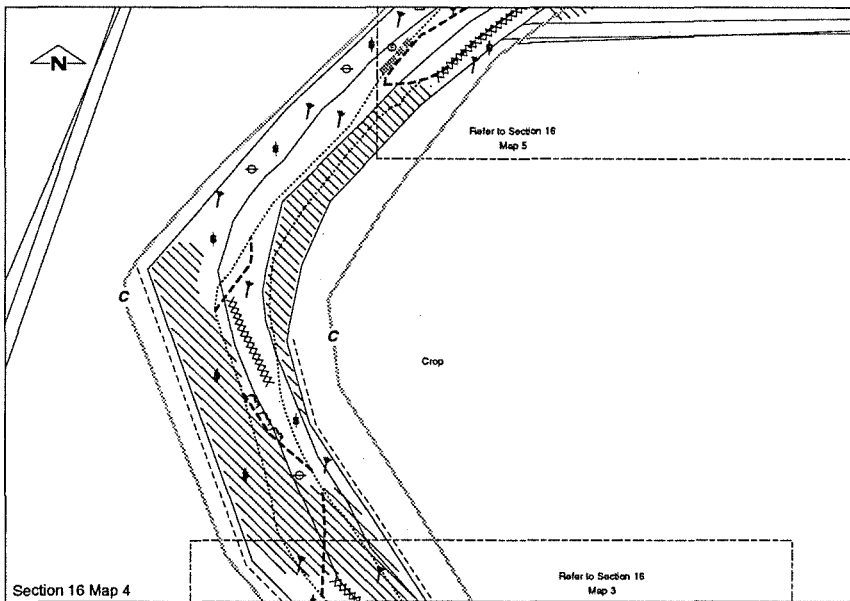
SECTION 16: GREENOUGH RIVER MAPS 1 – 12

This section of the Greenough River is characterised by an almost entirely mobile sandy bed. The low flow channel at the time of survey ranged from 5 m to 15 m wide. The dominant channel averages at 60 m wide. The riverbanks retained patchy Couch cover, with some sparse Spiny flatsedge (*Cyperus gymnocaulos*). The bank gradients were slight with steep to very steep banks on the powerbends. The steep slopes were generally vegetated and, although there was evidence of stock at this point in time, the damage is minimal on the outcrops. There is a localised area of exposed granite rocks instream.
