# **Victoria Bickley Redevelopment**

1200 Dia Gravity Outlet Main

Environmental Management Plan

Report No. WP 151  
January 1992

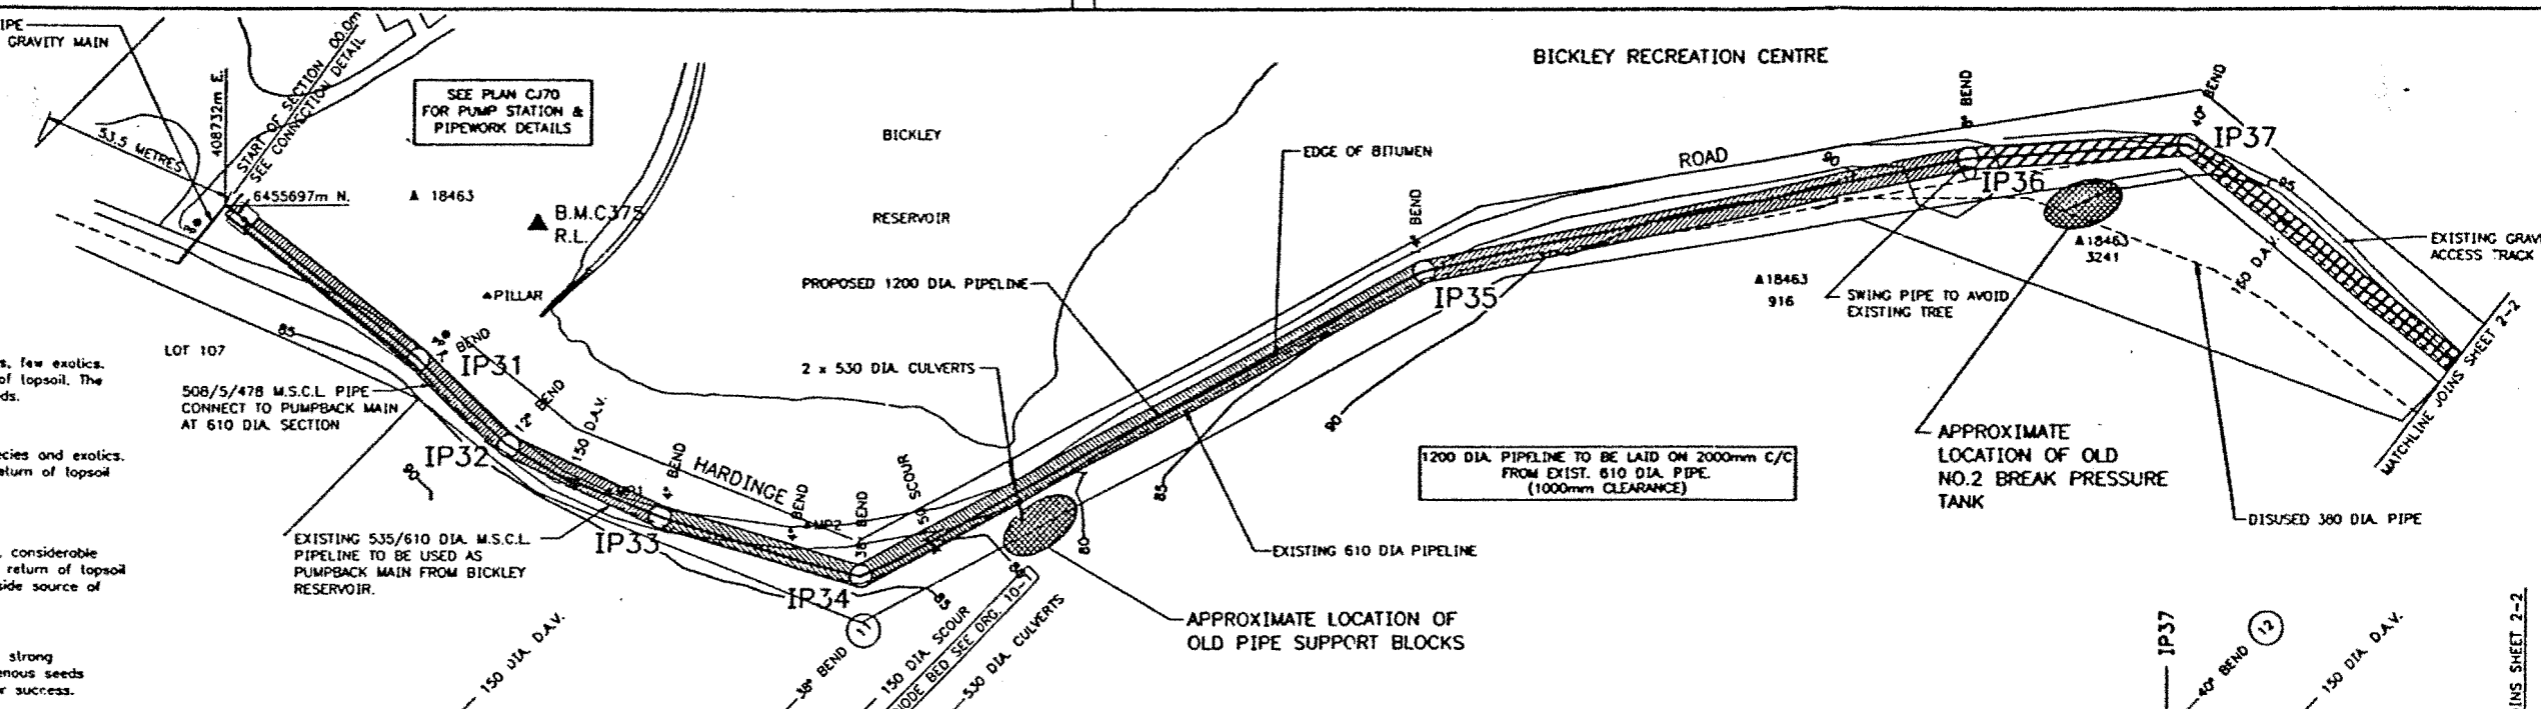
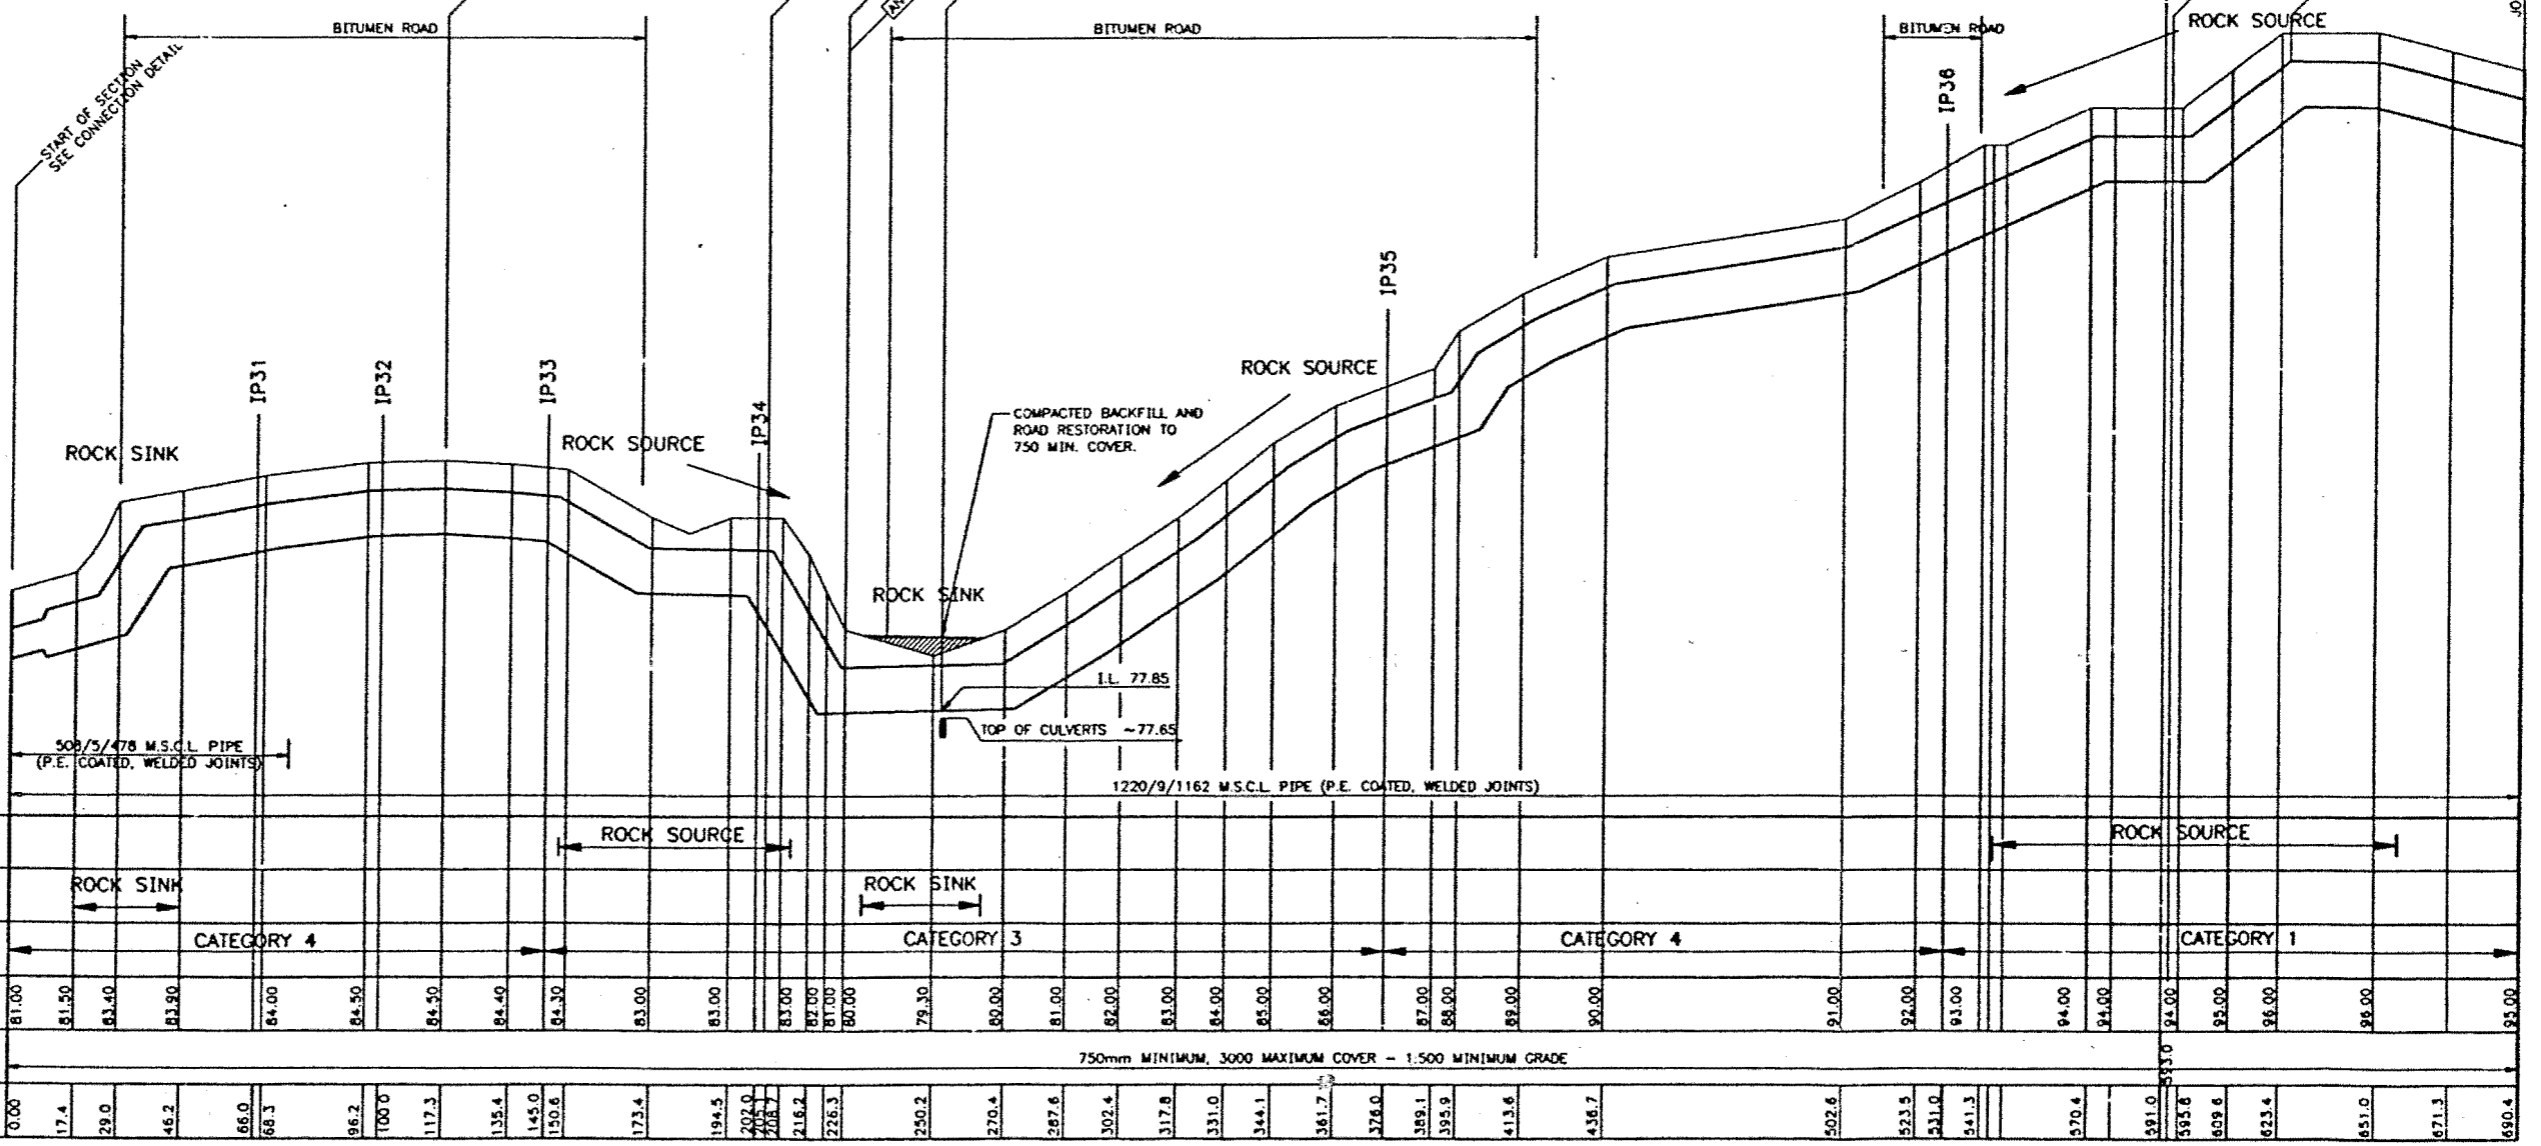
LONGITUDINAL SECTION

**NOTE:**  
NAILS OR PEGS HAVE STAMPED AL TAGS WITH  
IP31, IP32 etc.

REHABILITATION TREATMENT	75m ABOVE DATUM	
	ROCK SOURCE	ROCK SINK
REHABILITATION CATEGORY	CATEGORY 4	CATEGORY 3
NATURAL SURFACE LEVEL	81.00	81.00
INVERT LEVEL OF PIPE	81.50	81.00
RUNNING DISTANCE	0.00	0.00

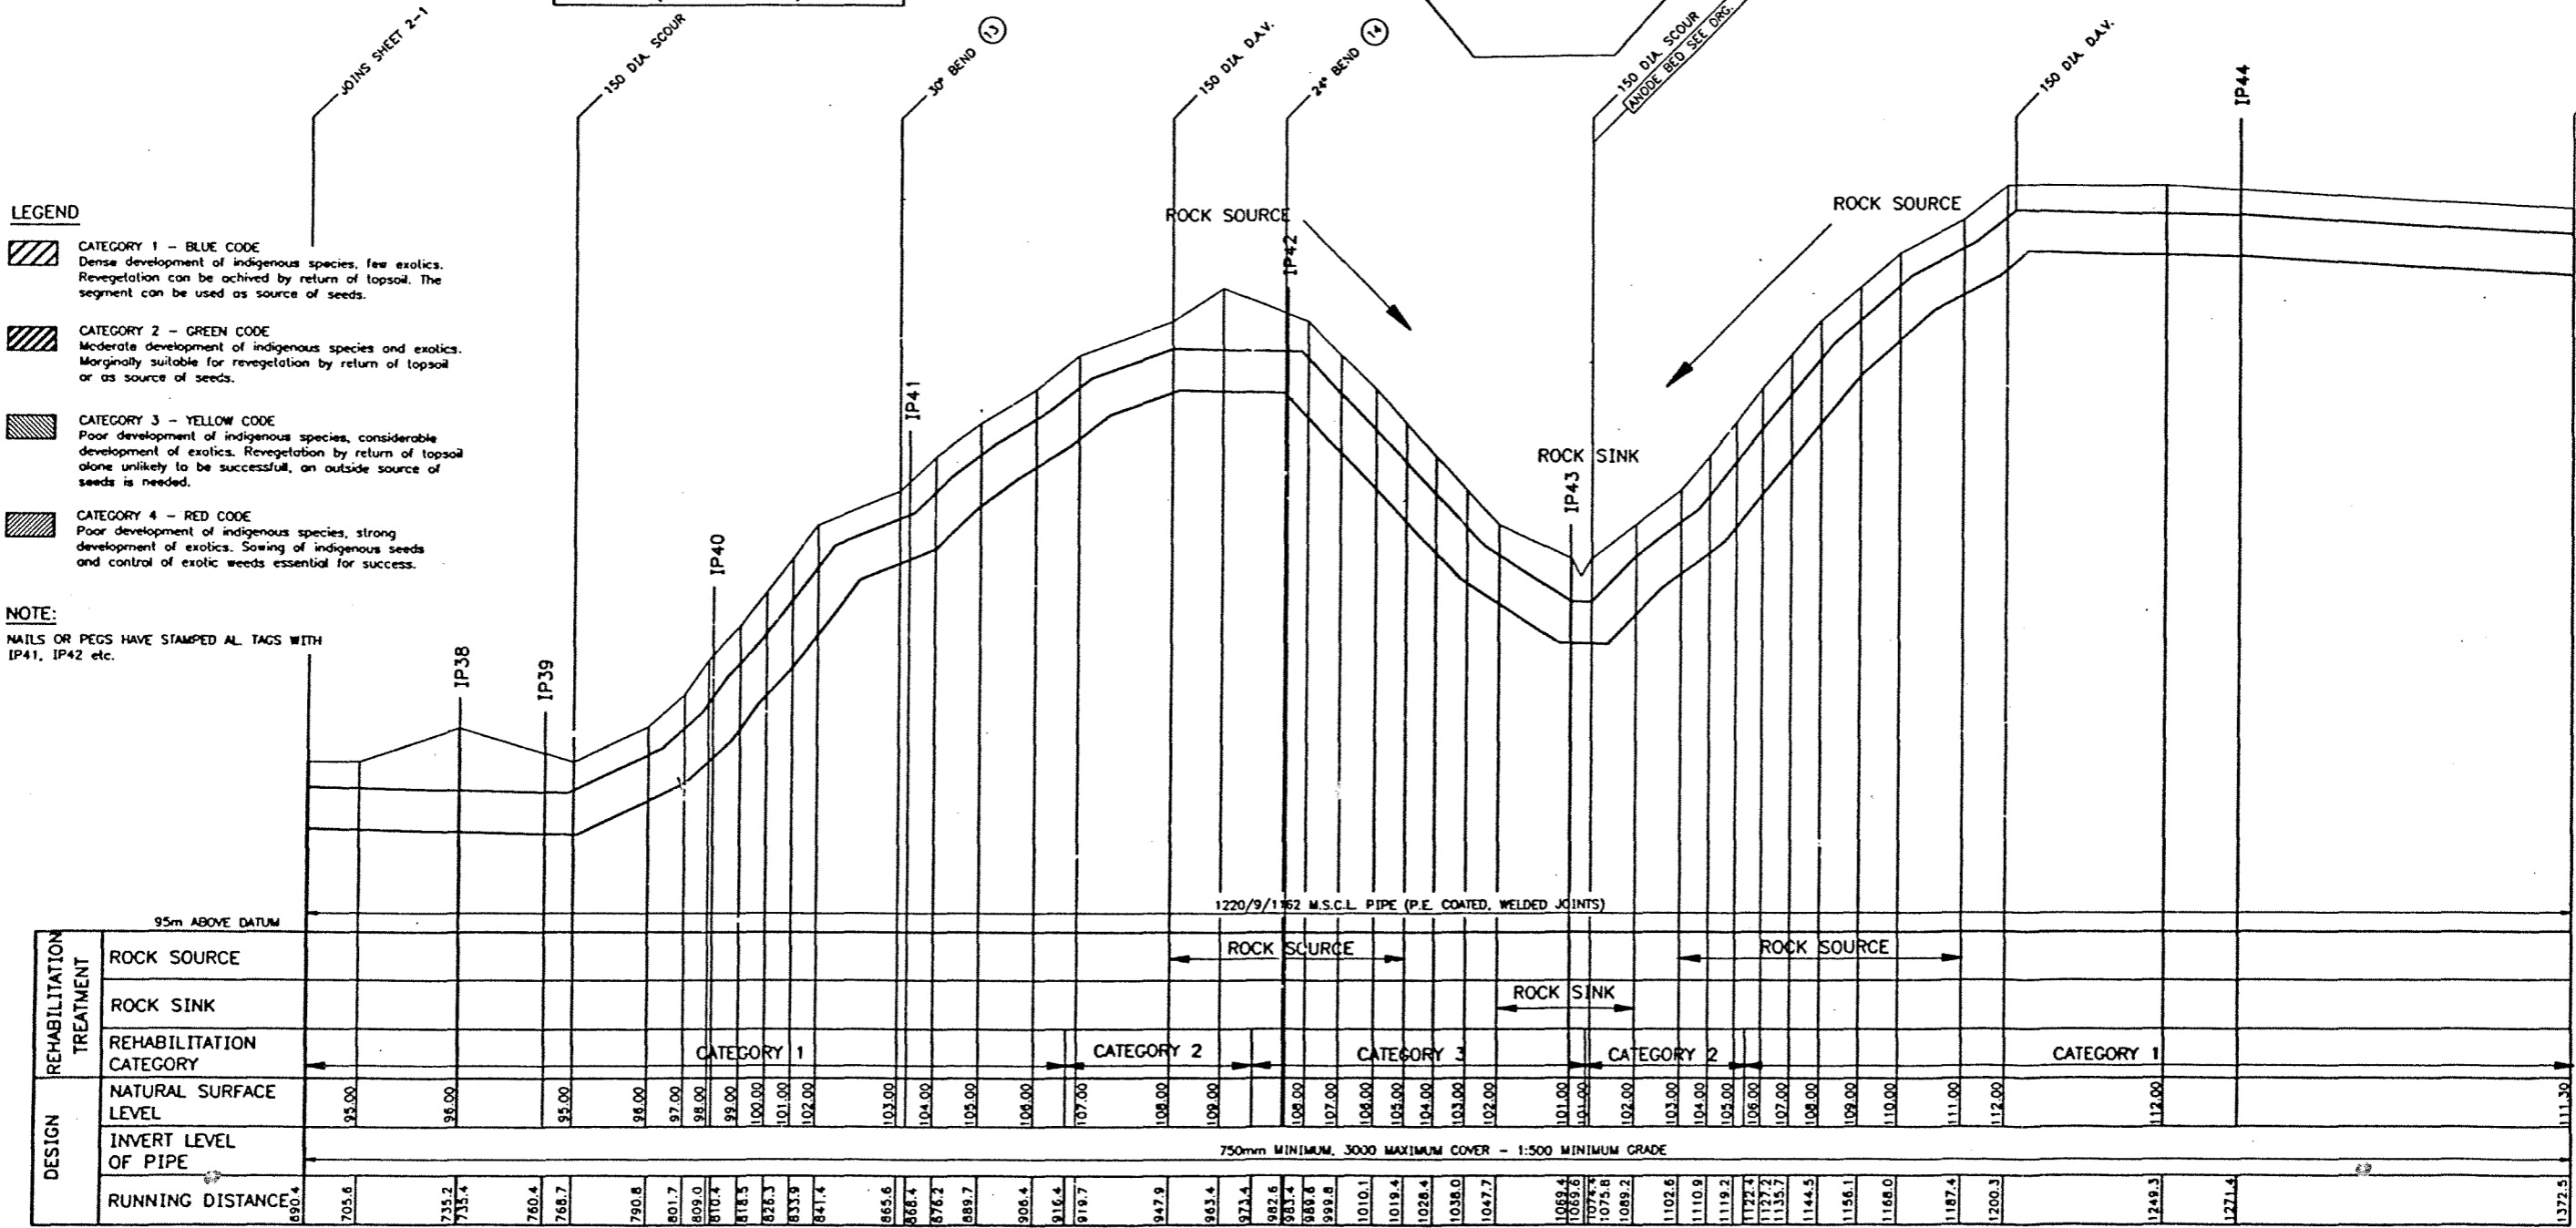
PLAN

1200 DIA. PIPELINE TO BE LAID ON 2000mm C/C FROM EXIST. 610 DIA. PIPE. (1000mm CLEARANCE)

NOTE:  
NAILS OR PEGS HAVE STAMPED AL TAGS WITH IP41, IP42 etc.

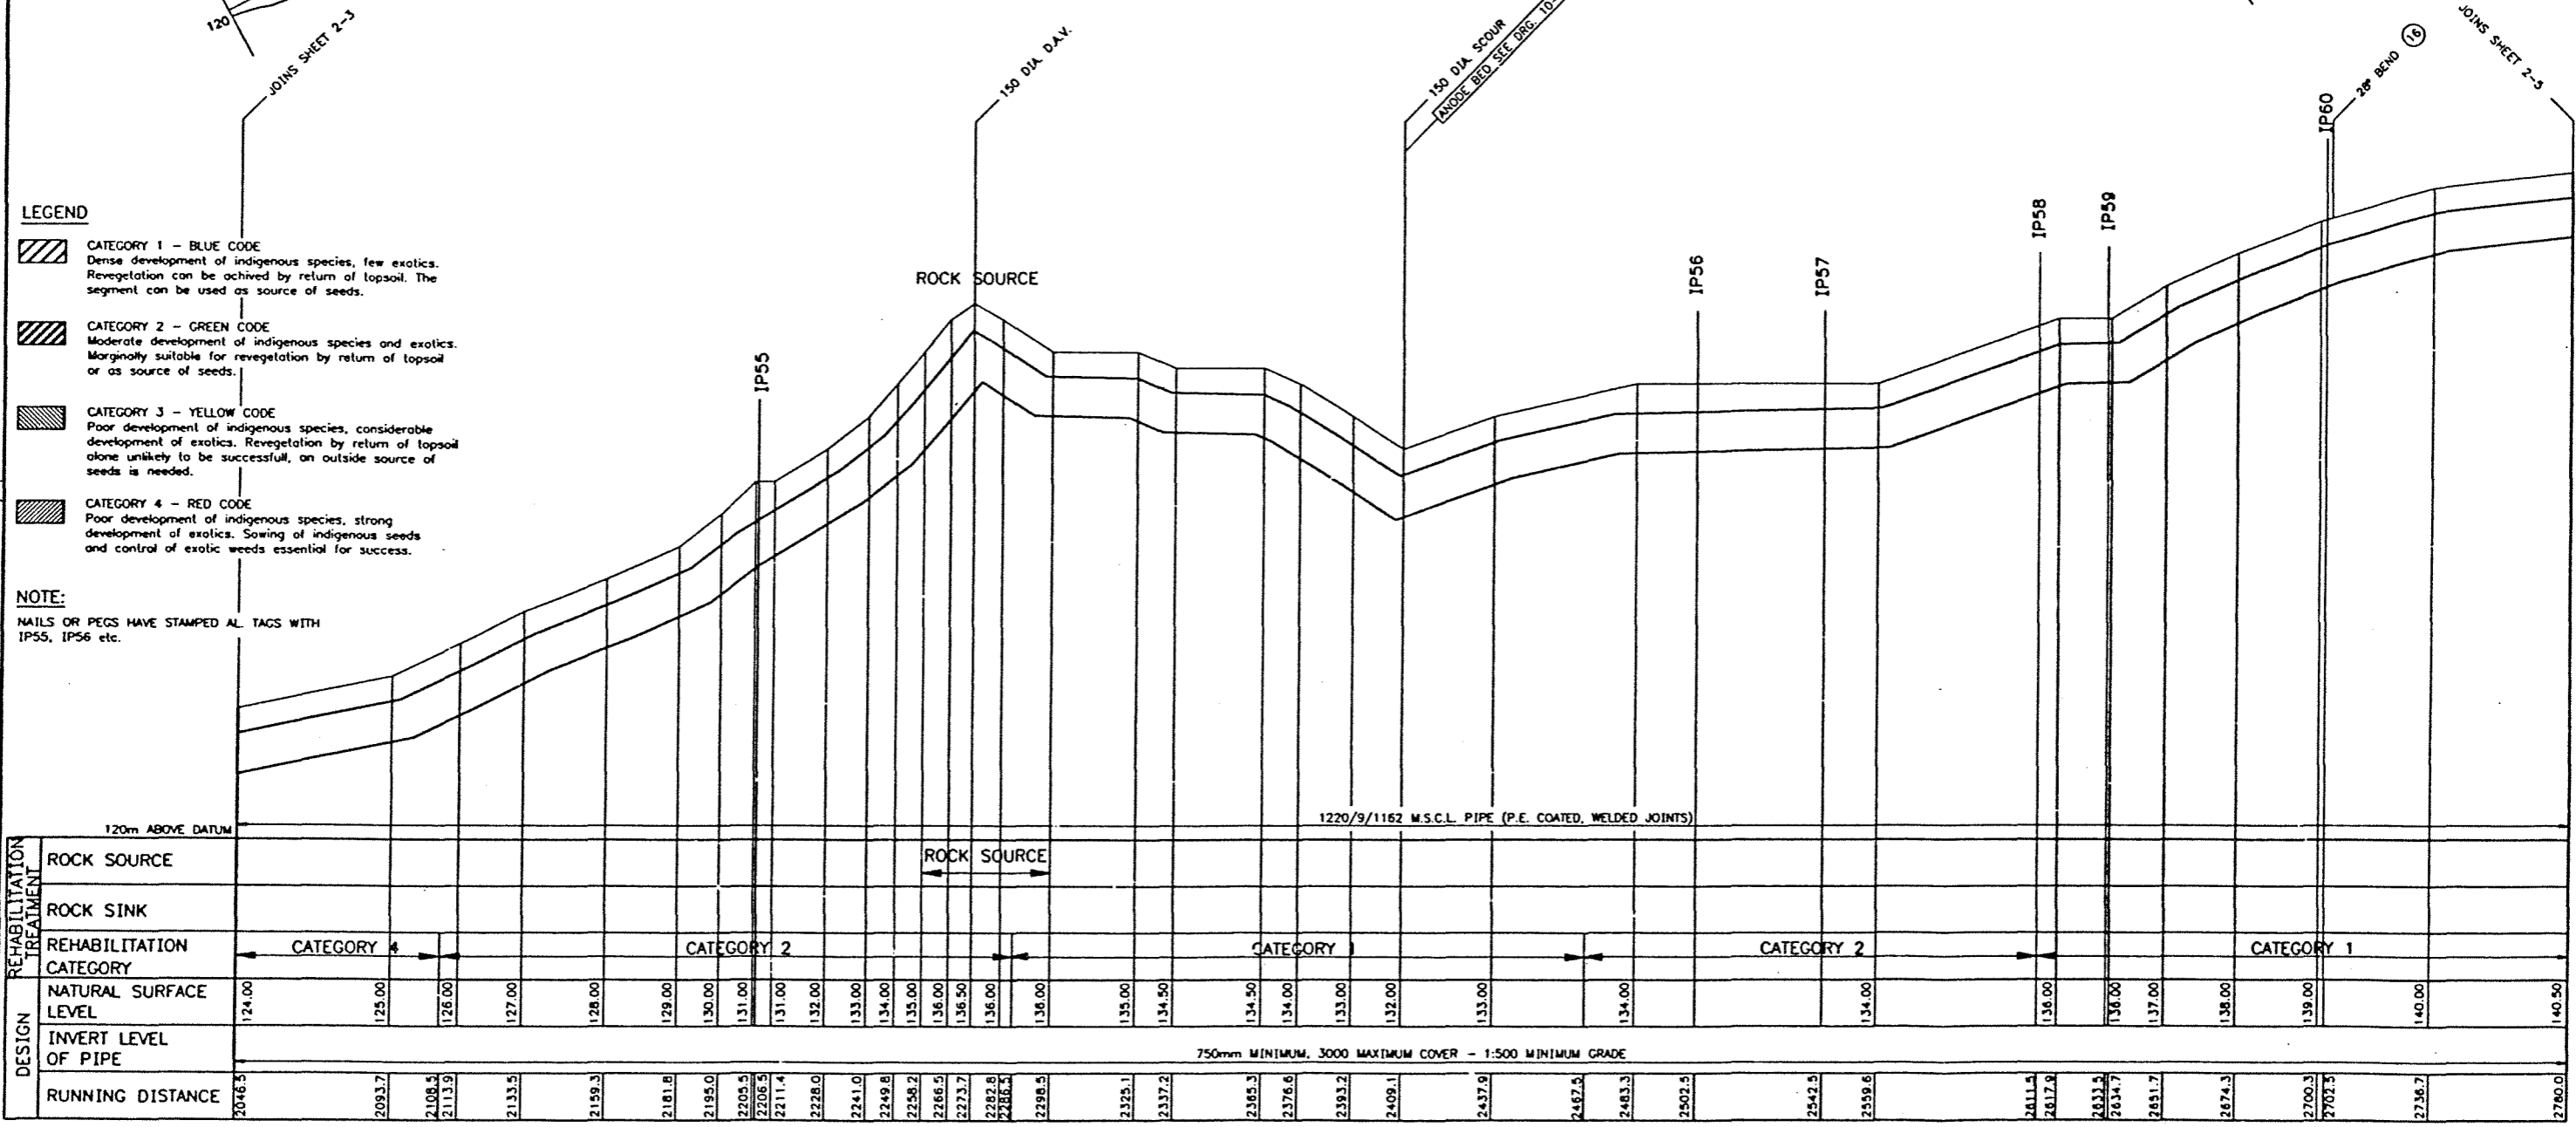
LONGITUDINAL SECTION

- LEGEND**
- CATEGORY 1 - BLUE CODE  
Dense development of indigenous species, few exotics. Revegetation can be achieved by return of topsoil. The segment can be used as source of seeds.
  - CATEGORY 2 - GREEN CODE  
Moderate development of indigenous species and exotics. Marginally suitable for revegetation by return of topsoil or as source of seeds.
  - CATEGORY 3 - YELLOW CODE  
Poor development of indigenous species, considerable development of exotics. Revegetation by return of topsoil alone unlikely to be successful, an outside source of seeds is needed.
  - CATEGORY 4 - RED CODE  
Poor development of indigenous species, strong development of exotics. Sowing of indigenous seeds and control of exotic weeds essential for success.
- NOTE:**  
NAILS OR PEGS HAVE STAMPED AL TAGS WITH IP55, IP56 etc.

One potential problem area that has been identified is an unidentified plant, possibly of Darwinia species, has been found at sections 60-61 and 62-63 (sheets 4 and 5). The status of this discovery is being investigated with CALM who may have to give a permit to move these plants if they cannot be avoided. The steps being taken and which will require to be taken are to;

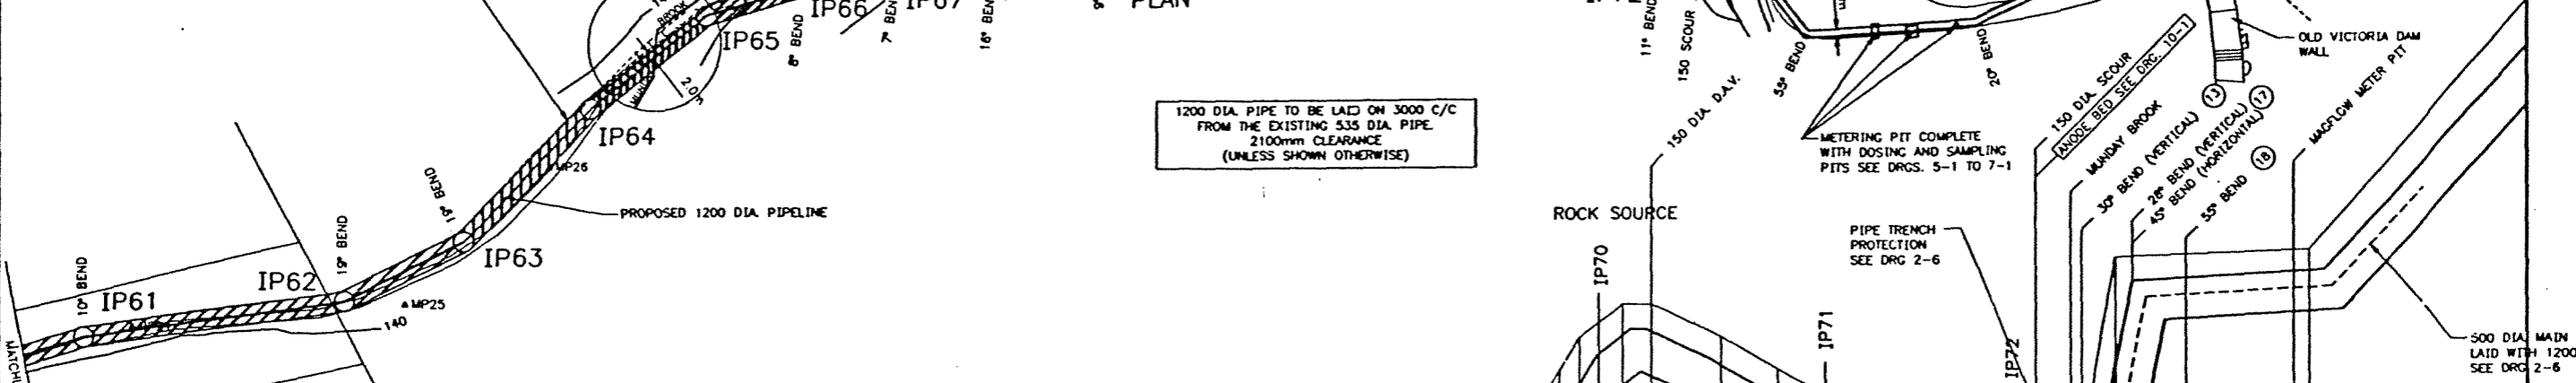
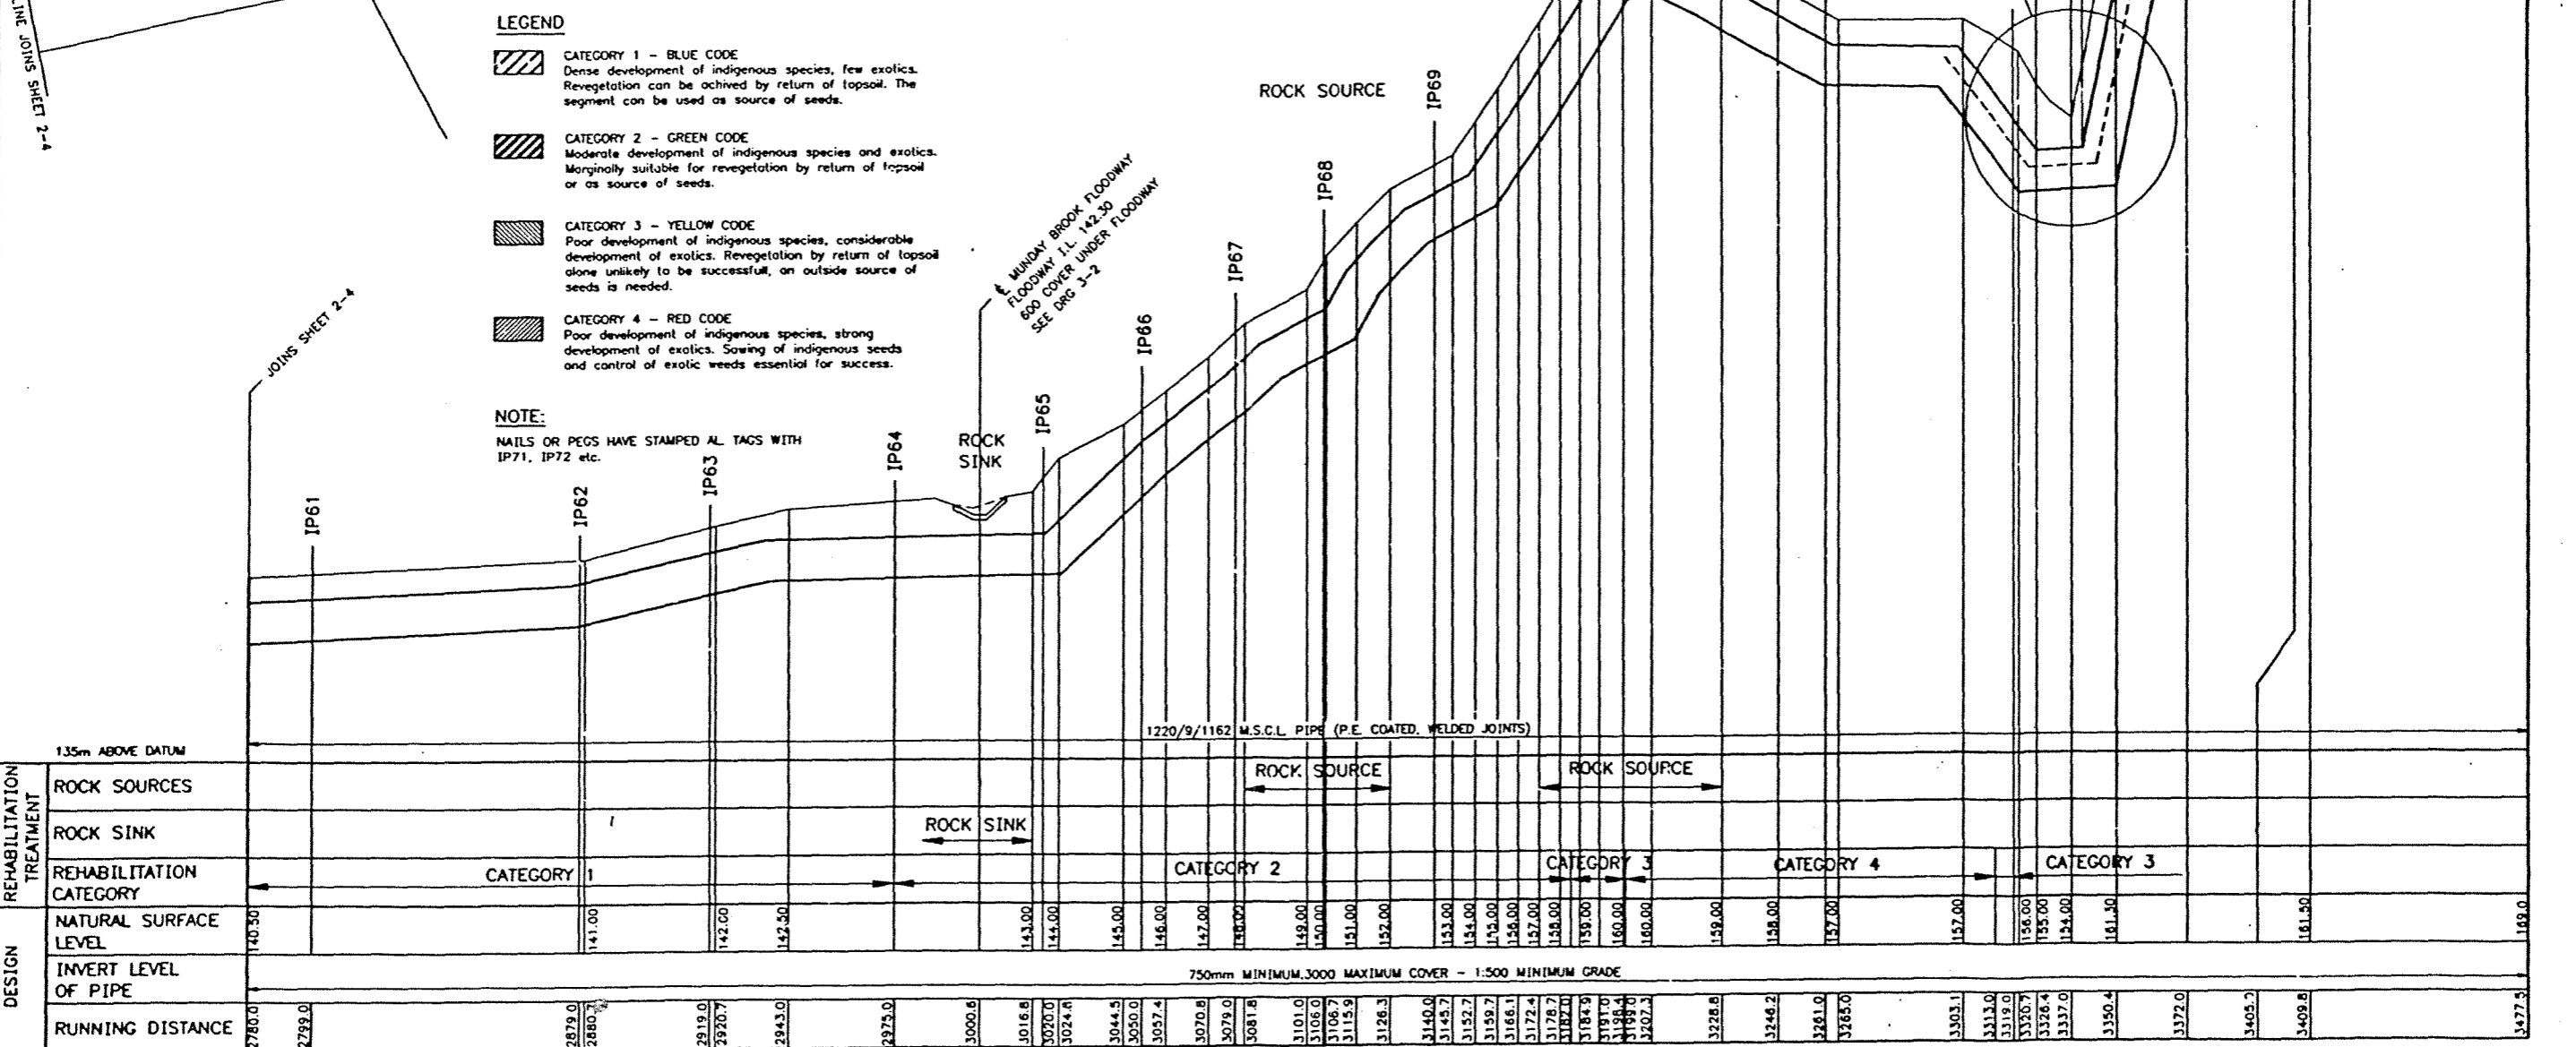
**LONGITUDINAL SECTION**

PROPOSED FLOODWAY  
EXISTING DIA. 535 PIPE TO BE  
RELAID WITH 500 DIA. PIPE  
SEE DETAIL DRG. 3-2

EXISTING 535 DIA. M.S.C.L.  
PIPELINE TO BE USED AS  
PUMPBACK MAIN FROM BICKLEY  
RESERVOIR.

1200 DIA. PIPE TO BE LAID ON 3000 C/C  
FROM THE EXISTING 535 DIA. PIPE.  
2100mm CLEARANCE  
(UNLESS SHOWN OTHERWISE)

NAILS OR PEGS HAVE STAMPED AL TAGS WITH  
IP71, IP72 etc.
