# Baselining wandoo crown condition

Preliminary report of wandoo crown decline surveys, 2006

Whitford K.R., Manning E.J., and Wills A.J.

June 2007

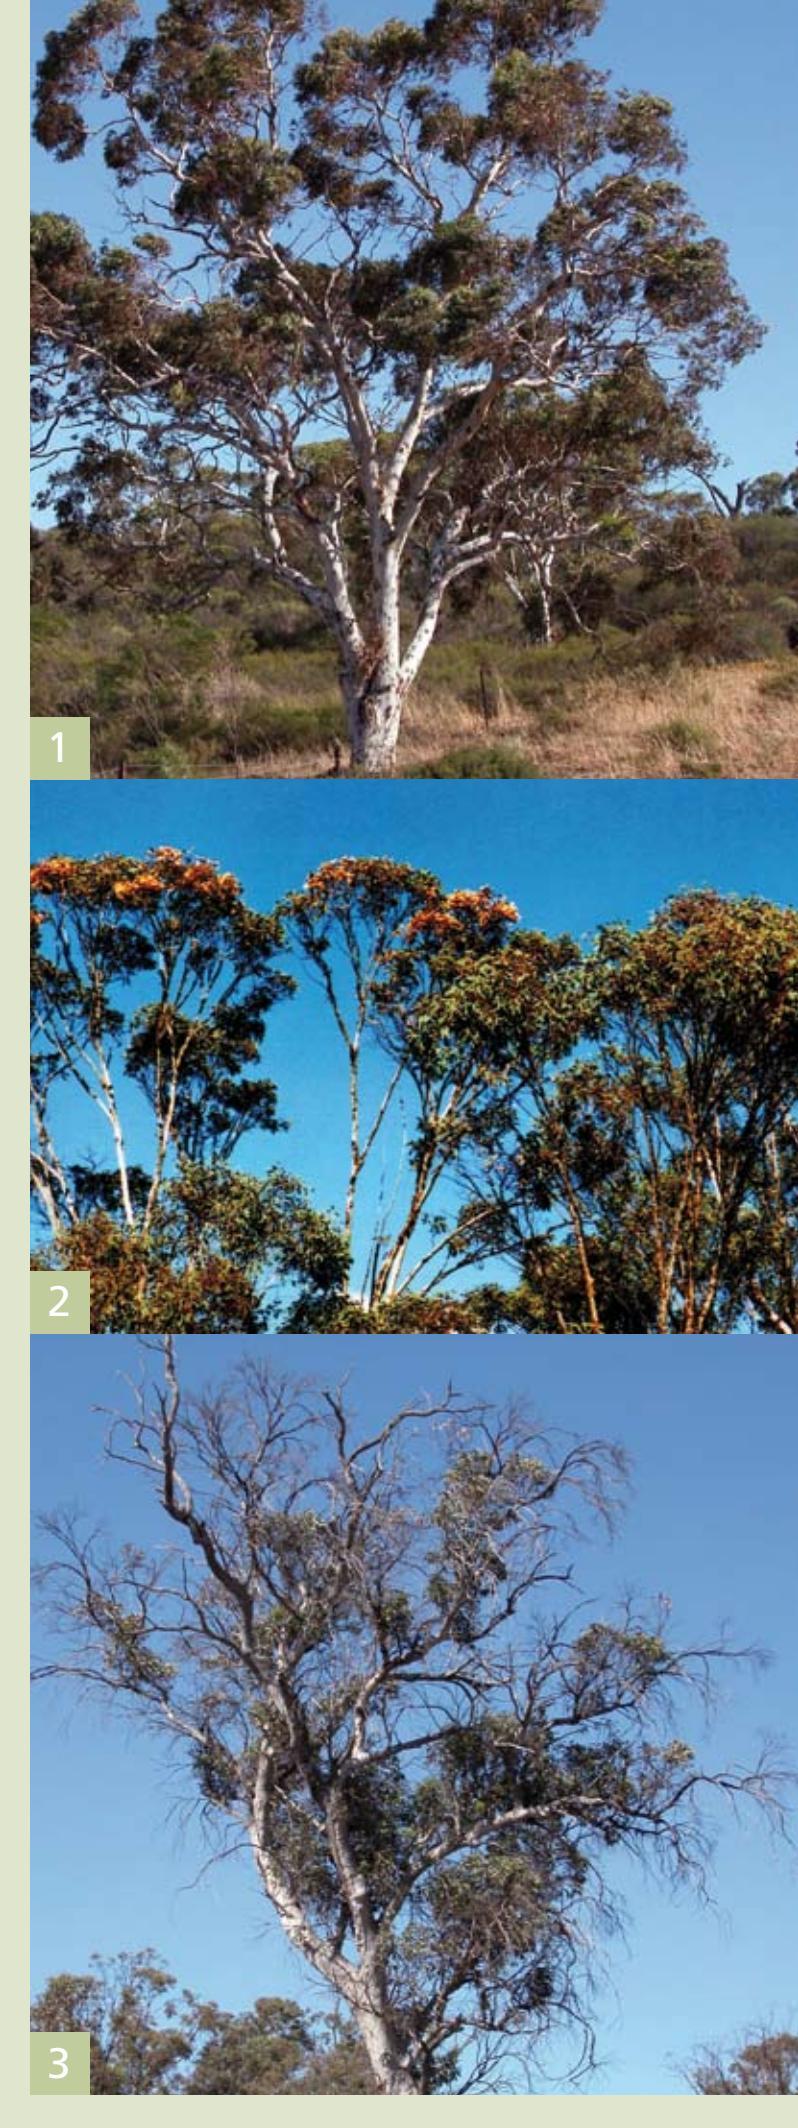
(Top) A healthy wandoo, (middle) initial flagging, (right) wandoo with advanced decline. Photos – P. Poot/A. Wills

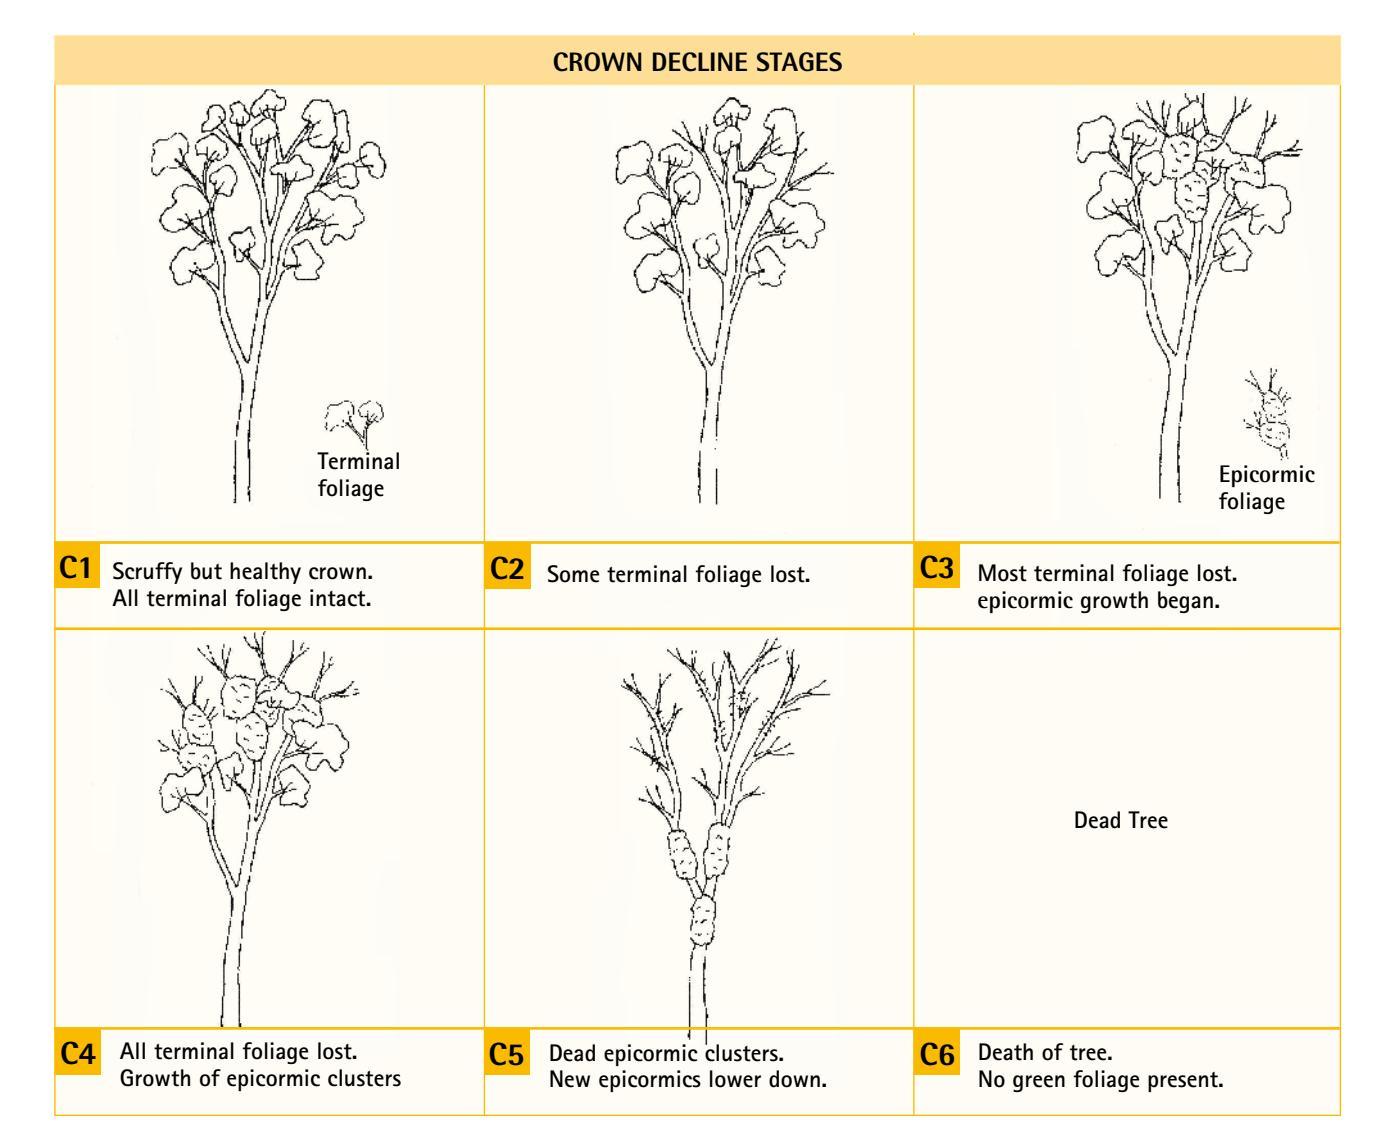
Figure 1. Line drawings of the six crown decline stages used to assess the degree of decline of individual trees. The use of this assessment scale and the associated survey procedure is described in *Surveying wandoo crown decline – A guide for assessors*, published by WRG.

This study reports results from surveys of wandoo crown decline by community groups and volunteers using the method developed by the WRG in 2005. Each survey is based on assessments of individual trees — in most cases along a 100m x 20m-transect within woodland blocks or along a road verge. In the survey, each tree is assigned to one of three diameter classes – 10 to 25cm, 25 to 50cm and more than 50cm – and assessed to determine the stage of decline (Figure 1) and the amount of flagging occurring in the tree crown.

Wandoo crown decline is most likely to progress and seriously impact those sites that have both a large amount of active crown decline (flagging) and trees in the early through to advanced crown decline stages (shown in Figure 1).

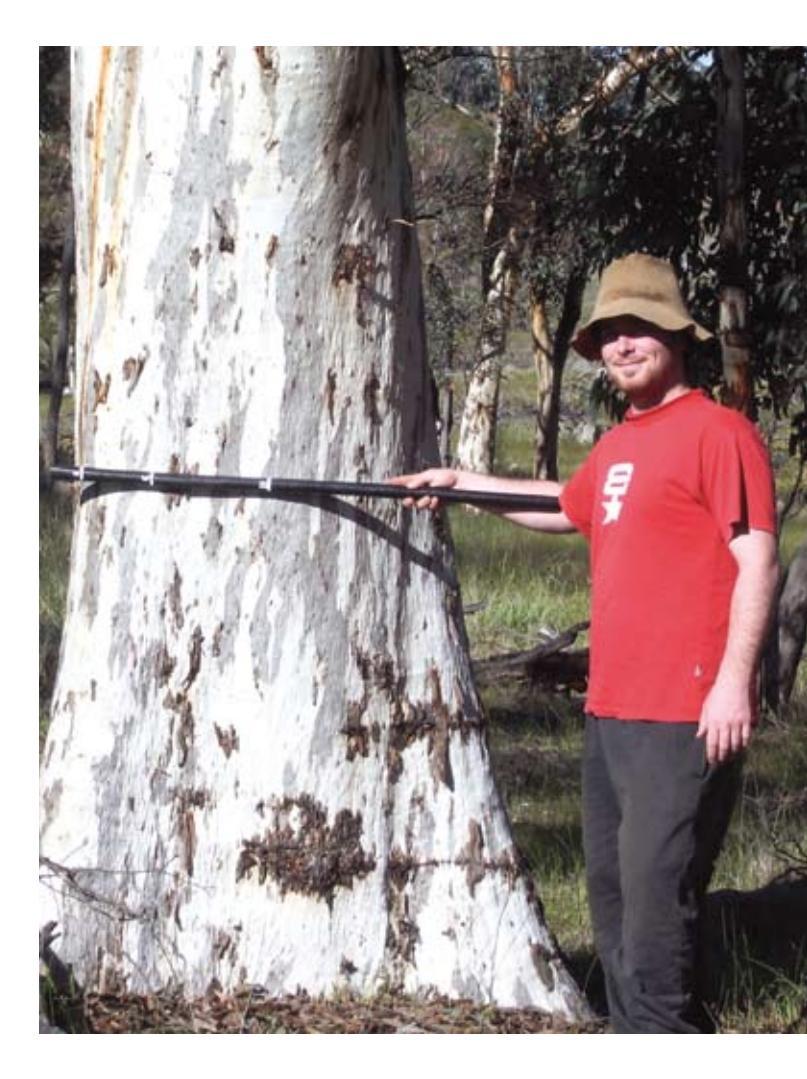
Measuring tree diameter 1.3m from the ground. Photo – L. Manning

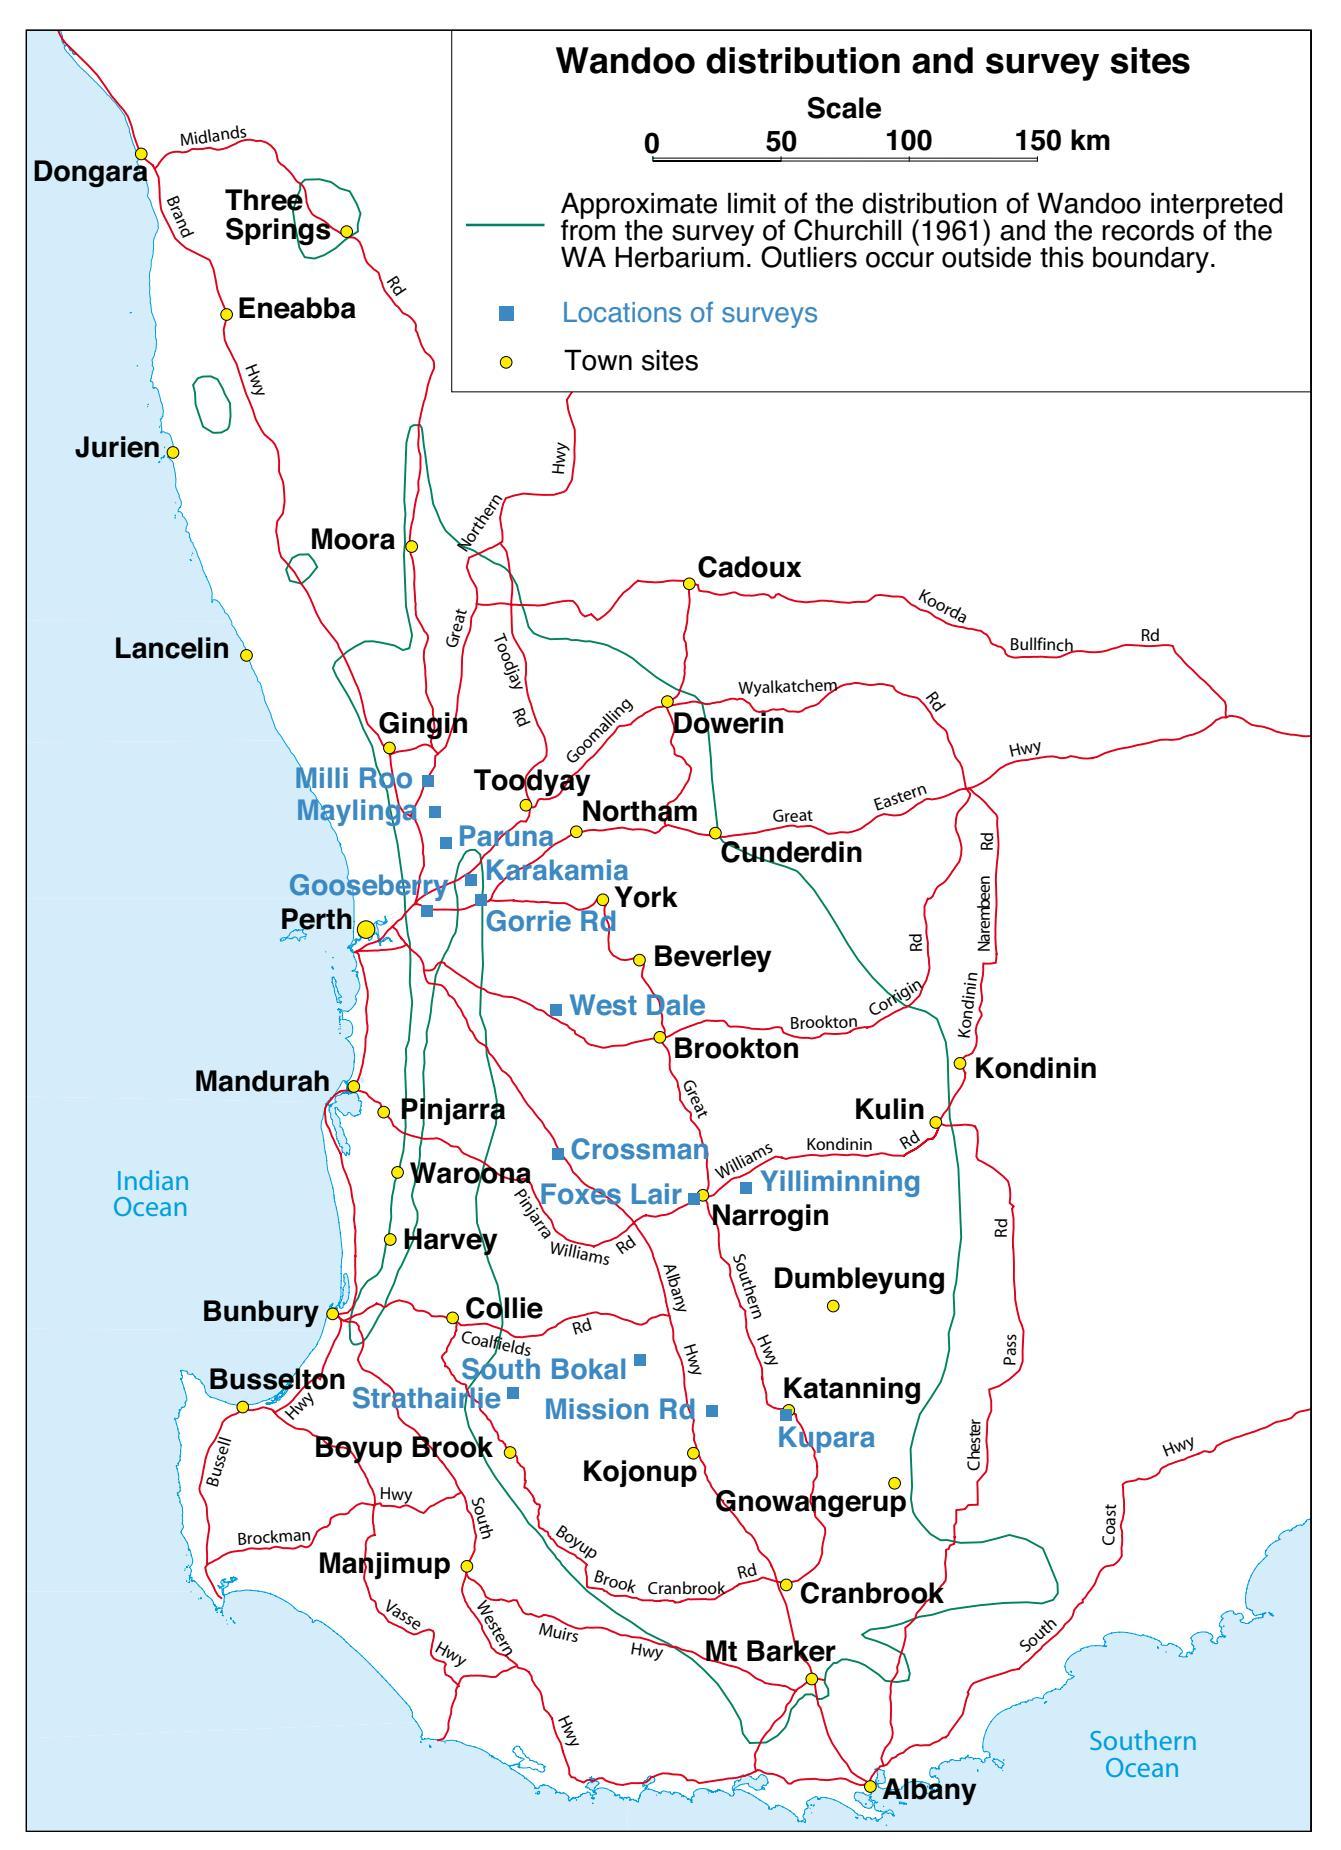
Figure 2. The location of wandoo crown decline survey sites. The green boundary is the approximate limit of the distribution of wandoo (*Eucalyptus wandoo*). Small stands and single trees will occur outside this boundary.

Thirteen monitoring sites have been established on a range of land tenures including private property, reserves and national parks in a north-south corridor from Chittering to Kojonup (Figure 2). During 2006, 32 transects were surveyed across the 13 monitoring sites. A total of 973 trees along 3350m of transects covering 6.7ha were assessed. Survey intensity ranged from one transect per site to seven transects per site.

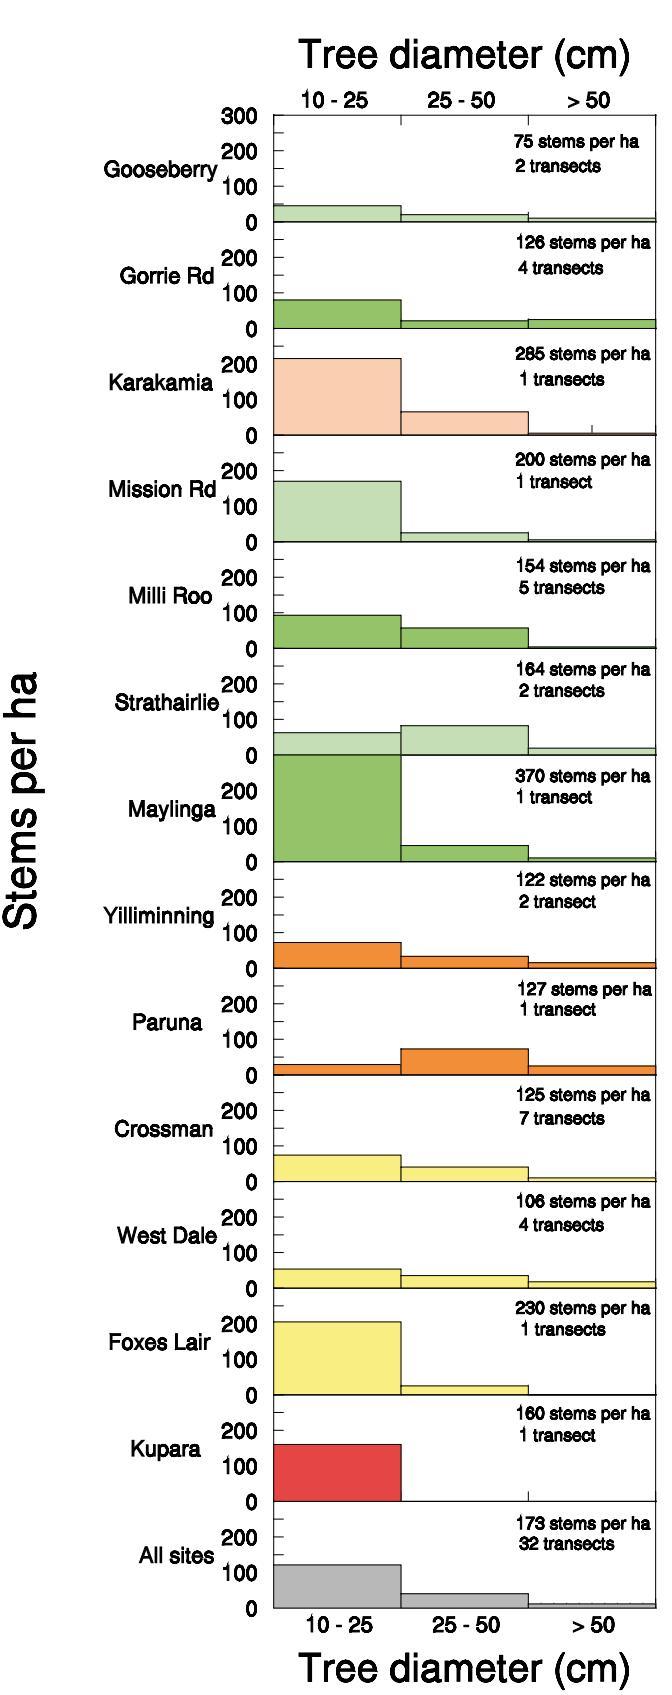
Figure 3 shows the distribution of tree diameters determined from the surveys of each site. The average stand density of trees across the survey sites was 173 stems per ha with a diameter greater than 10cm (this ranged from 75 stems per ha at West Dale to 370 stems per ha at the Maylinga property).

Eleven of the 13 sites surveyed had size distributions skewed to the 10-25cm diameter class. Five of these sites were heavily skewed, with many more trees in the small diameter class than in the larger classes. Such skewed distributions of tree diameters are common. The intermediate, 25-50 cm, diameter class was most frequent on two sites.

Although distributions of tree diameters vary greatly across the landscape, data from Rose (1993) for two wandoo stands that have never been logged indicates old-growth stands have a relatively flat distribution of tree diameters with approximately equal numbers of trees in each of the three diameter classes. The skewed distributions on many of the survey sites may be due to historical timber harvesting.

Figure 3. The number of stems per hectare at each site in the three diameter classes.

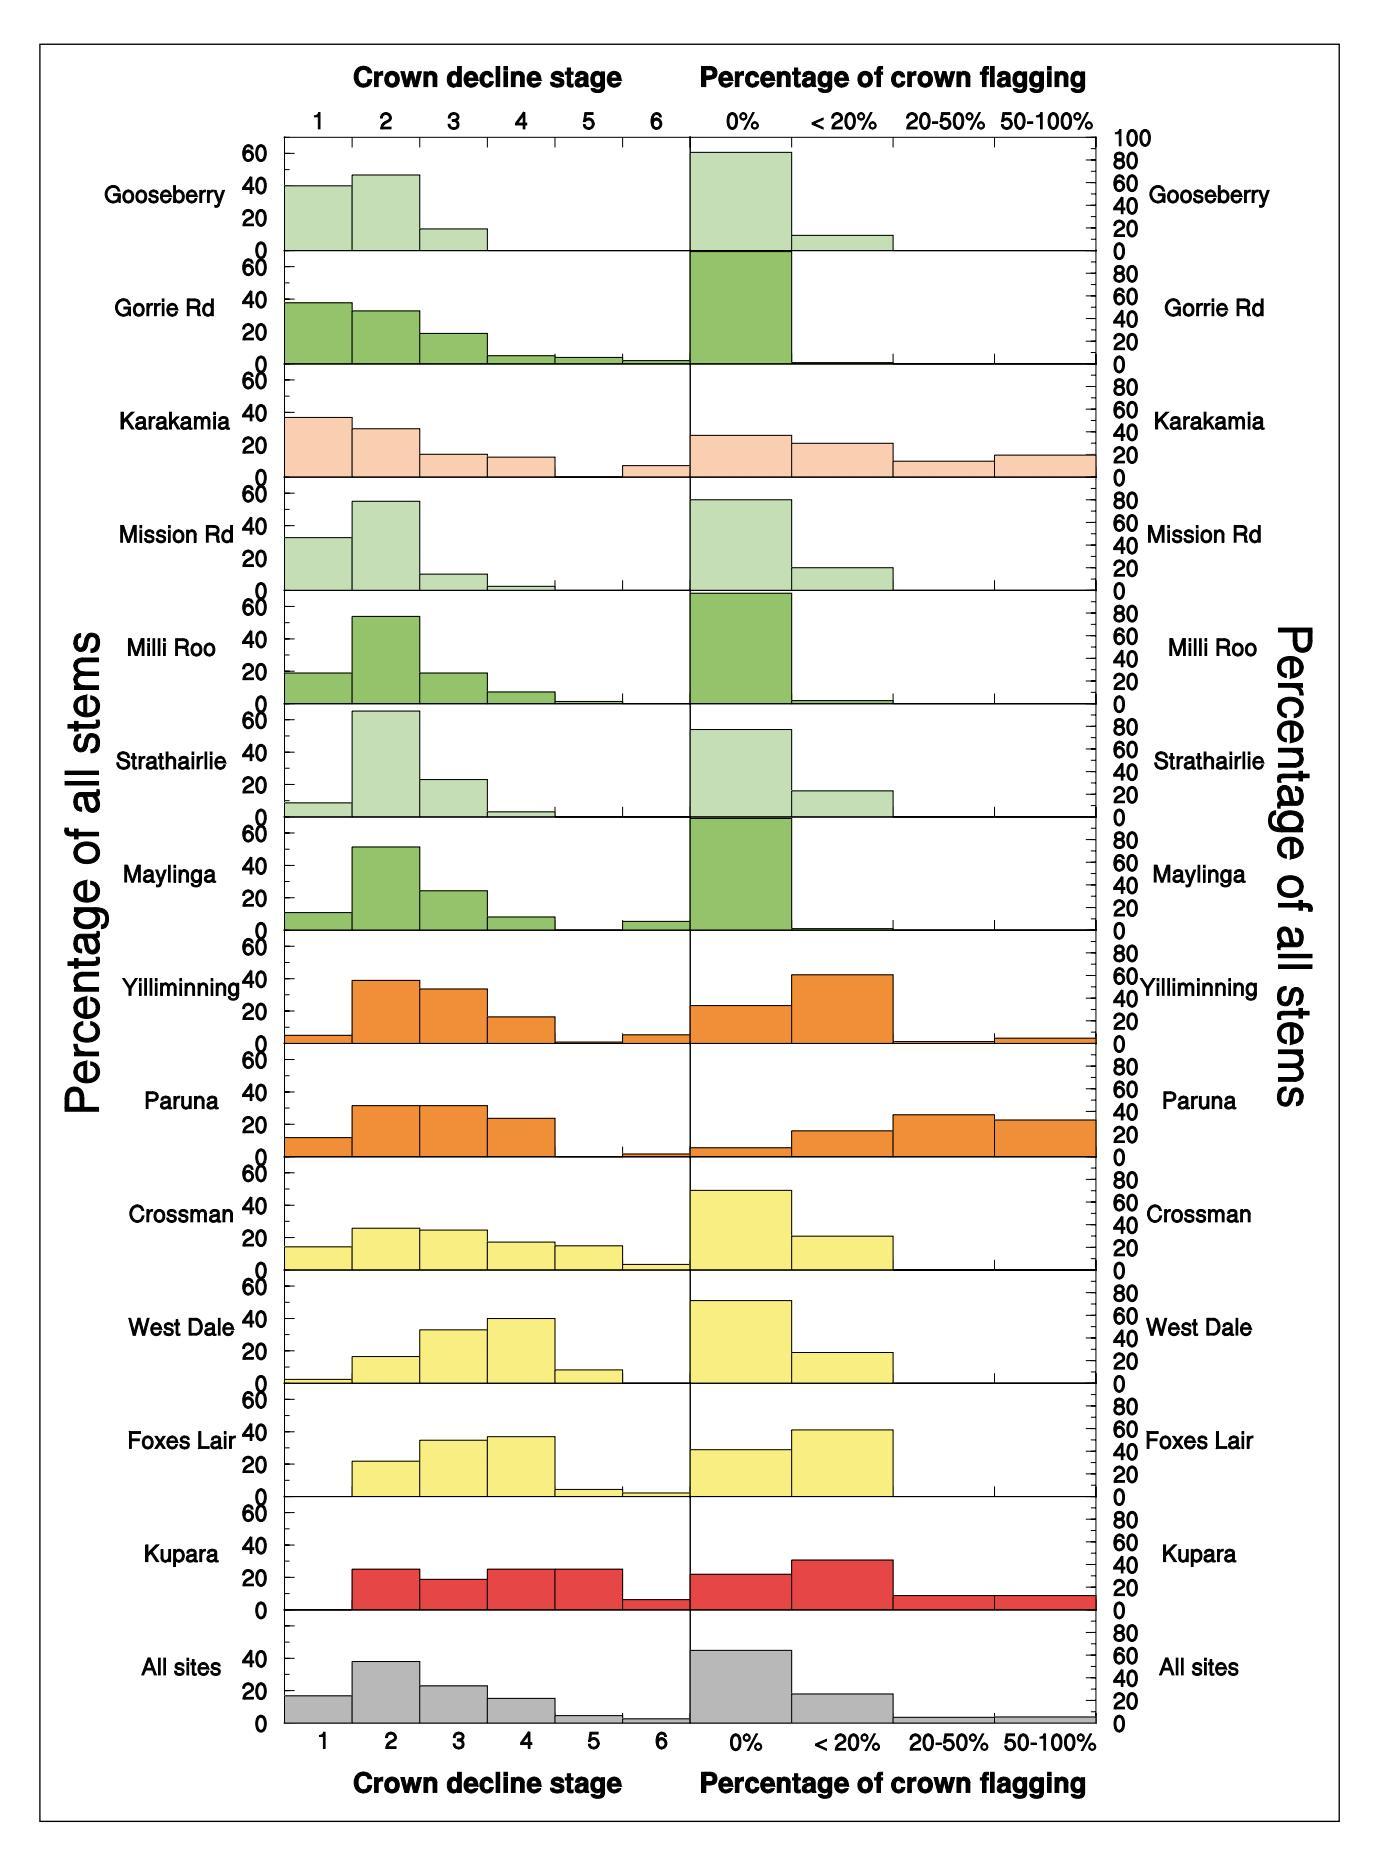
Figure 4 shows the percentages of trees in each of the six crown decline stages at each site, and the proportion of flagging leaves in the tree crown at the time of assessment.

Based on the available survey data, Kupara Reserve appears to be the site most threatened by wandoo crown decline. Karakamia, Yilliminning and Paruna also have extensive active decline and a wide range of crown decline stages (Figure. 4). It is likely that decline will progress to advanced stages at these sites.

Figure 4 (left hand side) The percentage of trees at each site assigned to the six crown decline stages. (Right hand side) The proportion of flagging leaves in the tree crown at the time of assessment. Classes are 0%; < 20%; 20%–50%; and 50%–100%.

Based on consideration of the crown decline stage and the presence of active crown decline (flagging) (Figure 4), summary interpretations were made for each site (Table 2). The summary interpretations are based solely on the survey data so may not adequately describe sites that only have one or two transects.

We are more optimistic about the progression of decline at the other nine sites. We do not expect the decline to progress at Gorrie Rd, Milli Roo, Maylinga, Gooseberry Hill, Mission Rd, or Strathairlie. It appears likely that crown decline at Crossman, West Dale, and Foxes Lair will stabilise and recovery will begin.
