# FIRE NOTE

ISSUE 69 NOVEMBER 2010

## PASSENGER VEHICLE BURNOVER IN BUSHFIRES

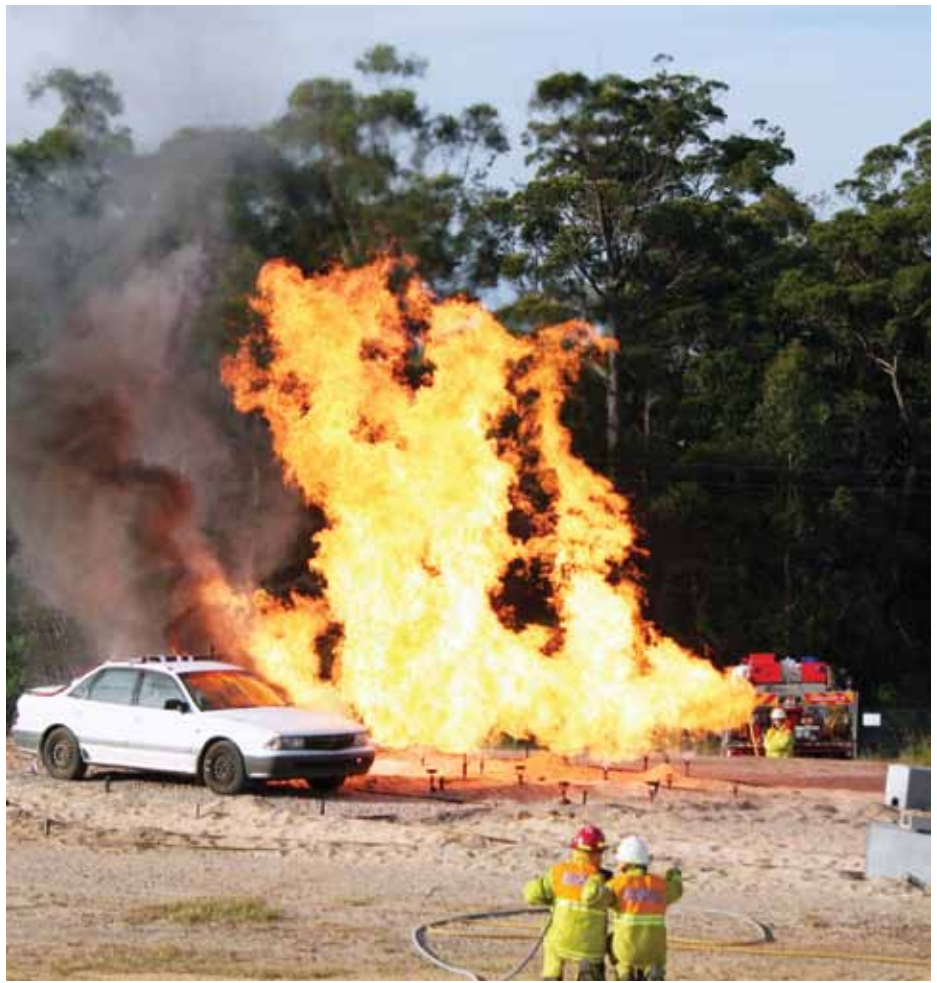
▲ Testing at the NSW Rural Fire Service Hot Fire Training Facility in Mogo.
