# FIRE NOTE

ISSUE 68 NOVEMBER 2010

## TANKS ON TRIAL: PERFORMANCE OF RAINWATER TANKS IN BUSHFIRE CONDITIONS

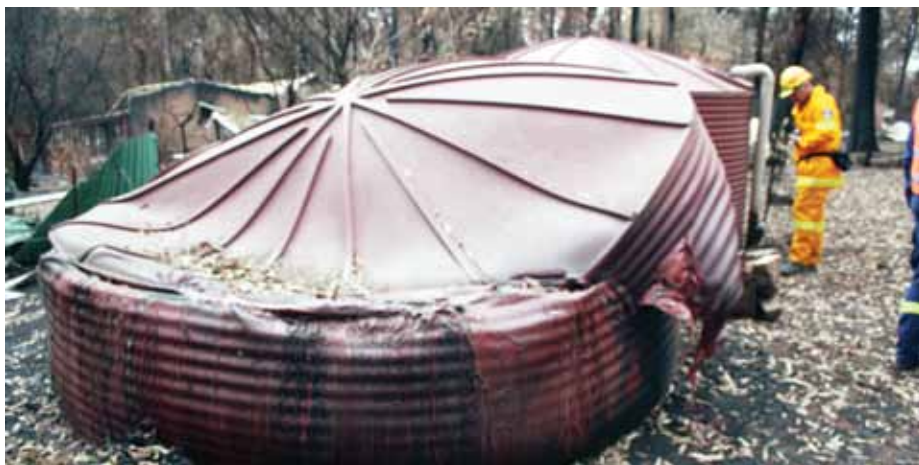
▲ Plastic tanks at Kinglake after the 2009 Black Saturday fires.

Polyethylene (plastic) constructed tanks fared worst under all levels of exposure. The first condition created a small ignition of the tank around the base and combustion

of the polyethylene to a depth of 20mm in one localised area, but no water loss. Under threat from ignited litter and pre-radiation, the polyethylene tank melted and deformed to the level of the water, and while some leaks were detected and the front surface was involved in flaming combustion for some time, the tank still held water. Under simulation of structural fire the tank quickly split and collapsed, emptying itself and melting down in complete failure.

While not fully explored, it was observed in site inspections and interviews undertaken by the Bushfire CRC Task Force immediately after Victoria’s Black Saturday fires of February 2009 that the test results from this research were consistent with the effects on water tanks of the extreme events of that time.
