Streambank stability

FACT SHEET 2

Publication data
Price, P. and Lovett, S. 2002, 'Streambank stability', Fact Sheet 2, Land & Water Australia, Canberra

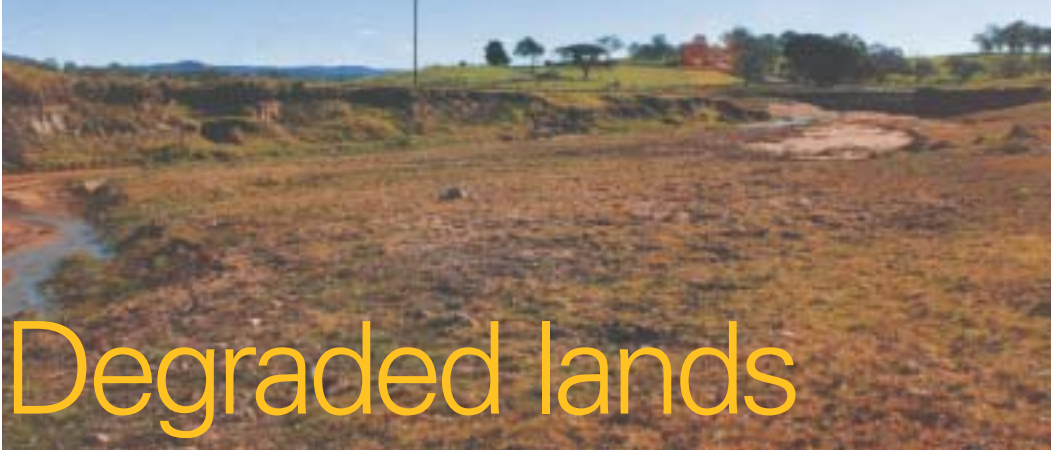
Large scale clearing of vegetation has degraded riparian lands and increased stream erosion.

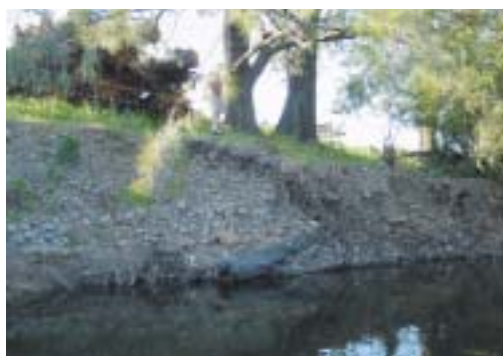
The stream is scouring the toe of this streambank which has no riparian vegetation to prevent this erosion from occurring.

- **Scour** — This occurs when the force applied to a streambank by flowing water exceeds the resistance of the bank's surface to withstand those forces. This often happens at the toe of the bank (i.e. at the water's edge) where suspended particles in the flowing water scour away the bank soil. It is also common on the outside bends of rivers, where the flow speed is fastest. Again, protecting the bank and reducing flow speed are critical actions to reduce this form of bank erosion.

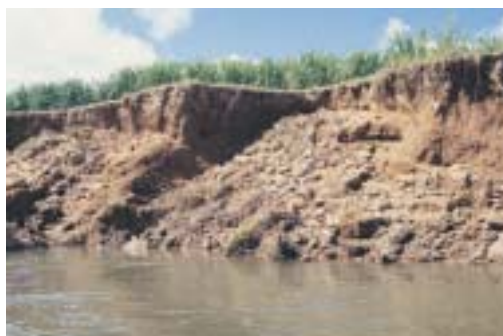
The removal of riparian vegetation has resulted in streambank erosion and the collapse of large sections of the bank.

- **Slumping** — This occurs when blocks of the bank collapse as a result of undercutting or other structural weakness within the streambank. The reinforcing effect of plant roots, and removal of moisture through plant use, can assist in reducing slumping processes in many situations.

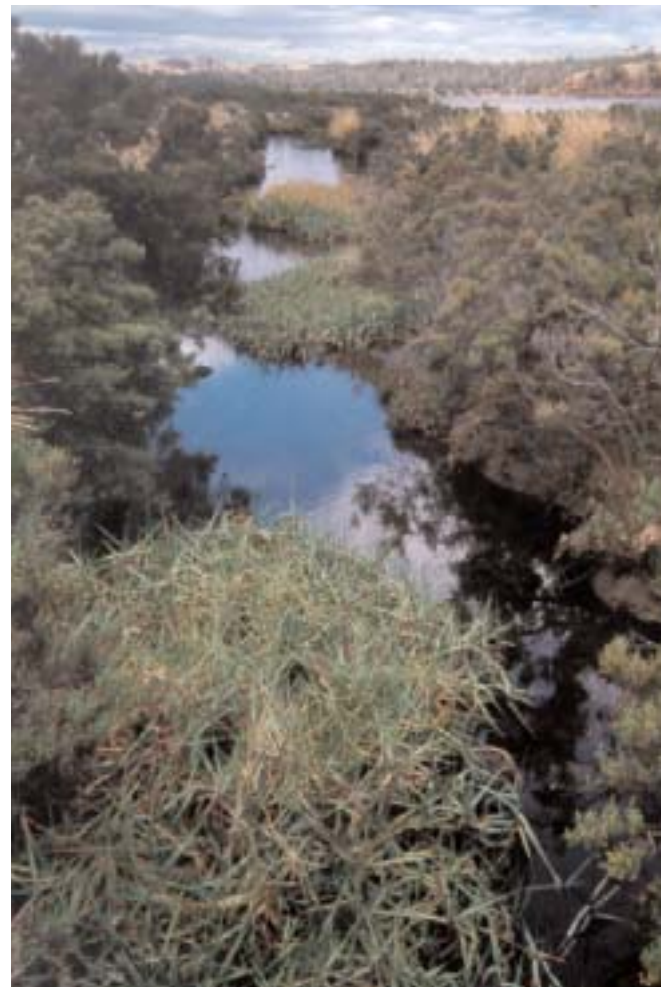
Exotic rice grass invading a small creek.

In some cases, highly-invasive vegetation may grow into the river channel. Vegetation growing within the channel will reduce scour by decreasing the flow speed adjacent to the bank. However, if the vegetation becomes too dense, for example in the case of reed beds or some invasive exotic grasses, it can direct flow into the banks and increase scour. As well, lower flow speed in channels invaded by vegetation, especially willows in southern Australia, can reduce channel capacity. The result may be an increase in the frequency of nuisance flooding.

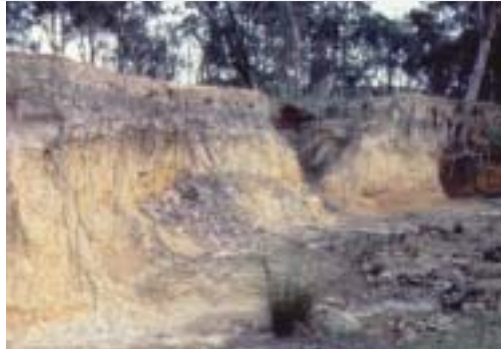
Stream incision.

- Incised streams — This occurs when the bed is deepening and the banks fail because they are over-steep and perhaps undercut. There is little point, in this situation, in stabilising streambanks until the streambed has been made stable. Vegetation on the channel or gully floor, while being very difficult to establish, is useful in stabilising the bed, although some initial grade control structures using rock or large woody debris may be needed. It is important that dense vegetation does not then fill the centre of the channel and divert flow onto the banks. In some cases, the best management is simply to fence the stream off from grazing, stabilise the bed with rock or woody debris, and allow the bed and banks to be colonised by grass. Another approach is to construct a stabilised rock riffle within the channel, positioned so as to retain an upstream pool that acts as a stilling pond during flow events, helping to protect the bed from further erosion.

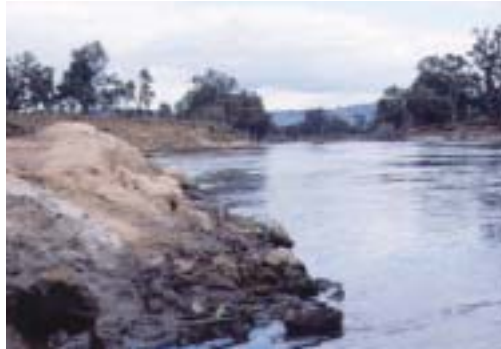
Channel widening.

- Channel widening — This may or may not be related to incision. If both banks of a stream are eroding, it may be that:

In large channels, the key is to establish vegetation as far down the face of the bank as possible, as well as on the bank top. Special attention needs to be given to stabilising the toe of eroding banks, and this may require rocks or other structures to help maintain the toe region while vigorous vegetation becomes established above it.

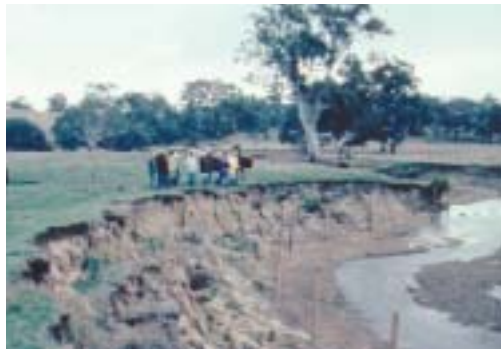
Erosion of the outer bank.

- Erosion of the outer bank — This usually occurs on steep banks located on the outside of a meander bend. This is the most common erosion problem faced on larger streams. The outside bank of a meander is often steep or even vertical, making it difficult to establish vegetation on the bank face. In general, the higher the bank, the less useful vegetation on the top of the bank is in reducing collapse. In other words, revegetation on its own is likely to be effective only when there is an approximate match between the height of the bank and the rooting depth of the vegetation.

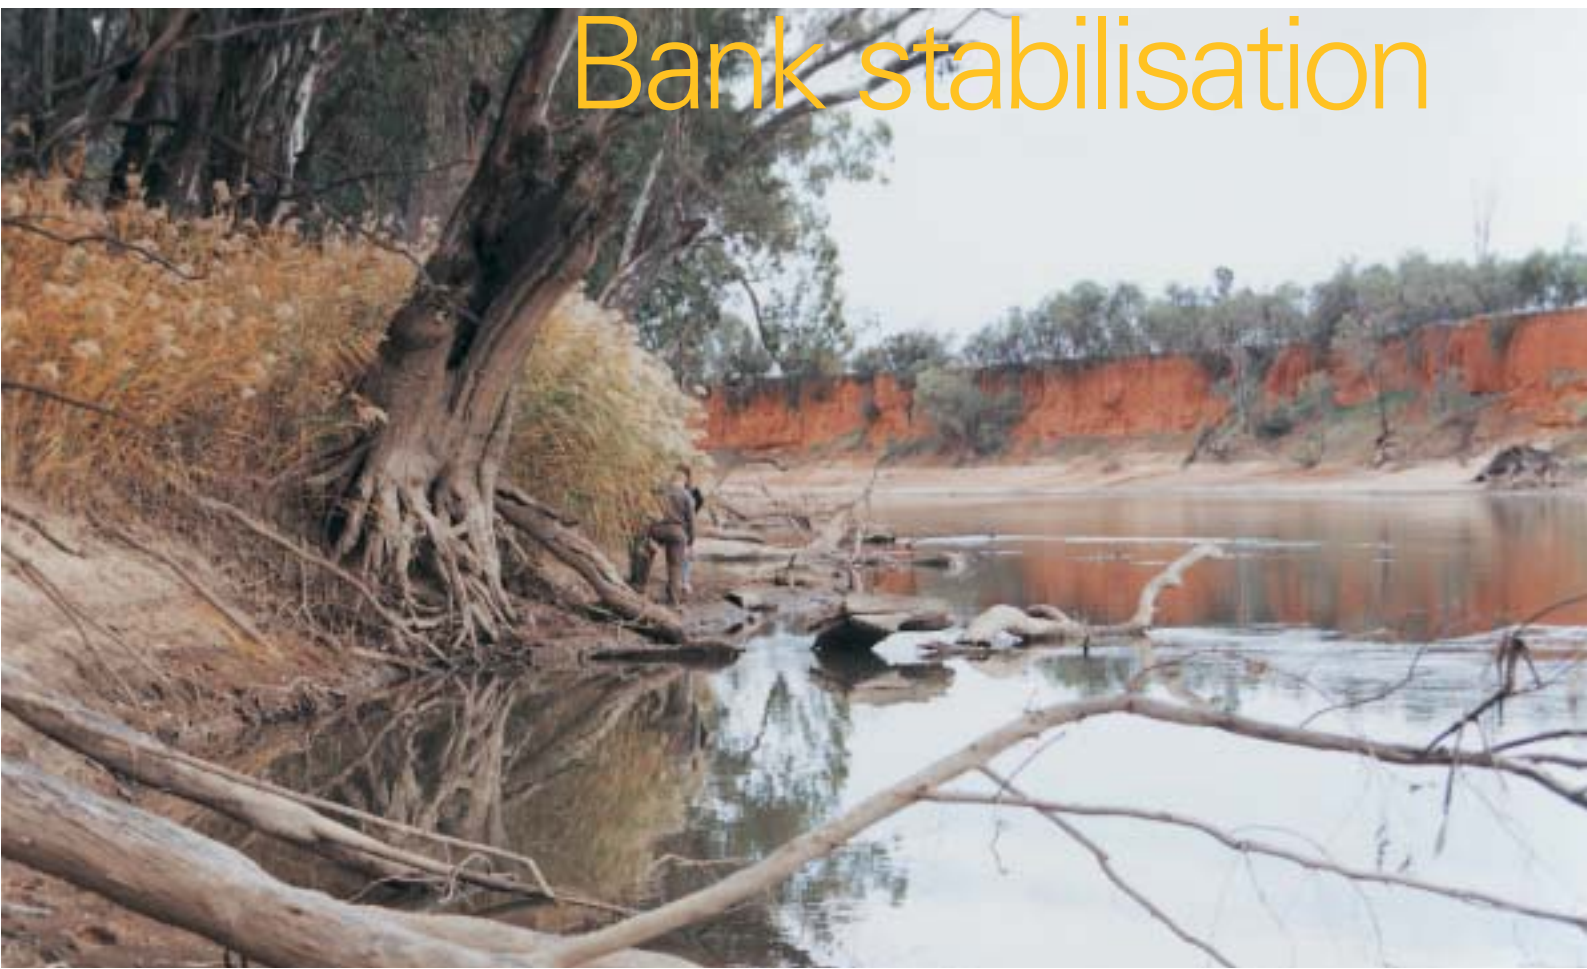
Phragmites growing over the bank of the Murrumbidgee River helping stabilise it against scour. Note also the protection from tree roots and the contrast with the vertical bank on the outside of the bend.

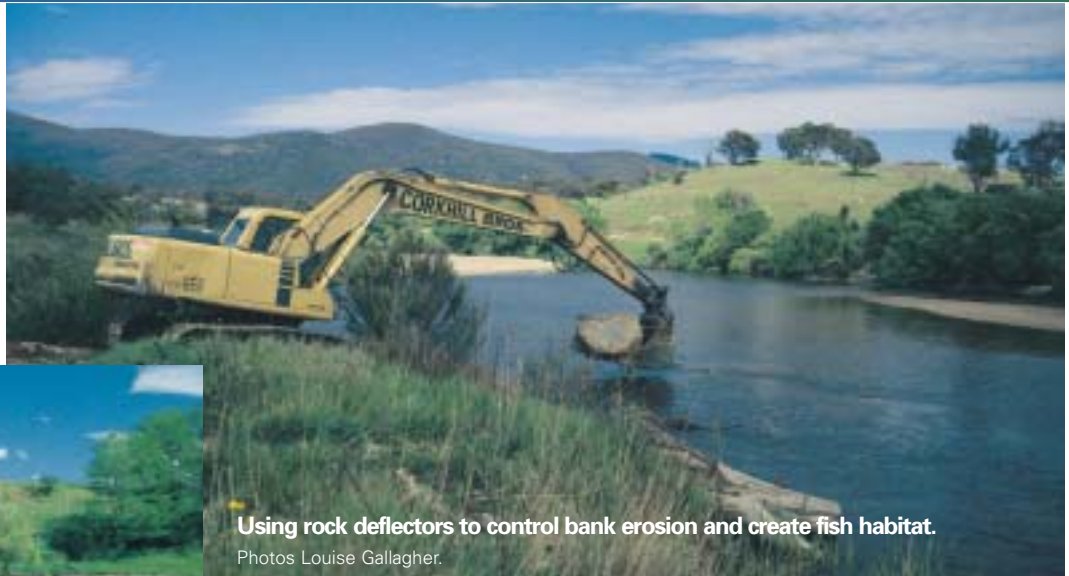
Using rock deflectors to control bank erosion and create fish habitat.

Vegetation and large, woody debris would need to occupy at least 10% of the cross-section of the channel before having much effect on flow velocity and flooding. Large woody debris is now known to have an important effect in helping to control the grade of channel beds and to armour both bed and banks against erosion. Where the total amount of woody debris within a channel may be approaching the 10% zone, some may be dragged back against the banks at an angle of around 40°, where it is known to have very little effect in diverting water flow onto the banks.
