Lake Bryde Recovery Catchment

Annual Report 2004

Darren Coulson

Lake Bryde Recovery Catchment Officer

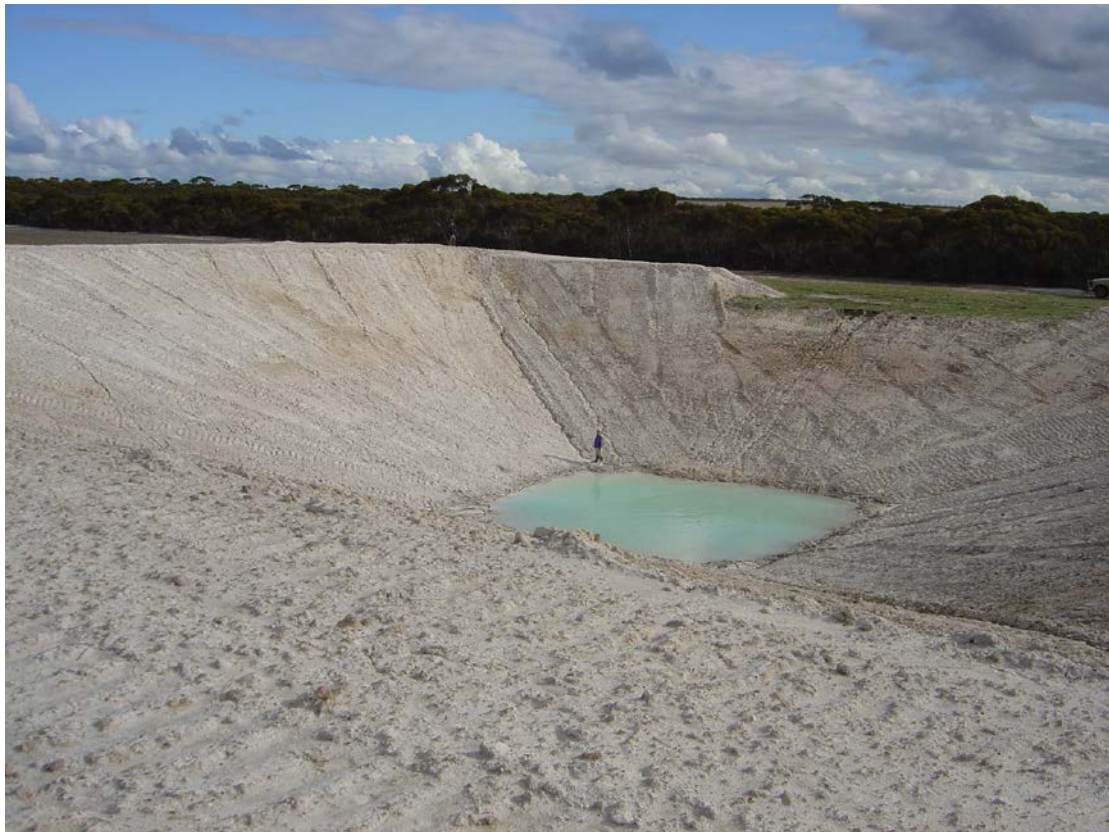
Dam constructed on private property through cost share agreement

- 6.4.4 **Surface Water Management Earthworks:** Desk top planning for surface water management on private property has been completed for the majority of properties within the catchment. Cost share agreements were finalised with 5 landholders and works implemented during autumn 2004. Six dams with a total capacity of 31,000 m³ and approximately 12km of conventional grade banks were constructed. Total cost share payments for surface water engineering works were \$35,373.
