Bennett Brook

Bennett Brook – facts and figures

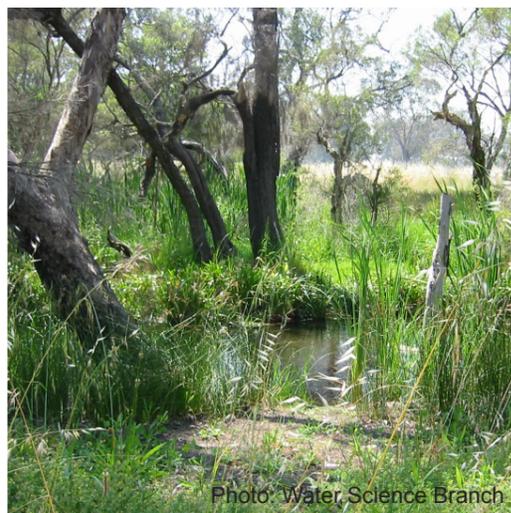
Photo: Water Science Branch
 Bennett Brook, riparian zone is reduced and dominated by exotics, November 2005.
