DEPARTMENT OF FISHERIES AND WILDLIFE
WETLAND — WATERBIRD SURVEY SHEET

WETLAND	Small Salt Lake
LOCATION	Nth of Lake Central 925 183 S 100000

INSPECTED BY	S. Benson
INSPECTION DATE	11.7.79
TIME START	1015
TIME FINISH	1025

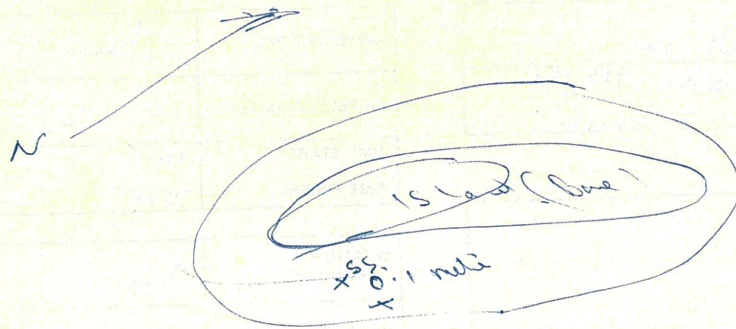
1. SKETCH MAP. (ROUTE OF INSPECTION SHOULD BE INDICATED.)

Small lake approx (5 ha) almost totally bare.
Small ~~number~~ of dead trees on east bank. This
is second line mallee sp. 30 meters from
water edge - just beyond HWM.
Sited in natural basin.

Line of silt of 0.15 m (surface).
No dead mallee altho debris signs
of recent activity by herons at
remains of wood. (Salmonia lake) + small
and white cream. carried into the
edge of water. Mallee debris into lake.
Max silt about 0.15 - 0.20 m.

Dense vegetation well Mallee sp (first lake)
~~mostly~~ ^{mostly} mallee live dead patches to south
of lake enters to Dusted lake.

Salicornia more towards south bank
(not Clavomy). Short species developed
+ small tufted species interspersed.
