REVEGETATION

IDENTIFYING AND MANAGING ACID SCALDS ON YOUR PROPERTY

Steve Appleyard

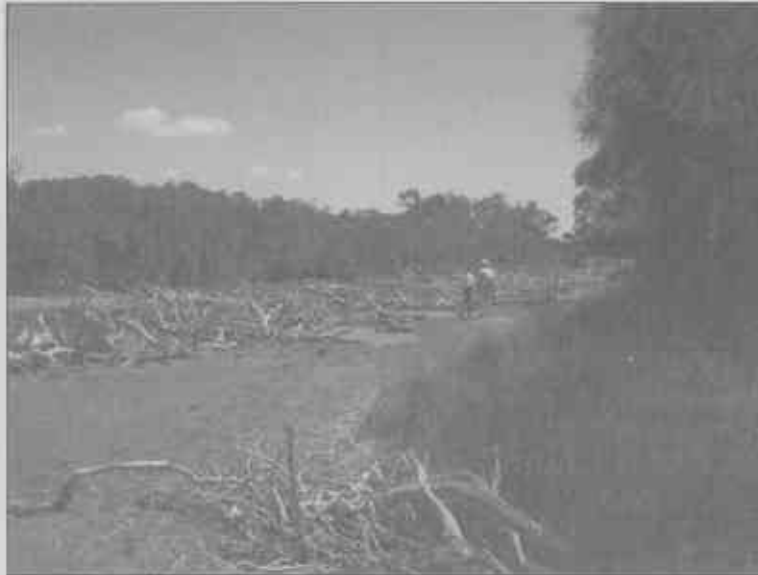
Acid scald near Yunderup, Peel Region
Photo: S. Appleyard

Acid scalds are the most visible indication that acid sulfate soils have been disturbed and are causing environmental harm. They are areas of bare land where vegetation has been killed by sulfuric acid, mineral salts and toxic metals drawn to the surface by capillary action as a result of the reaction of natural iron sulfide minerals with air in the soil profile. They typically start out as small bare patches a few metres across, but if not actively managed, they can expand to cover areas of more than 10 hectares over time intervals of as little as 5 to 10 years. Acid scalds as large as 200 hectares in area are known to occur in New South Wales and Queensland.

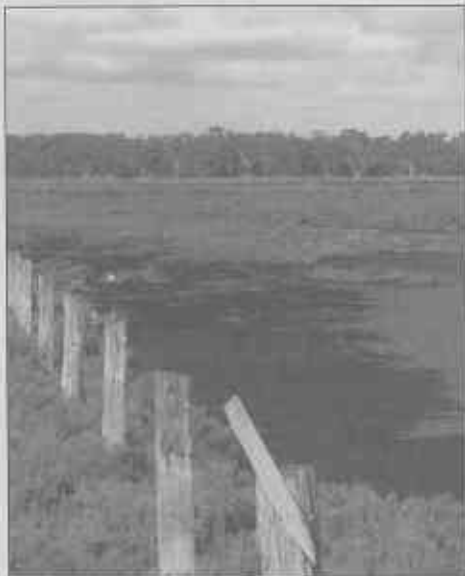
Iron monosulfides covering an acid scald, Leschenault Inlet
Photo: S. Appleyard

- *Surface deposits of black, oily-looking material (iron monosulfides)* – scald surfaces often have patches of black, oily material in waterlogged areas, particularly in winter. Occasionally the entire soil surface in scalds turns jet-black in winter, and then dries to a white or pale-brown colour in summer. The black material contains iron monosulfide minerals that are formed by bacteria in waterlogged conditions when there is a large amount of iron available.

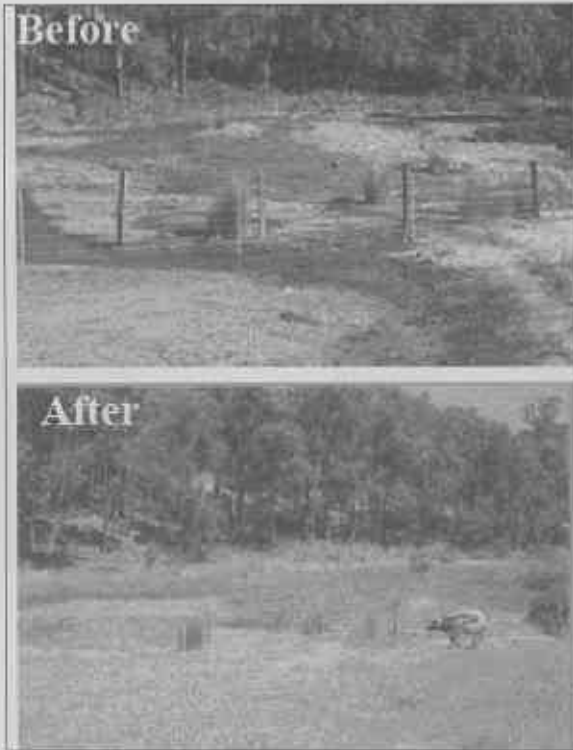
Changes in rehabilitation density in a scalded area near Capel one year after rehabilitation measures were implemented. Photo: Christine Webb

The following measures for revegetating acid scalds have been developed by Mark Rosicky at Southern Cross University in Queensland and have been successfully used to rehabilitate scalds near Capel:
