REVEGETATION

TALBOT HALL RESERVE REGENERATION PROJECT

Alison O'Dwyer and David Breen

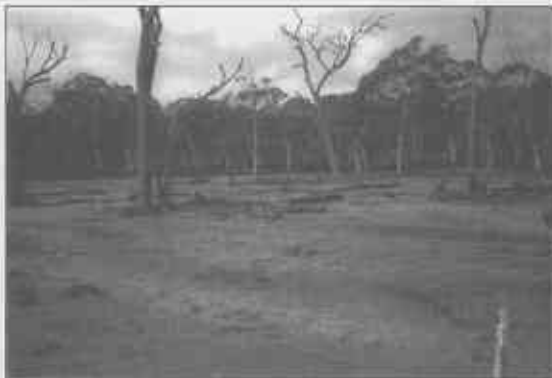
The area serves as a headwater of the Talbot Brook which flows into the Dale River before draining into the Avon River. The site is bounded by farmland and remnant wandoo woodland in excellent condition, but this location contains a seep and had been severely degraded by water erosion and salinity. The natural gradient of the site caused a sheeting effect that prevented seeds and seedlings from getting a firm foothold. At the time of commencing the rehabilitation project the group had no knowledge of acid sulphate soils and thought they were dealing only with a nasty salt scald and water erosion resulting from surrounding land disturbance.

Portion of degraded site before regeneration work commenced -1996

Management of surface water was achieved by machine digging a contour bank at the high end of the site and hand digging a shallower contour bank at the central point. The culverts at the lower end were cleared and upgraded to allow a free flow of water away from the site. (In light of the new knowledge of the behaviour of acid seeps, we are not sure of the value of some of this work.)

Fallen logs were left where they lay to arrest runoff. Salinity and pH levels were taken at selected sample sites.

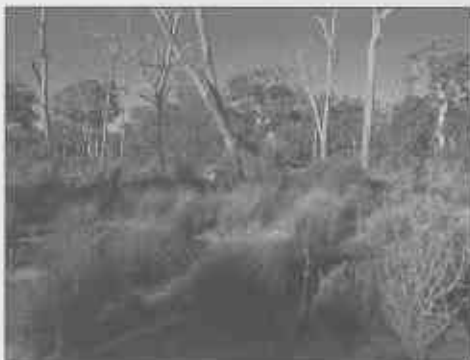
Portion of site after rehabilitation - 2006.

The site presents as a successful rehabilitation project. *J. kraussii*, *I. nodosa*, *M. thyoides* and *M. cuticularis* have grown well along the creeklines and in very wet areas and are absorbing, slowing and redirecting the water flow and stabilising the soil. The sheeting effect that was occurring in the higher ground has been reduced. The melaleucas are more than a metre high and the rushes are forming thick clumps. Samphire volunteers along the creekline are doing well.

Nearby, on comparatively higher ground, (often within metres of the creeklines) the replanted eucalyptus species and *C. obesa* are doing well. Also in these higher areas are a few healthy specimens of species that in 1998 were considered not to be doing
