River Science 14

The science behind the Swan-Canning Cleanup Program
Issue 14, October 2000

1998/1999 Canning River Oxygenation Trial

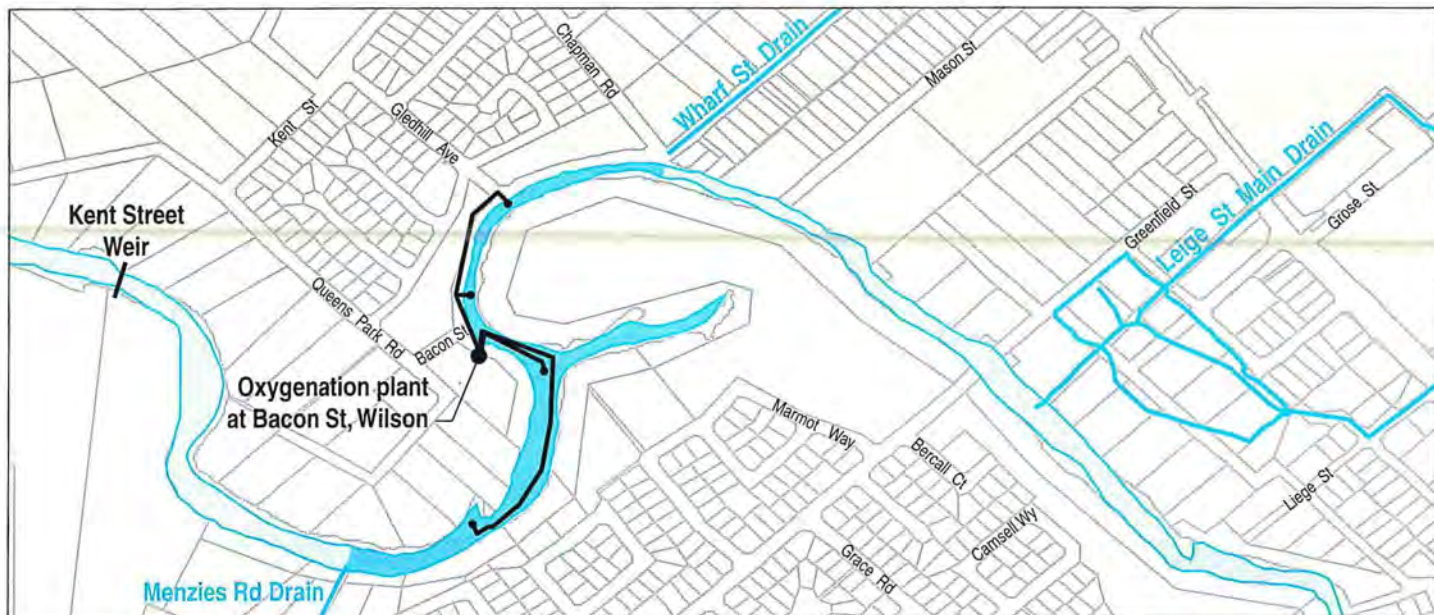
Figure 2: Location of oxygenation trial area showing location of plant and layout of diffuser pipes

The treatment area was 1 km long, and stretched 500 m either side of the oxygenation plant, which was situated at Bacon Street in Wilson. This area commonly experiences water quality problems related to anoxia (lack of oxygen) and often experiences severe phytoplankton blooms in summer.

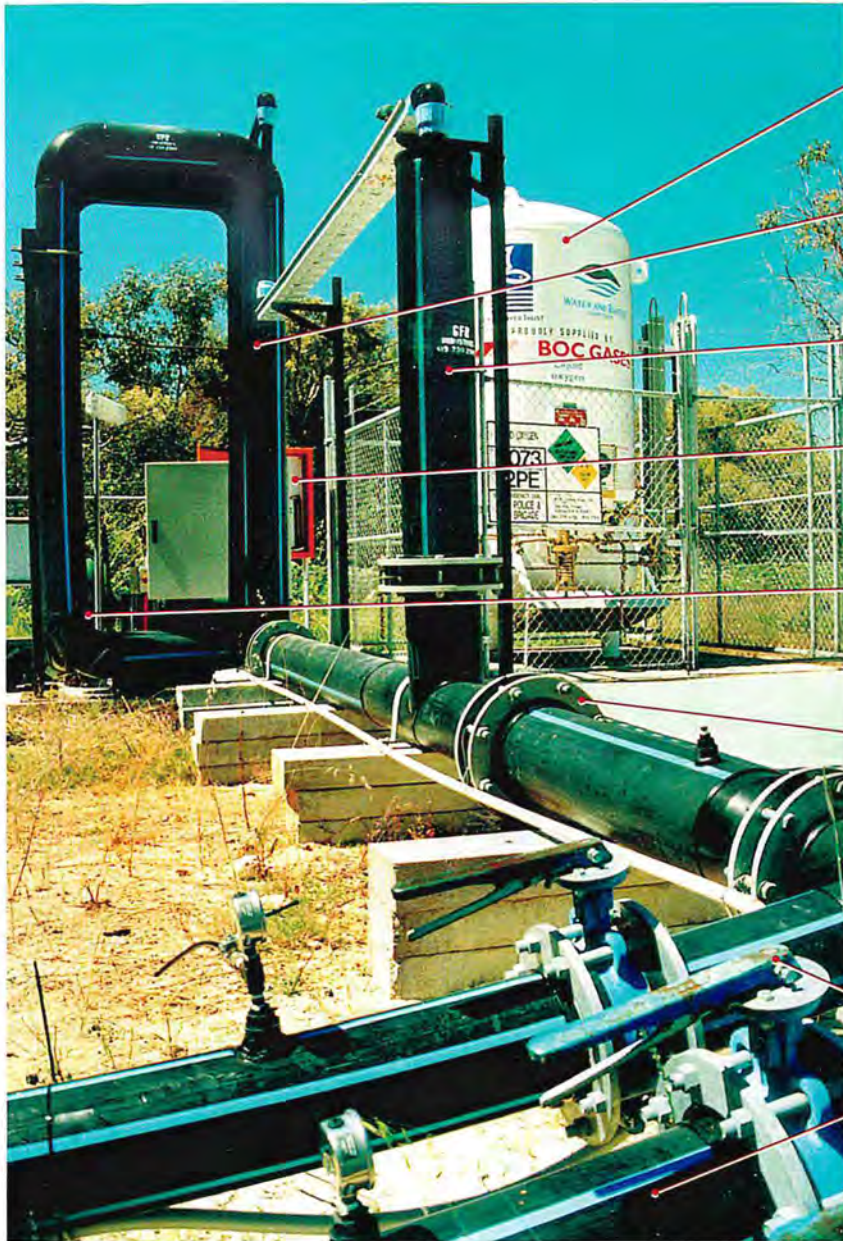
- Liquid oxygen vessel
- U-tube oxygen dissolver
- Pipe returning undissolved oxygen from phase separator to oxygen dissolver
- Control panel
- Pump draws water from the bottom of the river into the oxygen dissolver
- Phase separator collects the undissolved oxygen which is fed back into the dissolver
- Control valves allow flow to be distributed evenly between the pipes
- Distribution pipes return the oxygenated water to the trial area. The oxygenated water is gently diffused back into the river so that it doesn't stir up nutrient rich sediment

Figure 3: The oxygenation plant used in the 1998/99 trials

About 85% of the oxygen injected into the river remained in dissolved form. This was a major improvement from the previous trial, when the efficiency of the dissolver used was between 50% and 75%.
