CONSERVATION MANAGEMENT STRATEGY

GOLDEN VALLEY TREE PARK HOMESTEAD

PREPARED FOR: DEPARTMENT OF
BIODIVERSITY, CONSERVATION AND
ATTRACTIONS

DATE: FEBRUARY 2023

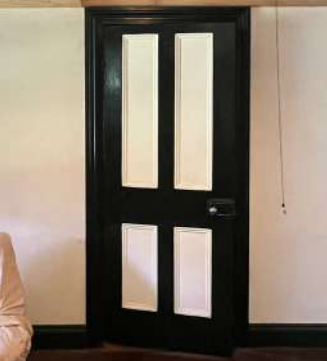
ITEM/ LOCATION	DEFECT DESCRIPTION	CONDITION	PROPOSED WORKS	PRIORITY	PHOTOGRAPH
D4 Bed 1	<ul style="list-style-type: none"> 4 panel timber door. Good condition New hardware introduced Cracking above door. Height of door with panes appears reduced 	B	<ul style="list-style-type: none"> Cracking above doorway to be rectified 	2

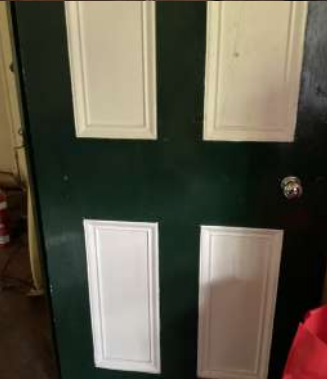
D5 Study	<ul style="list-style-type: none"> 4 panel timber door. New hardware introduced. Height of door with panes appears reduced. Door not fitting frame with some movement to frame evident. 	B	<ul style="list-style-type: none"> Door panel and frame to be adjusted to allow door to close. 	2

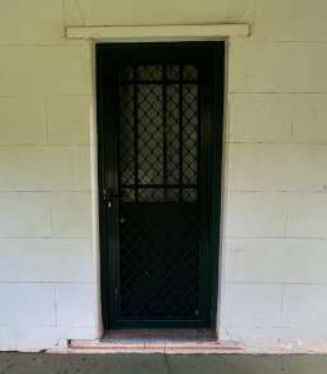
D6 Bed 1	<ul style="list-style-type: none"> New screen to door. Door works but sticky to open. Some movement to frame evident. 	B	<ul style="list-style-type: none"> Door panel and frame to be adjusted to allow door to be easily operable. 	2

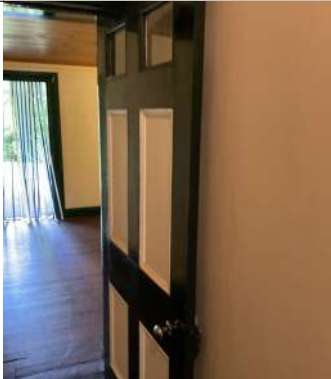
ITEM/ LOCATION	DEFECT DESCRIPTION	CONDITION	PROPOSED WORKS	PRIORITY	PHOTOGRAPH
D7 Hallway	<ul style="list-style-type: none"> 6 panel timber door with top two panels glazed. Good condition. 	B	<ul style="list-style-type: none"> No works required. 	4

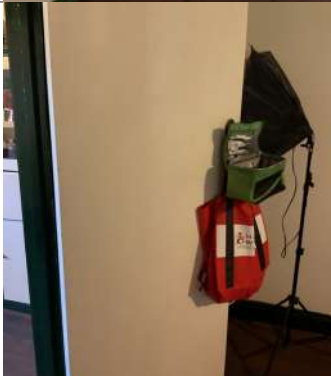
D9 Kitchen	<ul style="list-style-type: none"> Plain hollow core door. New door and hardware. 	B	<ul style="list-style-type: none"> No works required. 	4

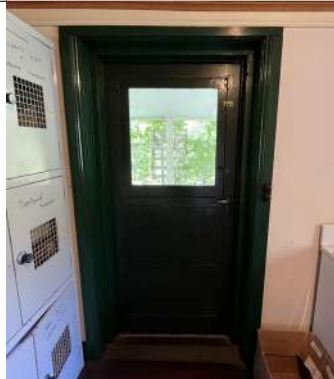
ITEM/ LOCATION	DEFECT DESCRIPTION	CONDITION	PROPOSED WORKS	PRIORITY	PHOTOGRAPH
D10 Kitchen	<ul style="list-style-type: none"> Stable style timber door with operable window. New hardware, additional latches. 	B	<ul style="list-style-type: none"> No works required. 	4

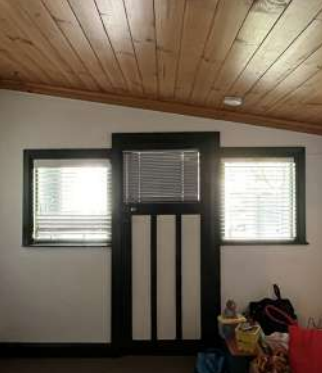
ITEM/ LOCATION	DEFECT DESCRIPTION	CONDITION	PROPOSED WORKS	PRIORITY	PHOTOGRAPH
D13 Bed 3	<ul style="list-style-type: none"> • Timber panel door with half glass and 3 vertical panels. • Blinds to sidelight windows and door glass pane/window. • New hardware. • Door stiff and often fails to function properly. 	B	<ul style="list-style-type: none"> • Adjust hardware to meet tenant's needs. 	4

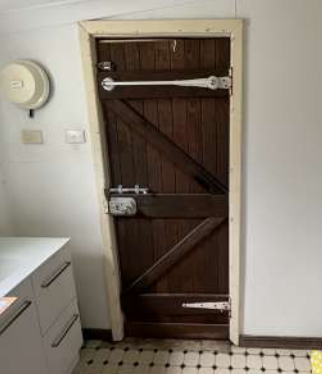
D14 Bathroom	<ul style="list-style-type: none"> • Ledged and braced timber door. • Dead bolt with latch. • Towel rail mounted to inside. 	C	<ul style="list-style-type: none"> • Oiling of timber door. • Weatherseal installed to the outside of the door. 	3

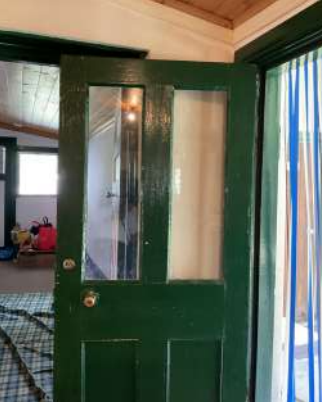
D15 Back Door/ Dining	<ul style="list-style-type: none"> • 4 panel timber door with top two panels glazed. • New hardware. • PVC strips as flyscreen. 	B	<ul style="list-style-type: none"> • No works required. 	4

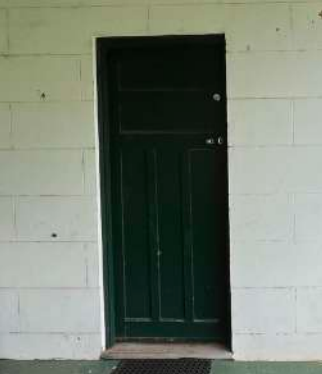
D17 Organ Room Back	<ul style="list-style-type: none"> Crack above door. New hardware. 	B	<ul style="list-style-type: none"> No works required. 	4

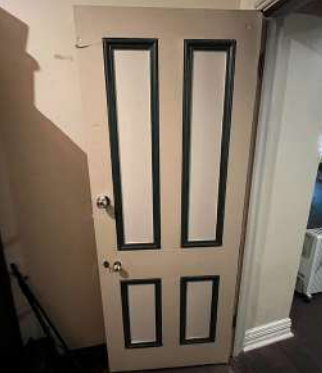
ITEM/ LOCATION	DEFECT DESCRIPTION	CONDITION	PROPOSED WORKS	PRIORITY	PHOTOGRAPH
D19 Organ Room/ Store	<ul style="list-style-type: none"> New 4 panel door 	B	<ul style="list-style-type: none"> No works required. 	4

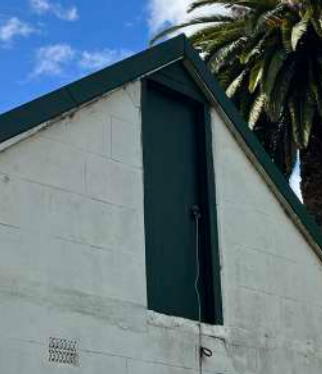
D20 Roof/ Loft	<ul style="list-style-type: none"> Ledged and braced timber door. Painted green. Good condition. 	B	<ul style="list-style-type: none"> No works required. 	4

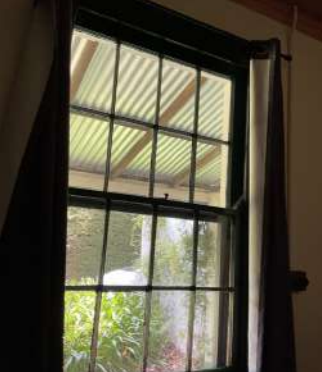
WINDOWS					
W1 Bed 2	<ul style="list-style-type: none"> Double-hung with 8 pane sashes. Functioning. New hardware evident. Hole in flyscreen. 	B	<ul style="list-style-type: none"> Flyscreen to be fixed. 	4

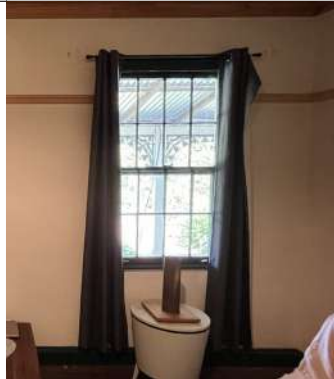
ITEM/ LOCATION	DEFECT DESCRIPTION	CONDITION	PROPOSED WORKS	PRIORITY	PHOTOGRAPH
W2 Living	<ul style="list-style-type: none"> • Double-hung with 8 pane sashes. • Painted shut • Previous fixings for curtains evident • Cracking above window 	B	<ul style="list-style-type: none"> • Window to be made operable 	2

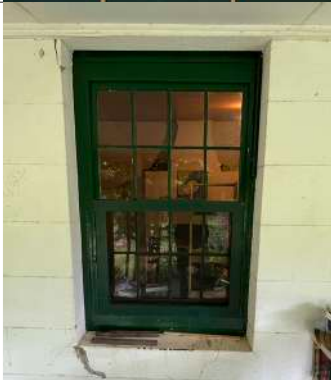
W6 Dining	<ul style="list-style-type: none"> Double-hung with 8 pane sashes. New hardware evident. Difficult to open. 	B	<ul style="list-style-type: none"> Window to be made operable 	2

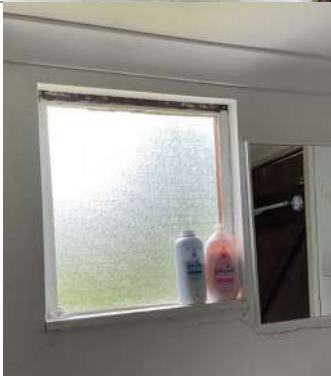
W7 Bathroom	<ul style="list-style-type: none"> Fixed opaque window. 	B	<ul style="list-style-type: none"> No work required. 	4

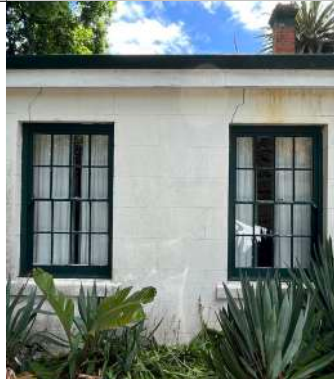
ITEM/ LOCATION	DEFECT DESCRIPTION	CONDITION	PROPOSED WORKS	PRIORITY	PHOTOGRAPH
W8/9	<ul style="list-style-type: none"> • Double-hung with 8 pane sashes. • Windows new c.1990 • Functioning • External cracking above windows • Weathering to external paint 	A	<ul style="list-style-type: none"> • No work required. 	4

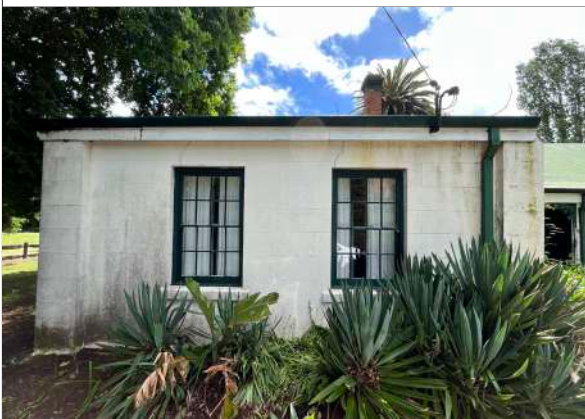
West elevation organ room

The west elevation of the organ room is rendered masonry with projecting corner piers. The elevation features two double hung windows with eight (8) paned sashes. There is cracking above each window. The rendered wall has a build up of moisture and mould to the base where the wall is adjacent to the front garden. The gutters are in poor condition and appear to be full with debris causing water damage to the fascias and render below.

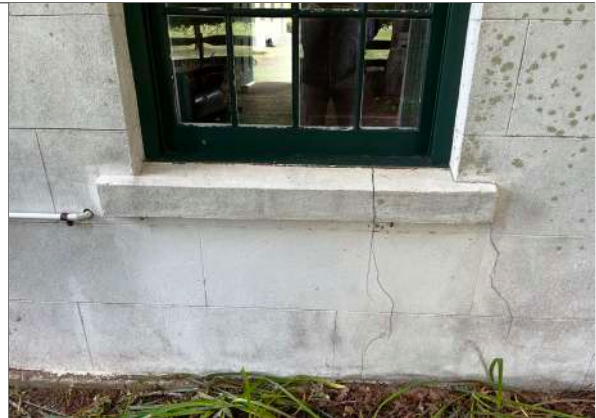
Northern window sill to organ room (W10)

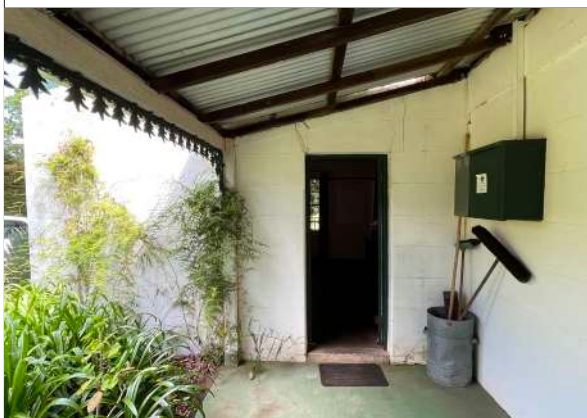
Organ room front door (D18)

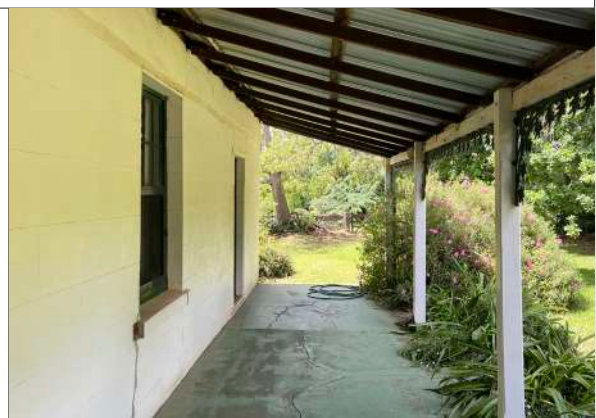
Front verandah facing south

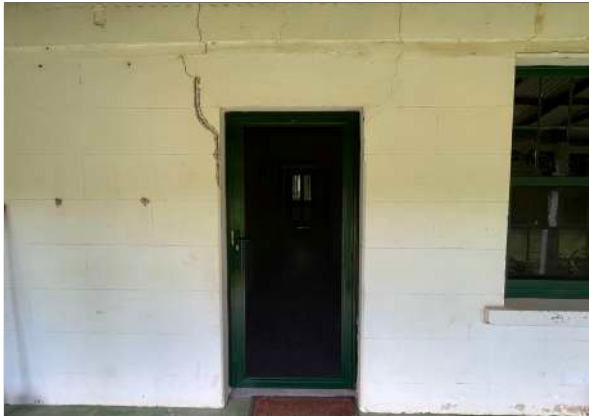
Homestead front door (D1)

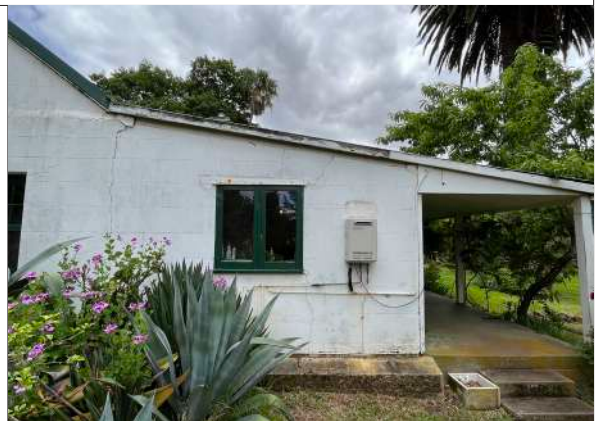
Rear kitchen lean-to and verandah

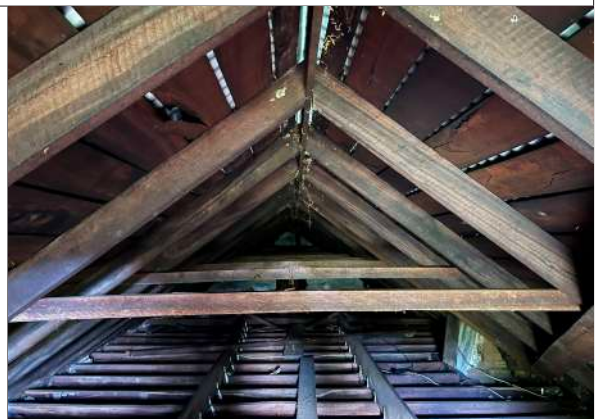
Roof rafters

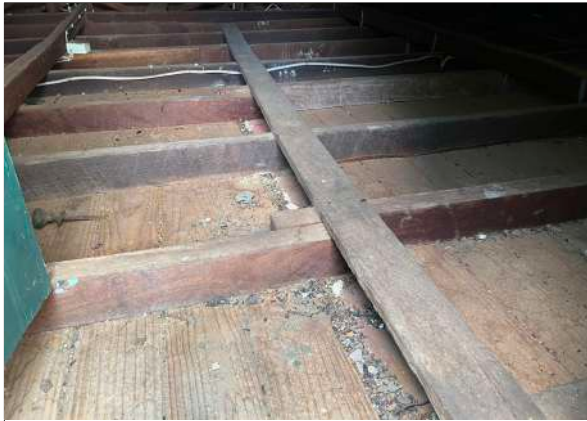
Ceiling structure

- 22 The existing ceilings in the Homestead were replaced during the c1990s. Further investigation is required to understand the original ceiling materials and details. If further information is uncovered then reinstating original ceiling detailing is recommended.

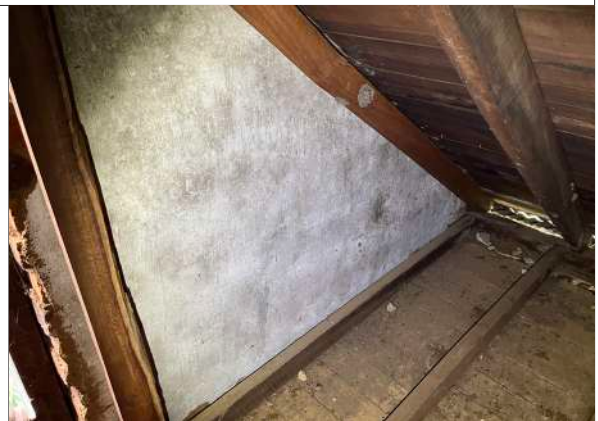
Evidence of original mud render

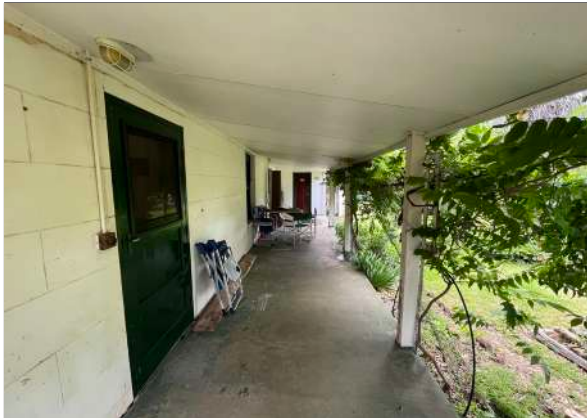
Rear verandah

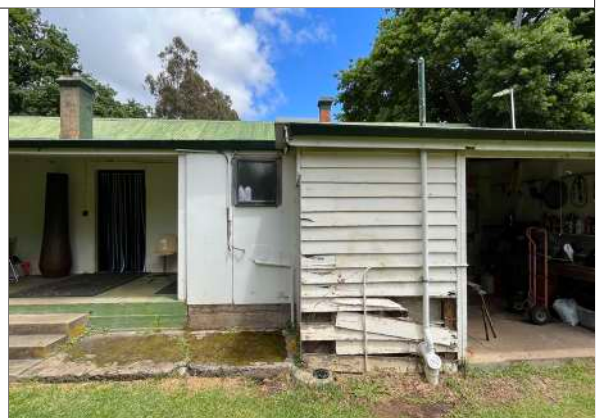
Attached Toilet

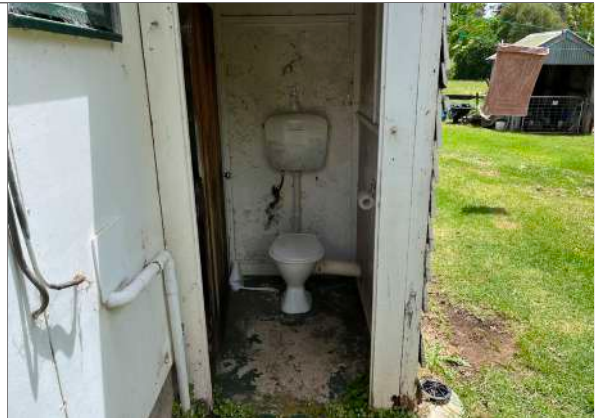
Toilet

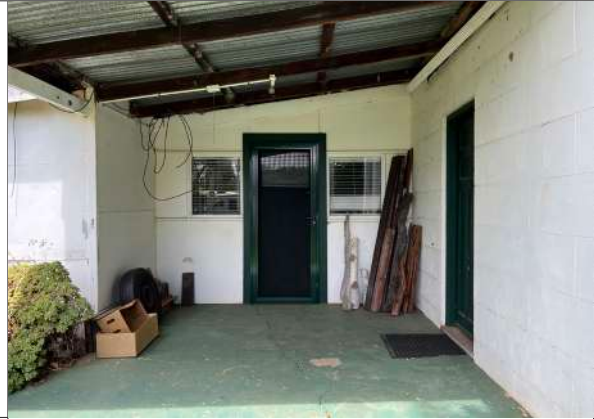
Side Verandah

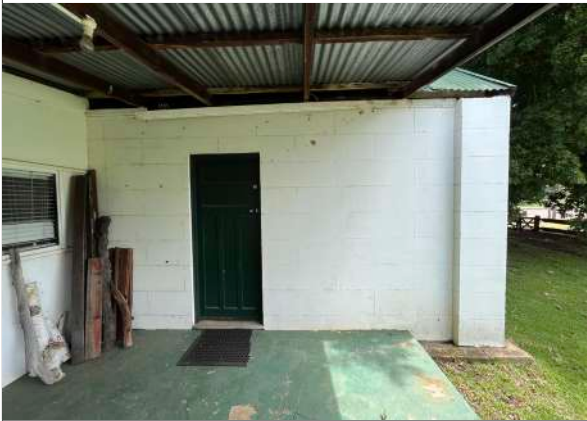
Side verandah with rear organ room door

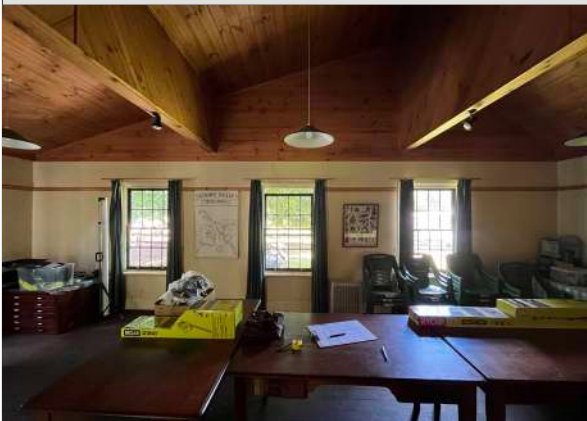
Organ Room northern windows

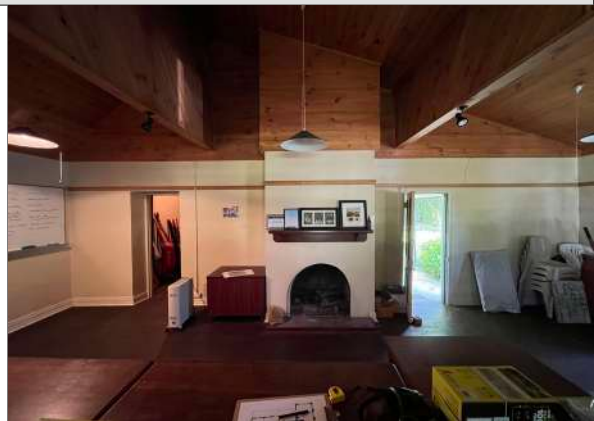
Organ Room fireplace

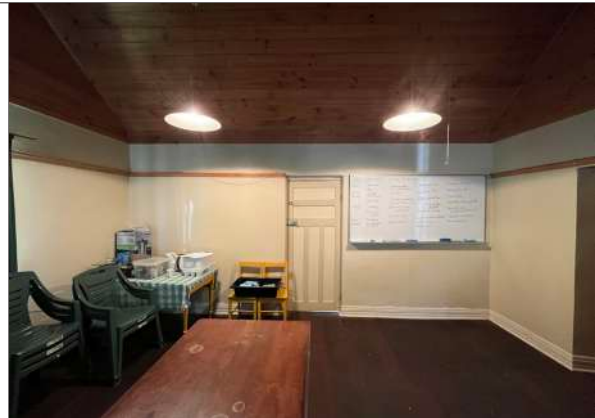
Organ Room back wall and door (D17)

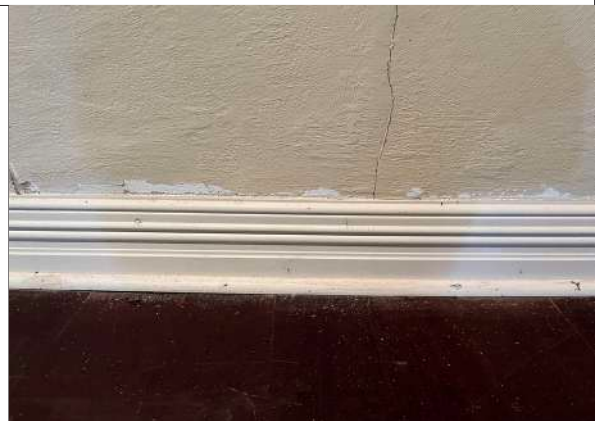
Organ Room skirting

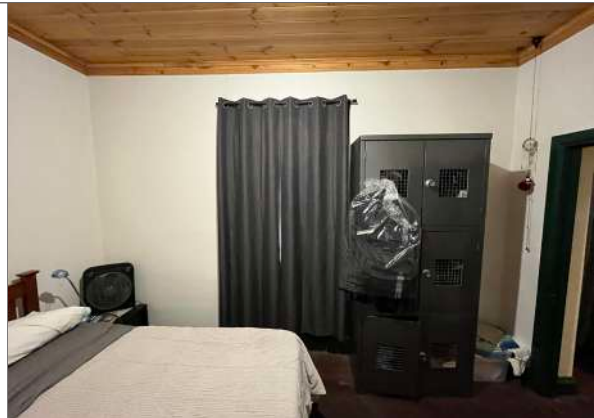
Curtain covering D6
